RE: FAUNA FLORA MANAGEMENT PLAN FOR STAGE V (INCLUDING PHASE 2 SWALE DRAIN) AND PHASE 1 SWALE DRAIN OF THE CARSELDINE VILLAGE RENEWAL MASTERPLAN

Attachment 1 – Stage V and Swale Development Plan

Attachment 2 – Stage V and Swale Fauna Flora Management Plan

Carseldine Village – Ecological Restoration Plan

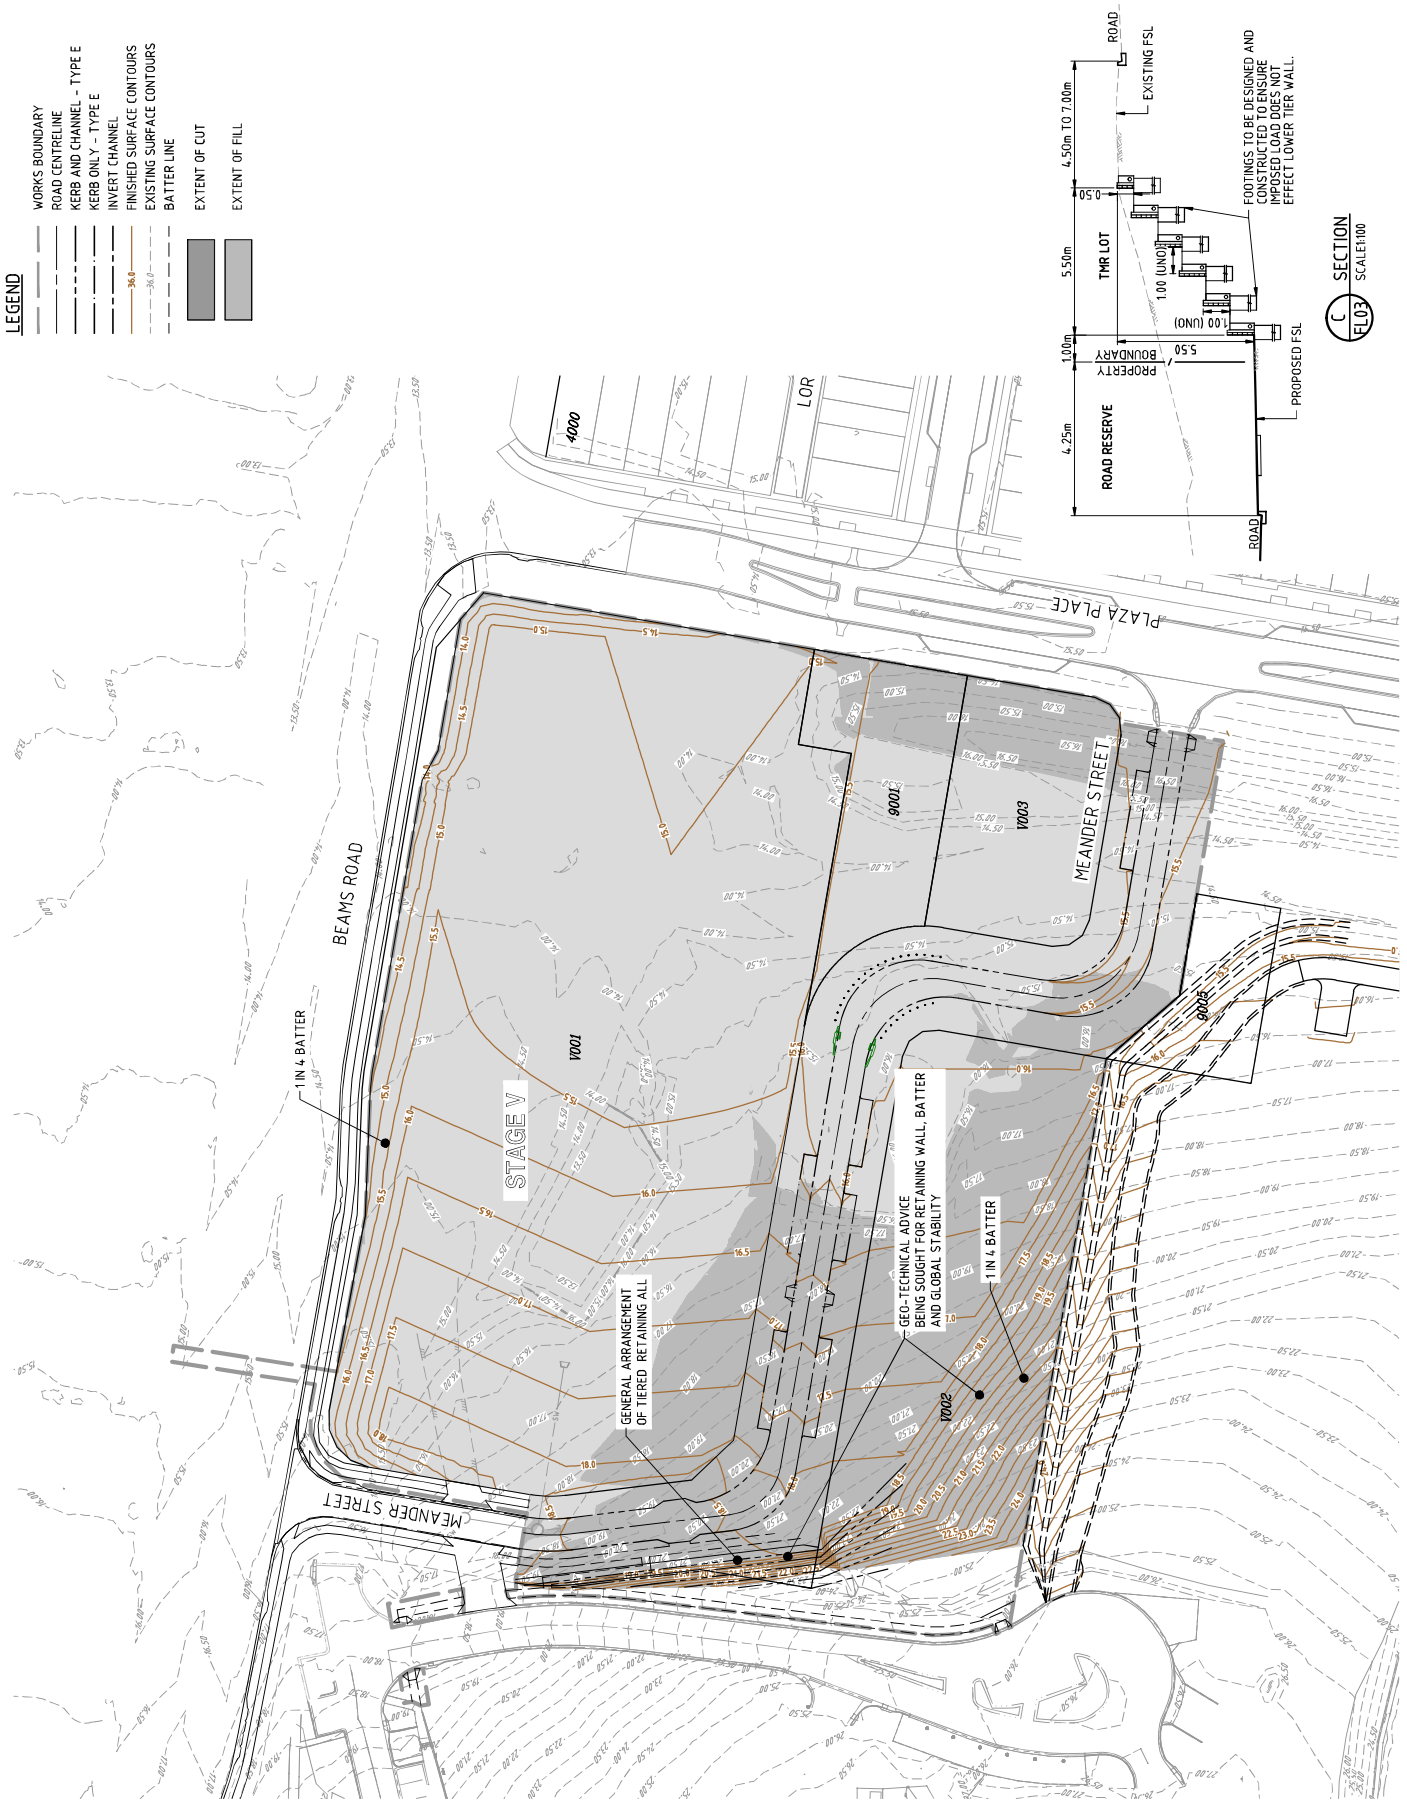
SECTION C (FLO3) SCALE: 1:100

FOOTINGS TO BE DESIGNED AND CONSTRUCTED TO ENSURE IMPOSED LOAD DOES NOT EXCEED LOWER TIER WALL.

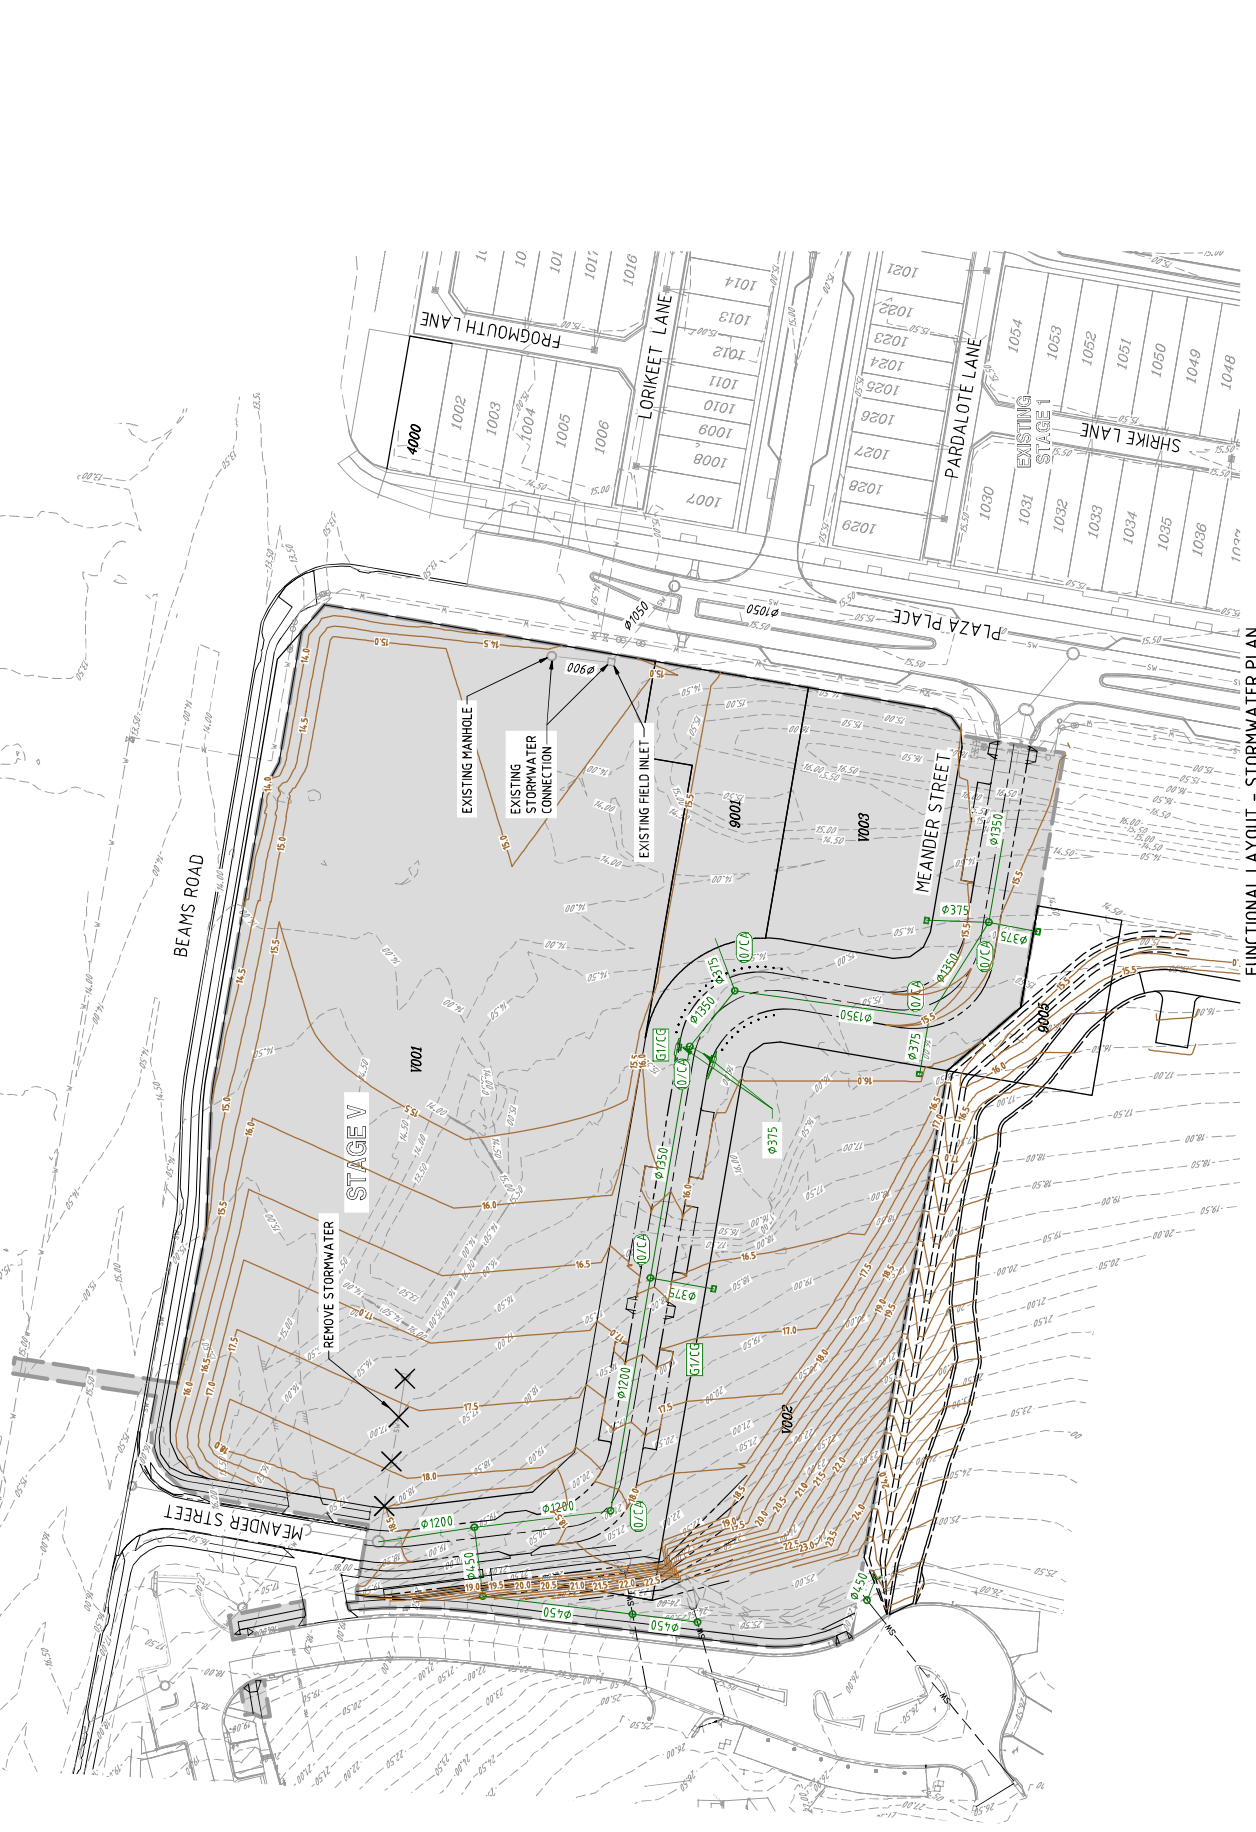
FUNCTIONAL LAYOUT - STORMWATER PLAN
SCALE 1:500

- LEGEND**
- WORKS BOUNDARY
 - KERB FACE
 - PROPOSED STORMWATER (PIPE SIZE TBC)
 - EXISTING STORMWATER

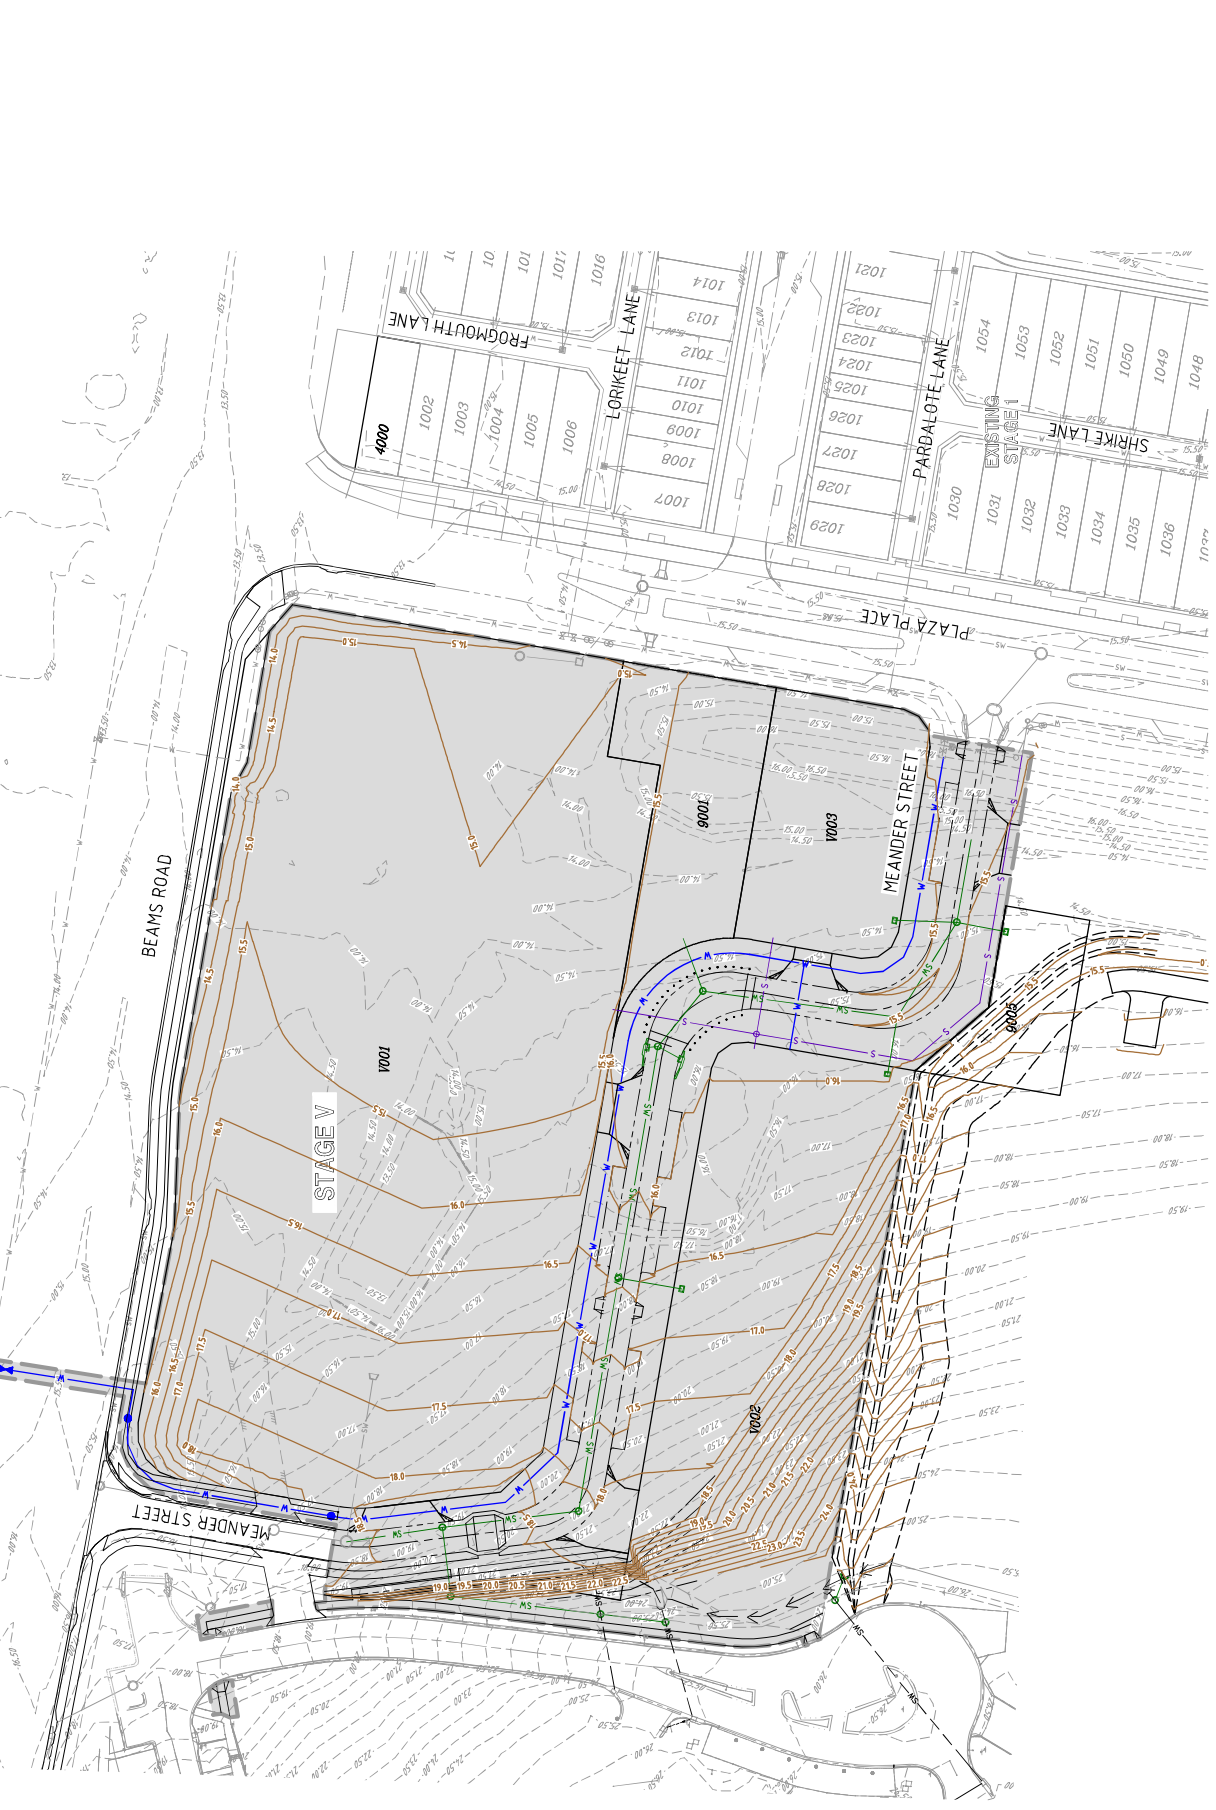
FUNCTIONAL LAYOUT- OVERALL SERVICES PLAN
SCALE 1:500 (AT UNREDUCED)

- LEGEND**
- WORKS BOUNDARY
 - KERB FACE
 - PROPOSED STORMWATER
 - PROPOSED SEWER
 - PROPOSED WATER RETICULATION
 - FINISHED CONTOUR
 - EXISTING STORMWATER
 - EXISTING SEWER
 - EXISTING WATER RETICULATION

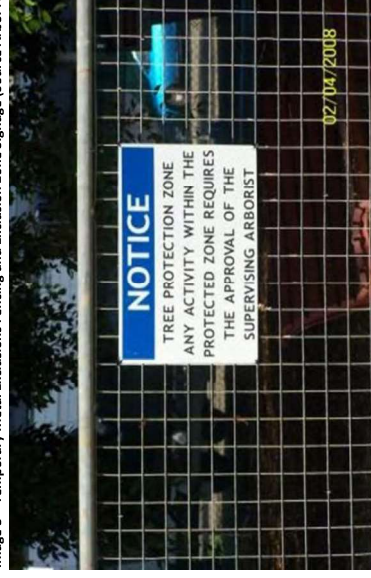
Image 3 – Temporary Metal Exclusions Fencing and Exclusion Zone Signage (Source Arbor Australis)

The Project Manager will be ultimately responsible to the establishment of or engage a contractor to establish the necessary Tree Protection Fencing in accordance with the recommendations by Project Arborist. Tree Protection Fencing must be erected under the direction of the Project Arborist and remain erected prior to and during all phases of the clearing and construction. Fencing may only be removed once construction works have been fully completed. Tree Protection Fencing requirements are outlined below:

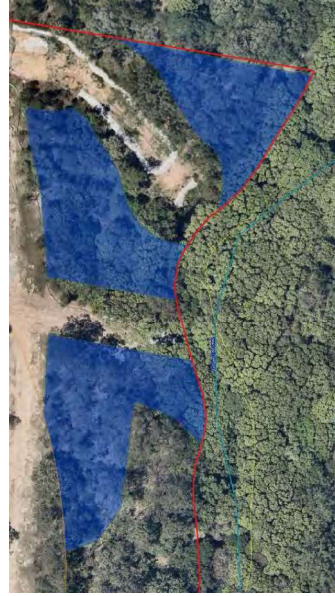
Inset 4 – MU2 and the degraded alluvial terrace

MU 2 is located within the far south eastern extent of the CV boundary and encompasses an existing patch of highly degraded vegetation. The existing vegetation is dominated by *Cinnamomum camphora** (camphor laurel), a highly invasive woody weed species with some highly scattered juvenile native canopy trees. This MU is considered to be non-remnant vegetation for the purposes of satisfying the compensation requirements under the FBMP and is a total of 0.59 hectares

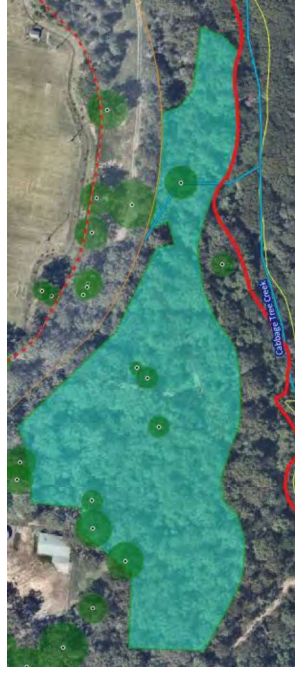
Inset 9 – View of MU4 and the extent of remnant vegetation to be subject to ANR

This community has a strong natural resilience and will benefit from weed management measures. The intent for this MU is to retain and enhance the open forest communities through natural regeneration methods. The main focus within this MU is to control, treat and remove the pest plant species, most notably the exotic understory. There are numerous exotic species present that will require attention the majority of which are listed in **Table 8**.
