**JOB NO DE21/264                      MAY, 2022**  
**GOLDING CONTRACTORS PTY LTD**  
**GEOTECHNICAL INVESTIGATION**  
**PRECINCTS 5 AND 6**  
**YARRABILBA**

Job No. DE21/264  
Ref No: 27330  
Author: D Marsden

**RE: REPORT ON GEOTECHNICAL INVESTIGATION FOR YARRABILBA – PRECINCTS 5 AND 6**

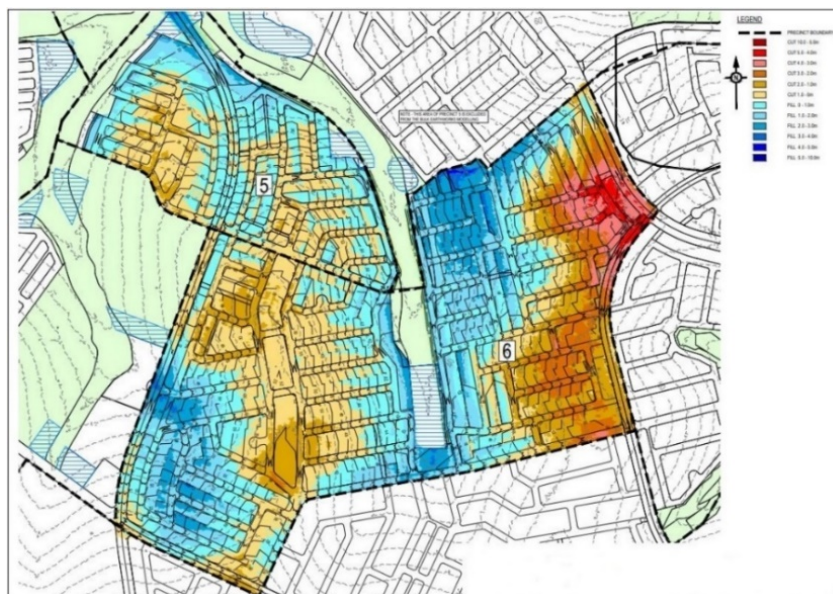
**Image 2 – Precincts 5 and 6 bulk earthworks plan (Provided by Peak Urban)**

The concept plans for the bulk earthworks are given in Image 2.

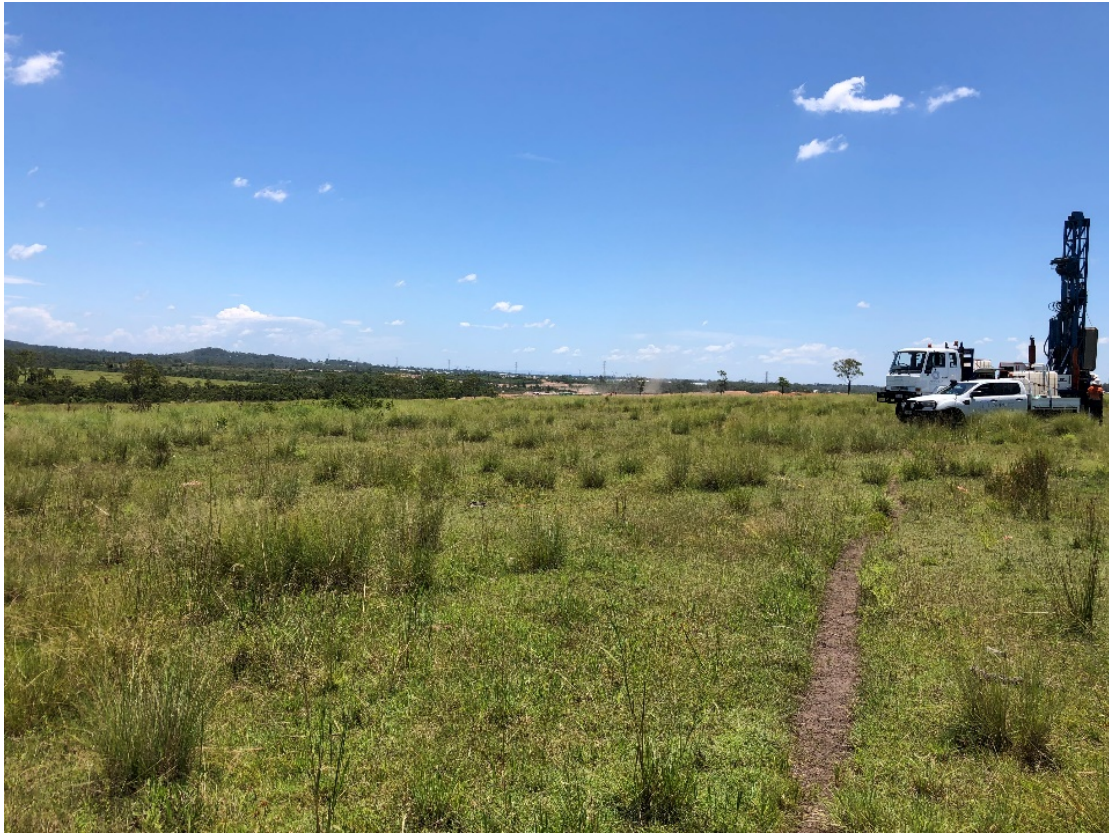
**Site Photo 1 – Photo looking north towards borehole BH6-3**

Site photographs 1 and 2 show the typical conditions of the Site at the time of the field work.
