# BUSHFIRE HAZARD ASSESSMENT & MANAGEMENT PLAN

**FLINDERS LAKE CABINS**

PLANS AND DOCUMENTS  
referred to in the PDA  
DEVELOPMENT APPROVAL

## Document Control

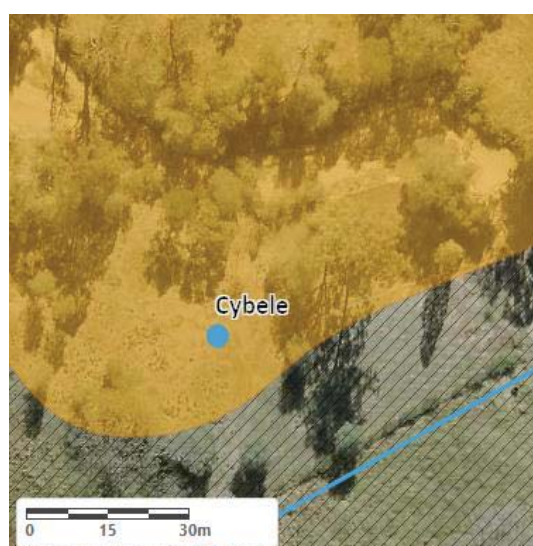
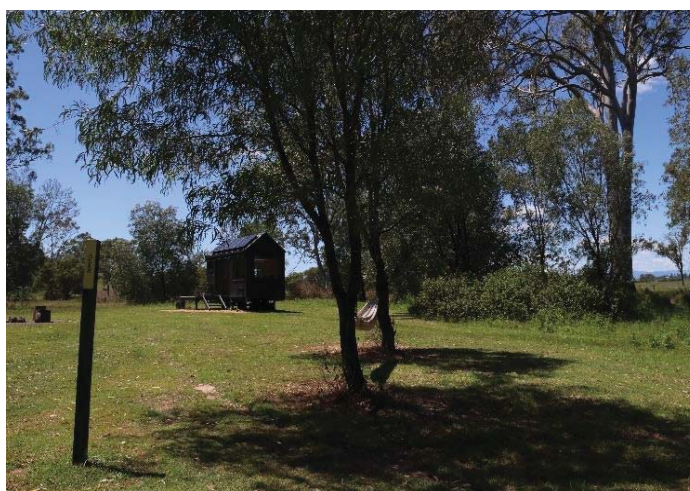
### Cabin Cybele

This cabin is located near the southeast corner of Lot 3 on S311896, with a creek wrapping the site to the east and north. The area is mapped as Medium potential bushfire hazard, and this is associated with vegetation within the narrow waterway corridor. The area immediately around the cabin is mature trees over a lawn or pasture grassland area.

Based on our site assessment the land around the cabin up to 100m can effectively be described as a low bushfire hazard based on the site characteristics of vegetation, fuel loads and slope.

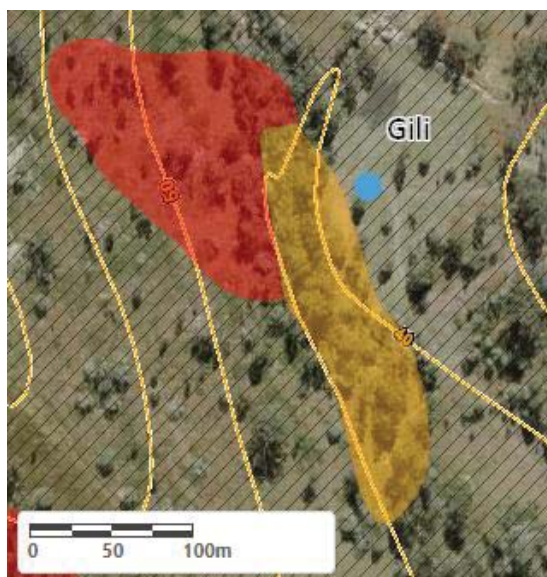
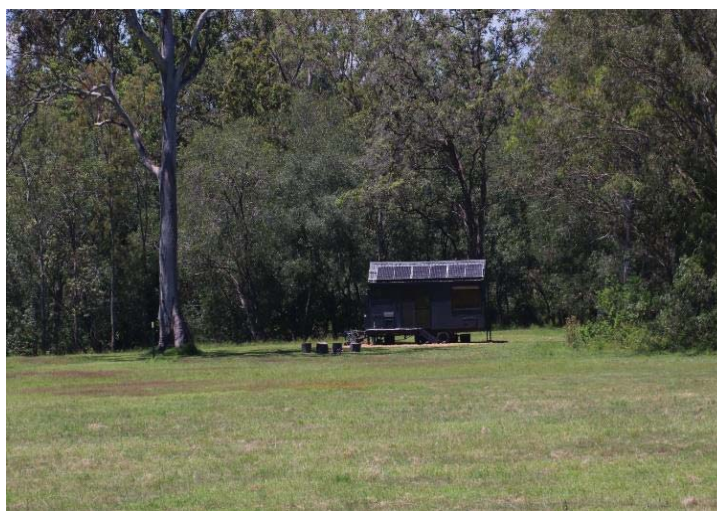
## **Cabin Gili**

The cabin is located near the southern boundary of Lot 200, in a loop of a Woolloman Creek tributary.

The cabin is located on a higher flat area with the vegetation to the west mapped as Medium and High potential bushfire hazard. The vegetation is within a waterway corridor with steep banks in some areas. The vegetation is a narrow corridor with much of the hazard mapping occurring over land that is clear of woody vegetation.

Based on our site assessment the land around the cabin up to 100m can effectively be described as a low bushfire hazard based on the site characteristics of vegetation, fuel loads and slope.

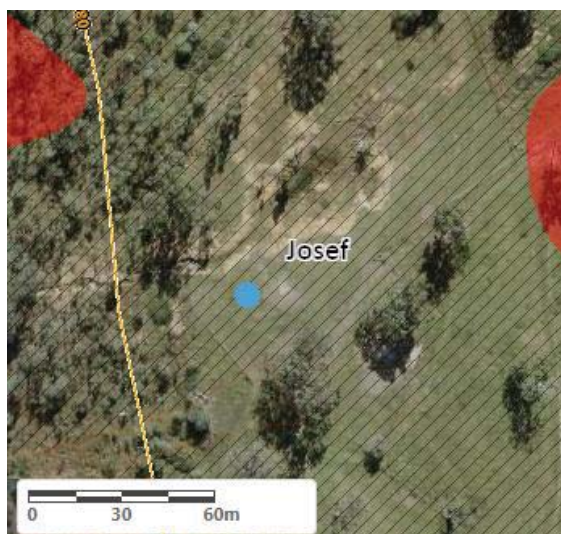
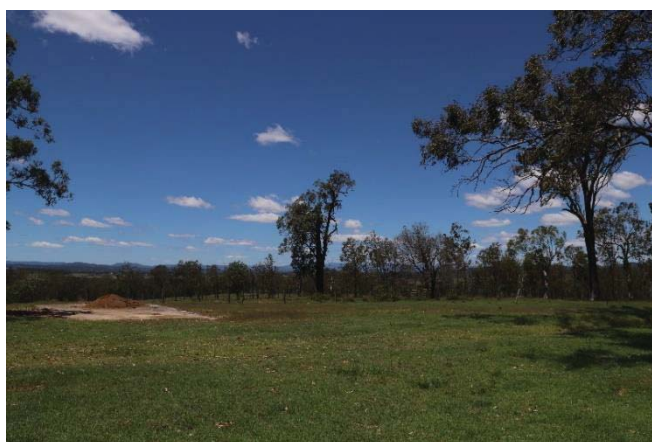
### **Cabin Josef (proposed)**

This cabin is located on a hillside to the south of a disused quarry near the eastern boundary of Lot 200 SP133189.

This area is mapped as a 100m bushfire impact buffer area. There are some individual trees within 100m of the proposed location. A stand of trees is located to the east on neighbouring land and is mapped as hazardous. This is likely a result of the topography rather than canopy cover. Bushfire mitigation will be to maintain an area of low fuel around the cabin preventing any potential fire run from neighbouring vegetation.

Based on our site assessment the land around the cabin up to 100m can effectively be described as a low bushfire hazard based on the site characteristics of vegetation, fuel loads and slope.

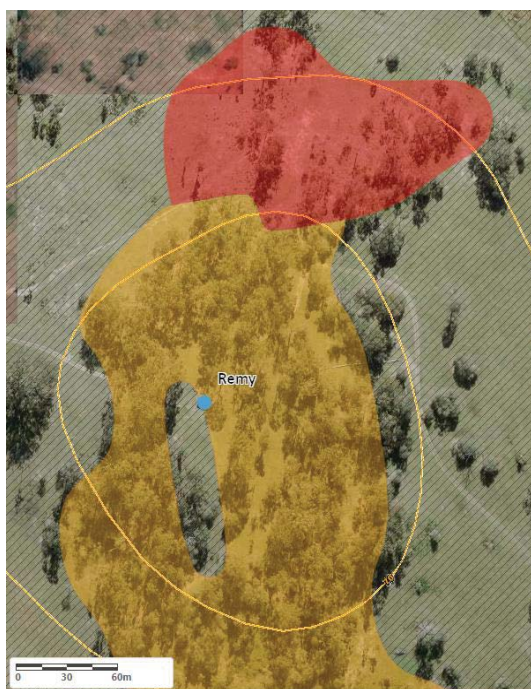
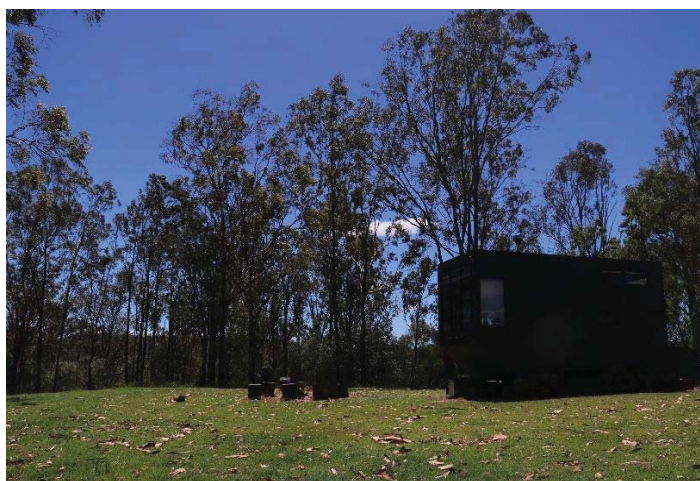
## **Cabin Remy**

The cabin is located on a treed hilltop in the southwest corner of Lot 3 S311896.

The area immediately around the cabin site is mapped as Medium potential bushfire hazard with a connected polygon of High potential bushfire hazard to the north. The topography of the land would result in short fire runs burning upslope to the plateau where the cabin is located or lower intensity flanking fires burning across the slope. The area mapped as high potential hazard is largely clear of woody vegetation and trigger mapping is related to topography rather than canopy cover.

Based on our site assessment the land around the cabin up to 100m can effectively be described as a low bushfire hazard based on the site characteristics of vegetation, fuel loads and slope.

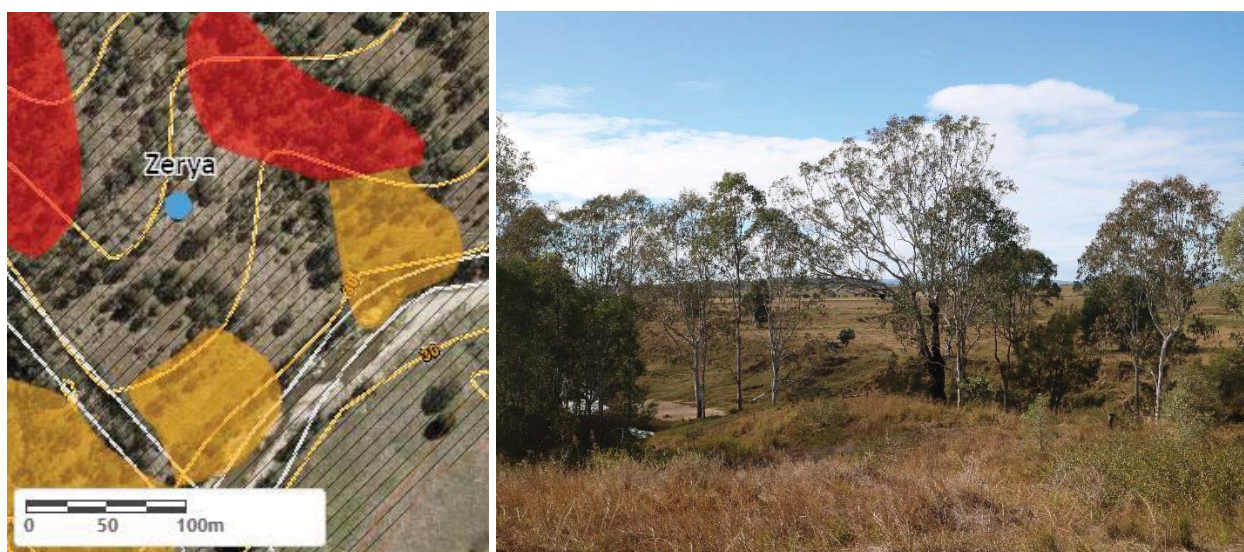
### **Cabin Zerya (proposed)**

Located to the north of a creek in Lot 200 on SP133189, the cabin is located on a south face of a hillside to the south of Wyatts Road. The site looks towards neighbouring land and the creek.

This area is mapped as a 100m bushfire impact buffer area. There are some individual trees and stands of trees within 100m of the proposed location. To the west is a gully with steep banks and this vegetation is mapped as hazardous. Similarly, to the west an area of vegetation is mapped as high potential bushfire hazard. This is likely a result of the topography rather than canopy cover. Bushfire mitigation will be to maintain an area of low fuel around the cabin preventing any potential fire run from neighbouring vegetation.

Based on our site assessment the land around the cabin up to 100m can effectively be described as a low bushfire hazard based on the site characteristics of vegetation, fuel loads and slope.

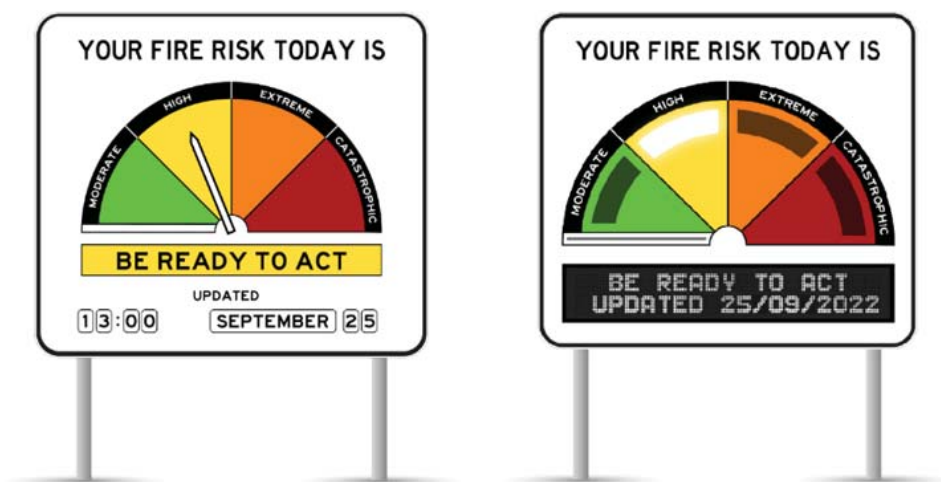
Fire danger ratings under the Fire Behaviour Index can be viewed on the Bureau of Meteorology website (BoM, 2022) under the “South East Coast” district:

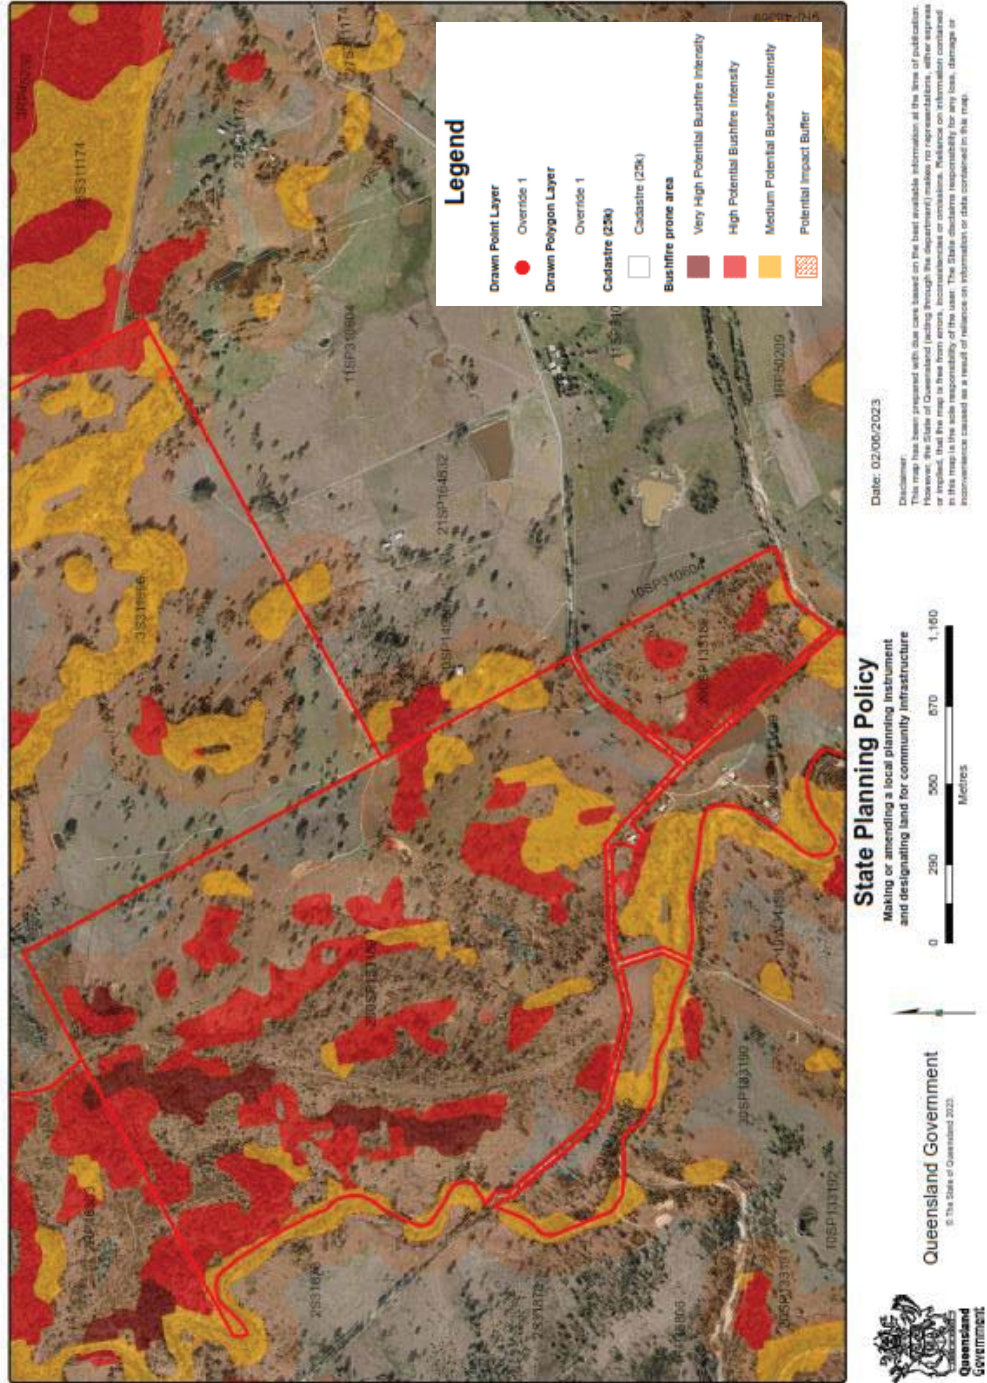
9 ATTACHMENT 1 – BUSHFIRE HAZARD MAPPING

The State Planning Policy Natural Hazards Risk and Resilience Bushfire Hazard mapping (Attachment 1) maps polygons of High and Medium Potential Bushfire Hazard within the property. Two cabins are located in a mapped medium potential bushfire hazard area and the remaining three cabins are mapped within an associated 100m impact buffer area.

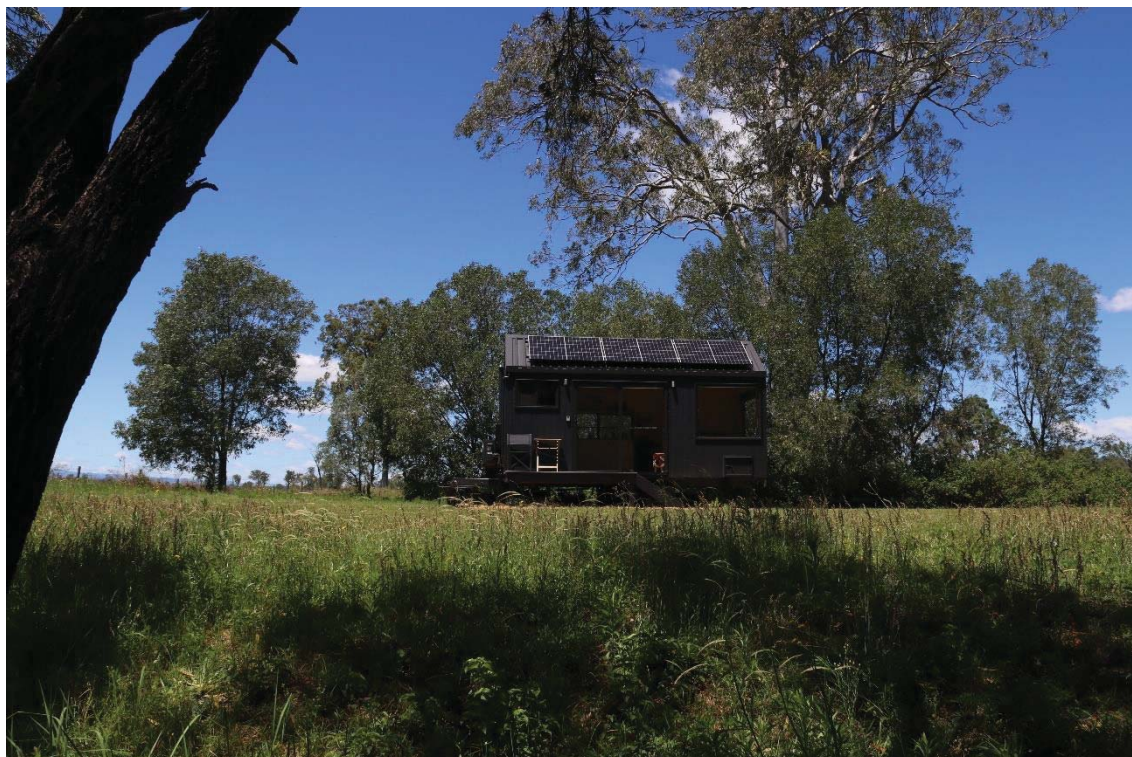
**Photographic Plate 1:** View of Cabin Cybele from the creek bank to the north of the location. The grass up to 10m from the cabin and campfire area is maintained at 100mm. Pasture areas greater than 10m away are regularly slashed or grazed

An asset protection zone around each cabin should be maintained up to 20m from all assets and guest accommodation and amenities, with grass regularly mown to a height of no more than 100mm.

9. A grass area less than 100mm in height is to be maintained up to 20m from the cabins.
10. Vegetation within the greater area of the property is maintained by short-term rotational grazing and regular slashing.

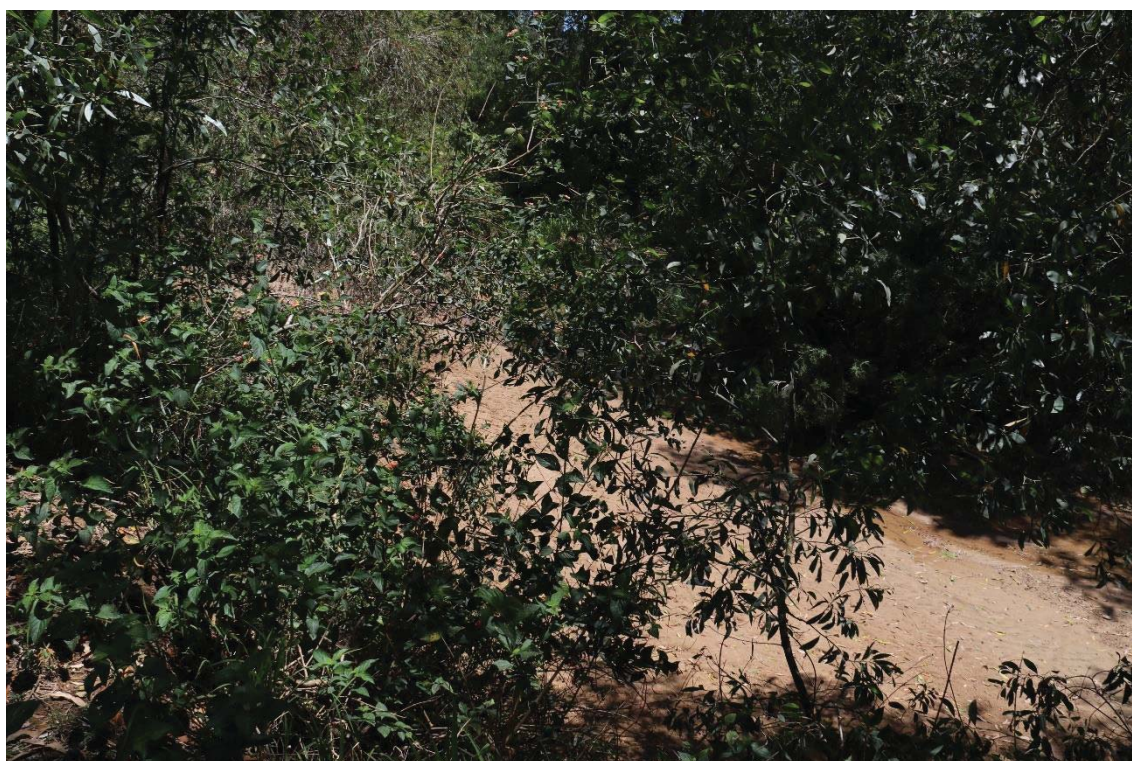
**Photographic Plate 2:** View into the sandy creek bed to the north and east of cabin Cybele.

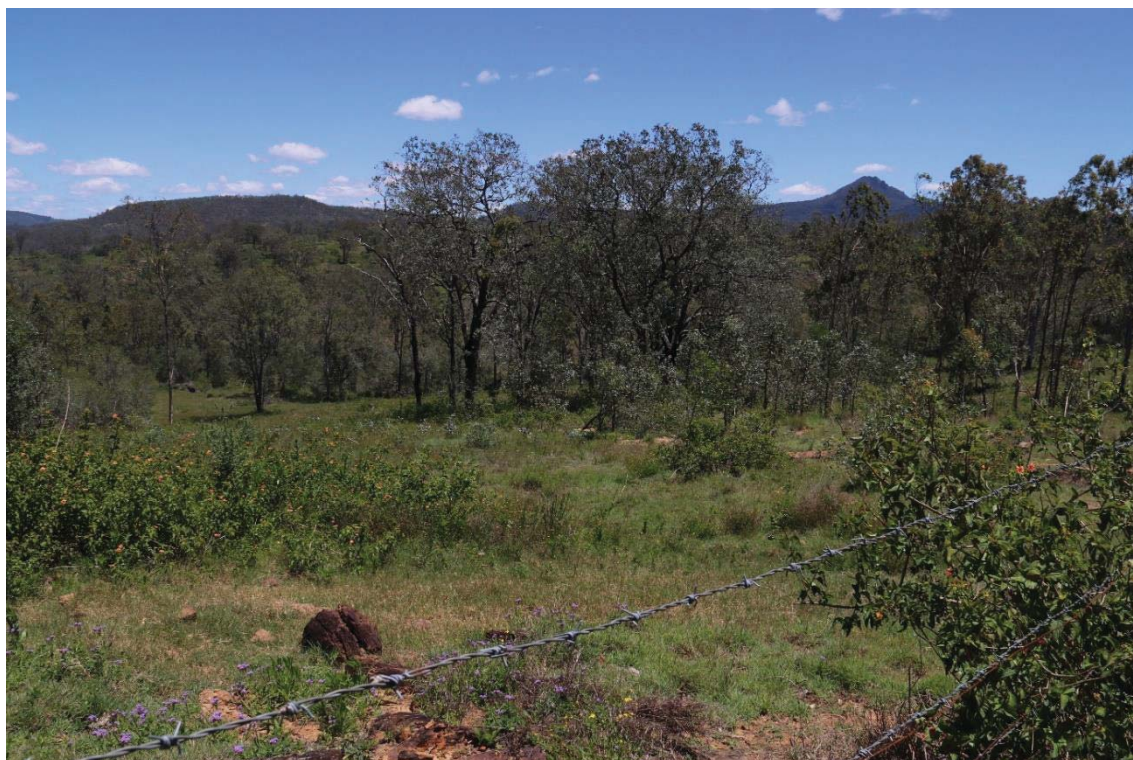
**Photographic Plate 3:** Vegetation mapped as hazardous near Cabin Josef proposed location. Note the understory is low grassland with some Lantana under mature trees and stands of trees.

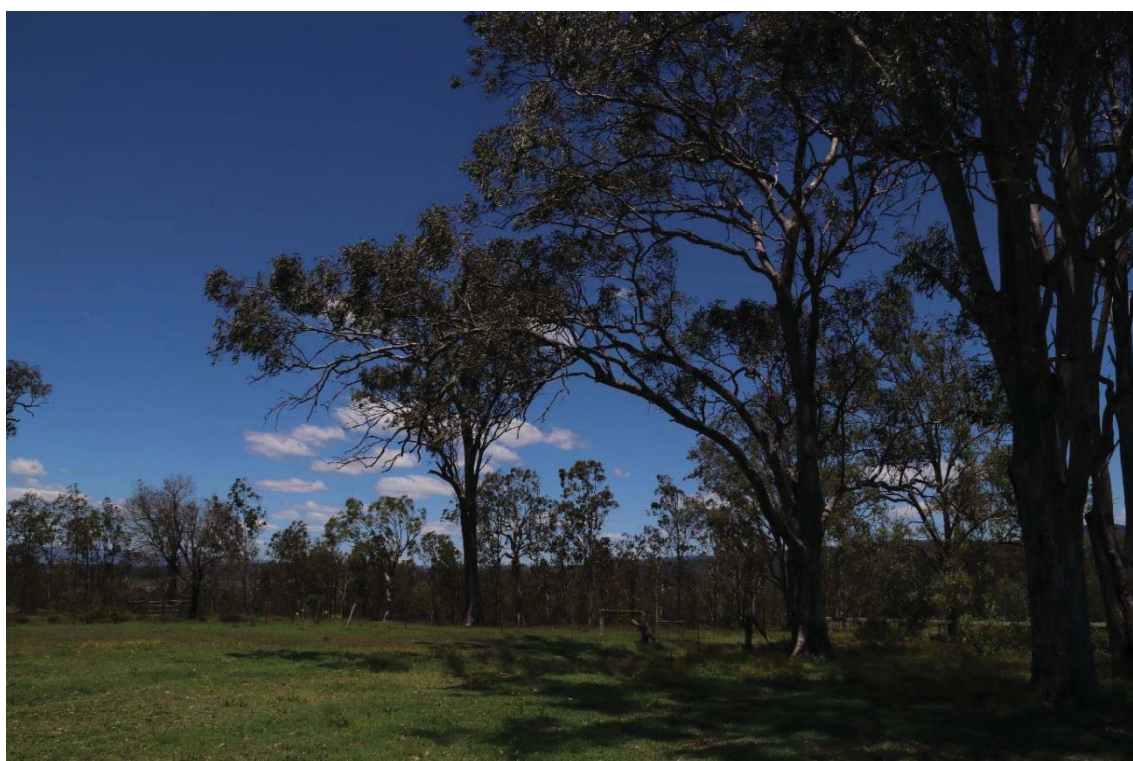
**Photographic Plate 4:** View of potential site for Cabin Josef and vegetation to the southwest.

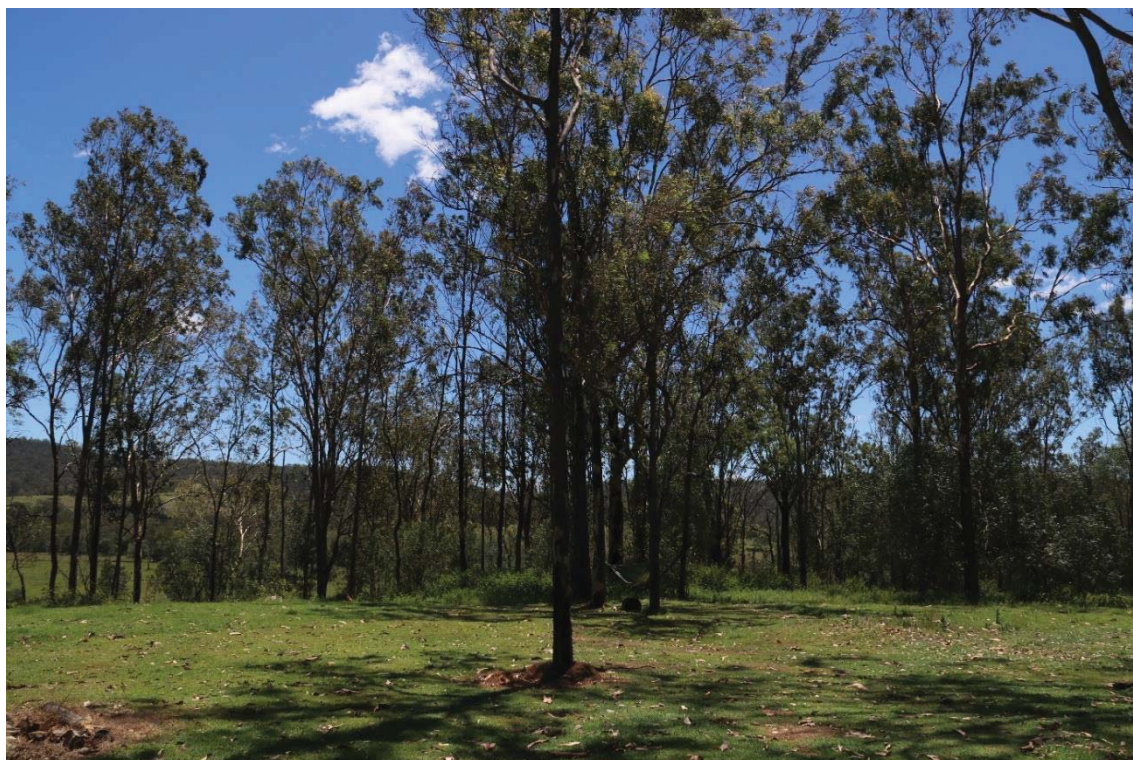
**Photographic Plate 5:** Vegetation mapped as potentially hazardous to the north of Cabin Remy. This cabin is located on a hilltop that has woody vegetation on the slopes surrounding the cleared plateau.

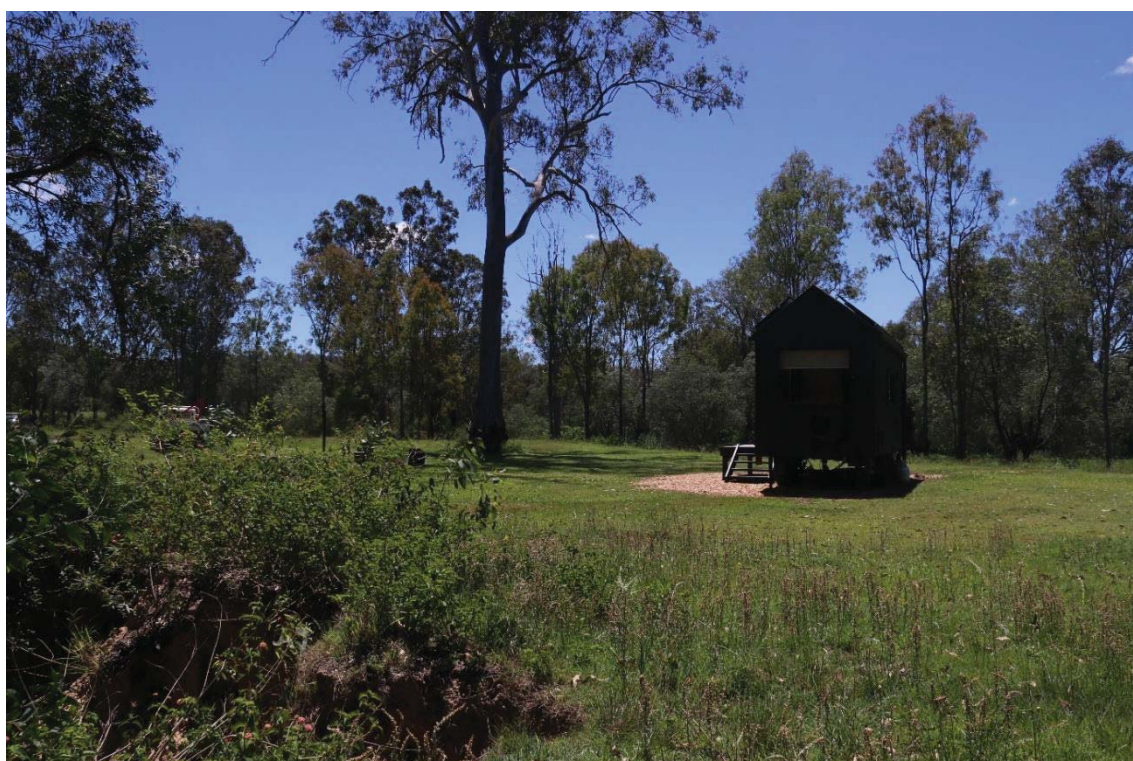
**Photographic Plate 6:** View of Cabin Gili from the step bank of the waterway to the west of the site.

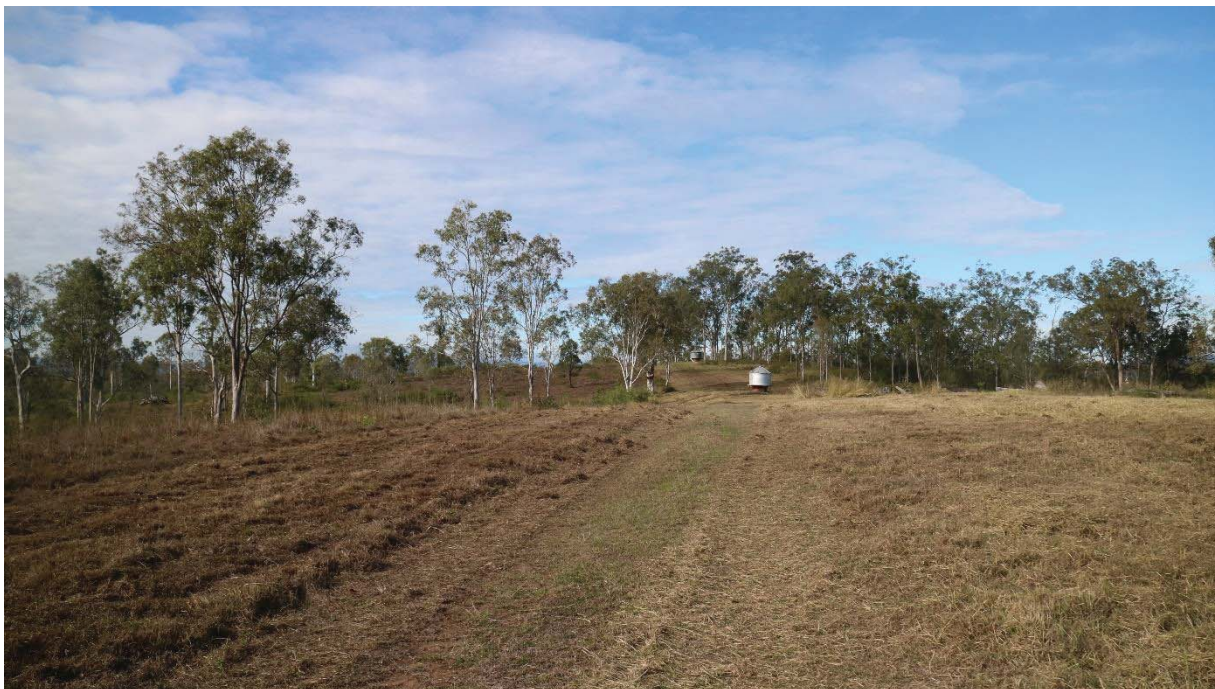
**Photographic Plate 7:** View to the north of Cabin Zerya showing an access track to Wyatt Road for occasional vehicle access.

6. Internal vehicle tracks meet the requirements of the Natural Hazards, Risk and Resilience - Bushfire State Planning Policy state interest guidance material (2019):
7. Access tracks have a minimum trafficable width of 3 metres and are cleared of woody vegetation to 5 meters wide and 6 meters high.
8. All pedestrian pathways are to be clearly identified with high-vis pegs and maintained to a Class ¾ track as per AS2156.1-2001 Walking Tracks Part 1.

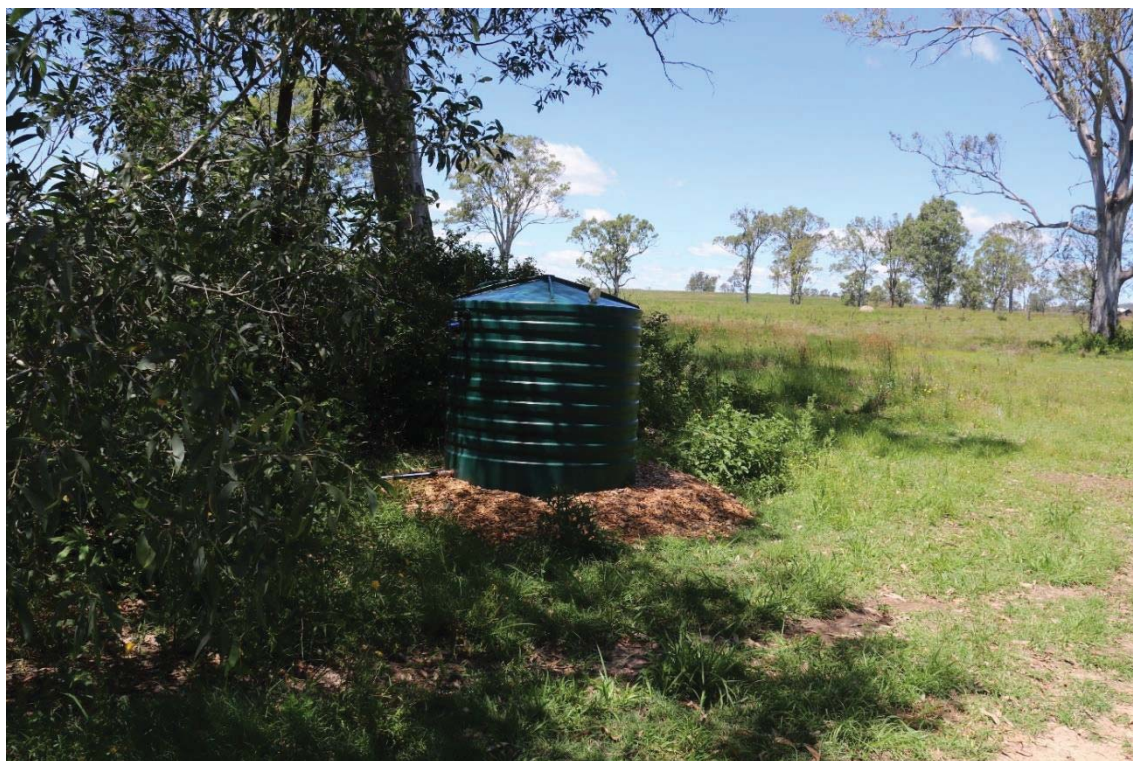
**Photographic Plate 8:** Potable water storage for each cabin is located within 100m of the cabin site and is not used for firefighting purposes.

3. Gas bottle storage is on a concrete pavers with no vegetation growing around the storage area.
4. Potable water storage is to be located within 100m of each cabin on a non-flammable bases.
5. Campfire areas are a gravel base approximately 2.5m in diameter with non-flammable designated central fire pit. Herbicides are used to control any vegetation growth around the campfire areas.

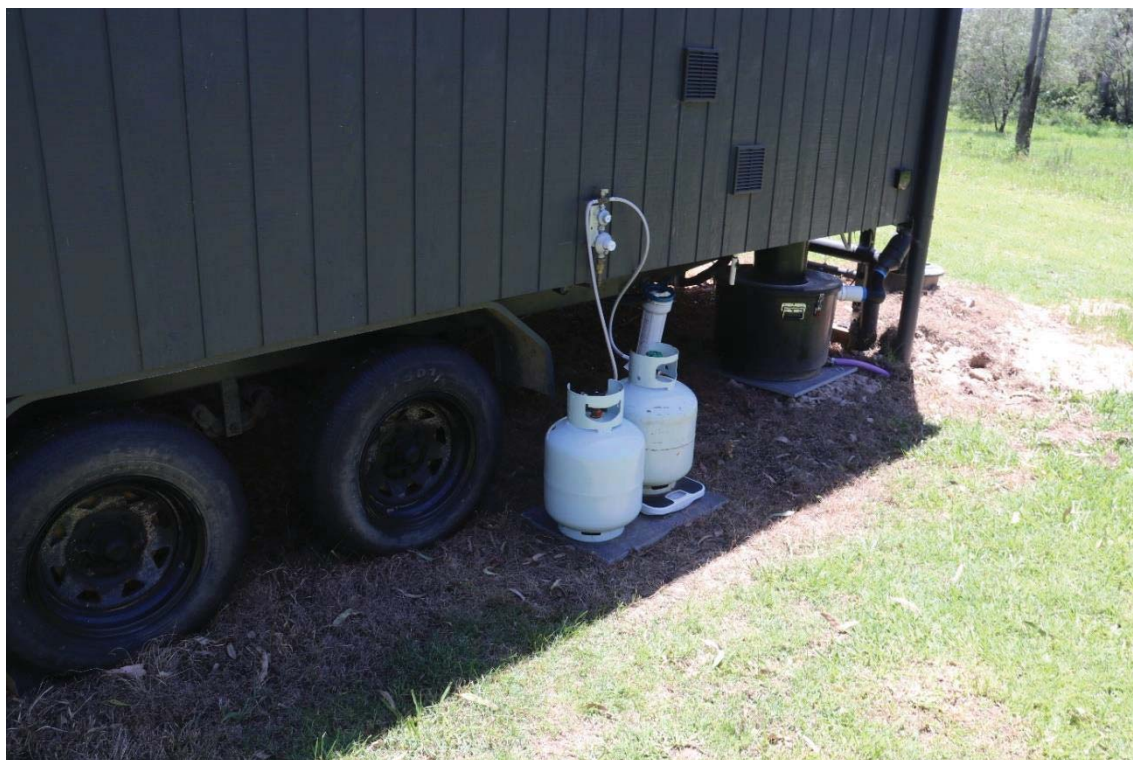
**Photographic Plate 9:** Gas tank storage is located on a concrete slab at each location. Weed and vegetation control is undertaken under the cabins and around the gas storage areas.

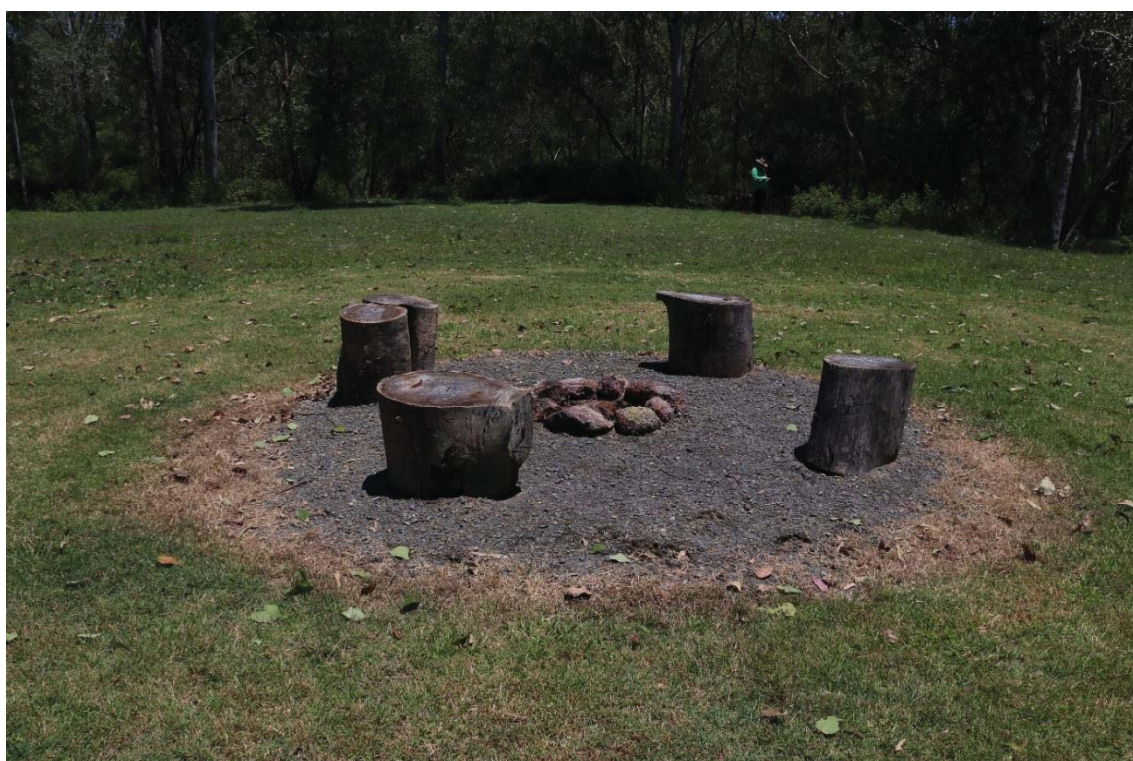
**Photographic Plate 10:** Campfire areas are a gravel base approximately 2.5m in diameter with non-flammable designated fire area. Pesticides are used to control any vegetation growth around the campfire areas.

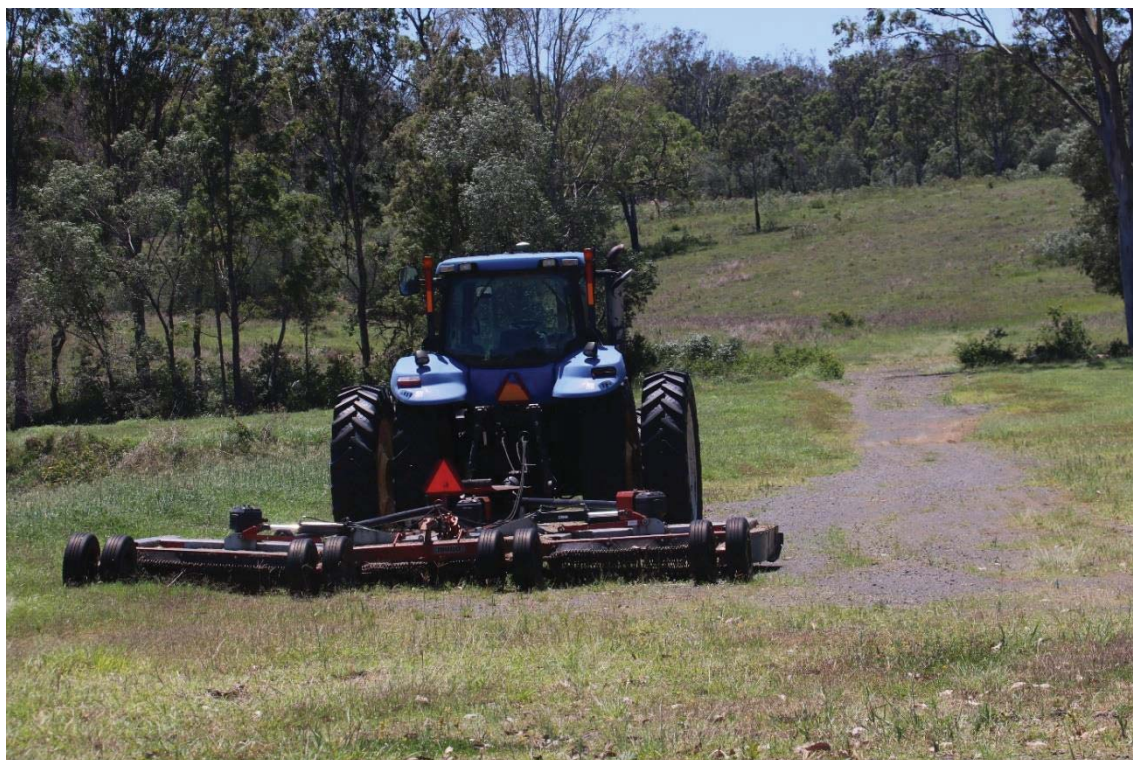
**Photographic Plate 11:** Regular slashing is part of ongoing vegetation management between grazing cycles. This will reduce the risk of any bushfire impacting cabins and other infrastructure.
