Report on  
Geotechnical Investigation

Proposed Residential Development  
Park Road, Yeronga

Prepared for  
Brisbane Housing Company

Project 97679.00  
January 2021

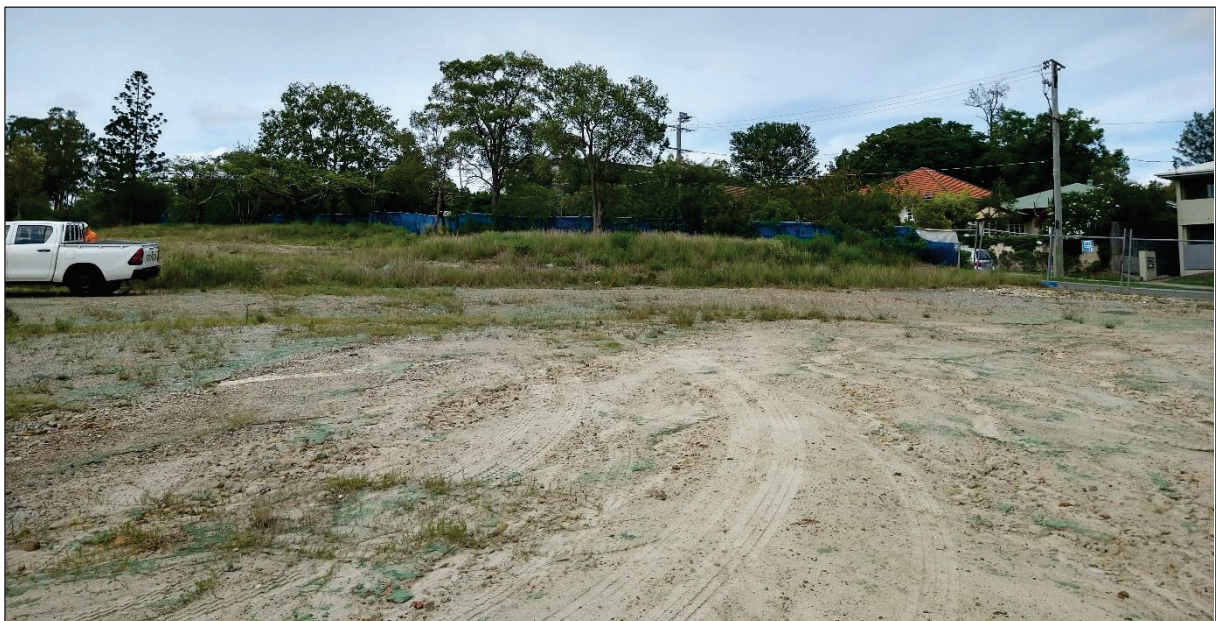
At the time of the investigation the site was vacant and comprised exposed earth and grasses, with some outcropping sandstone rock evident at the surface.

Topographically the site generally slopes down to the north and north east via a series of bench and batters left from the previous development, falling from approximately RL 13 m to RL 10 m.

**Figure 1: View of the site looking south west toward Park Road.**

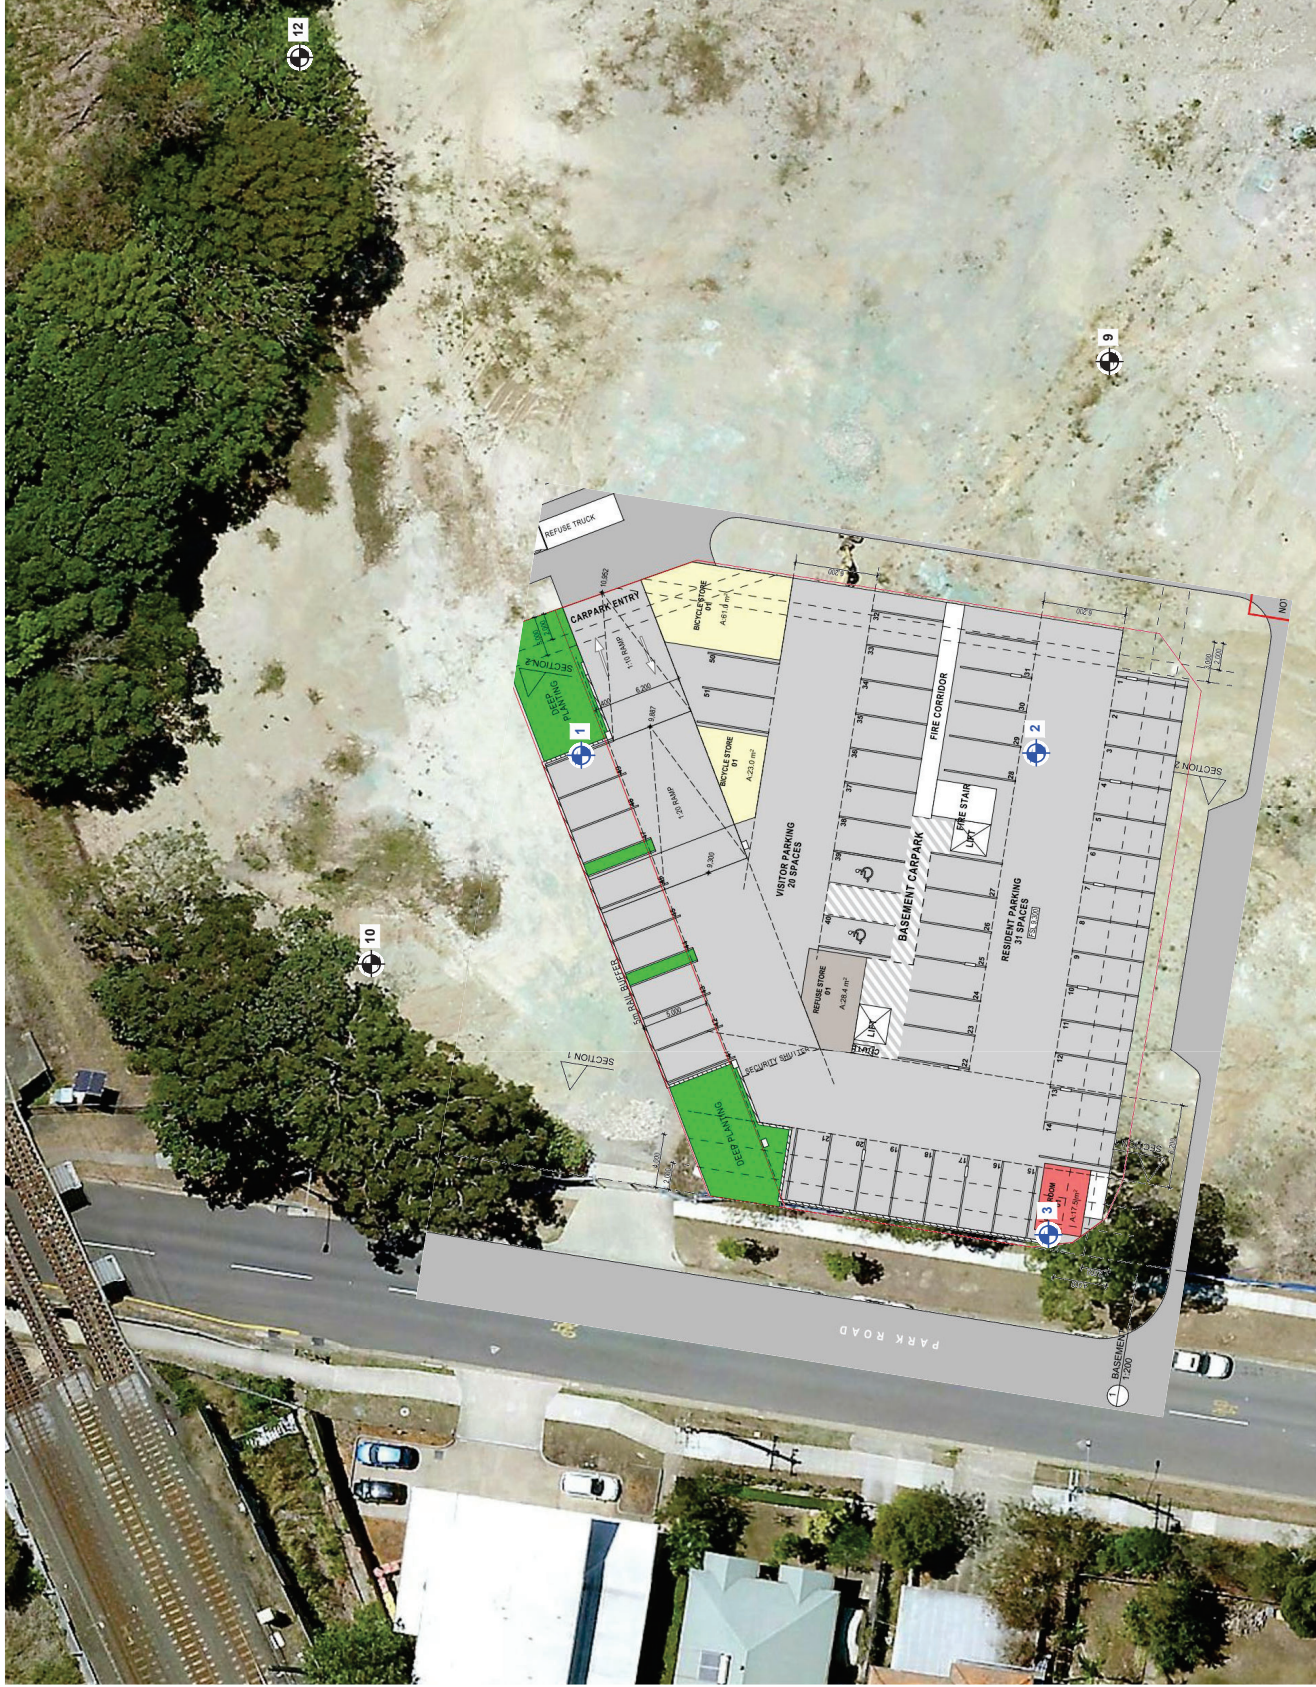
Drawing 1 – Site and Test Location Plan

The approximate location of this bore is included on Drawing 1 in Appendix B and a copy of the borehole log is included in Appendix C.

The development site is located on the eastern side of Park Road in Yeronga, as indicated on Drawing 1 in Appendix B. The site is within the Yeronga State High School extended campus with the proposed development area currently surrounded by vacant land (which is proposed to be developed by others).
