Geotechnical Desktop Assessment

Proposed Highrise Unit Development

15 Anderson Street, Fortitude Valley

Report Number: J001972-001-R-Rev1

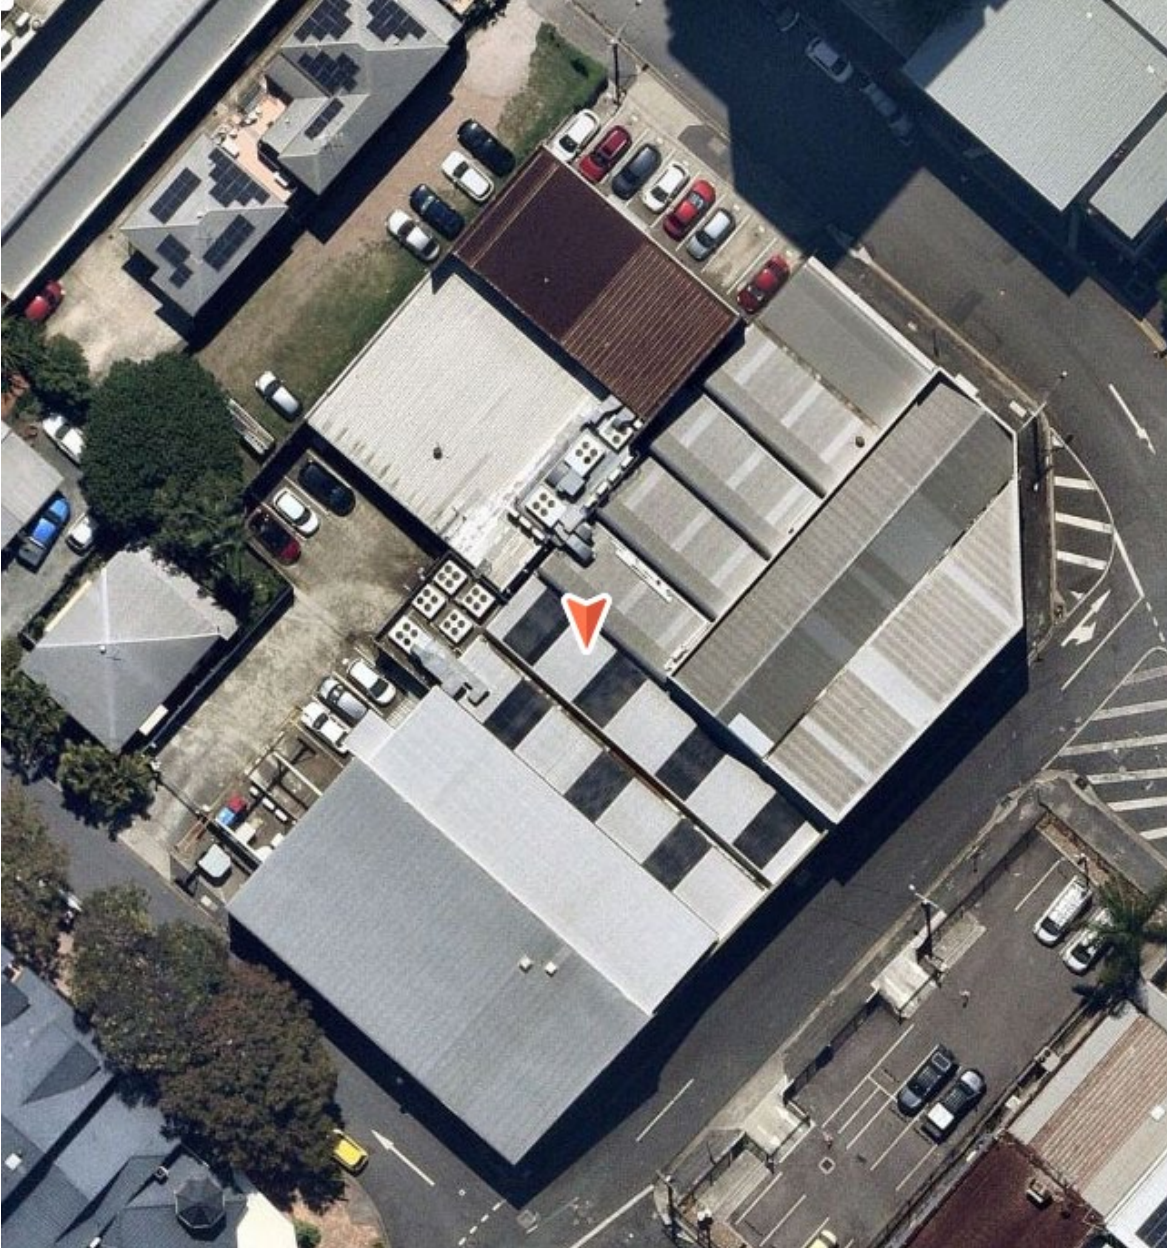
Image 3: Site Location

The site is located at 15 Anderson Street, Fortitude Valley and is approximately 65 m by 50 m and adjoined by Anderson Street to the southwest, Water Street to the southeast, Costin Street to the northeast and highset timber buildings and an open carpark along the northwest boundary. An aerial view of the site is shown in Image 3.

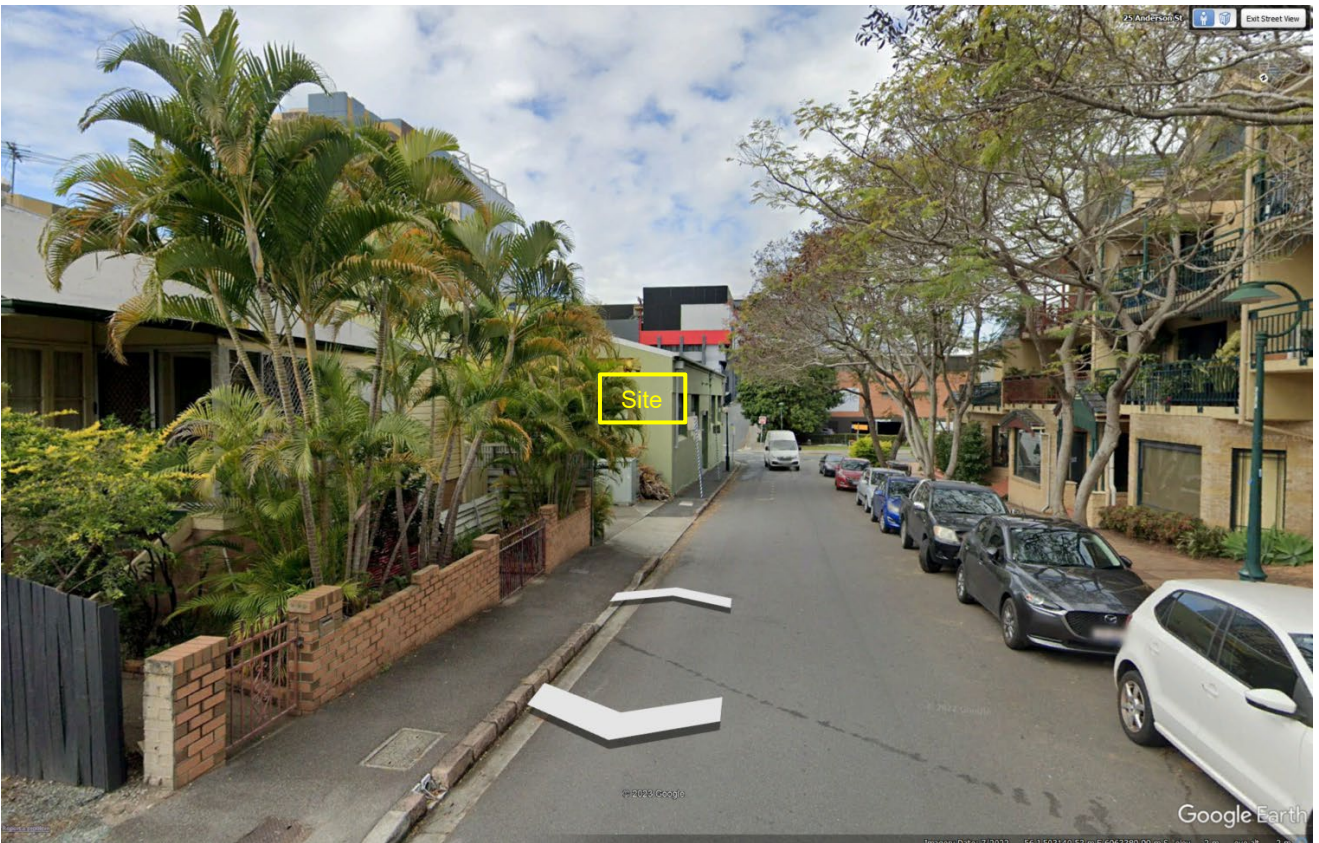
Image 4: View along Anderson Street looking southeast (Google Earth, annotations by Core)

Site conditions including adjoining properties are shown below in Images 4 to 6.

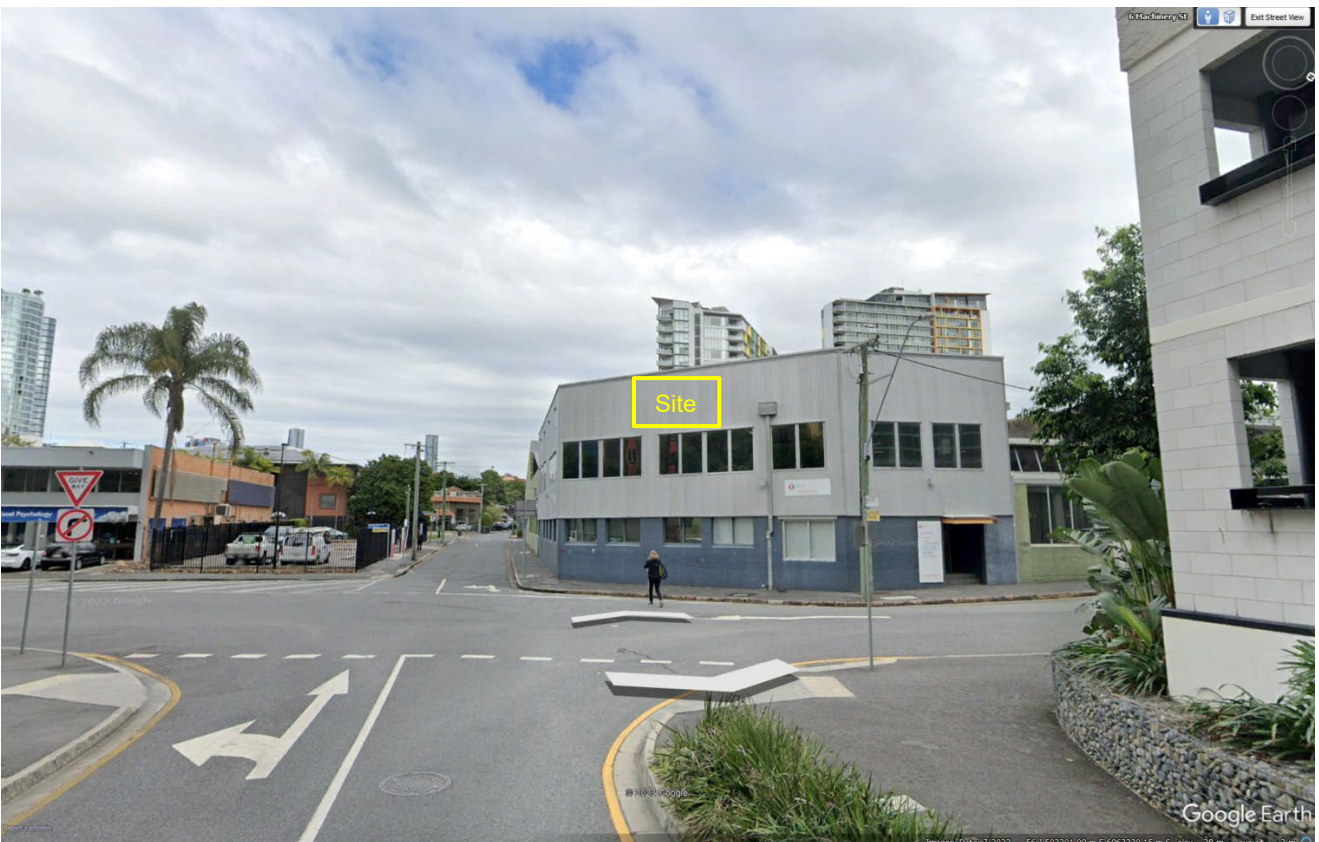
Image 5: View along Water Street looking southwest (Google Earth, annotations by Core)

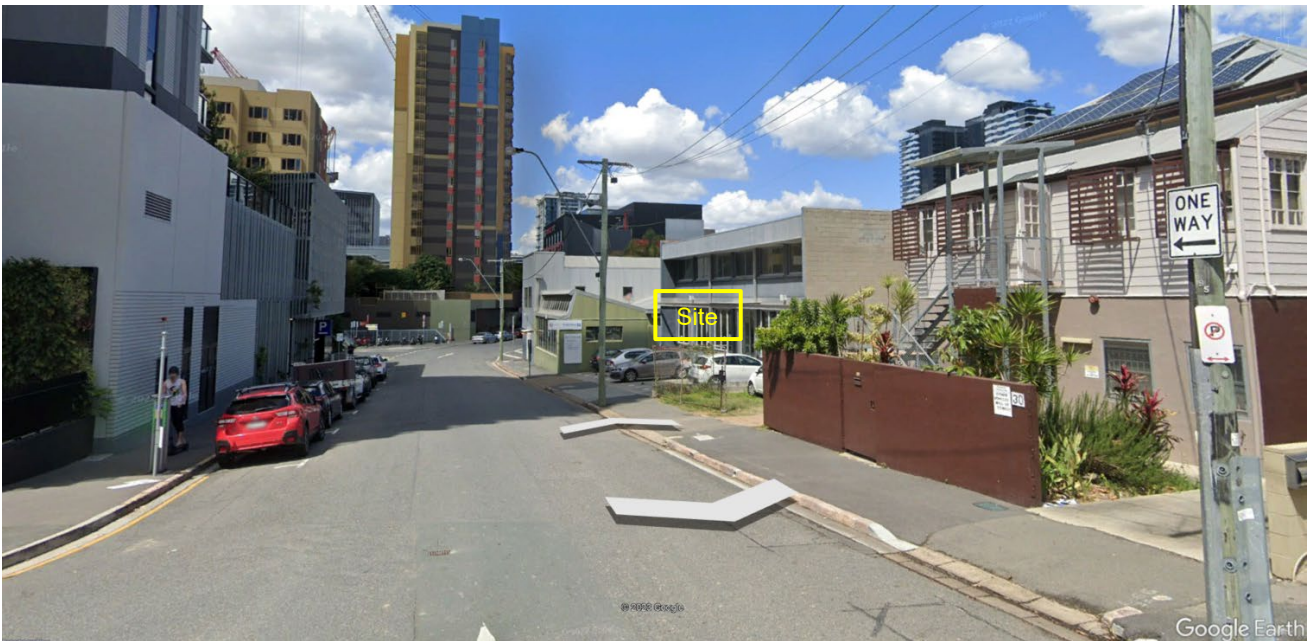
Image 6: View along Costin Street looking southeast (Google Earth, annotations by Core)

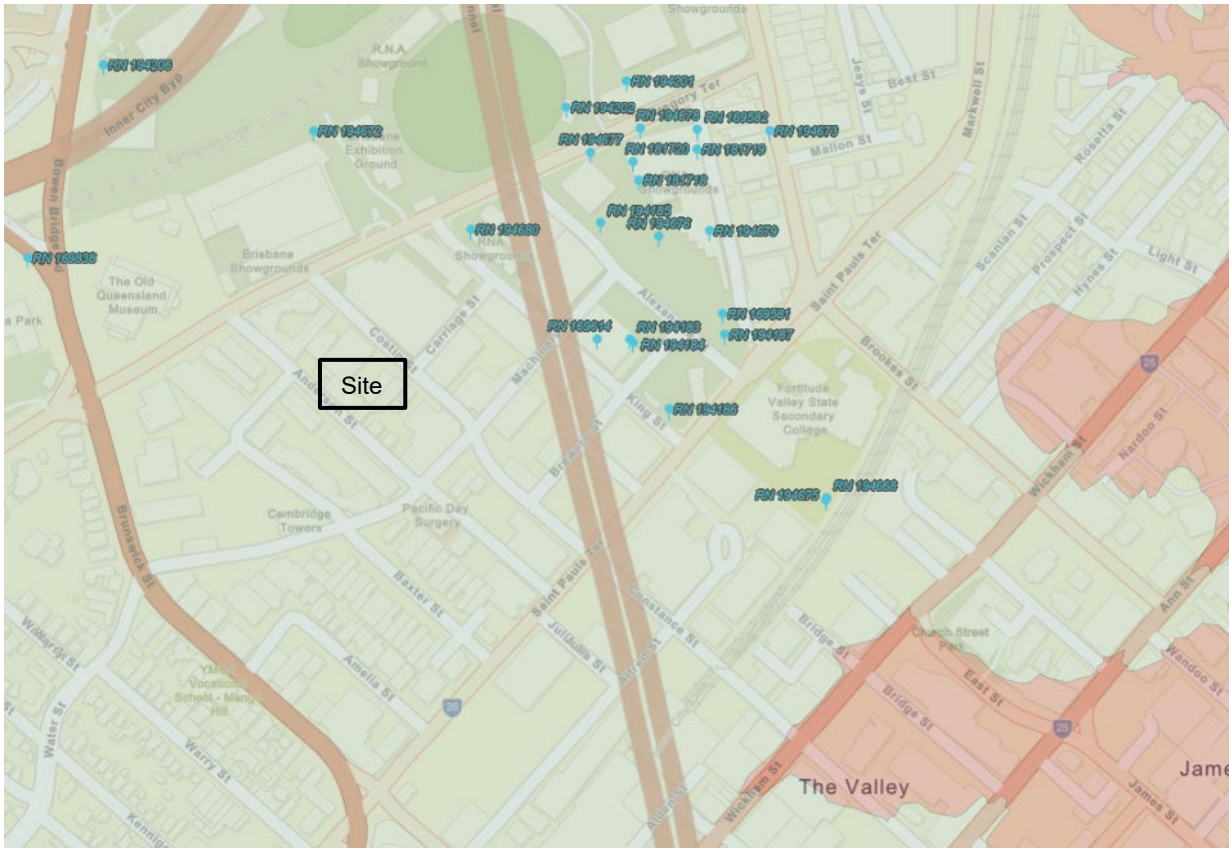
Published ASS information² (refer Image 8 below) shows that the site is zoned Cq(p4) extremely low (1-5%) probability of ASS. The nearest mapped zone of high probability ASS is shown about 0.5 km to the east.

Image 8: Extract of QLD acid sulfate dataset with registered groundwater bores

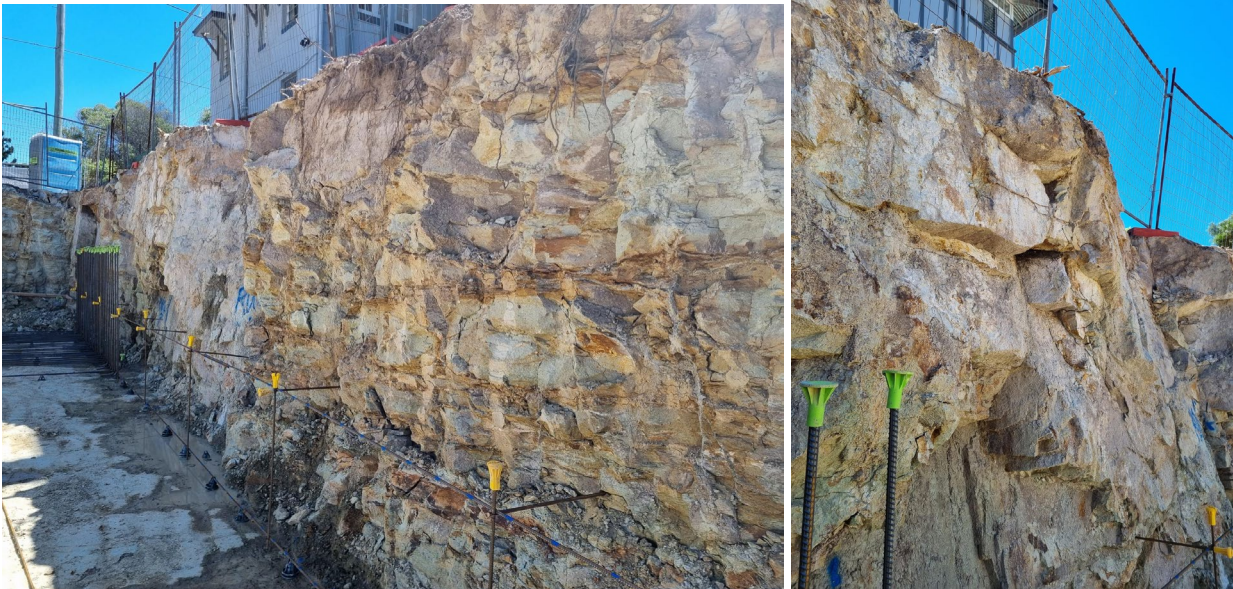
From these, typically in the upper 3 m the Tuff is fractured, weathered and medium strength, increasing to high strength, and then below that, slightly fractured, less weathered and high or very high strength. The dominant jointing in the Tuff is typically subvertical to about 70°.

Images 10a and 10b – Nearby excavation face in Tuff (St Pauls Terrace)

In the less weathered tuff at depth, isolated props might be required where there is a potential rock wedge similar to that seen in Image 10b. Preliminary analysis for a wedge 3 m high and 2 m in width indicates that a prop load of approximately 20 kN is required to support this size of rock wedge. Where wedges are identified, excavation would need to progress in stages with an initial prop left in place on a rock shelf until the excavation is progress to the side, and then a replacement prop installed and the remaining rock shelf then removed. Shotcrete pads with short pins (not extending beyond site boundaries) into the rock might locally be required to engage the prop with the rock wedge.

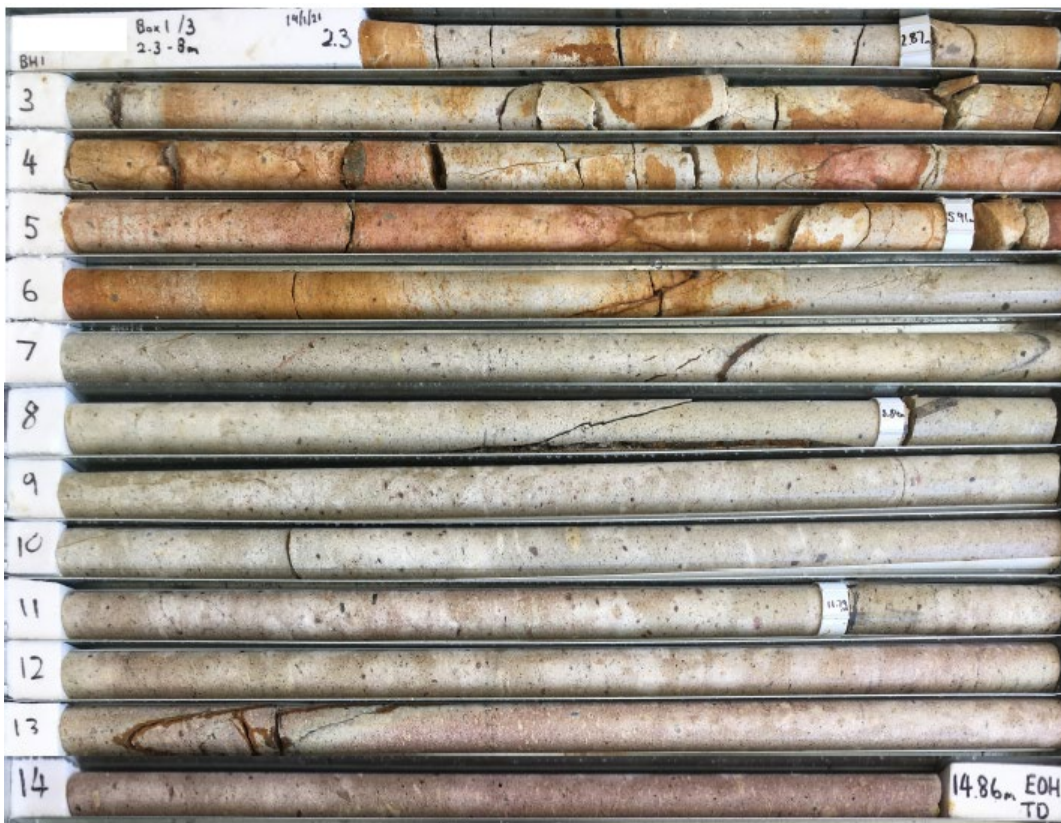
Image 11 – Rock Core sample in Tuff

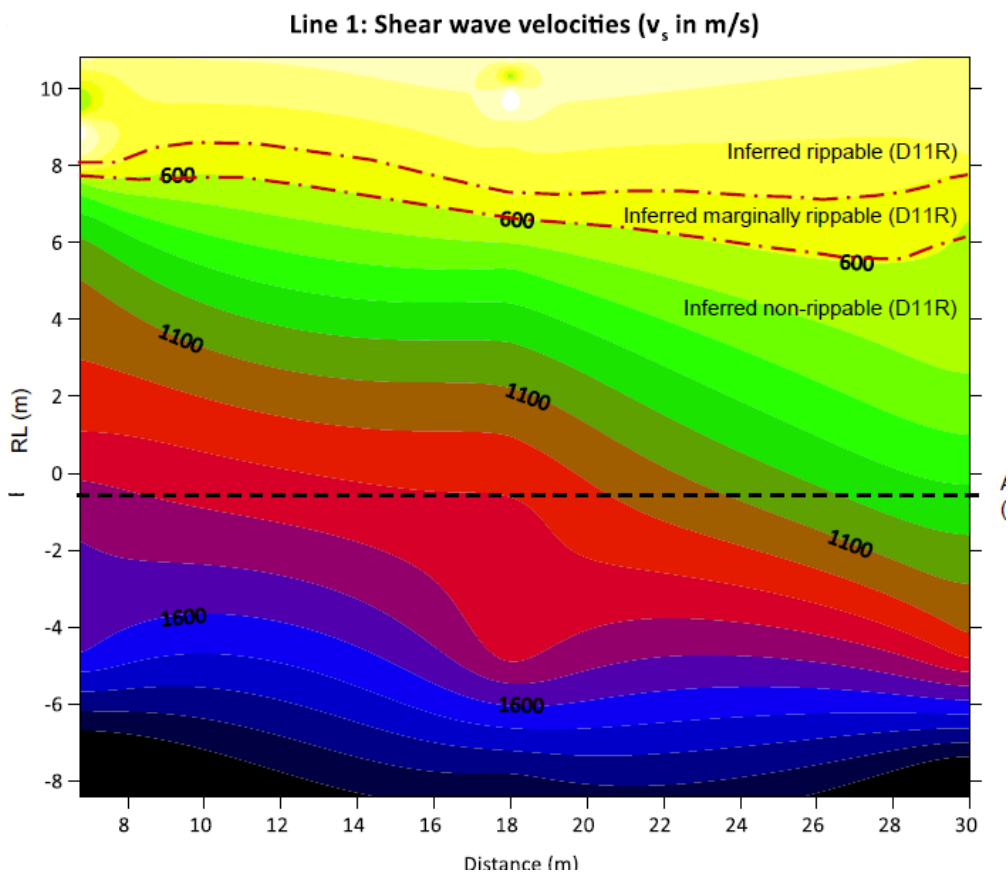
Image 12 – Seismic Shear Wave Velocity Profile in Tuff

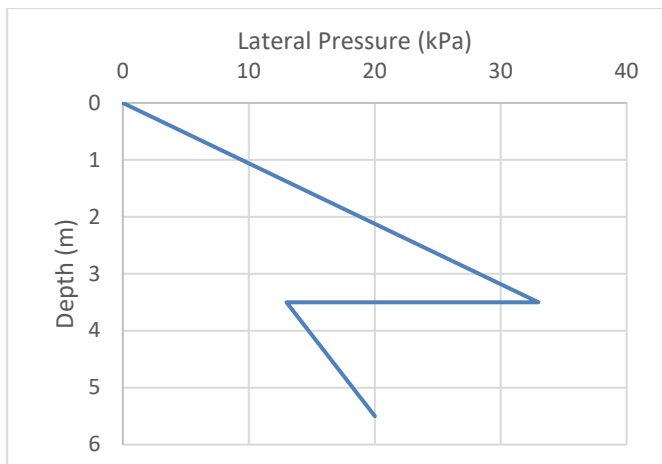
For the propping option, the soldier piles should extend to 'toe' into relatively unfractured medium strength tuff; conceptually these piles might be around 4 m deep and 0.6 m diameter spaced at about 1.8 m centres (i.e. 3 times pile diameter) with shotcrete lagging between piles. These piles would cantilever to 2.5 m depth with movements of the supported not exceeding about 10 mm; the internal propping could be installed at this point before advancing the bulk excavation. For preliminary design of the temporary support system, at rest earth pressures (to minimise ground movement to less than 10 mm) should be used with an at rest earth pressure of 0.5 and cohesion of 5 kPa for the soils, and an earth pressure coefficient of 0.15 for the weathered tuff rock zone with an applied external surcharge of 10 kPa. The earth pressure diagram for these values is shown below in Image 14.

Image 14 – Earth Pressures for Temporary Propping Design
