# YARRABILBA PRECINCT 6 ROL<sub>2</sub> STORMWATER MANAGEMENT PLAN

VERSION 1

DesignFlow  
Prepared for Lendlease  
October 2023

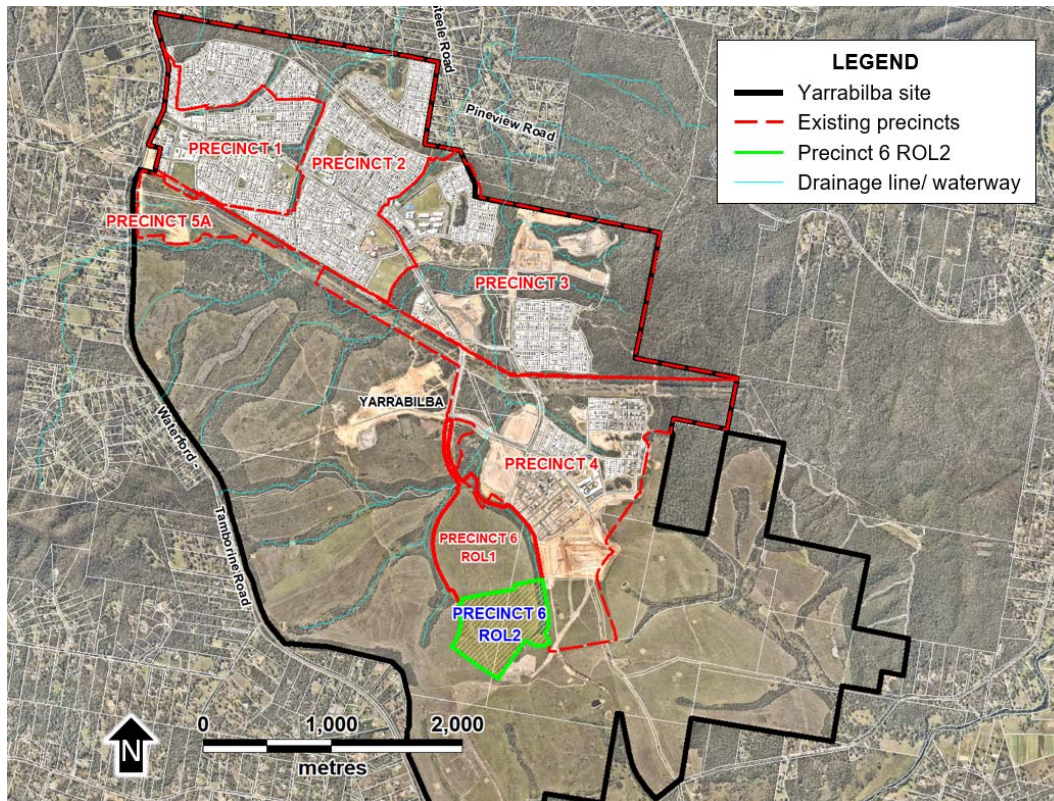
Figure 1: Yarrabilba Precinct 6 ROL2 locality

The lawful point of discharge for stormwater from Precinct 6 ROL2 is to the existing waterways on the northwestern and eastern boundaries, which flow to the southern tributary of Quinzeh Creek as illustrated in Figure 1. These watercourses are mapped as drainage feature under the Water Act (2000). Quinzeh Creek flows through Yarrabilba before discharging north (between Precinct 3A and 3C) near Steele Road approximately 3 km downstream of Precinct 6 ROL2.

Development Precinct 6 ROL2 (P6 ROL2) lies in the central portion of the Lendlease Yarrabilba site bordering the western edge of existing Precinct 4 as shown in Figure 1. The precinct covers a total area of approximately 36.1ha. It forms the southern portion of the broader Precinct 6 Context Planning Area Strategy (CPAS) approved by EDQ (DEV2011/187/27, 13 July 2023)

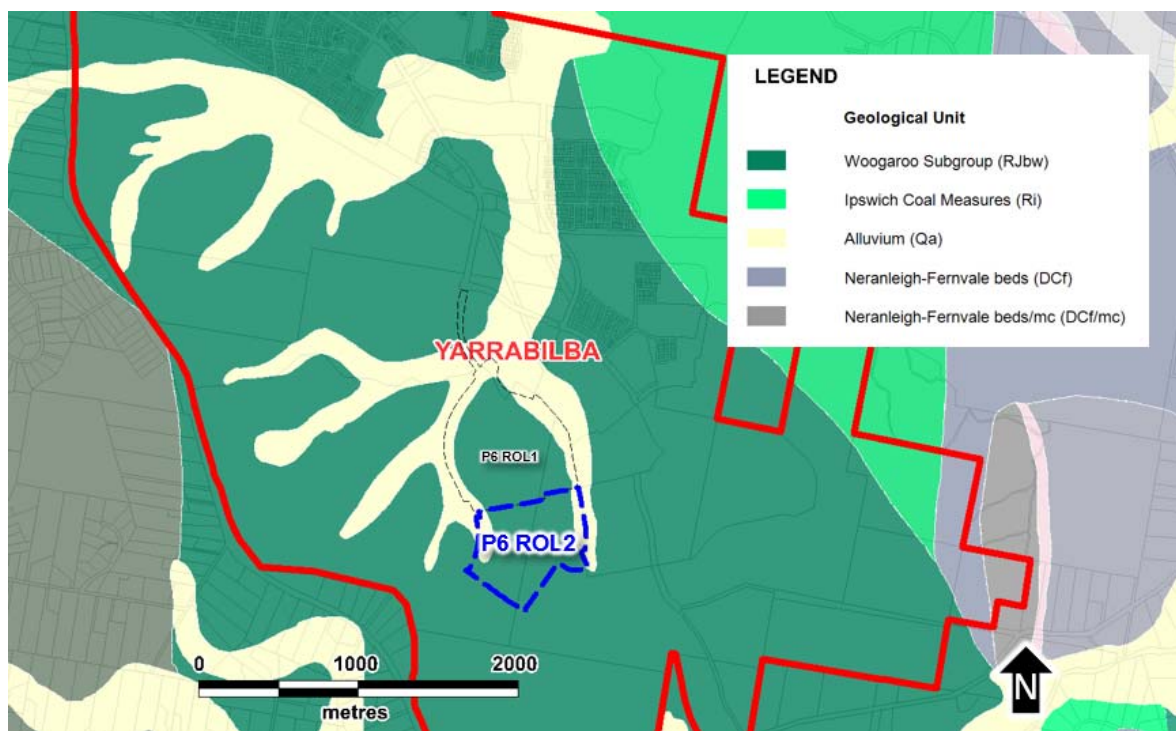
Figure 3: Geology and soils

Broad scale geotechnical investigations completed across the site (Bowler, 2004) indicate subsurface soils are typically sands overlying silty clays and weathered sandstones. The soil conditions for much of Precinct 6 ROL2 are not expected to vary significantly from those encountered in the balance of Precinct 3 and 4 previously (i.e. those within the lower slope development zones). The alluvium zones (perimeter of P6 ROL2) have often displayed deep sand zones in localised areas where historic channel/creek incisions have been filled with sediment eroded from upslope catchments. Further site specific geotechnical investigations will occur within Precinct 6 ROL2 to confirm soil conditions for civil engineering design.

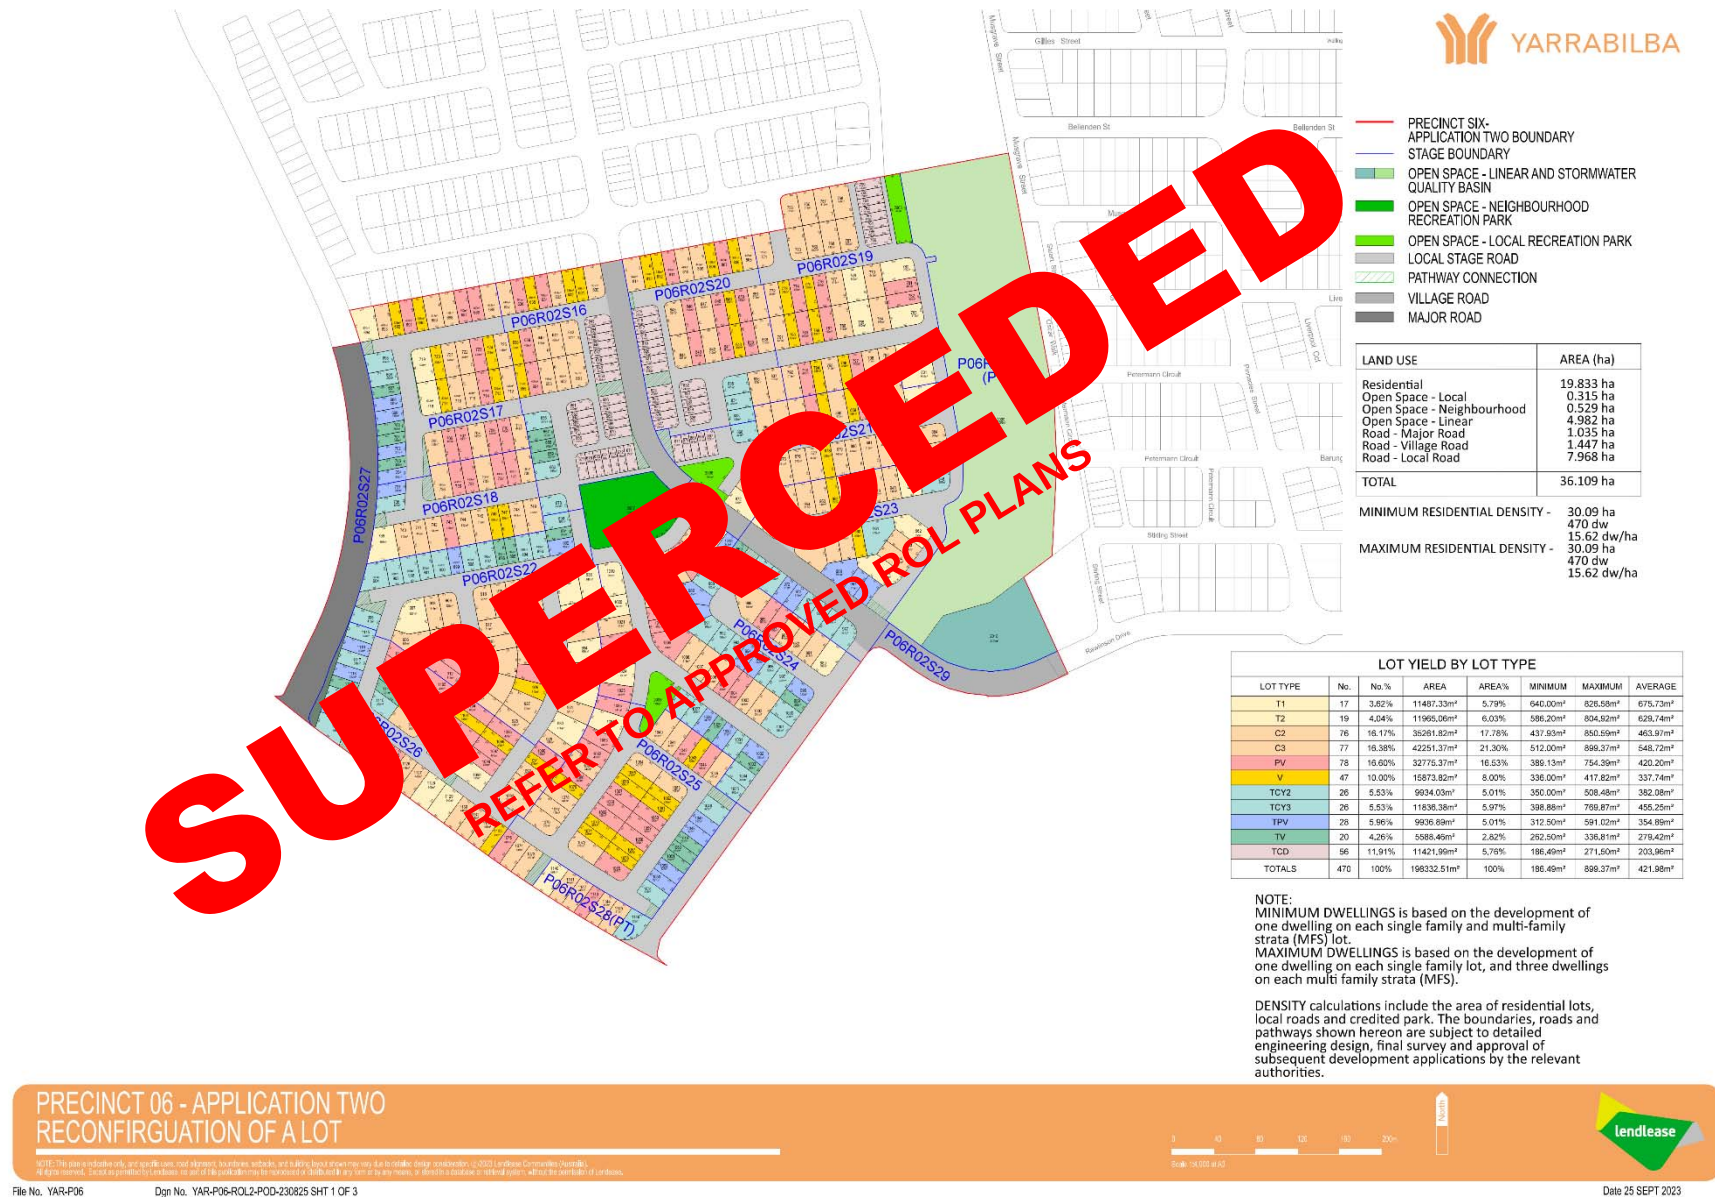
Figure 4: Precinct 6 ROL2 proposed layout

The proposed development covers an area of approximately 36.1 ha which includes just over 19.8 ha of development lots, 10.5 ha of roads and around 5.8 ha of open space, waterway corridor and stormwater treatment areas. The precinct layout is shown in Figure 4.

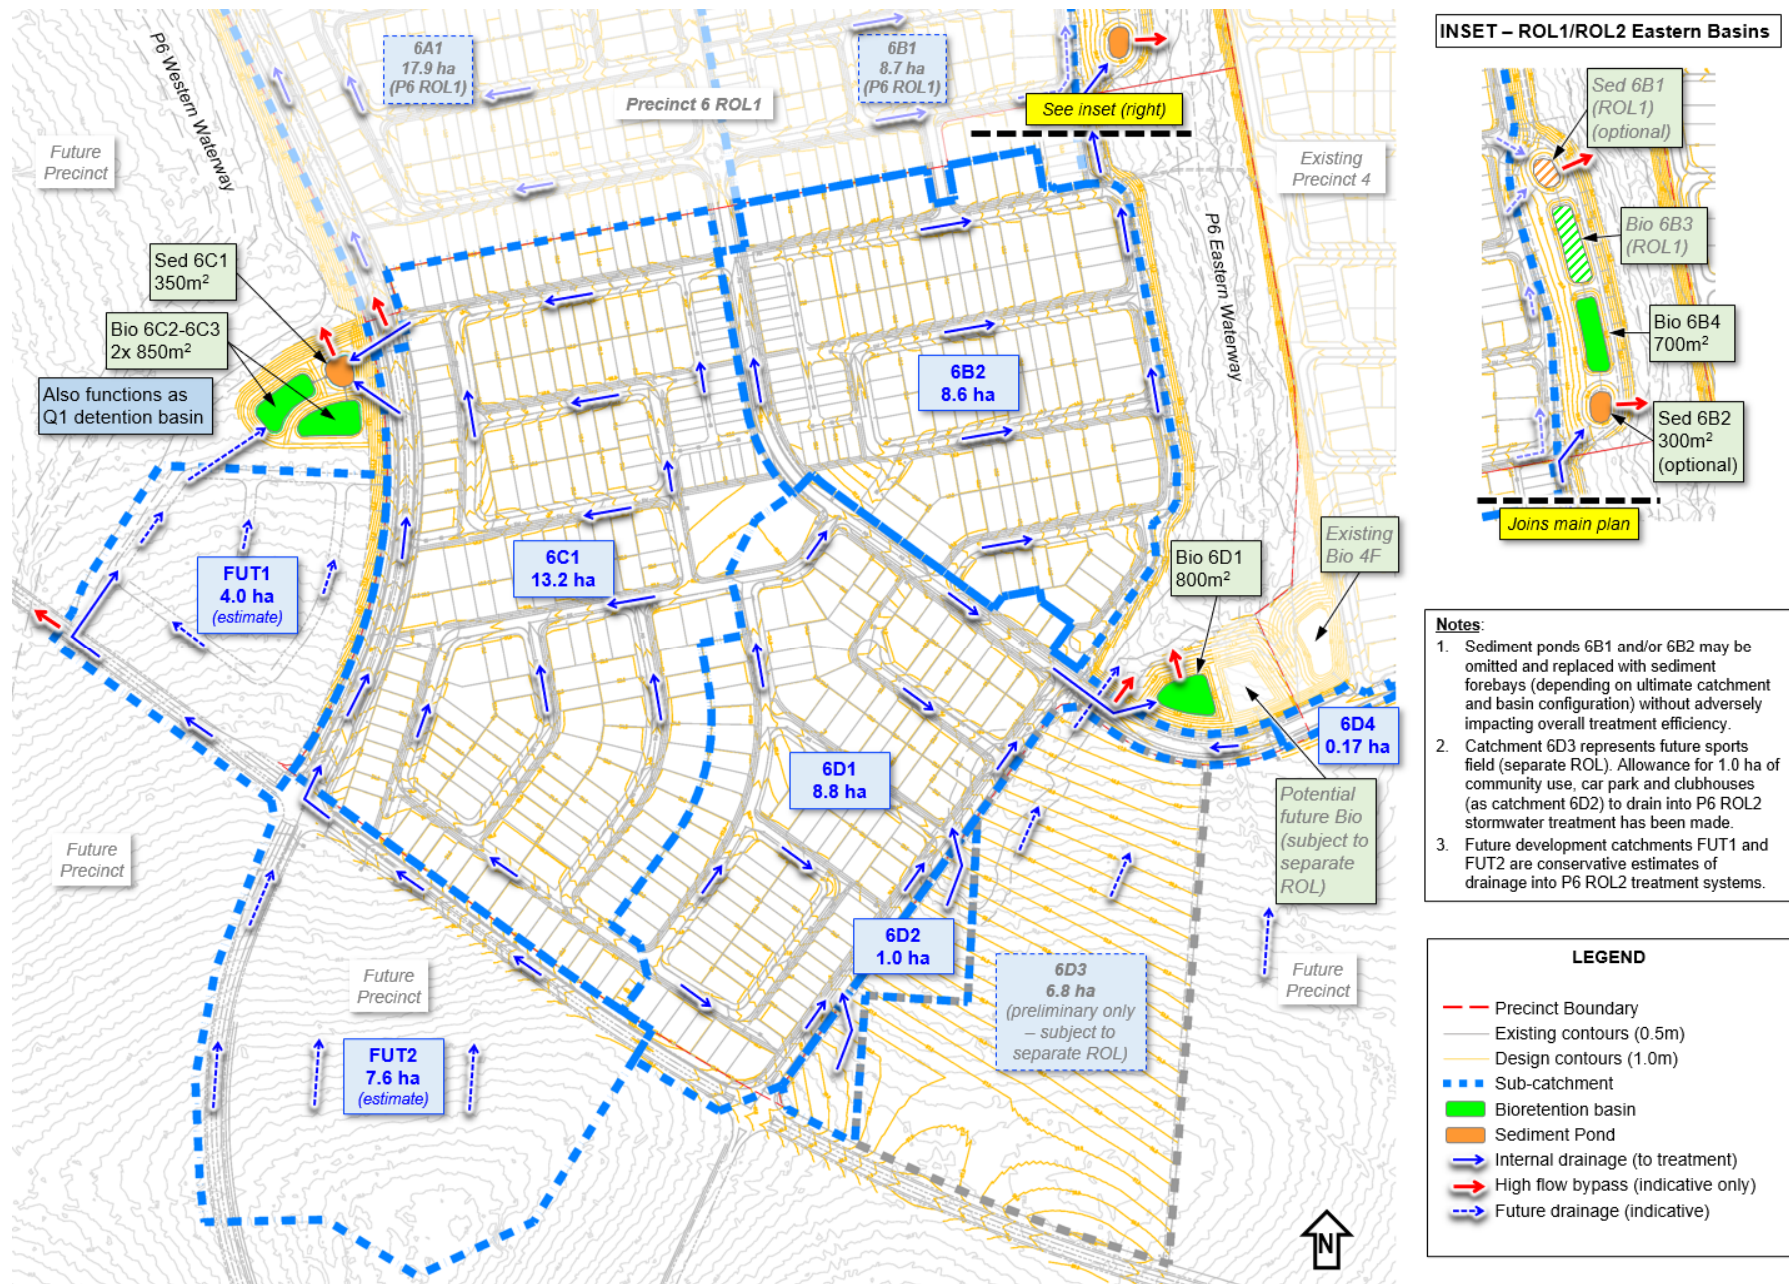
Figure 5: Precinct 6 ROL2 stormwater quality management strategy

The concept layout for the proposed sediment ponds and bioretention basins has been documented in the functional design plans by KN Group (Appendix A). Key design parameters are summarised in Table 3 and Table 4. These are subject to detailed design as part of operational works and some flexibility in configuration exists in these basins to enable design response to ultimate catchment and landscape outcomes in these zones (e.g. sediment ponds may be replaced with sediment forebays).

As noted previously in Section 4.3, the upper reaches of the P6 western waterway require post-development minor flow attenuation to manage the potential waterway stability issues outlined in Section 4.2.3. While this waterway will receive discharge from multiple future development precincts, the proposed approach to minor flow management (63.2% AEP / 1 Year ARI) is to maintain equivalent pre-development peak discharge from the respective development precincts for the critical duration at each location. The assessment below applies to the western stormwater treatment basin of P6 ROL2 (incorporating Sed 6C1 and Bio 6C2-6C3) which manages catchments 6C1, FUT1 and FUT2 in Figure 5 previously (totalling 24.8ha).

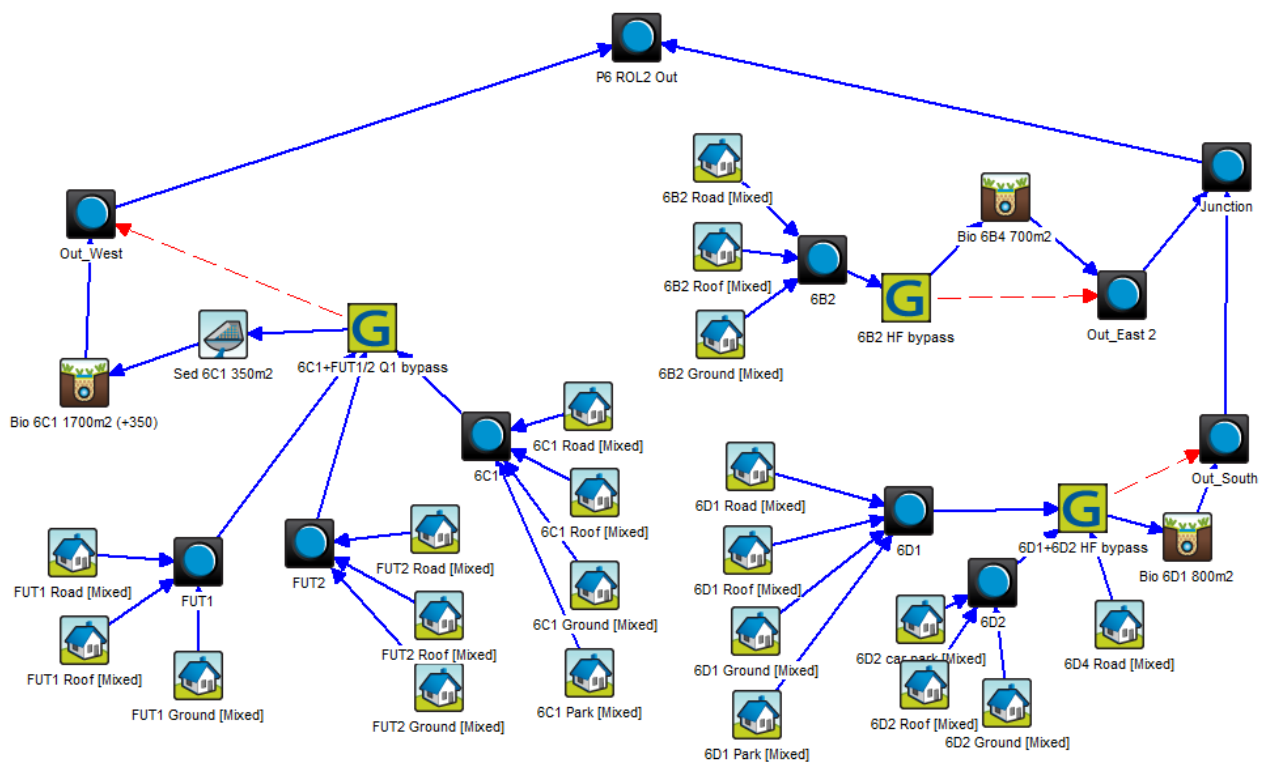
Figure 6: MUSIC model layout

The structure of the MUSIC model is shown in Figure 6 with the general data provided in Table 6. MUSIC model parameters were adopted generally in accordance with the *MUSIC Modelling Guidelines* (Water by Design, 2010/2018) using 10 years (1990-2000) of modified Shailer Park meteorological data. Six minute rainfall data and monthly average evapotranspiration data was used. The Shailer Park station was selected for adoption as it is the closest rainfall station to the site with 6 minute data. The rainfall data set was modified to generate a data set closer representing Logan Village rainfall. The Shailer Park 6 minute rainfall was reduced by a factor of 0.849 to produce a rainfall data set with a similar annual total to Logan Village (950mm) for the period considered. Discussion of this was provided in Section 5.1 of the *Precinct 1 Stormwater Management Plan* (DesignFlow, 2011) and has been consistently used in all subsequent applications since that time.

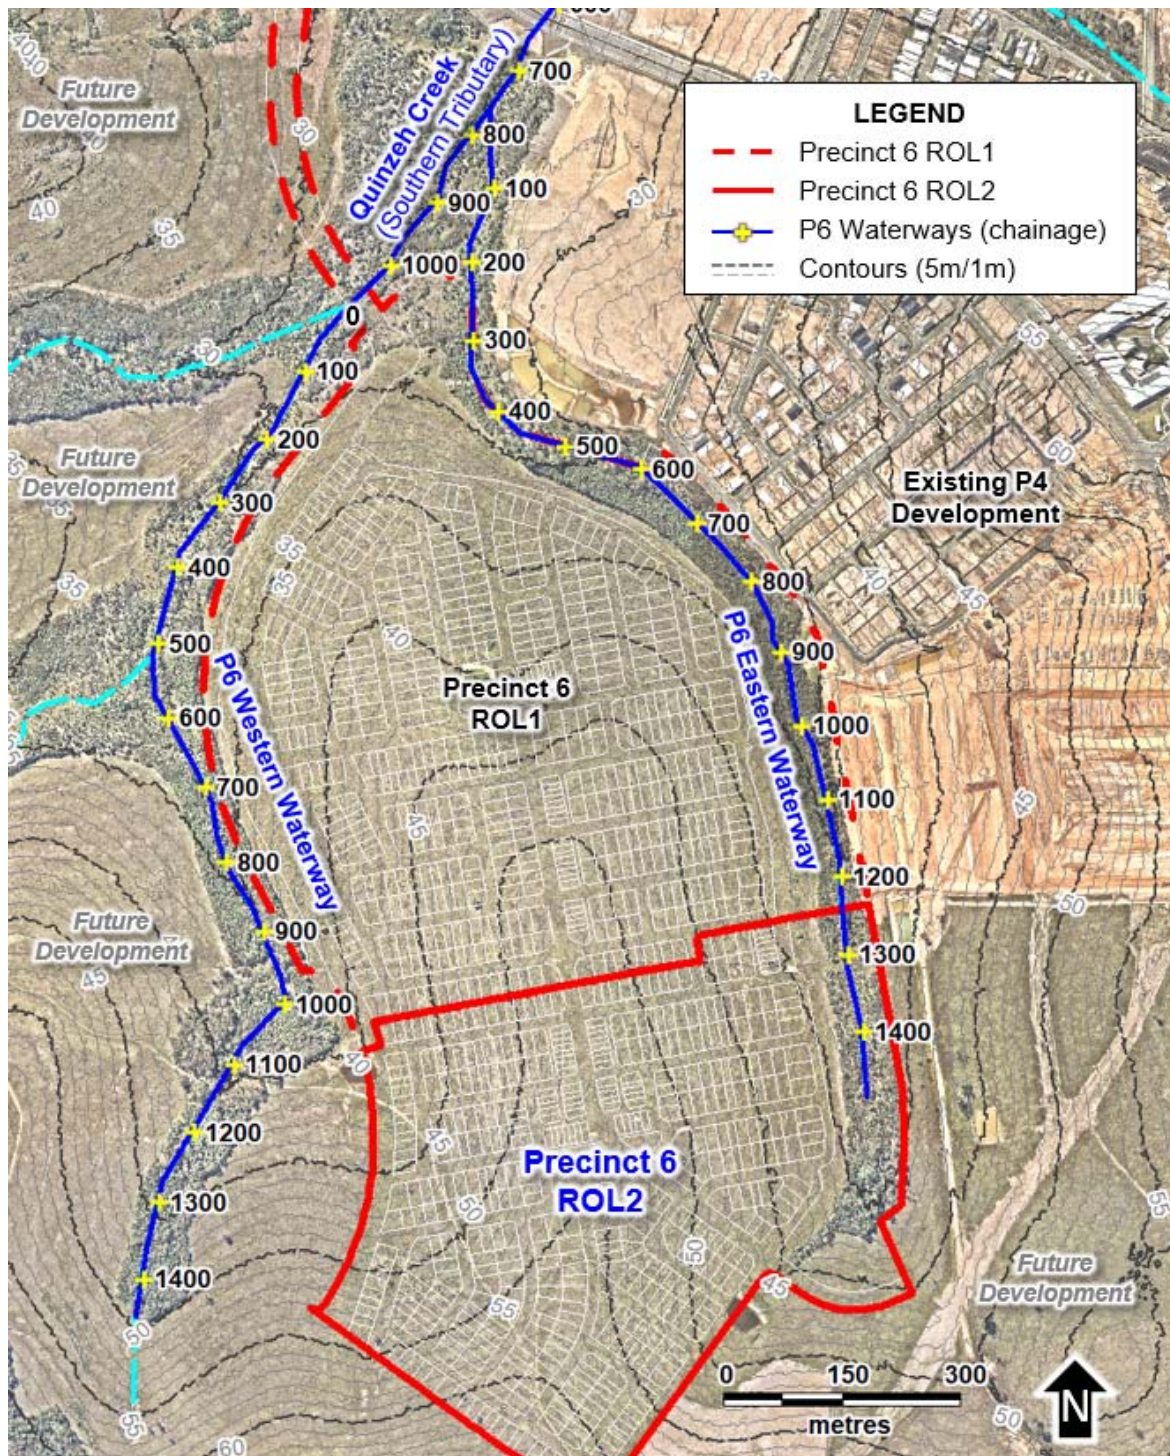
Figure 7: Precinct 6 waterway layout

A brief overview of these findings is provided below with additional information provided in Appendix B. Figure 7 provides the Precinct 6 waterway layout and chainage locations referred to in the following sections.

The western waterway of P6 extends generally south-west to south from the main upper Quinzeh Creek floodway. The lower reach (chainage 0-500m in Figure 7) is very broad with low gradient (~0.7%) and intermittent low flow channel (very narrow and shallow) and localised scour pools. Generally good grass groundcover exists with scattered trees and shrubs and local areas of more dense trees (regrowth). Localised ground disturbance and grazing was evident from native and feral animals (kangaroos and pig observed) and livestock (horses and goats in adjacent areas) but no significant instabilities present. While no standing water was present, evidence of scattered shallow scour holes/former ponds and emergent water plants was observed (now died back and dry).

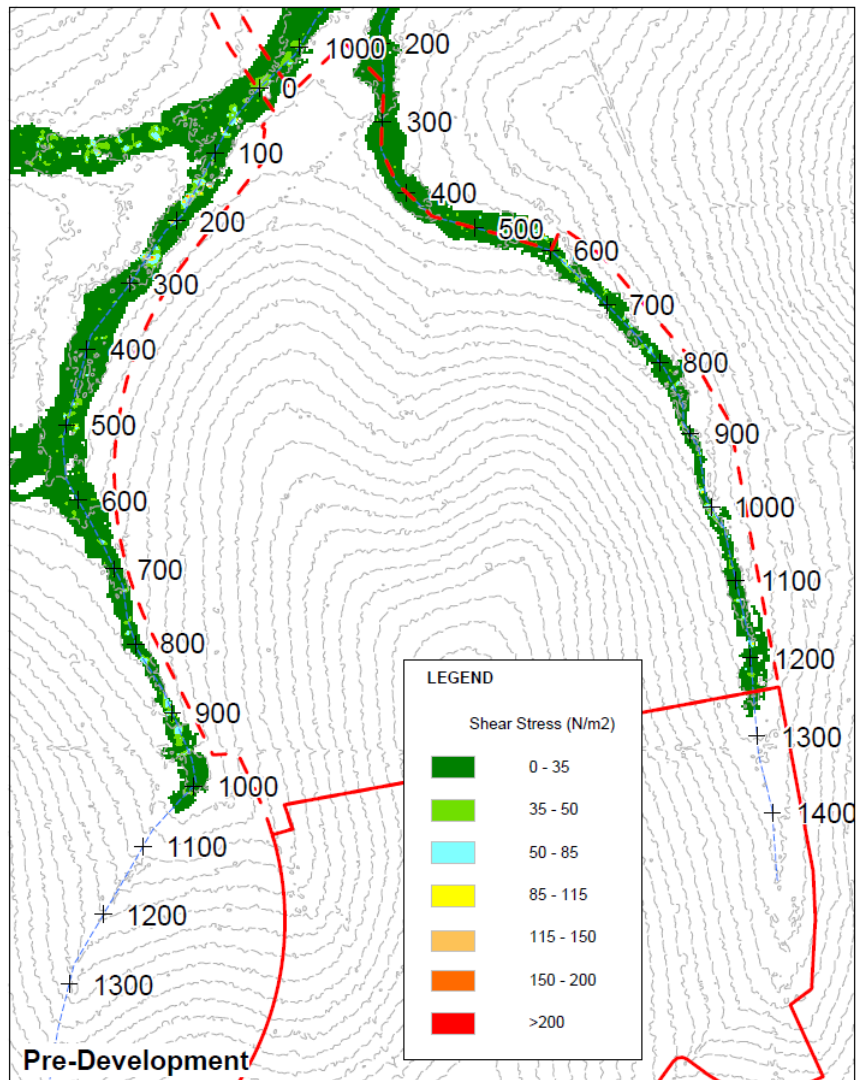
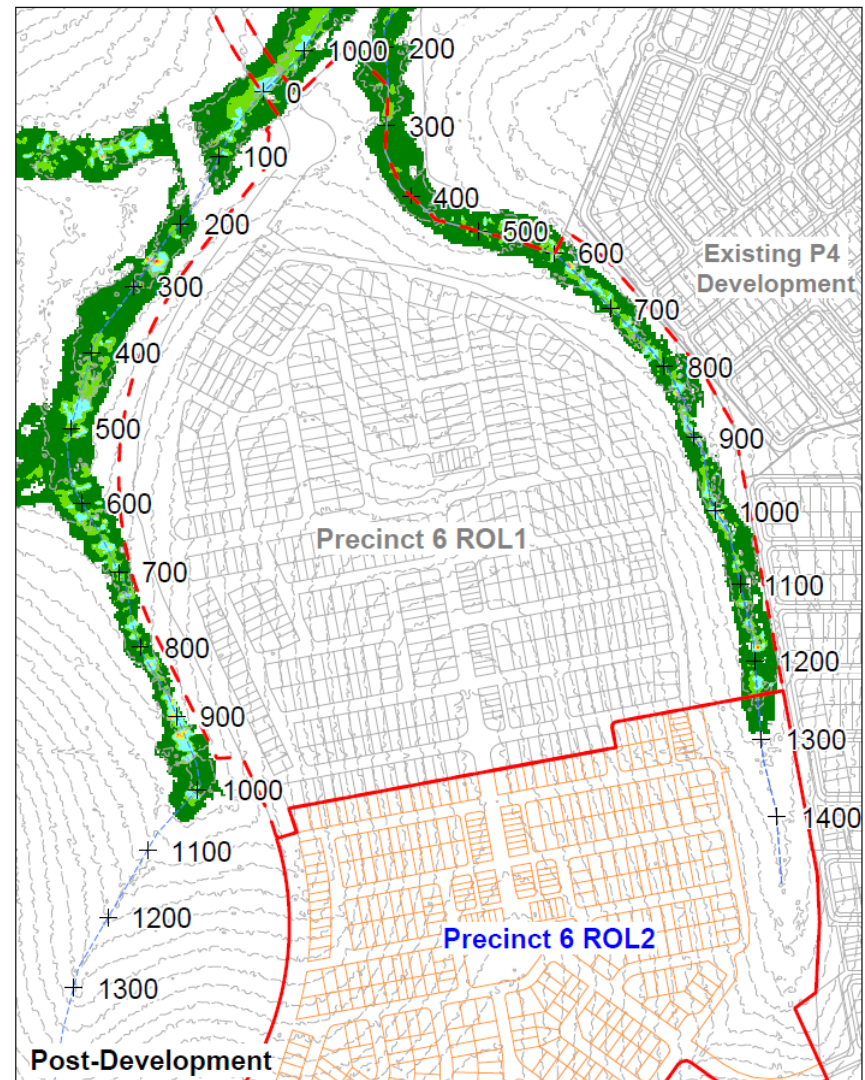
Figure 8: 1 year ARI bed shear stress comparison

Further detailed review of the upper western waterway has also been undertaken due to the increased waterway slope in the mid to upper reaches and the presence of existing scour and potential adverse soil conditions.

The bed shear stress mapping indicates that under pre-development conditions, the P6 eastern waterway shear stresses (in the order of 35-85 N/m<sup>2</sup>) represents relatively minor and localised instability (i.e. model outputs were broadly correlated with site based investigations/observations of current conditions in Appendix B). Under post-development hydrology, the shear stress magnitude generally remains in this range but over a broader area through the channel invert (refer Figure 8 above). The targeted waterway management strategy therefore aims to manage existing scour issues while also allowing rehabilitation/stabilisation to target the expected post development flow regime coupled with an adaptive management strategy that responds to the uncertainties in channel geomorphology.

Similar to the eastern waterway, bed shear stress mapping in the lower and mid reaches of the P6 western waterway indicates that under pre-development conditions, the bed shear stress (in the order of 35-85 N/m<sup>2</sup>) represents relatively minor and localised instability (i.e. model outputs were broadly correlated with site based investigations/observations of current conditions in Appendix B). Under post-development hydrology, the bed shear stress magnitude generally remains in this range for much of the waterway but over a broader area through the channel invert (refer Figure 8 in Section 4.2.2). However, there are a few more areas of significantly higher bed shear stress that may be attributed to the slight increase in waterway slope in the western waterway and these are expected to be exacerbated in the areas at and upstream of the limit of flood modelling available (where slopes increase to around 2.5%). In contrast to the eastern waterway where slopes remain fairly consistent, the increase in channel slope in the upper reaches represents a greater risk to increased instability, especially under post-development flows.

Where no (or very minor) erosion exists or potential future scour areas may occur based on high bed shear values (refer to Figure 8 previously) consideration should be given to minimising intervention in these areas where surrounded by very stable and/or well vegetated waterways zones. The potential impact of accessing these zones to undertake remedial activities (i.e. with earthmoving machinery) would likely create greater disturbance than benefit. Therefore, in the first instance, these areas will be monitored over the course of Precinct 6 development as well as into the adjoining precinct(s) development to review if these areas are degrading further. Reactive and targeted remediation can therefore be undertaken as required.

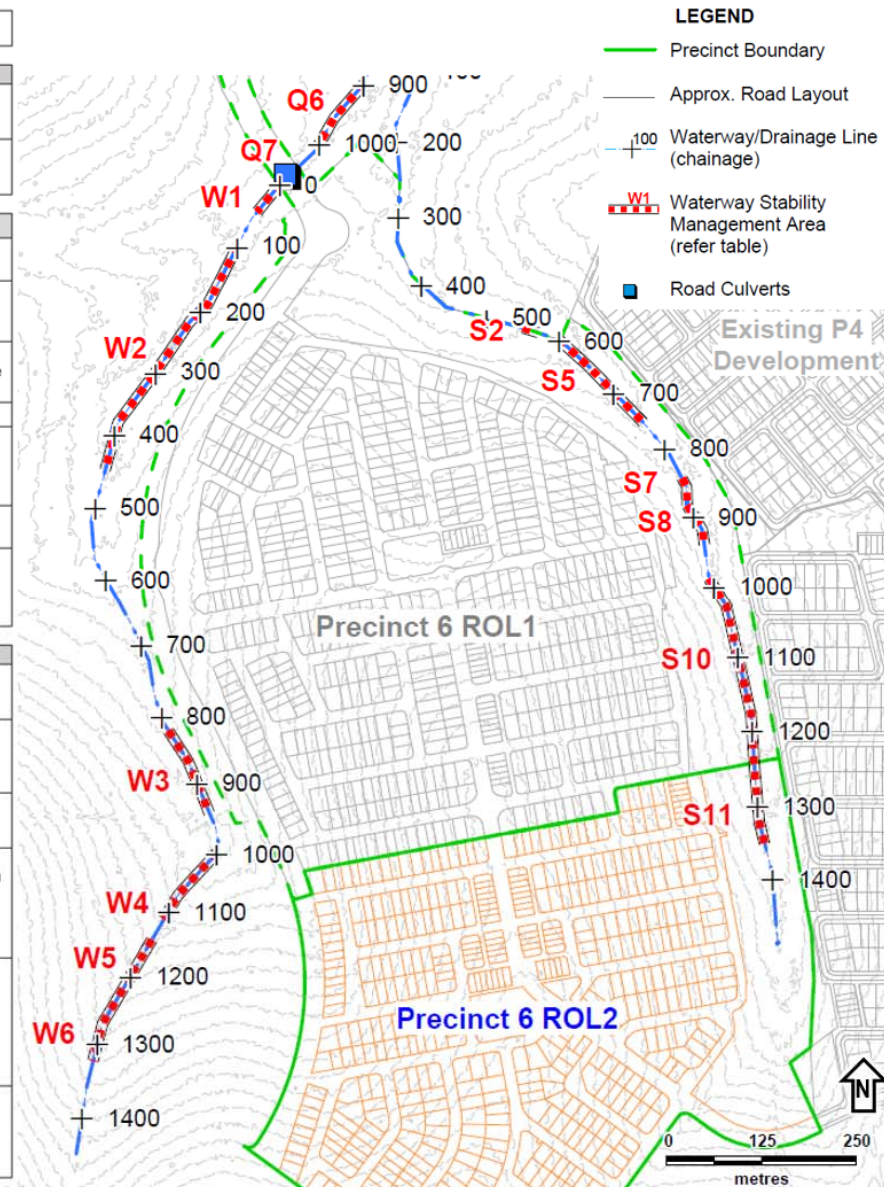
Figure 9: Waterway stabilisation management strategy

Figure 9 provides the overall precinct waterway stability management strategy that targets the degraded and/or future disturbance areas associated with development. Typical stabilisation techniques applicable to this strategy (and adopted in previous precincts onsite) area described in Section 4.3.1.

| ID | CHAINAGE (APPROX.) | WATERWAY STABILITY MANAGEMENT |
|---|---|---|
| S8 | 880-930 | Chain of ponds (scour pools) with establish trees – review habitat value with ecologist and undertake targeted works to stabilise banks, remove/relocated woody debris causing high energy flow, revegetate livestock damaged banks, and monitor zone following upstream development. |
| S11 | 1300-1350 | Ephemeral wetland/pond - review habitat value with ecologist and undertake targeted works to stabilise banks, decommission or stabilise track crossing at downstream edge, formalise ephemeral wetland vegetation, revegetate livestock damaged banks, and monitor zone following upstream development. |
| W6 | 1200-1320 | Upstream of head-cut at CH1200, flow path returns to broad, grassed area with intermittent shallow low flow definition. Grasses are not tall and may be grazed by livestock. Localised minor scour zones evident with minor undercutting of trees. Weaker soil layer also evident at CH1320 as seen at CH1200. Reshape and backfill scour with non-dispersive soil, revegetate and monitor stability. |

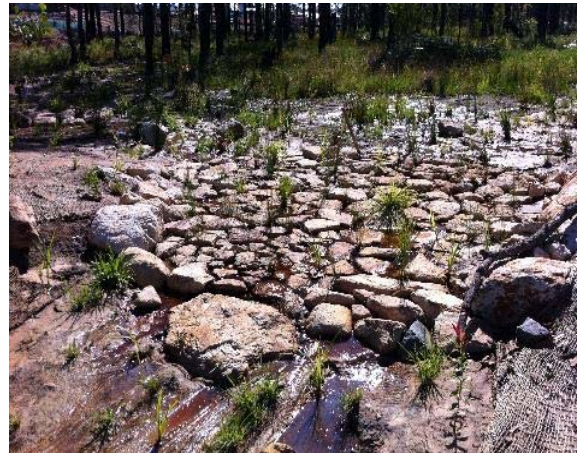
##### *Rock Protection*

Scoured areas and incised channels can be reshaped to flatten vertical edges and placement of rock or rock mattress over geofabric to armour underlying soil. Integrate planting within rock voids where practical. Rock protection must be formed with depressed centre to ensure flows are directed into and through the area and set down slightly below the natural ground level to avoid flow redirection around the edges (creating new scour).

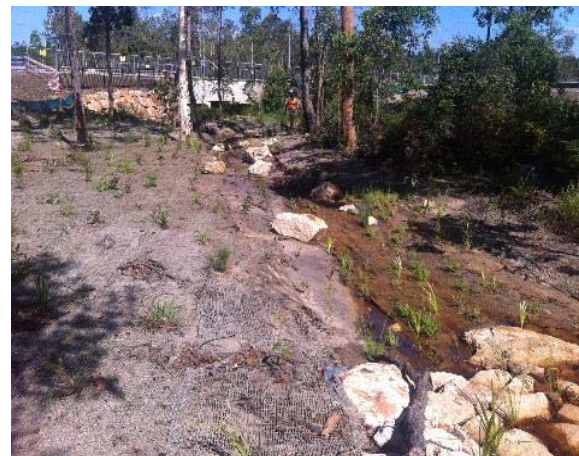
##### *Revegetation*

Areas with little or no vegetation cover should be replanted with a mix of locally established species to create both a soil anchor (via roots) as well as flexible grasses that can lay flat during flow (as a surface armouring) to create a stable flow path. This is most appropriate to broad low gradient flow paths (where rock channel linings are not required). The use of pinned down jute or coir mat (not net) prior to planting is required to create a short term soil stabiliser until vegetation is established. Revegetation should also form part of any rock protection works.

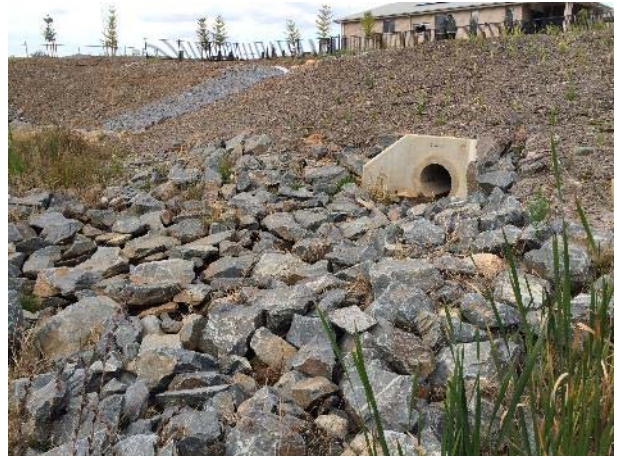
### ***Stormwater Outlets***

All stormwater headwalls to be provided with rock aprons configured appropriately (in accordance with QUDM) to the size and number of pipes. Where natural channel just downstream of apron is susceptible to further instability, aprons should be enlarged or lengthened beyond unstable area. Further, if instream stabilisation has been identified, the rock apron should be linked to this zone to avoid potential scour between two areas.

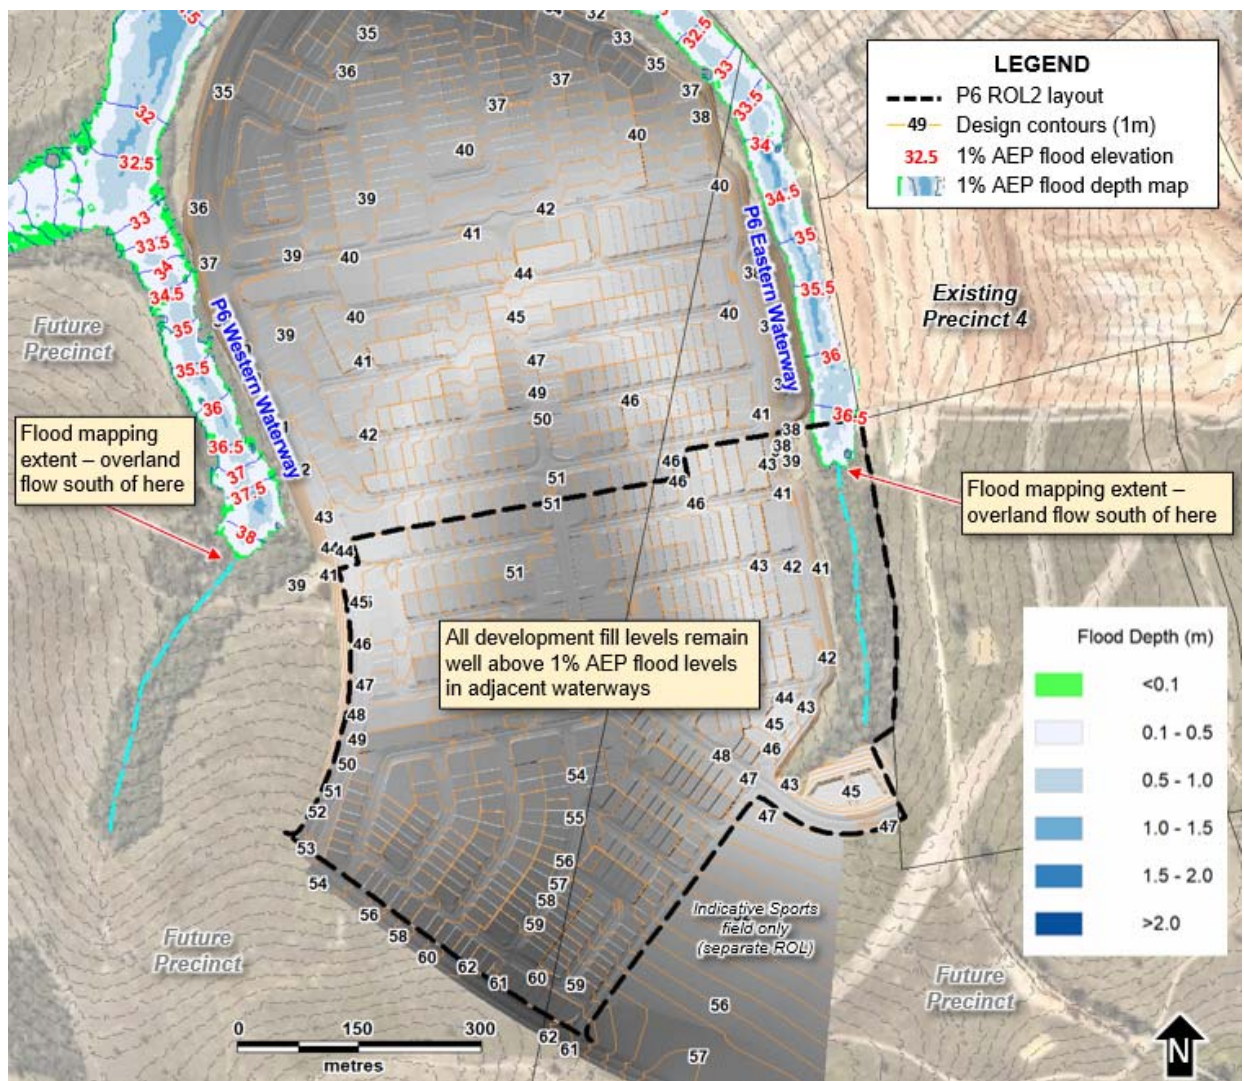
Figure 10: 1% AEP Flood levels and preliminary earthworks

A review of the preliminary earthworks design of the proposed development area in relation to local flood levels is provided in Figure 10. This indicates that P6 ROL2 is well above the 1% AEP flood level being conveyed through the adjacent waterways to the southern tributary of Quinzech Creek.

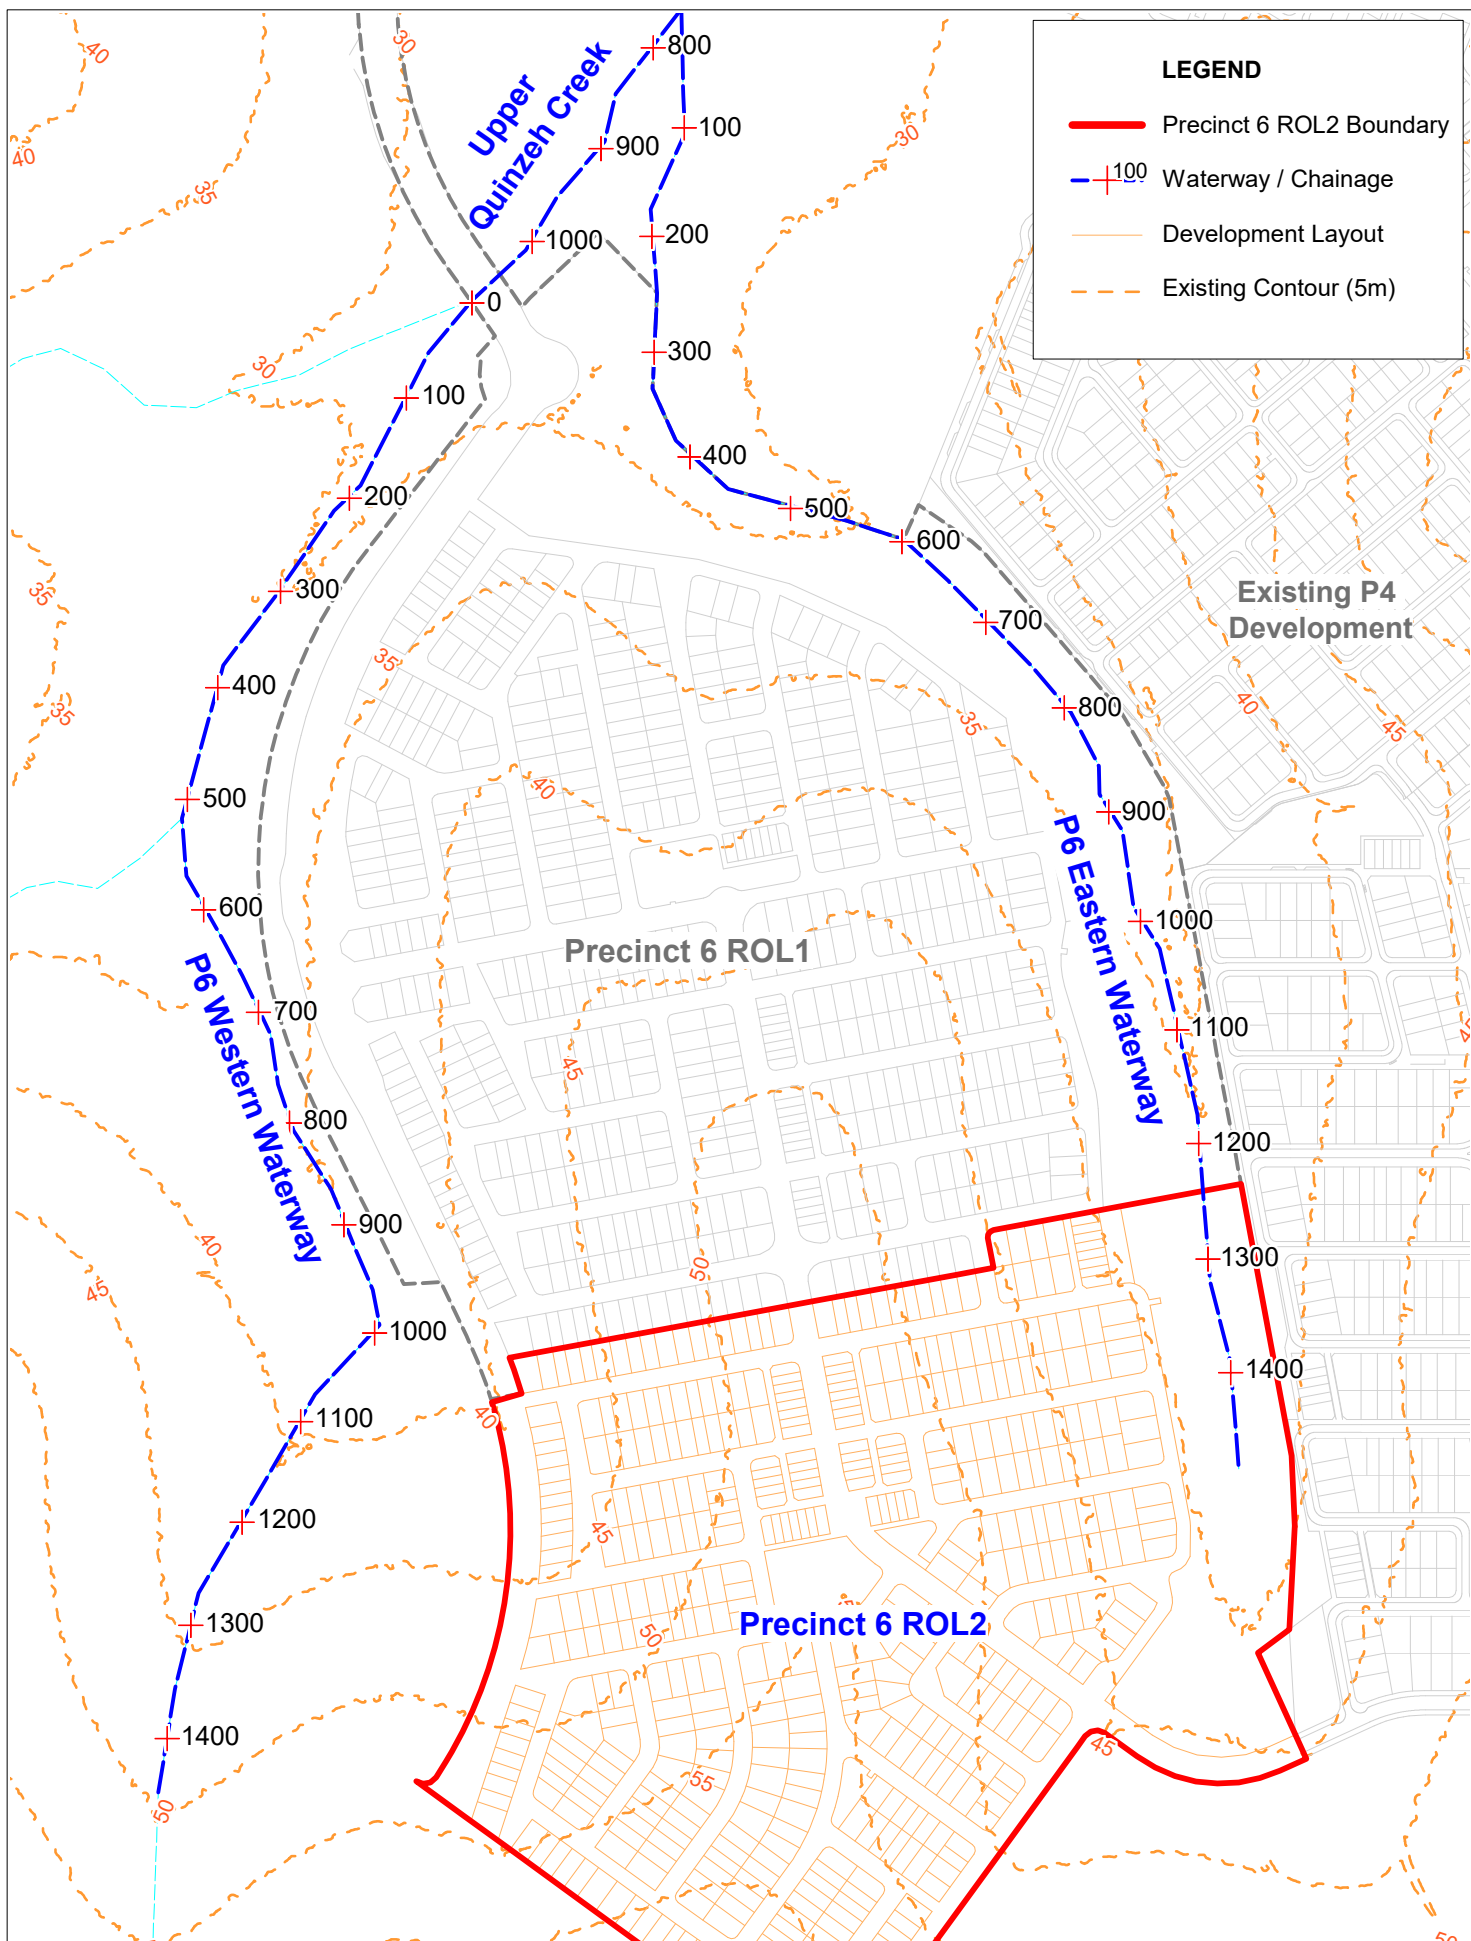
The Precinct 6 ROL2 waterway inspection photo log summary is provided in the following sections with chainage references identified in Figure B1. All chainages commence at zero at the downstream extent/confluence of each tributary. Inspection was carried out 20 April 2017 (eastern waterway) and 28 August 2023 (western waterway).

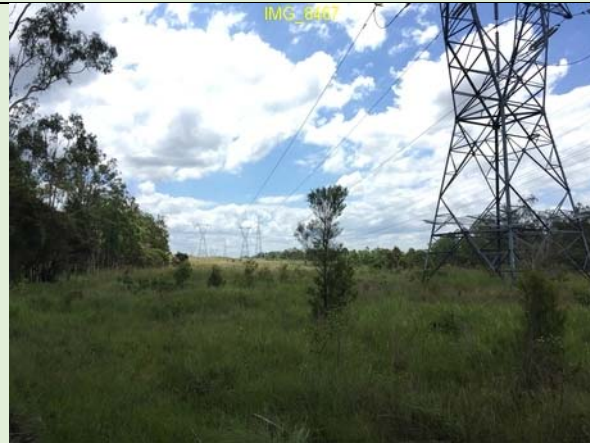
CH0-200 Powerline easement is fully cleared (grasses and some immature regrowth remain), broad flat scattered boggy zones.

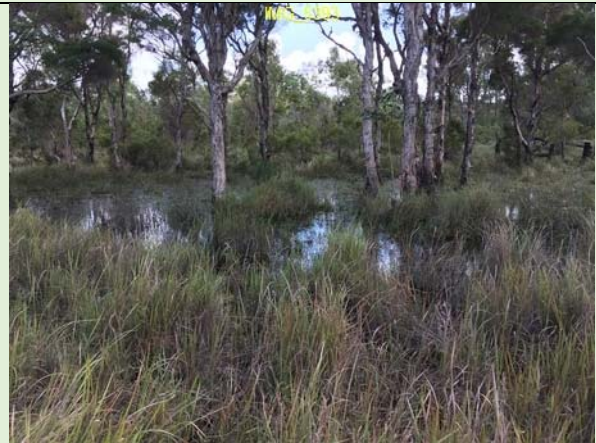
CH200-400 mapped wetland - upstream extent with standing water, lower extent damp only. Excellent vegetation coverage.

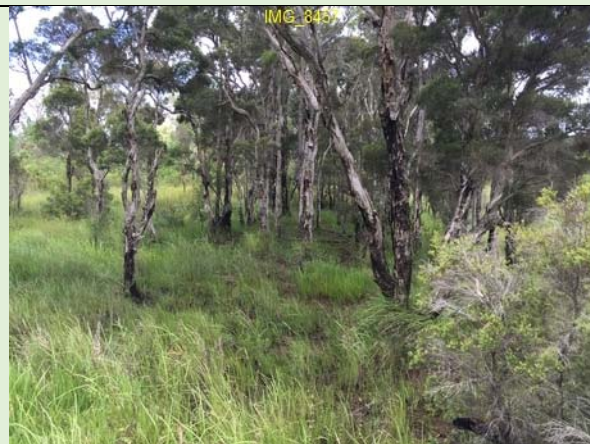
CH400-600 Dense wetland understorey, moderate canopy, broad, flat, profile, no defined channel. Standing water throughout, no instability.

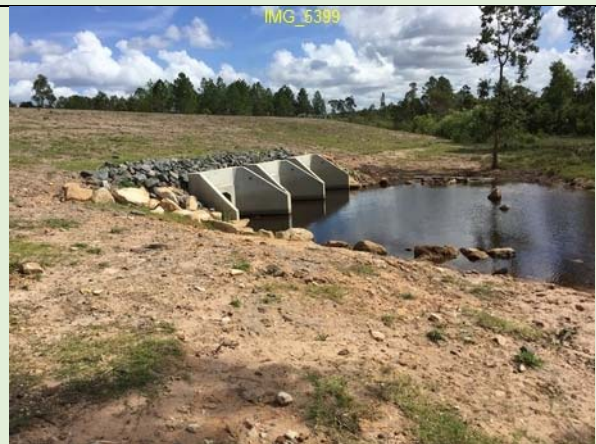
CH600 Interim flood bund 16-INT (downstream side). Post-civil works so minimal established vegetation evident.

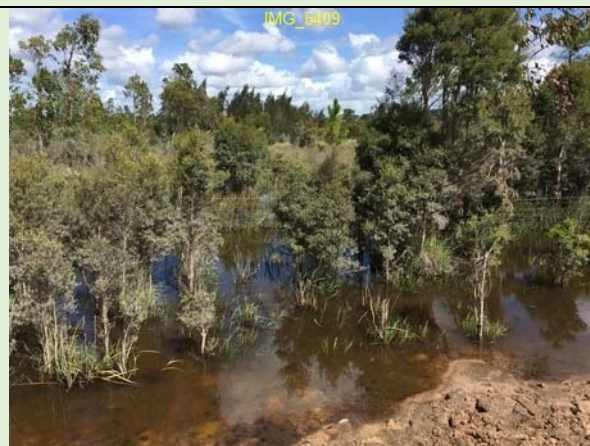
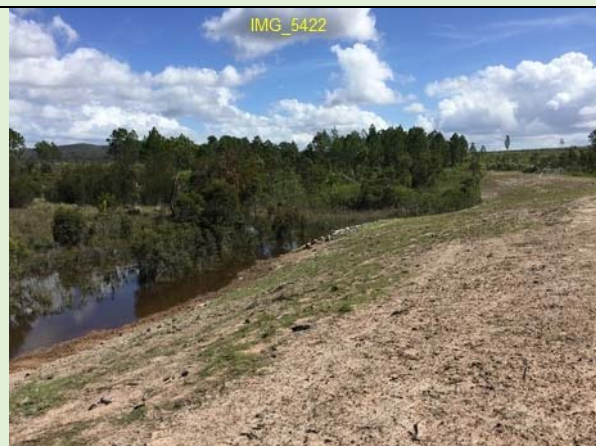
CH600-800 broad flat wetland zone, moderate/dense vegetation within standing water. Vegetation (u/s of flood bund 16-INT).

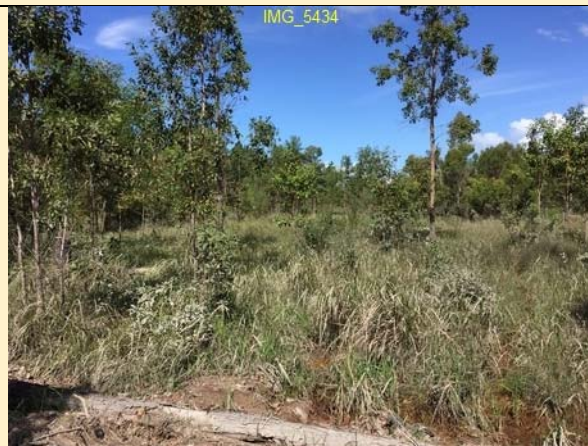
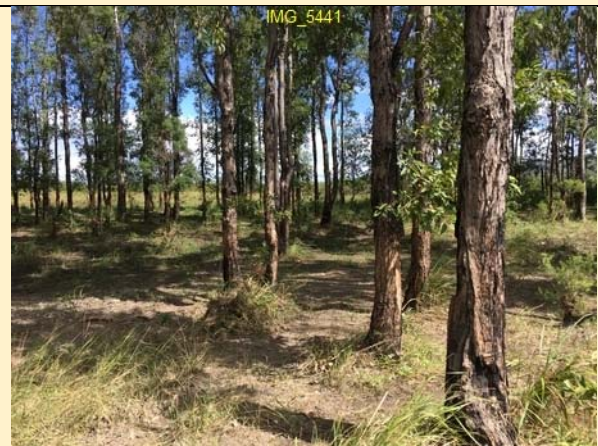
CH0-500 open vegetation downstream transitioning into localised wooded zones, undefined low flow path within very broad flat waterway, scattered wet depressions throughout.

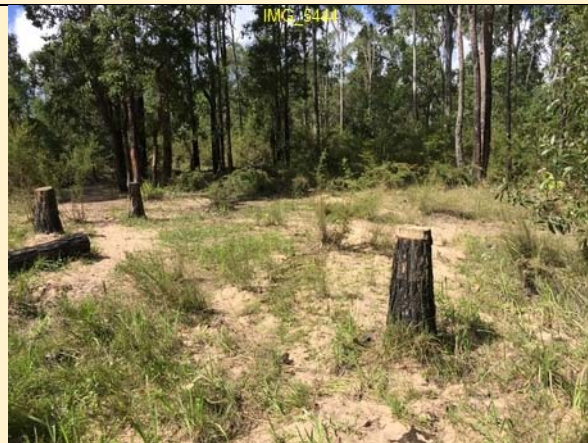
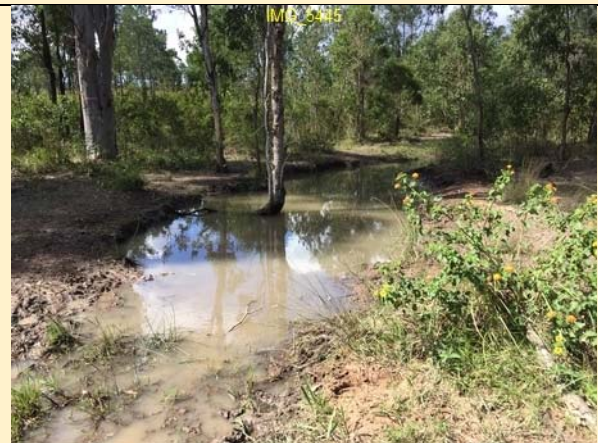
CH500-600 moderate groundcover, clumps of trees, localised shallow pool and downstream sediment deposition area. Some livestock damage near pool.
