# YARRABILBA PRECINCT 6 ROL<sub>2</sub> STORMWATER MANAGEMENT PLAN

VERSION 1

DesignFlow  
Prepared for Lendlease  
October 2023

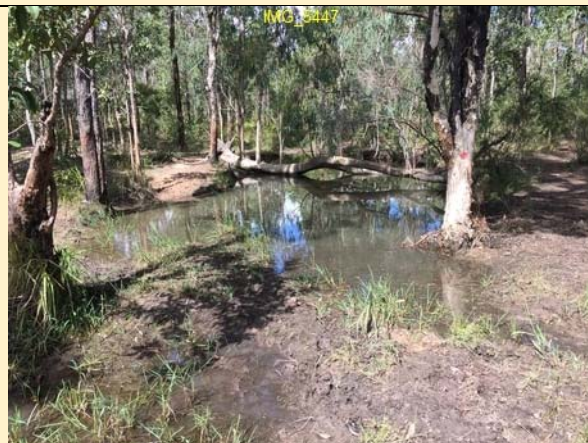
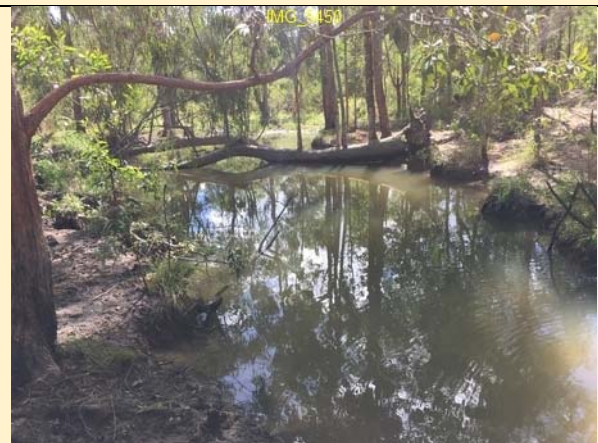
CH600 stable pond, bare banks surrounded by mature and regrowth trees, some livestock damage to fringe.

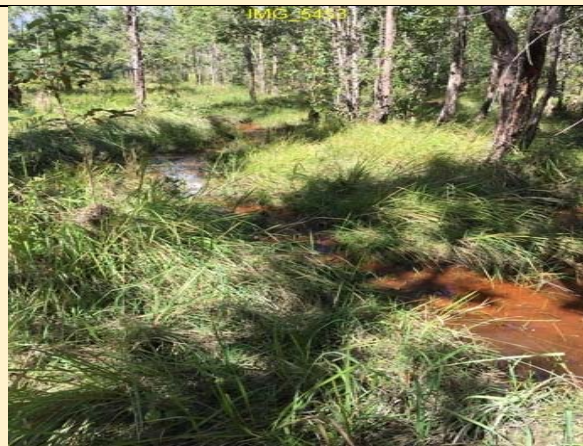
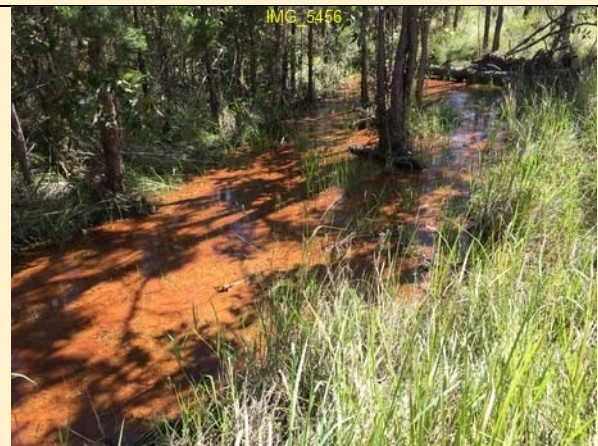
CH600-800 iron bacteria coloured low flow shallow channel surrounded by dense groundcover and moderate tree canopy. No significant instability within low flow.

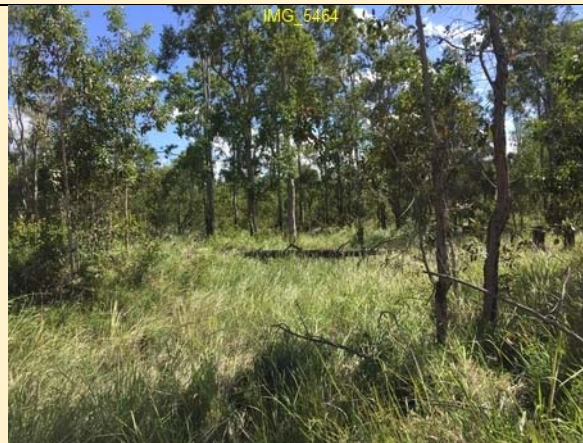
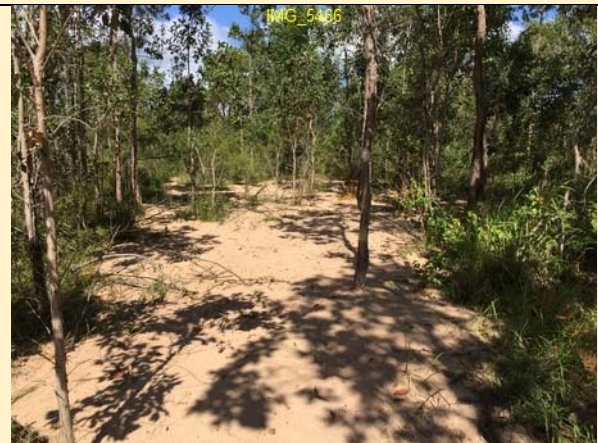
CH800-850 well grassed broad flow path with localised sediment slug interspersed (material from upstream chain of ponds/scour pool)

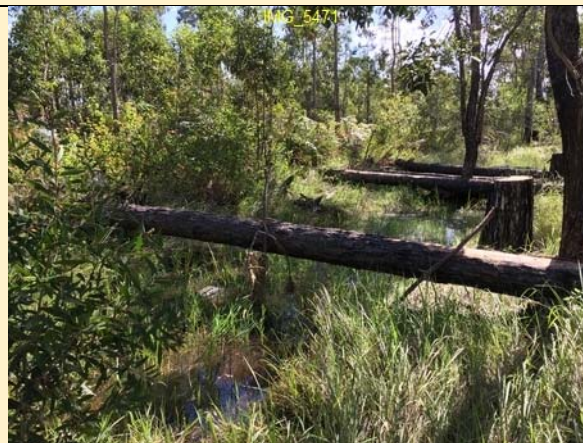
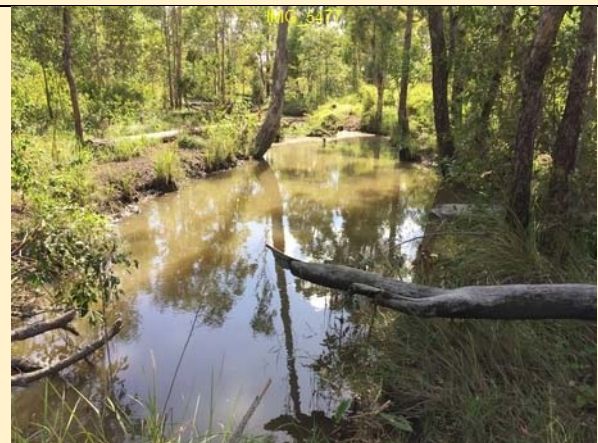
CH850-950 Chain of ponds surrounded by dense vegetation. Local areas of instability and/or livestock damage.

| ID | CHAINAGE (APPROX.) | WATERWAY STABILITY MANAGEMENT |
|---|---|---|
| S8 | 880-930 | Chain of ponds (scour pools) with establish trees – review habitat value with ecologist and undertake targeted works to stabilise banks, remove/relocated woody debris causing high energy flow, revegetate livestock damaged banks, and monitor zone following upstream development. |

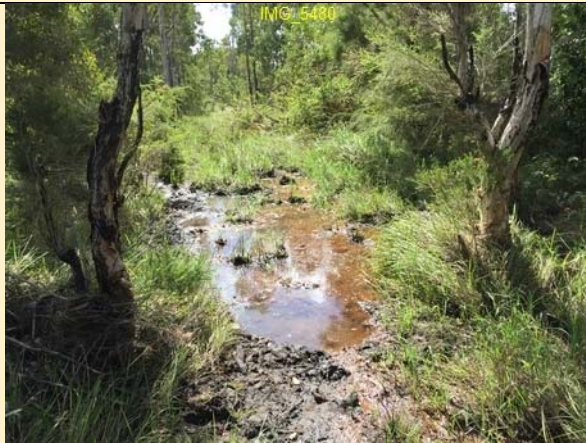
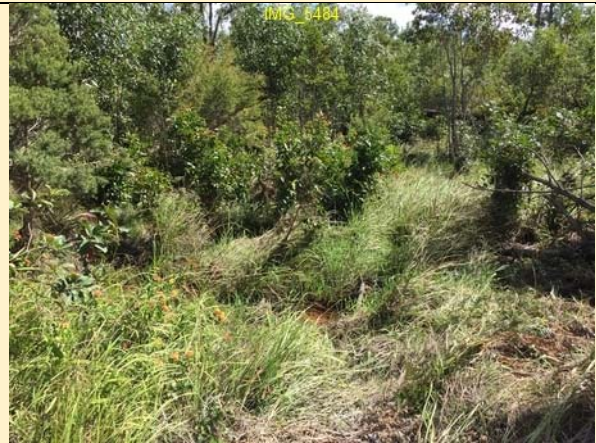
CH950-1200 livestock disturbance, iron rich seepage within undefined low flow channel surrounded by dense ground and tree cover.

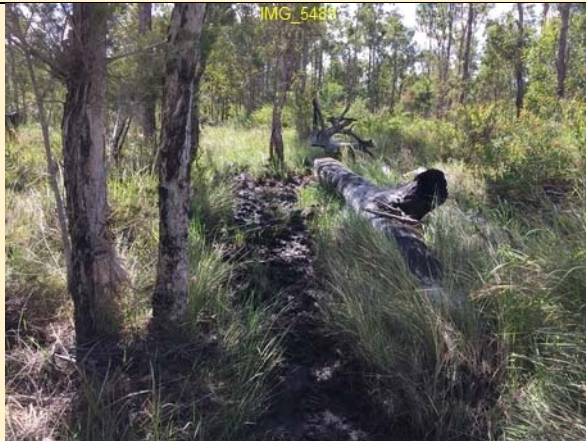
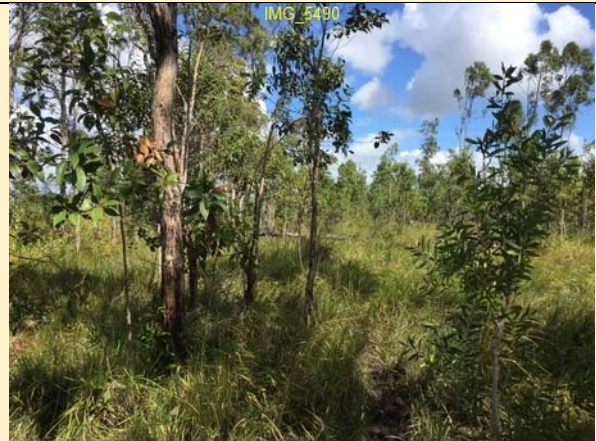
CH1200-1300 dense grass surrounding iron rich low flow channel with pockets of livestock disturbance. Minimal instability issues.

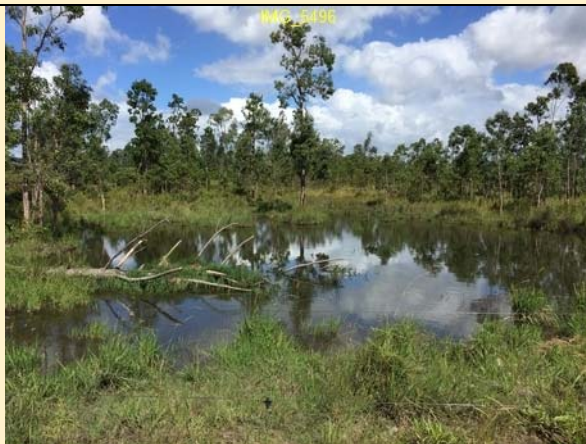
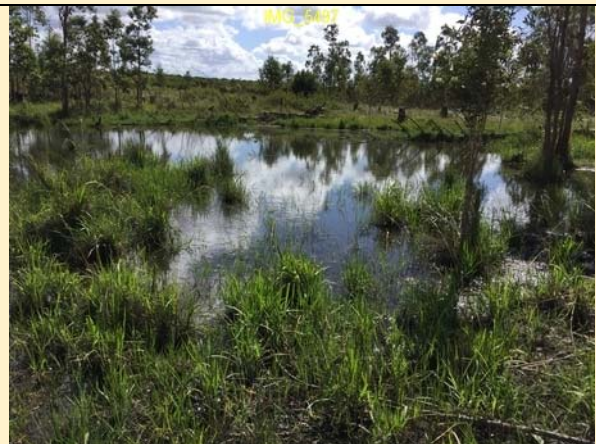
CH1300-1350 moderate size pond ~30m x 50m (upstream of track crossing)

| ID | CHAINAGE (APPROX.) | WATERWAY STABILITY MANAGEMENT |
|---|---|---|
| S11 | 1300-1350 | Ephemeral wetland/pond - review habitat value with ecologist and undertake targeted works to stabilise banks, decommission or stabilise track crossing at downstream edge, formalise ephemeral wetland vegetation, revegetate livestock damaged banks, and monitor zone following upstream development. |

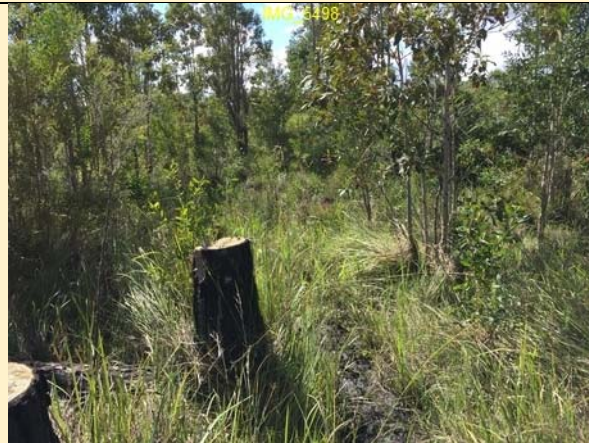
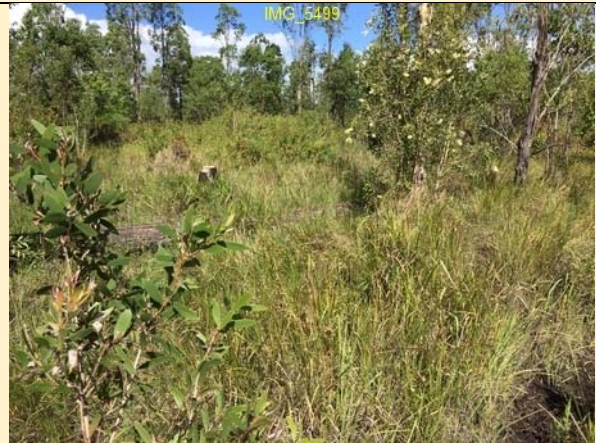
CH1350-1500 dense grass, regrowth and very low seepage evident in localised pockets (no defined channel)

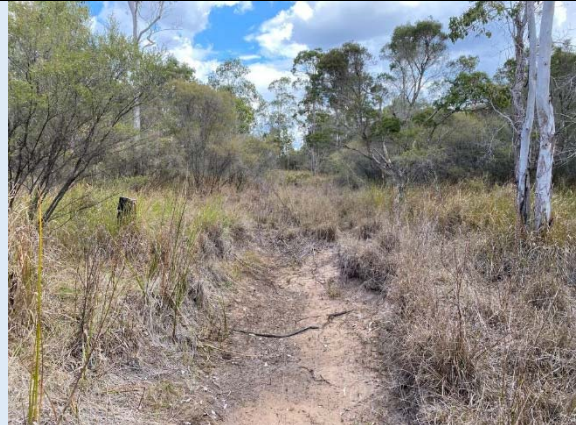
CH0-50 Low flow channel evident with isolated scour pool (dry) approx. 10m long, 3m wide surrounded by dense groundcover vegetation. Fill, provide rock lining and interplant with grasses/shrubs. Will likely form part of road crossing works.

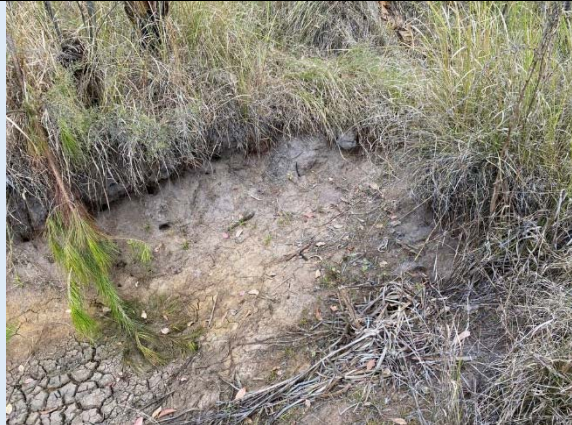
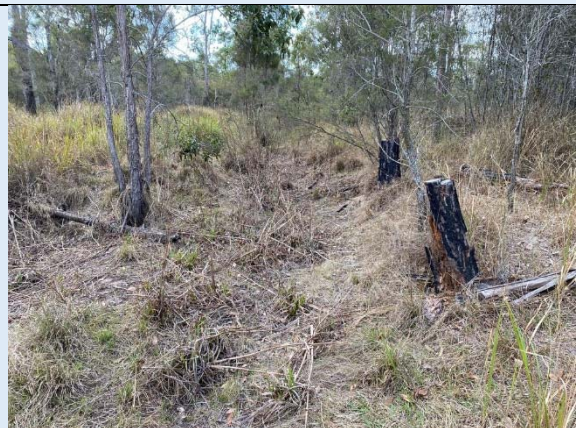
CH50-100 Low flow channel evident with emergent wetland plants (now dry and died back). Surrounding area densely vegetated with grasses/shrubs. Monitor area as development progresses to assess resilience. No obvious instability at present.

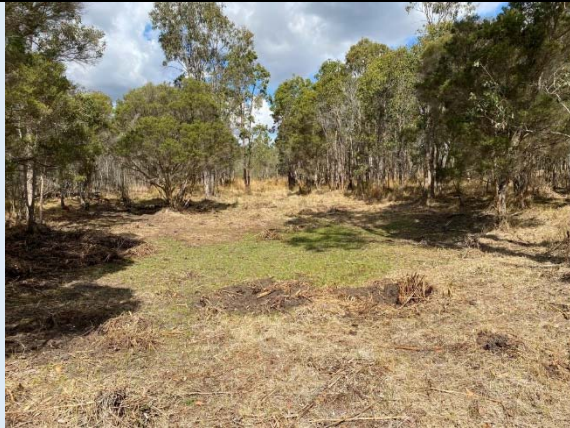
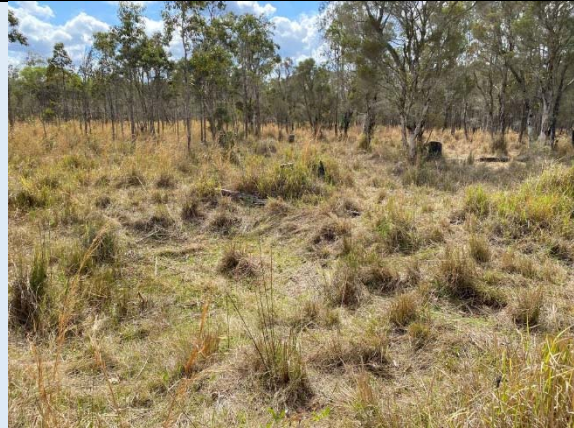
CH100-450 Broad grassed flow path with scattered trees. No defined low flow or scour zones. Minor livestock/feral pig disturbance locally. Occasional shallow flow path evident on animal trail but low gradient minimizes instability. Grazing of grasses evident from vegetation height. Monitor and plant disturbed areas if natural regeneration is slow.

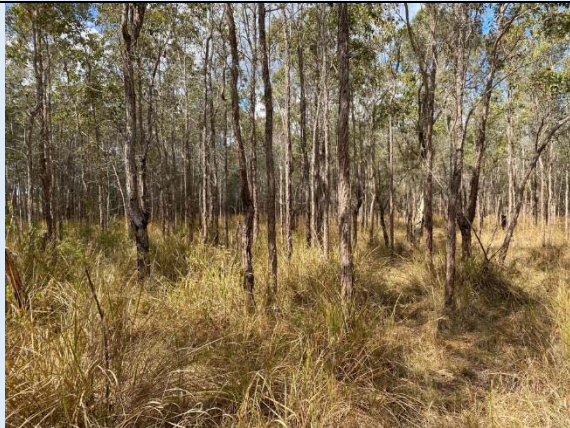
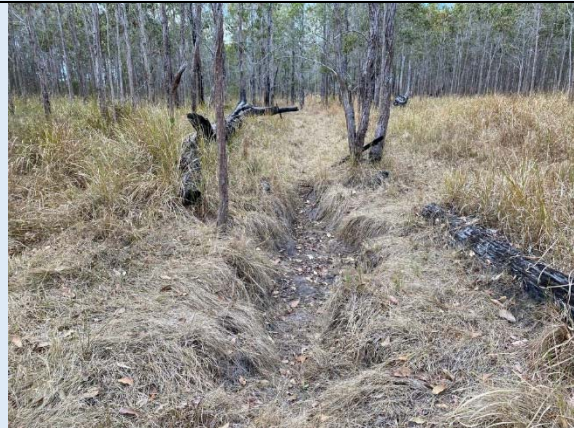
CH450-820 Shrub/tree density increases (compared to downstream) with grass cover (and height) increasing. Broad well vegetated flow path with minimal defined low flow channel in most parts. No obvious instability observed.

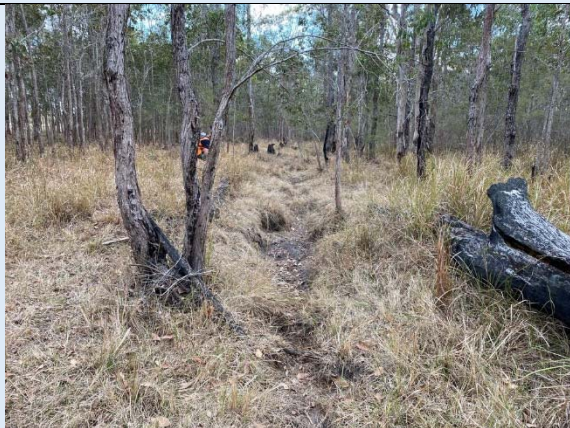
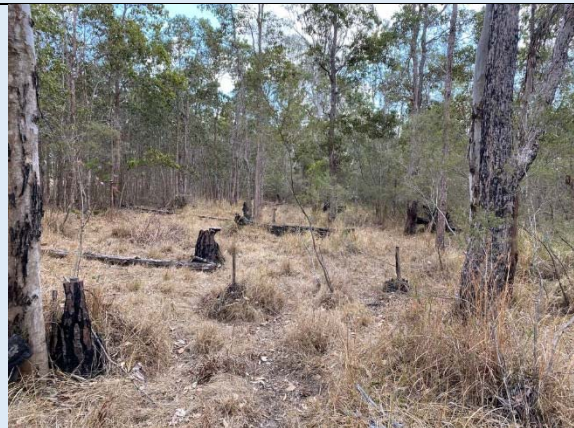
CH820-950 Minor low flow channel (periodically) but very localised and on very low gradient. Scattered shallow scour pools (dry) likely partly from livestock trail and disturbance. Low risk. Monitor and plant disturbed areas if natural regeneration is slow.

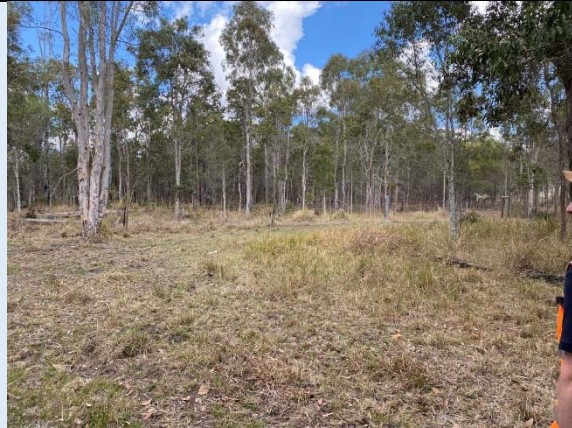
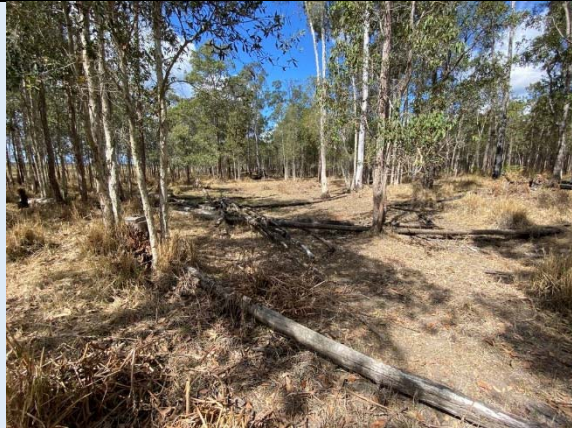
CH950-1000 Localised open grassed area with lower tree density. Broad flat area likely shallow ponding in wet periods with scattered wetland plants now died back (now dry). Adjacent to former vehicle track crossing. No obvious scour or instability present.

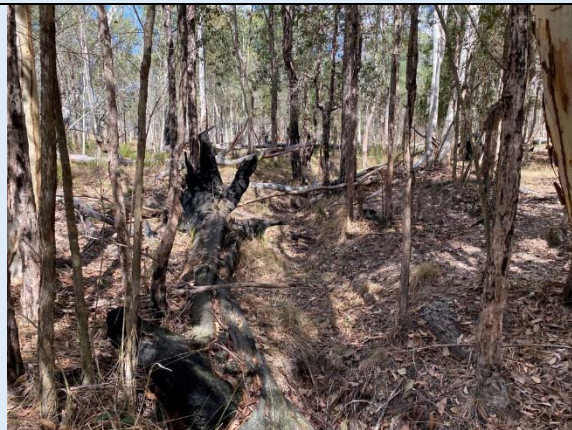
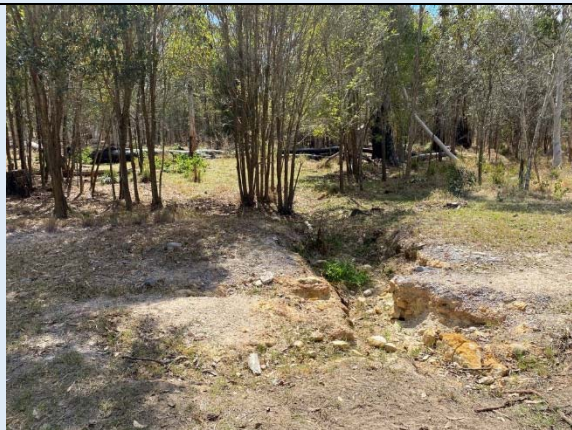
CH1000-1120 Shallow low flow channel commences and extends upstream with gradual deepening and evidence of scour. Fallen logs increase scour locally (while still shallow). Surrounding area broad, flat and well grassed. Vehicle track crossing at CH1120 with localised washout of gravel. Local filling with non-dispersive soil and revegetation. Monitor stability and natural regeneration of vegetation surrounding. Where continued instability occurs in low flow, local rock scour protection may be required.

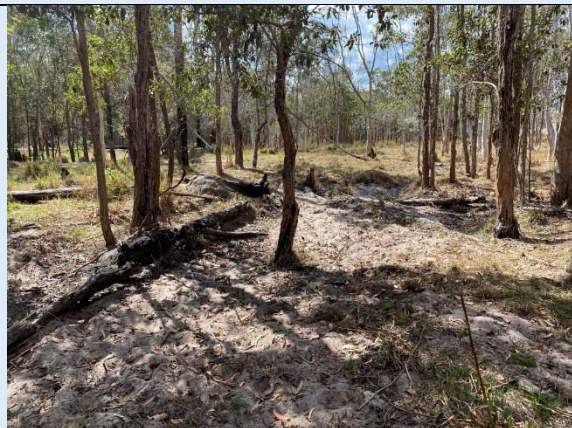
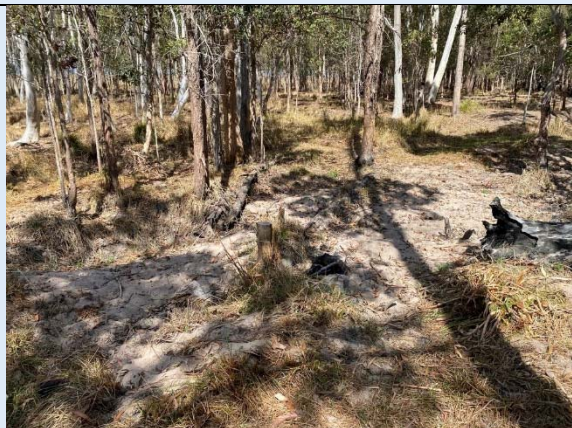
CH1120-1150 Sand deposition zone from upstream scour zone. Minor low flow channel evident but remains shallow.

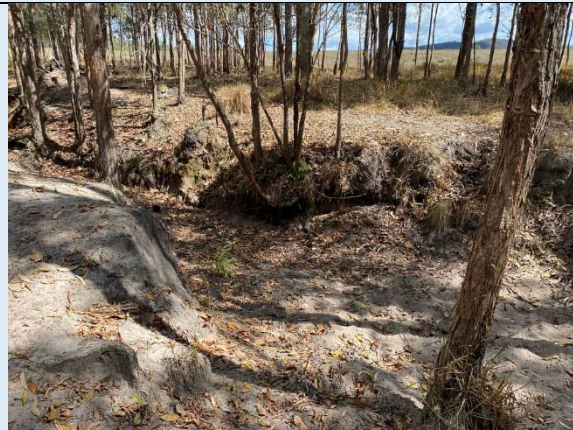
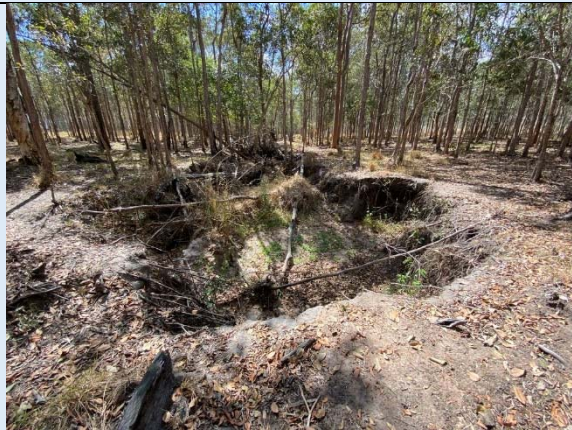
CH1150-1200 Commencement of incised low flow channel with vertical sides and local undercutting of trees. Depth varies <0.5. to 1m. Soil appears to be weak/dispersive. Fallen logs may be exacerbating local scour in flow path. At CH1200, a significant head-cut exists ~0.8-1m deep and 5-6m across. No obvious steep or defined flow paths into this location. Soils may be an issue here. Cemented layer at ~0.6-0.8m depth which appears to have been weaker in wet period. Reshape and backfill with non-dispersive soil, revegetate and monitor stability. Rock may be required to manage grade change at head-cut.

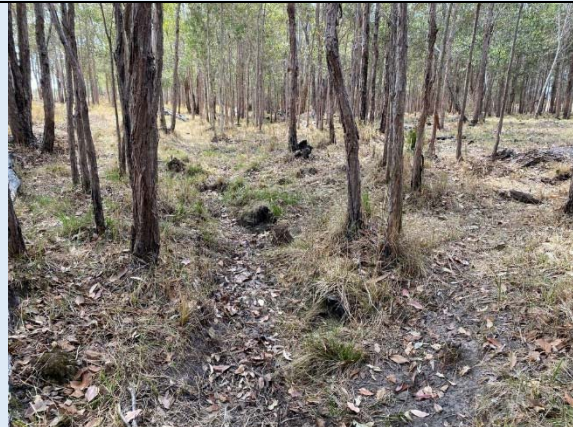
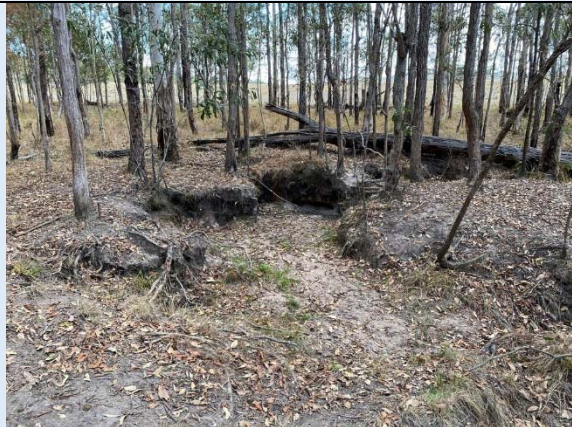
CH1200-1320 Upstream of head-cut at CH1200, flow path returns to broad, grassed area with intermittent shallow low flow definition. Grasses are not tall and may be grazed by livestock. Localised minor scour zones evident with minor undercutting of trees. Weaker soil layer also evident at CH1320 as seen at CH1200. Reshape and backfill scour with non-dispersive soil, revegetate and monitor stability.

| ID | CHAINAGE (APPROX.) | WATERWAY STABILITY MANAGEMENT |
|---|---|---|
| W6 | 1200-1320 | Upstream of head-cut at CH1200, flow path returns to broad, grassed area with intermittent shallow low flow definition. Grasses are not tall and may be grazed by livestock. Localised minor scour zones evident with minor undercutting of trees. Weaker soil layer also evident at CH1320 as seen at CH1200. Reshape and backfill scour with non-dispersive soil, revegetate and monitor stability. |

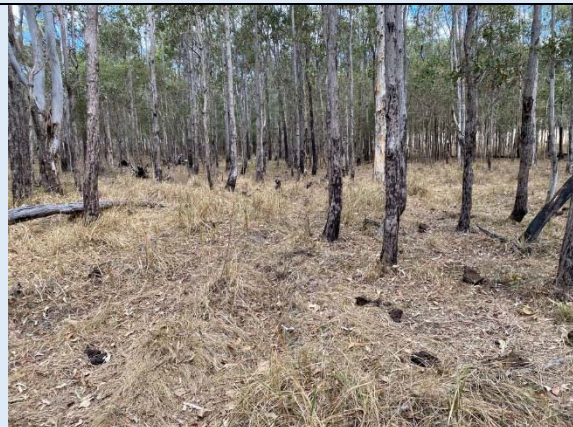
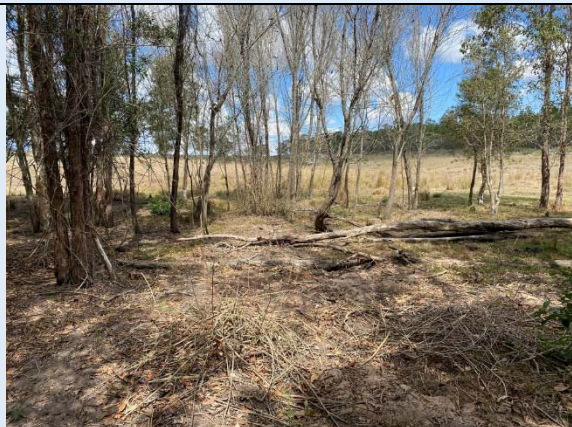
CH1320-1450 Broad grassed area with scattered to moderate tree cover. Minimal defined flow path definition in this area. Vegetation corridor ends at CH1450. Open grazing land beyond.
