# Riverbend

## Earthworks Strategy

## Infrastructure Master Plan

| Our Reference: | 20-0190-IMP-EWKS_1 |

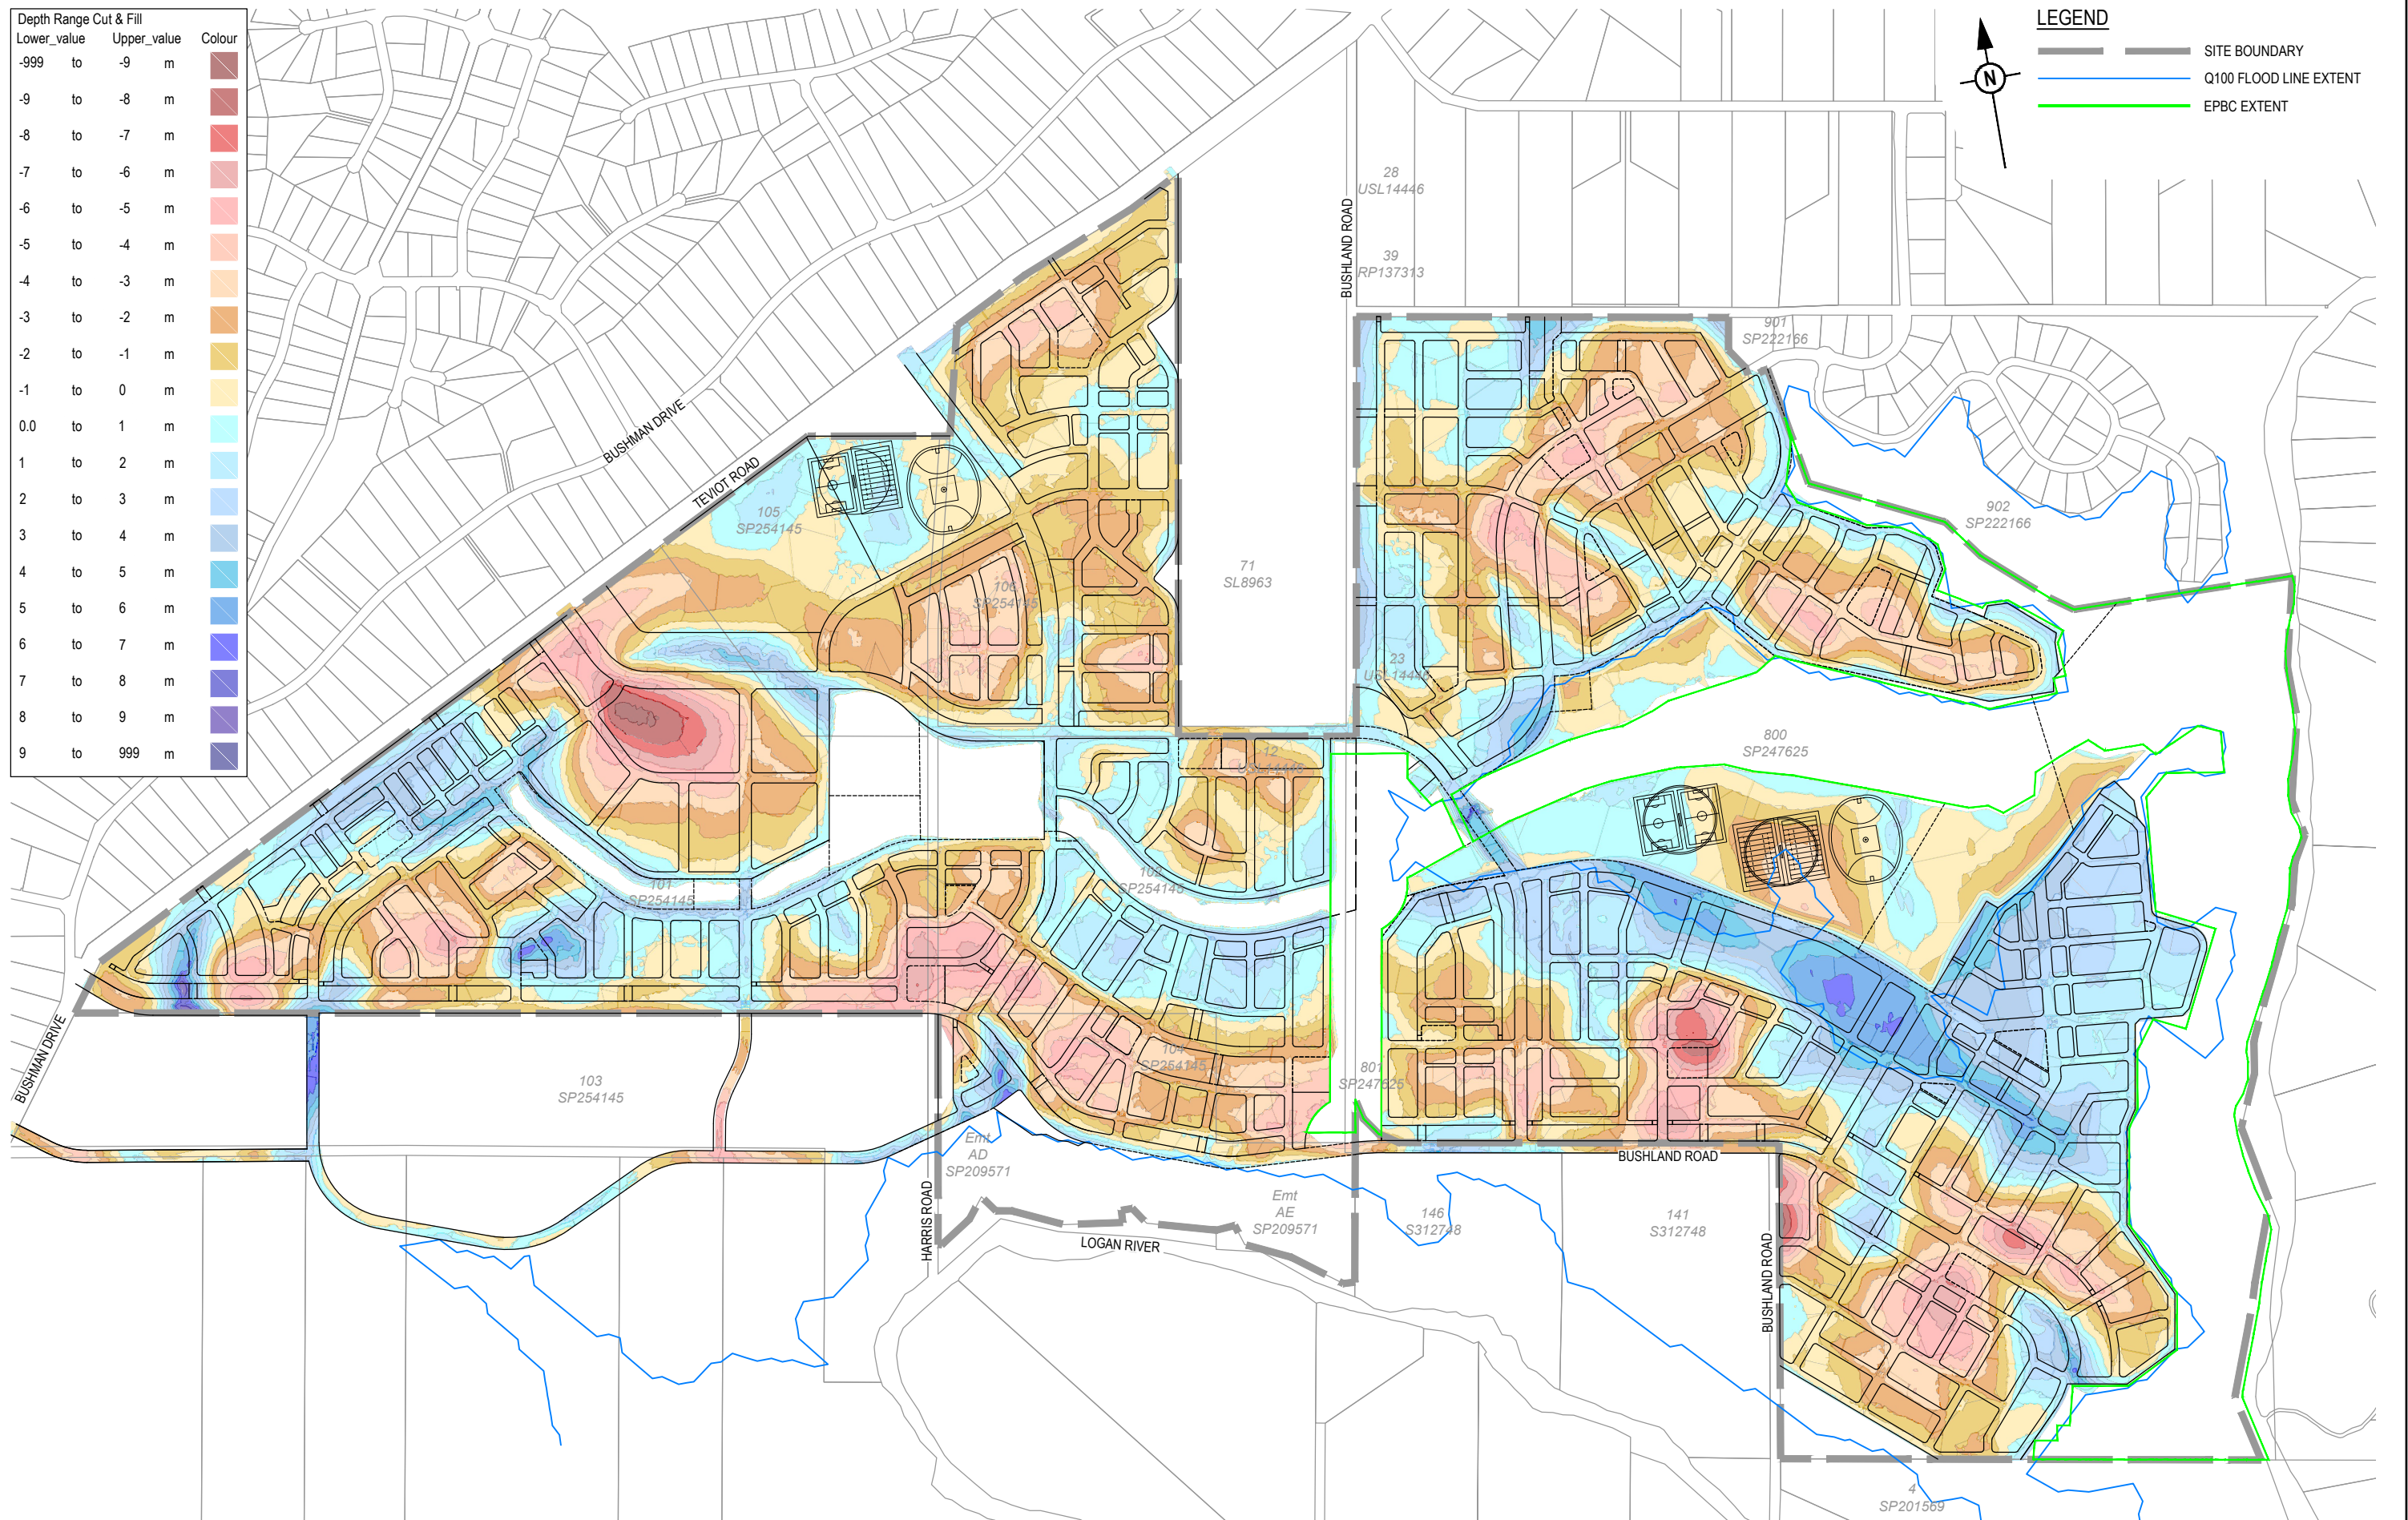
| REV | DATE | DESIGN | DRAWN | REVISION DETAILS | | | DRAWN | STATUS | | | | SCALE | | CLIENT | | PROJECT NAME | | DRAWING TITLE | | | | |
|---|---|---|---|---|--|--|---|---|--|--|---|---|---|---|---|---|---|---|---|---|---|---|
| A | 07.05.24 | ML | BA | ORIGINAL ISSUE | | | | NOT FOR CONSTRUCTION | | | | 1:6000 | 120 | 0 | 120 | 240 | A1 | CELESTINO DEVELOPMENTS<br>PTY LTD | RIVERBEND | DEPTH OF CUT/FILL PLAN | | |

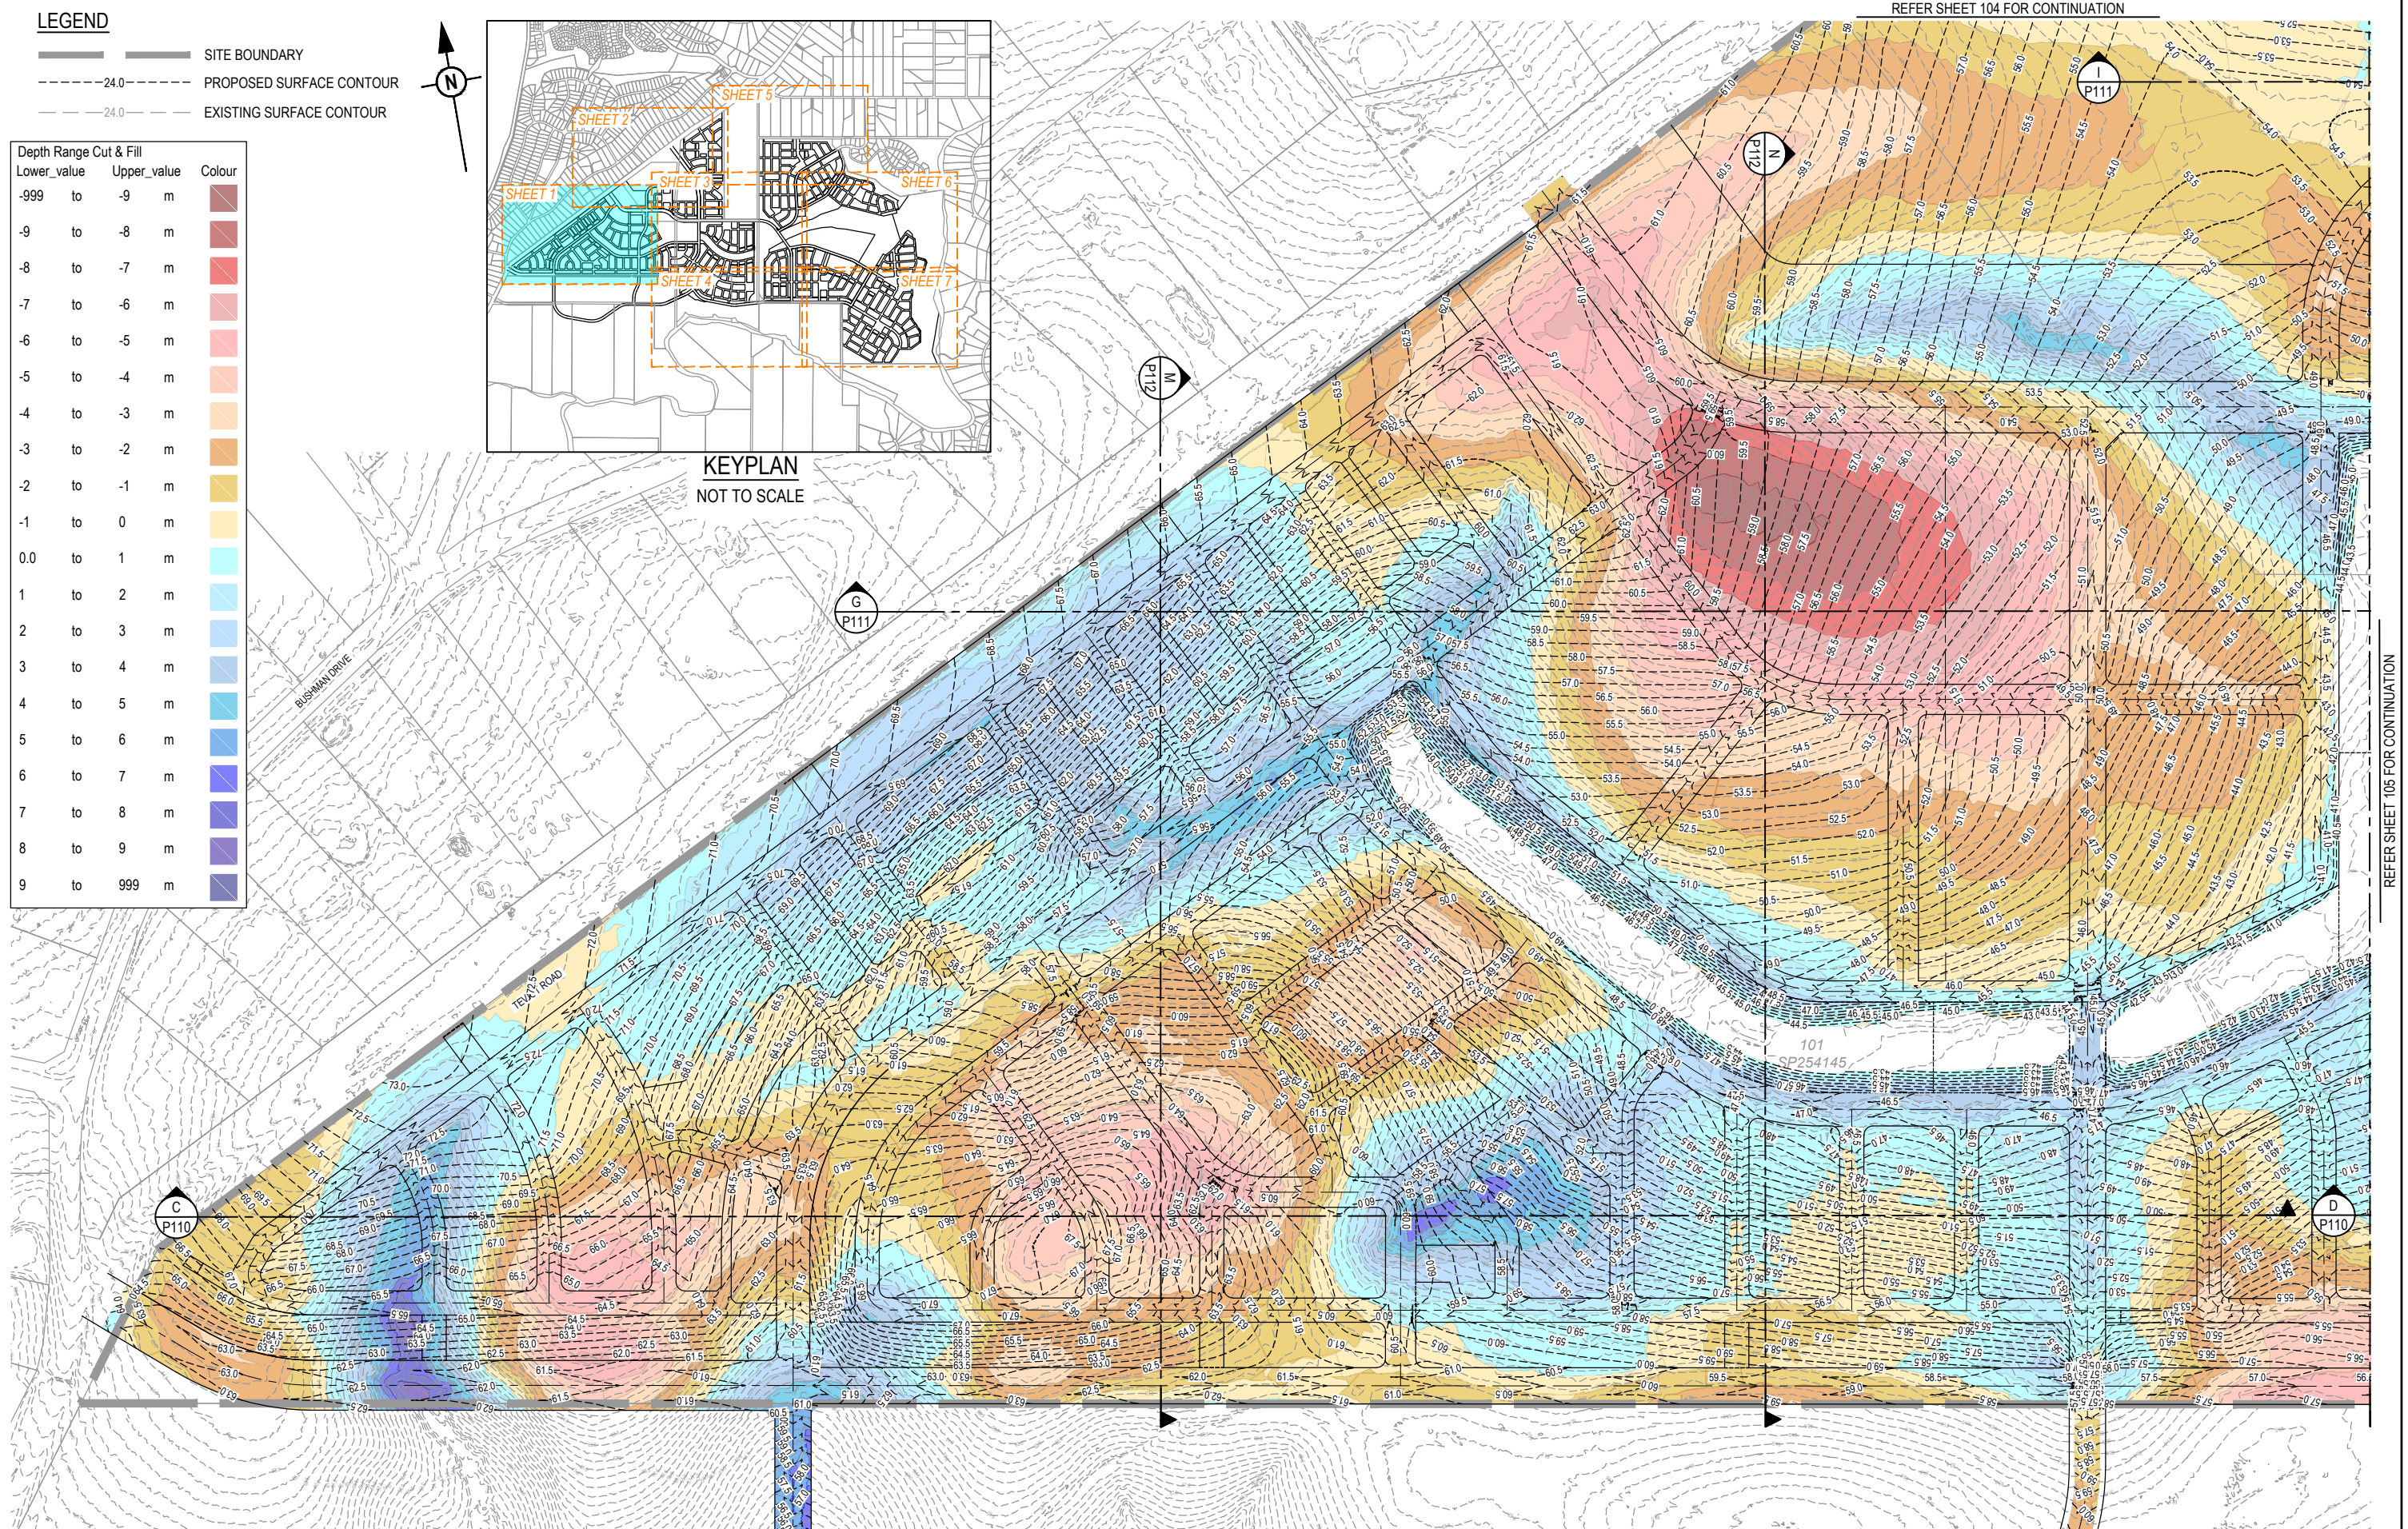
| REV | DATE | DESIGN | DRAWN | REVISION DETAILS | | DRAWN | STATUS | | | SCALE<br><br>1:2000 20 0 20 40 60 80 100 A1<br>1:4000 | CLIENT<br><br>CELESTINO DEVELOPMENTS<br>PTY LTD | PROJECT NAME<br><br>RIVERBEND | DRAWING TITLE<br><br>CONCEPT BULK EARTHWORKS<br>LAYOUT PLAN SHEET 1 OF 7 | | |

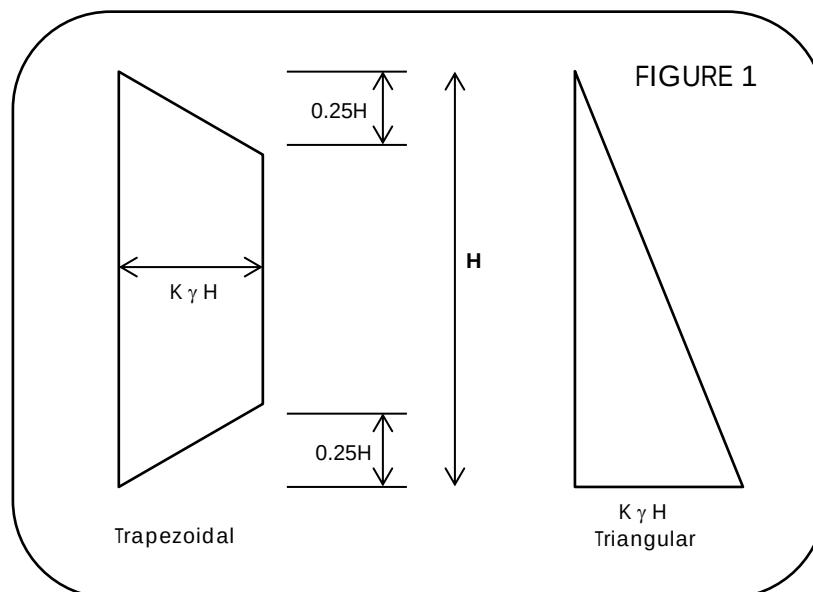
The design of flexible retaining walls could be undertaken using a triangular pressure distribution and the earth pressure parameters given in Table 5. Flexible walls are those which are free to rotate or tilt (such as cantilevered walls) and should be designed using active ( $K_a$ ) earth pressure coefficient. Rigid walls are those which are restrained against rotation or tilt (i.e. single anchored/propped walls) and should be designed using the at-rest earth pressure ( $K_o$ ) and a trapezoidal pressure distribution as per Figure 1.

- K is either  $K_a$ ,  $K_o$ , or  $K_p$  for “active”, “at rest” or “passive” earth pressure conditions, respectively
- $\gamma$  (kN/m<sup>3</sup>) is the relevant density of the soil or rock
- H (m) is the distance down from the top of the wall
- q (kPa) is any uniform surface surcharge load behind the wall
- $\sigma L$  (kPa) is the lateral pressure on the wall resulting from adjacent surcharges.

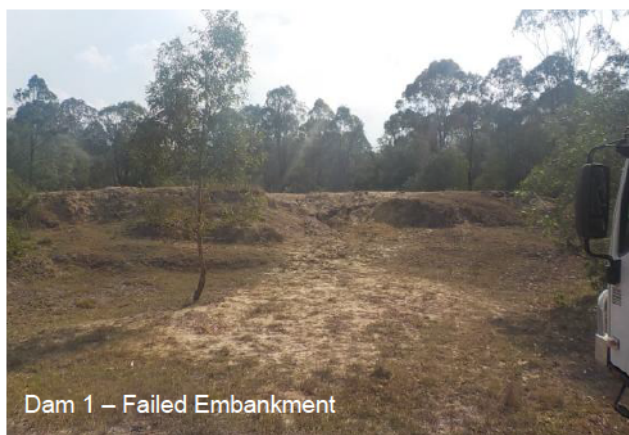
Based on site observations (i.e. the existing failed embankment), the potential landslide travel distance would be considered to be in the range of approximately 10 to 20m.

Dam 1 – Failed Embankment

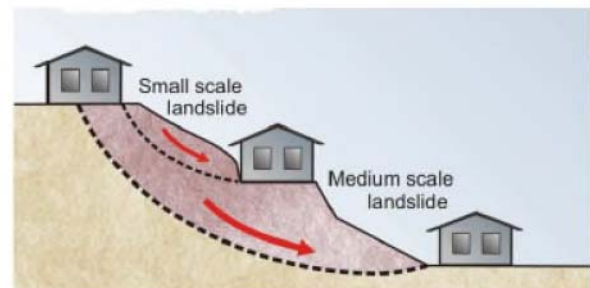
Figure 1

**Rotational or circular slip failures (Figure 1)** - can occur on moderate to very steep soil and weathered rock slopes (Table 1). The sliding surface of the moving mass tends to be deep seated. Tension cracks may open at the top of the slope and bulging may occur at the toe. The ground may move in discrete "steps" separated by long periods without movement. More rapid movement may occur after heavy rain.

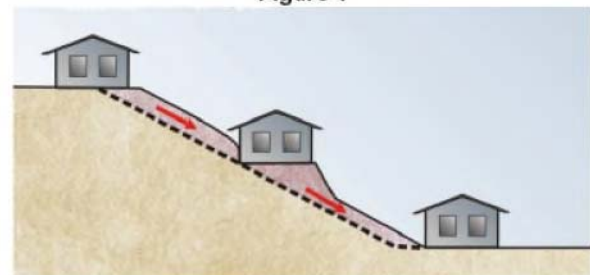
Figure 2

**Translational slip failures (Figure 2)** - tend to occur on moderate to very steep slopes (Table 1) where soil, or weak rock, overlies stronger strata. The sliding mass is often relatively shallow. It can move, or deform slowly (creep) over long periods of time. Extensive linear cracks and hummocks sometimes form along the contours. The sliding mass may accelerate after heavy rain.

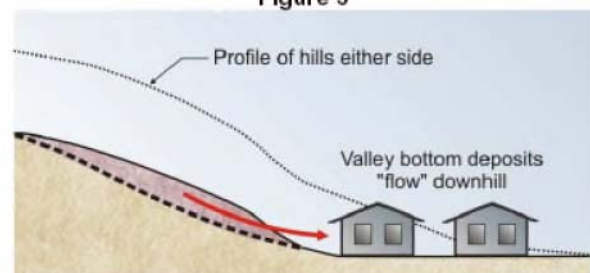
Figure 4

**Debris flows and mud slides (Figure 4)** - may occur in the foothills of ranges, where erosion has formed valleys which slope down to the plains below. The valley bottoms are often lined with loose eroded material (debris) which can "flow" if it becomes saturated during and after heavy rain. Debris flows are likely to occur with little warning; they travel a long way and often involve large volumes of soil. The consequences can be devastating.

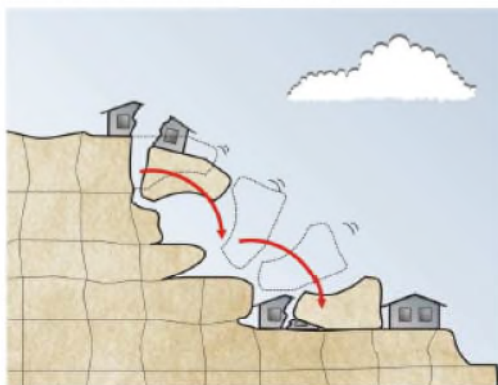
**Figure 1 - Failure of an undercut block**

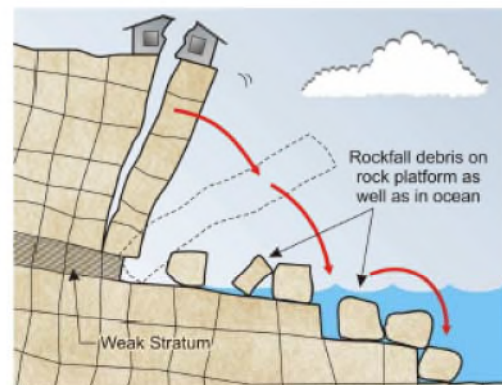
**Figure 2 - Toppling failure**

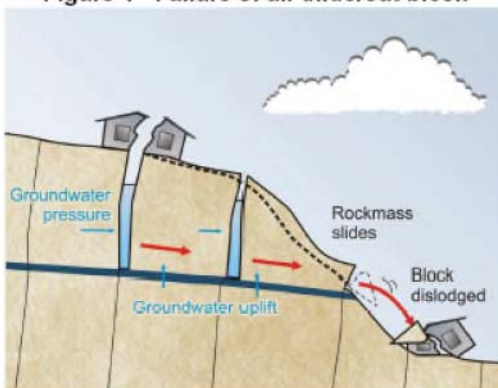
**Figure 3 - Block slide on weak layer**

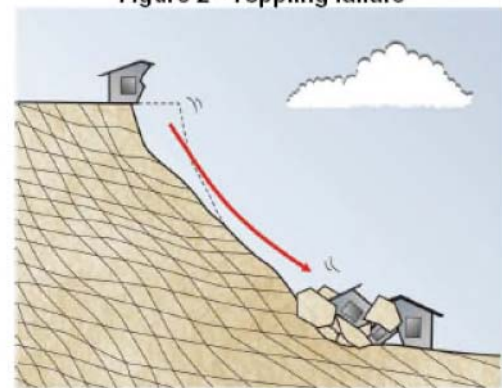
**Figure 4 - Wedge failure along discontinuities**

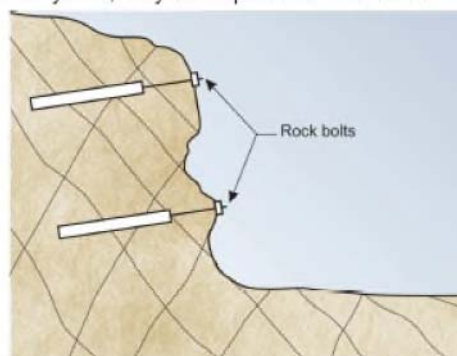
Figure 5

**Rock bolts and rock anchors** (Figure 5) - can be installed in the ground to improve its strength and prevent individual blocks from falling. Rock bolts are usually tightened using a torque wrench, whilst rock anchors carry higher loads and require jacking. Both can be designed to be "permanent" using stainless steel, or sheathing, to inhibit corrosion, but the cost can be up to 10 times that of the "temporary" alternative. You should inspect rock bolts and rock anchors for signs of water seepage, rusting and deterioration around the heads at least once every 5 years. If you notice any of these warning signs, have them checked by a geotechnical practitioner. It is recommended that you keep copies of design drawings and maintenance records (GeoGuide LR11) for the anchors on your site and pass them on to the new owner should you sell.

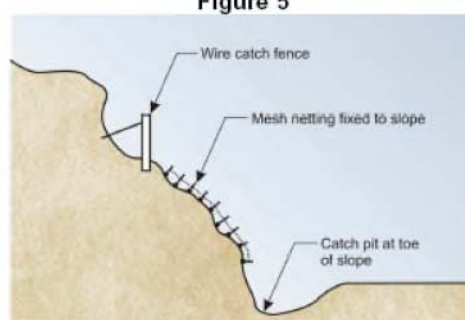
Figure 6

**Rock fall netting, catch fences and catch pits** (Figure 6) - are designed to catch or control falling rocks and prevent them from damaging nearby property. You should inspect them at least once every 5 years, and after major falls, and arrange for fallen and trapped rocks to be removed if they appear to be filling up. Check for signs of corrosion and replace steel elements and fixings before they lose significant strength.

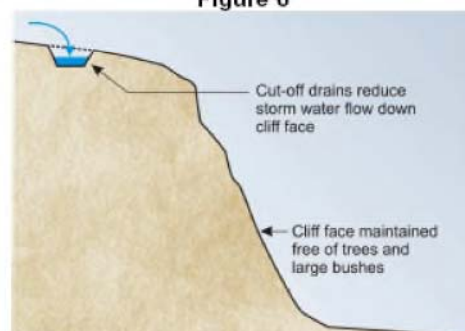
Figure 7

**Cut-off drains** (Figure 7) - can be used to intercept surface water run-off and reduce flows down the cliff face. Suitable drains are often excavated into the rock, or constructed from mounds of concrete, or stabilised soil, depending on conditions. Drains must be laid to a fall of at least 1% so they drain adequately. Frequent inspection is needed to ensure they are not blocked and continue to function as intended.

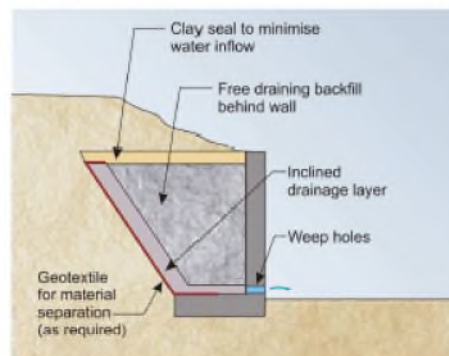
**Figure 1- Typical formed concrete wall**

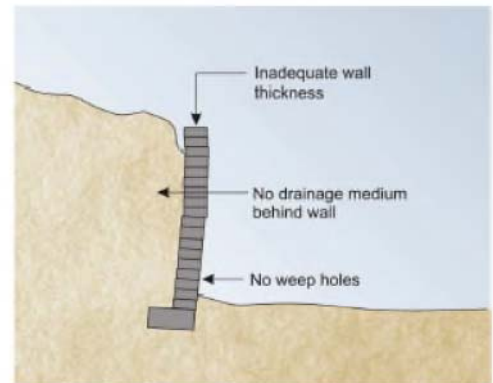
Figure 4 - Poorly built masonry wall

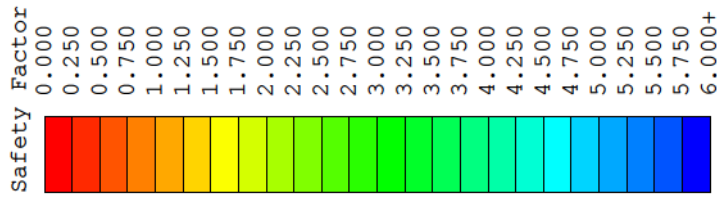
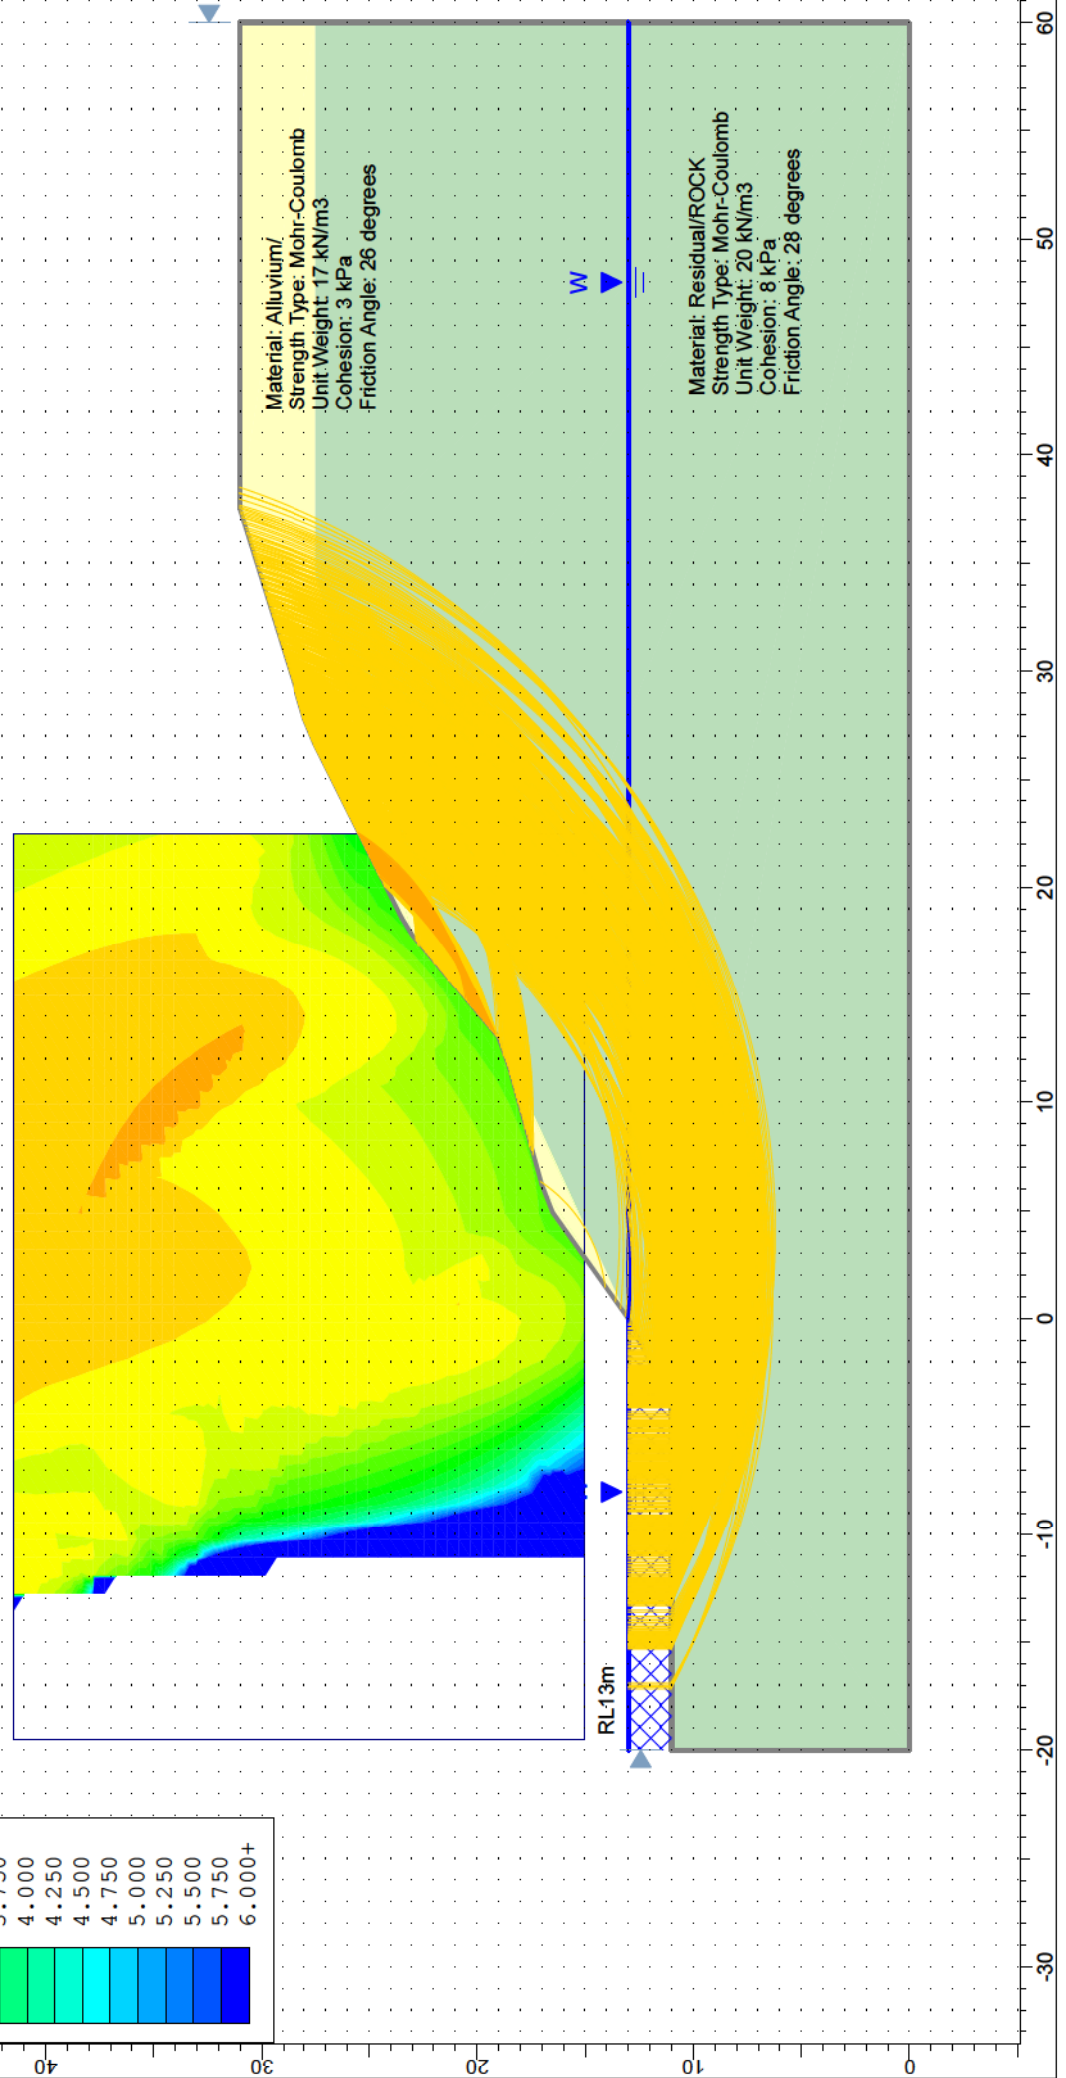
SGSE/16/220  
RIVERBEND / TEVIOT BROOK, JIMBOOMBA  
GLOBAL STABILITY ANALYSIS  
LOGAN RIVER BANK - SECTION A

STEADY STATE CONDITION

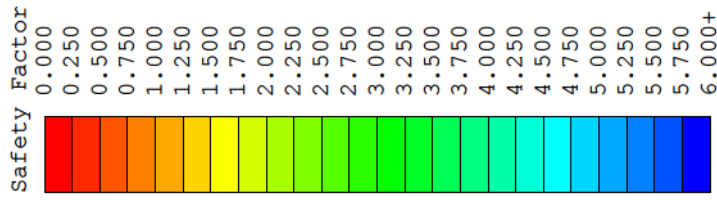
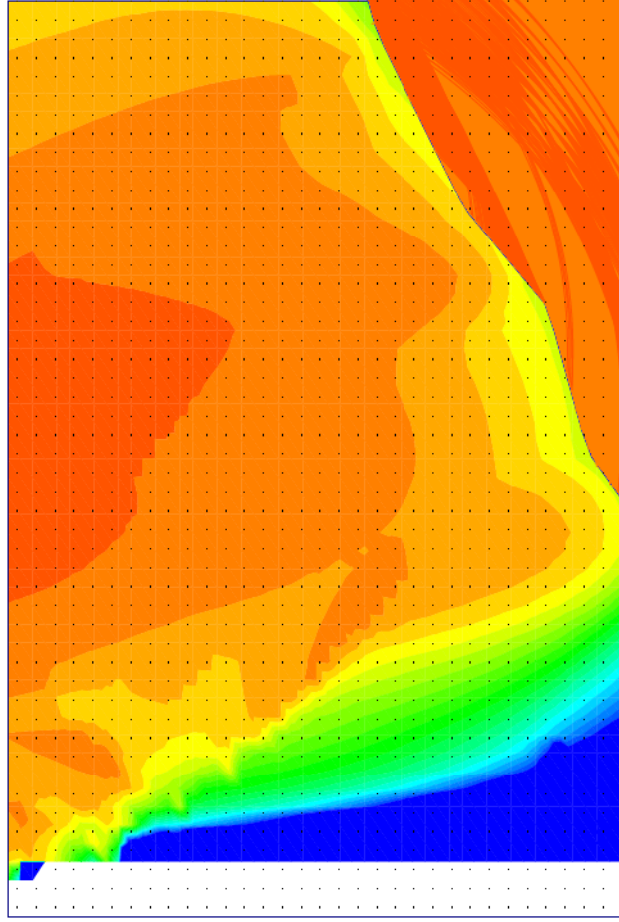
SGSE/16/220  
RIVERBEND / TEVIOT BROOK, JIMBOOMBA  
GLOBAL STABILITY ANALYSIS  
LOGAN RIVER BANK - SECTION A  
RAPID DRAWDOWN CONDITION

Flood Level - RL31m
