ENGINEERING SERVICES REPORT

AURA PRECINCT 15 'WEST'

Prepared for Stockland Development Pty Ltd

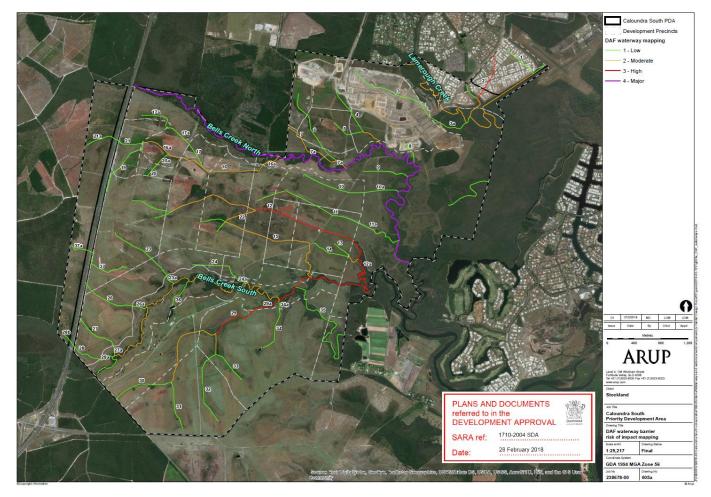
FIGURE 2. DAF WATERWAY BARRIER RISK OF IMPACT

Mapping indicates that there is no declared fish habitat anywhere in the vicinity of Aura. There is, however, Waterway Barrier mapped tributaries within Precinct 15 (with a rating of 'low'). The treatment and removal of these waterways is required to be strictly in accordance with the existing DAF approval conditions. Risk to impact to waterway barriers in accordance with the DAF waterway approval have been identified in the image below.

Reference has been made to the Department of State Development, Manufacturing, Infrastructure and Planning approval (1710-2004 SDA dated 28 February 2018) which provides a conditional approval for the proposed earthworks across the site. Figure 2 below is a snapshot of the DAF identified waterway barrier risk of impact mapping.

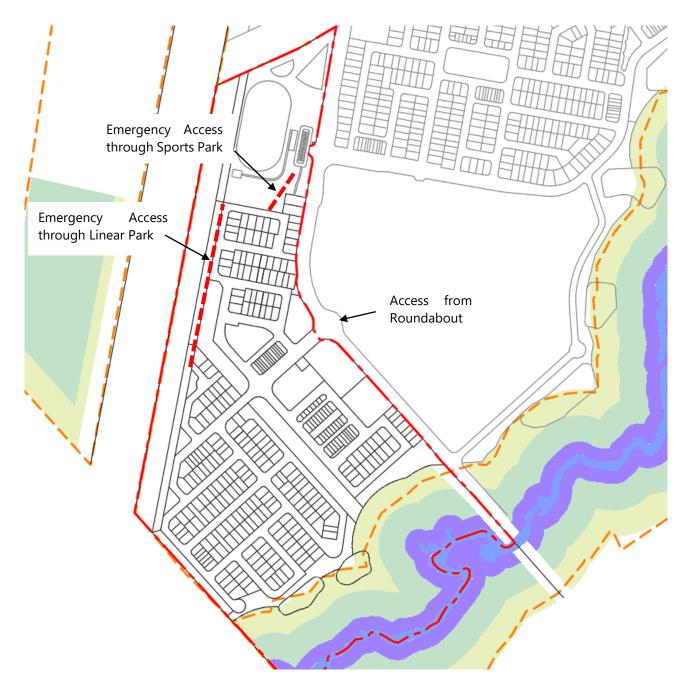
FIGURE 4. ACCESS LOCATIONS

Refer to Figure 4 below for the location of the proposed accesses and to drawing 3058-DA058 in Appendix E.

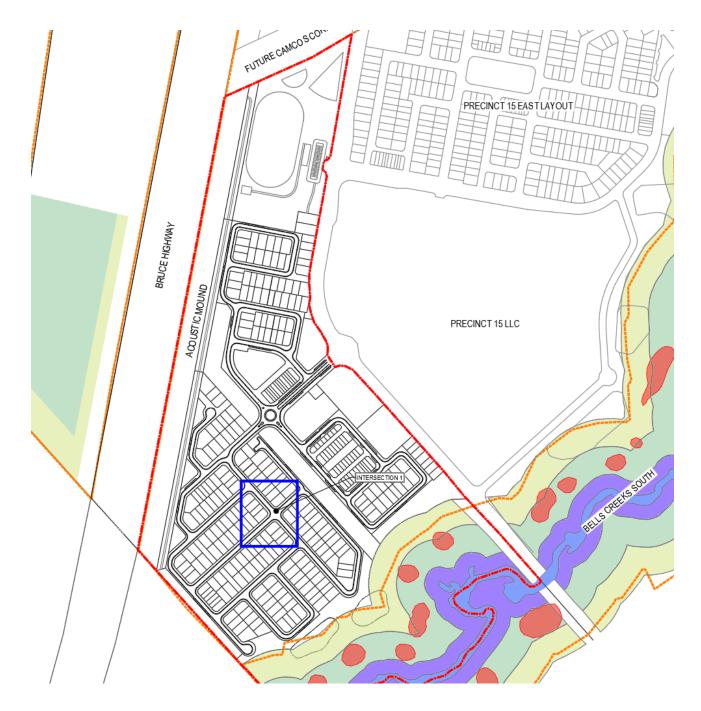
FIGURE 5. LOCATION OF FOUR-WAY INTERSECTIONS

The four-way intersection is between two access streets. Refer to Figure 5 below for the location of these intersections.

These proposed intersections are consistent with Economic Development Queensland PDA Guideline No. 06 which indicates that four-way intersections of access streets are typical for neighbourhoods (refer to extract below in Figure 6) where they are situated a minimum depth of two lots away from the closest intersection.

Four-way intersection #1 is proposed to be a priority yield intersection, where traffic signs will be required on the lessor priority road to provide clarity to drivers on who has right of way. Confirmation of the lessor priority road will be made during the Design Compliance Phase by providing a 'Signs and Linemarking' drawing, including traffic signs and surface treatments on the lessor priority road as necessary. Sight distances will also be reviewed during the Design Compliance Phase to determine whether parking limits will be required on the higher priority road, to ensure adequate sight distance for the lessor priority road.

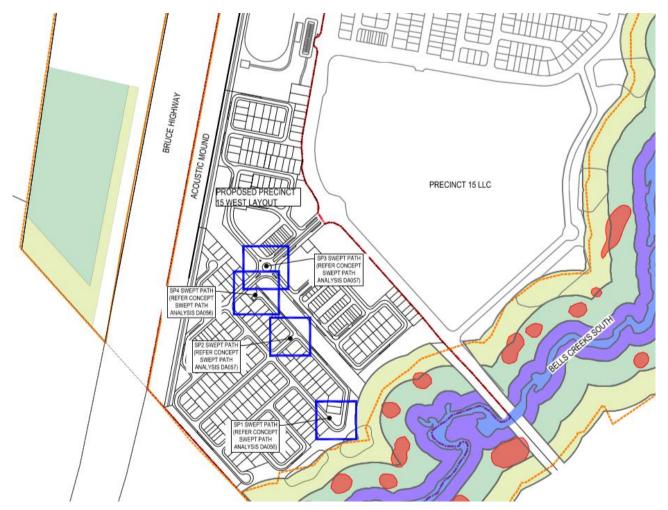
FIGURE 7. SWEPT PATH ANALYSIS REFERENCE NUMBERS

Referring to Figure 7 below, these four areas have been identified.

This Swept Path review has conceptually identified:

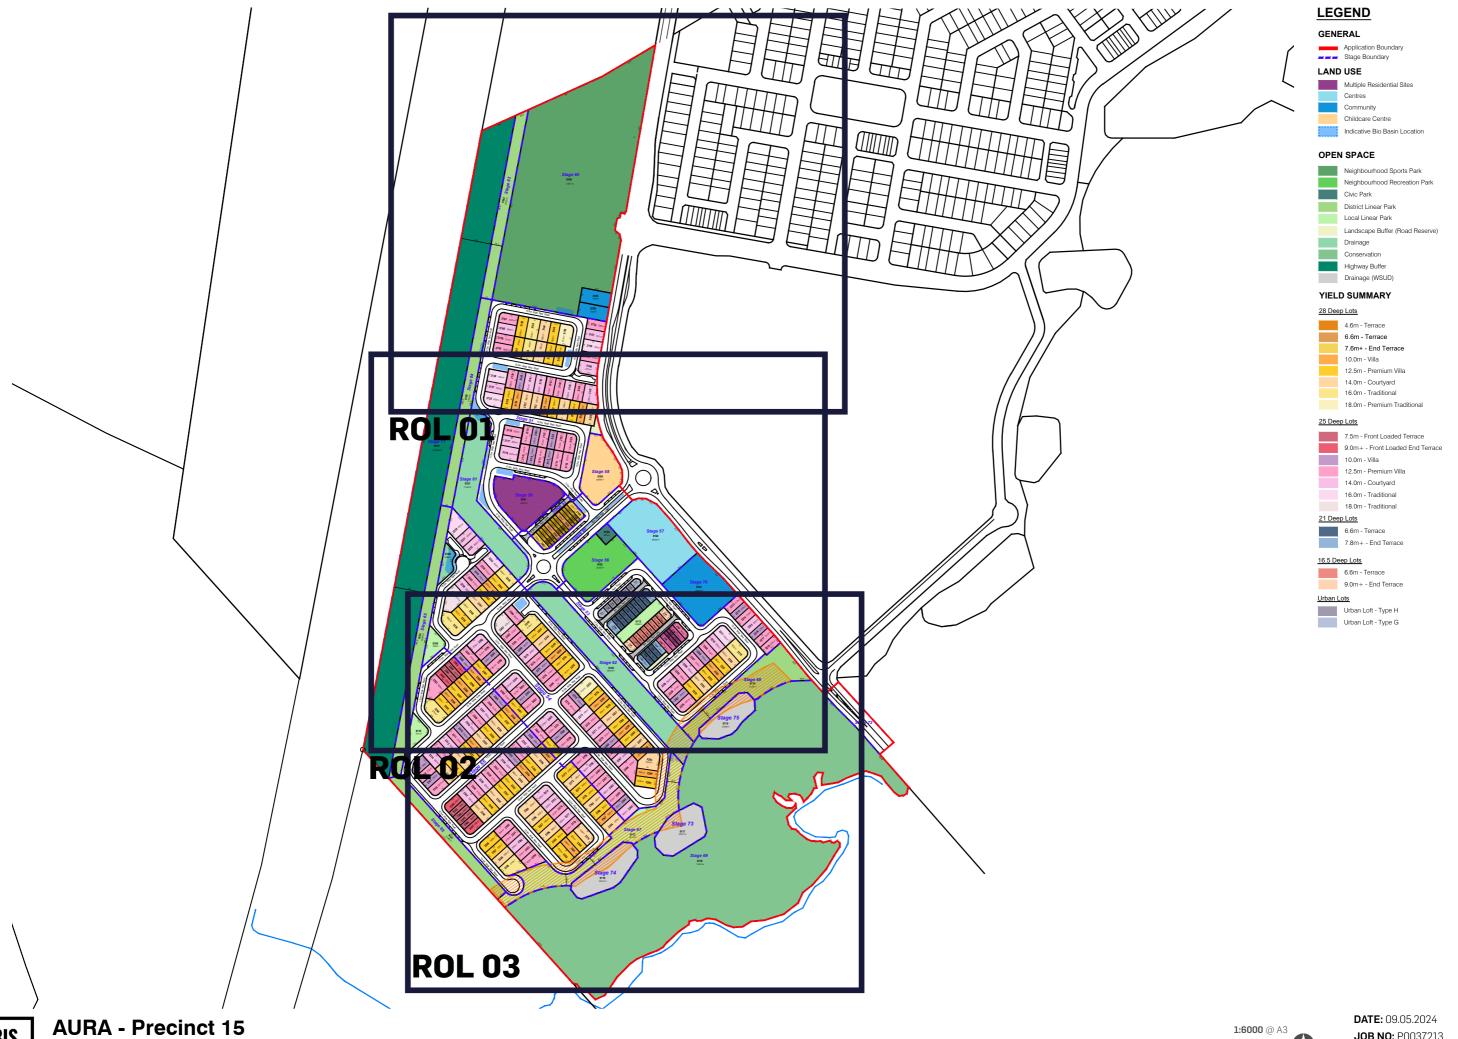
DATE: 09.05.2024 1:6000 @ A3 **JOB NO:** P0037213 0 50 100 150 200 250 300 DWG NO: ROL-00

Reconfiguring of a Lot - Overall

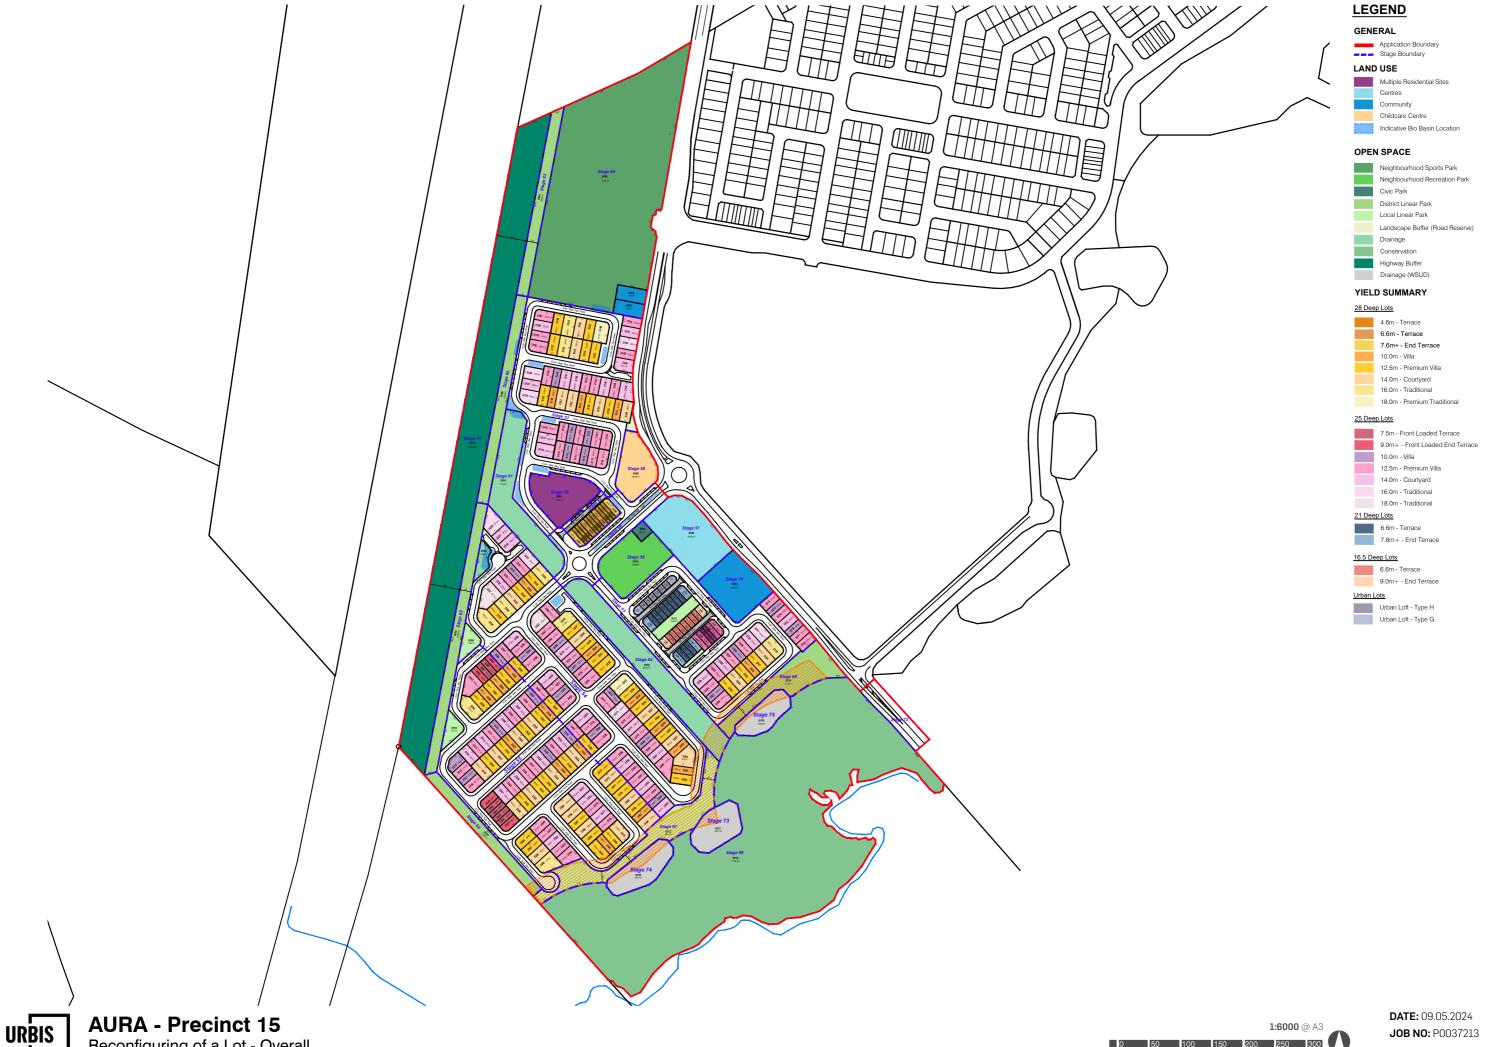
JOB NO: P0037213 DWG NO: ROL-01

Reconfiguring of a Lot - Overall
