Geotechnical Site Investigation & Landslide Risk Assessment @ Context 3, New Beith Road Flagstone QLD 4280

Geotechnical Investigation & Landslide Risk Assessment @ Context 3, New Beith Road, Flagstone Qld 4280

Interpretative Report

Report Ref. No.: 6464 – 24-338

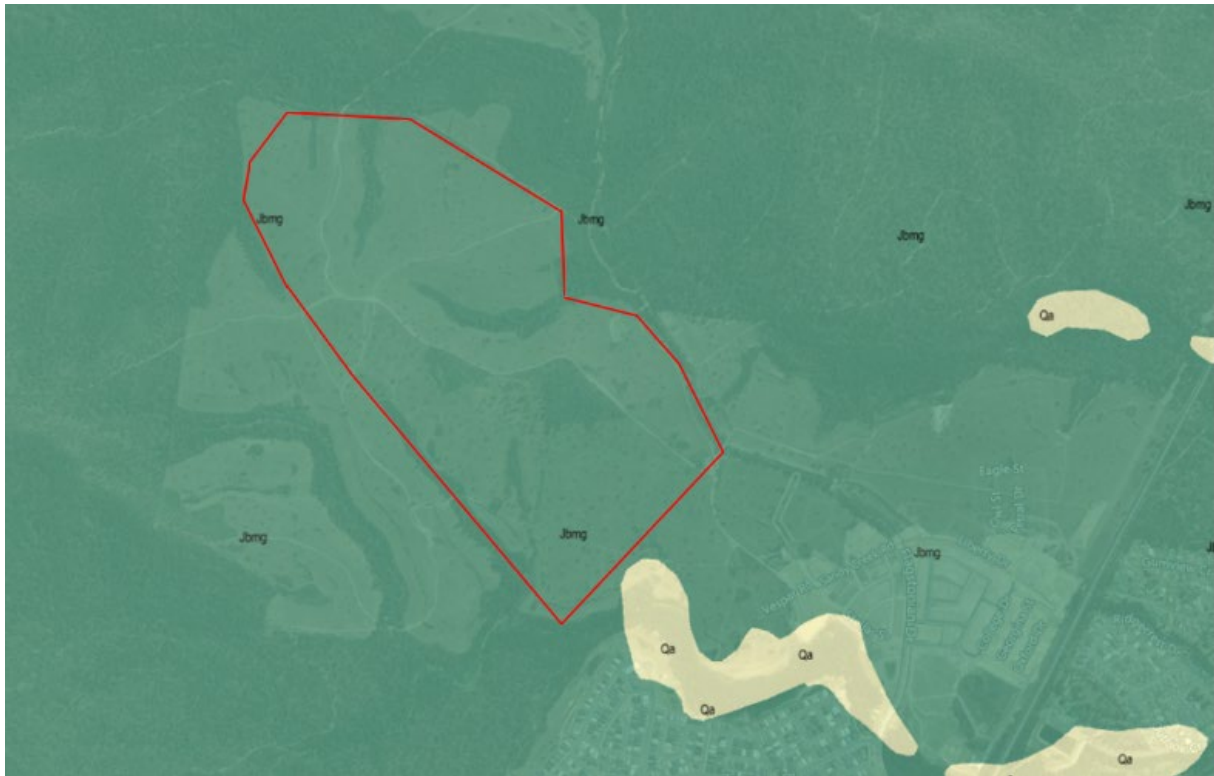
Figure 3: The Detailed Surface Geology Map, The Site Highlighted in Red

Therefore, the shallow soils encountered onsite are residual in nature derived from the recent weathering of the underlying parent rock.

An extract from the Detailed Surface Geology map showing the site is presented in *Figure 3*.

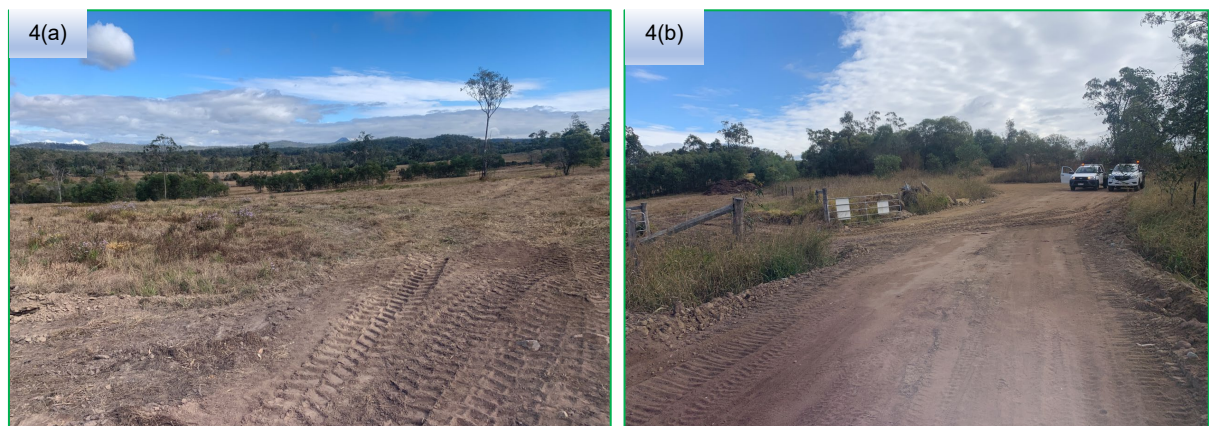
Figure 4: Selected Photographs of The Site

Vegetation on the site at the time of the fieldwork was recently slashed grass, overgrown weeds, bare ground, some regrowth shrubs, stockpiles of topsoils, gates/fence lines, water dams, and established trees. Evidence of recently removed trees was noted with stockpiles of wood chips scattered across the site.

The topography was noted to have planar slopes transversing in all directions. Evidence of soil creep was recorded on the existing trees and shrubs leaning downslope, with slight to moderate gradients measuring between 2 to 30°. Photographs showing typical site conditions are presented in *Figures 4a & b*.

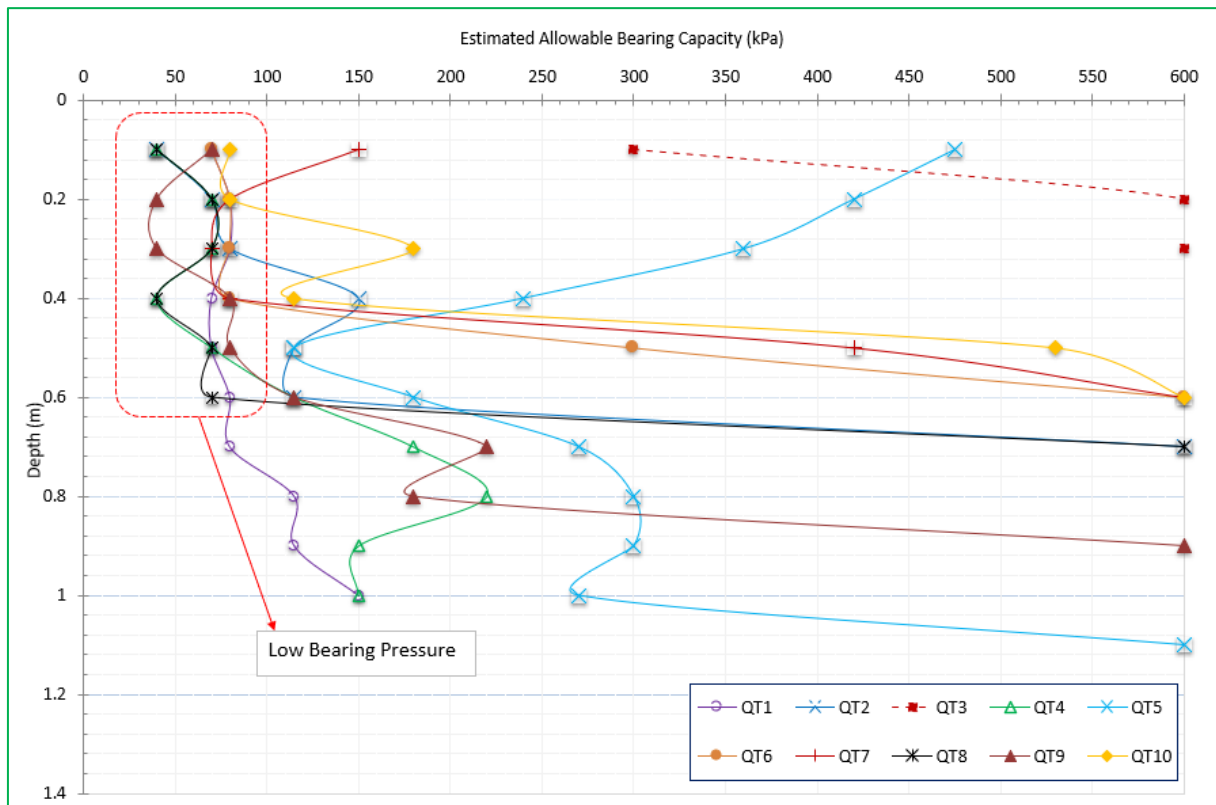
Figure 7: The Allowable Bearing Capacity of Onsite Soils with Depth; Derived from DCP Data

The allowable bearing capacity of the subsurface soils at the DCP test locations (QT1 to QT10) with depth is presented in *Figure 7*.

Based on *Figure 7* above, the upper 0.6m soil profile shows a bearing capacity of less than 100kPa. This could be associated with the water-softened conditions onsite. These soils are considered unsuitable for pad or fill foundations. Beyond 0.6m, the allowable bearing pressure increased significantly.

Qualtest recommends an allowable bearing capacity of 150kPa and 250kPa for the soils and weathered rock, respectively.

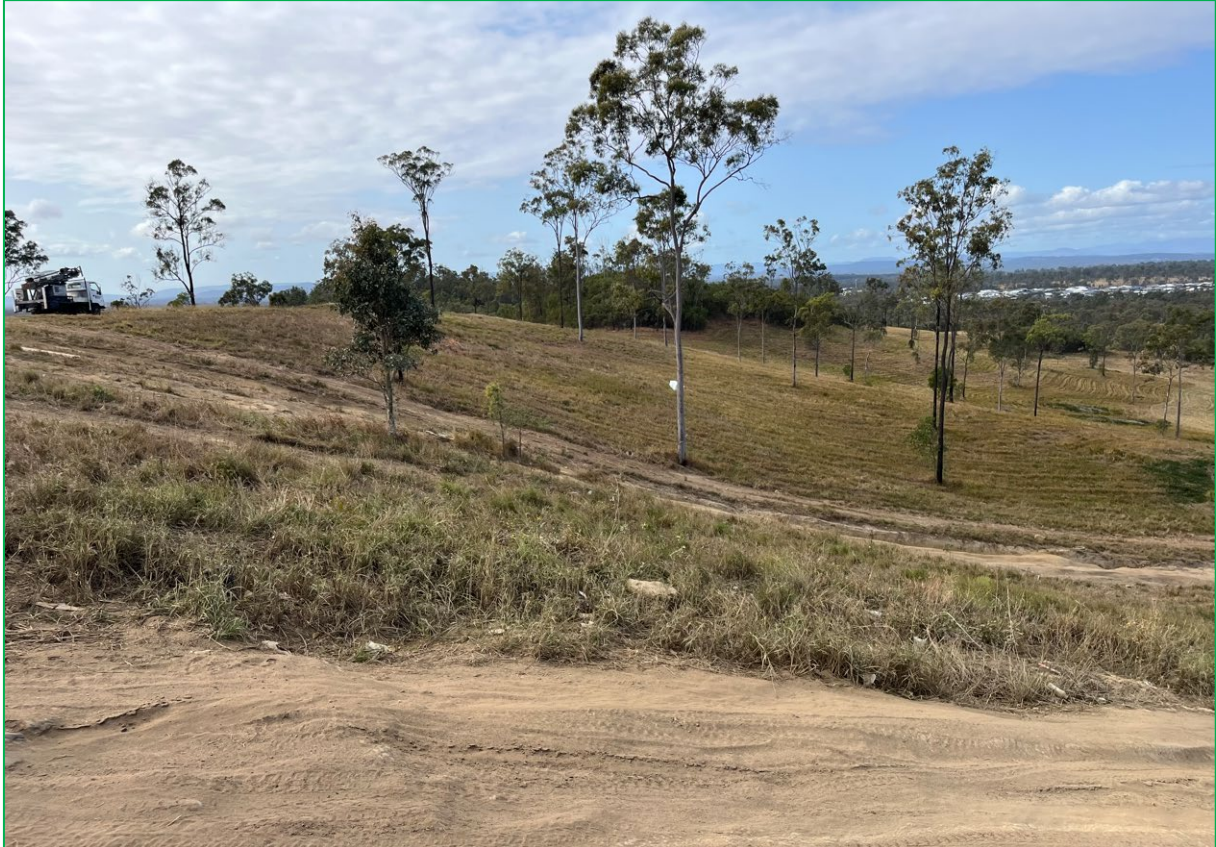
Figure 9: Photograph of The Existing Site Conditions

The several ridges and sloping surfaces across the site significantly influence the surface topography. The ground slopes vary from about 2 - 30 degrees, falling in all directions, with localised slopes exceeding 30° towards the valley corridors.

A photograph showing typical site conditions is presented in *Figure 8*.

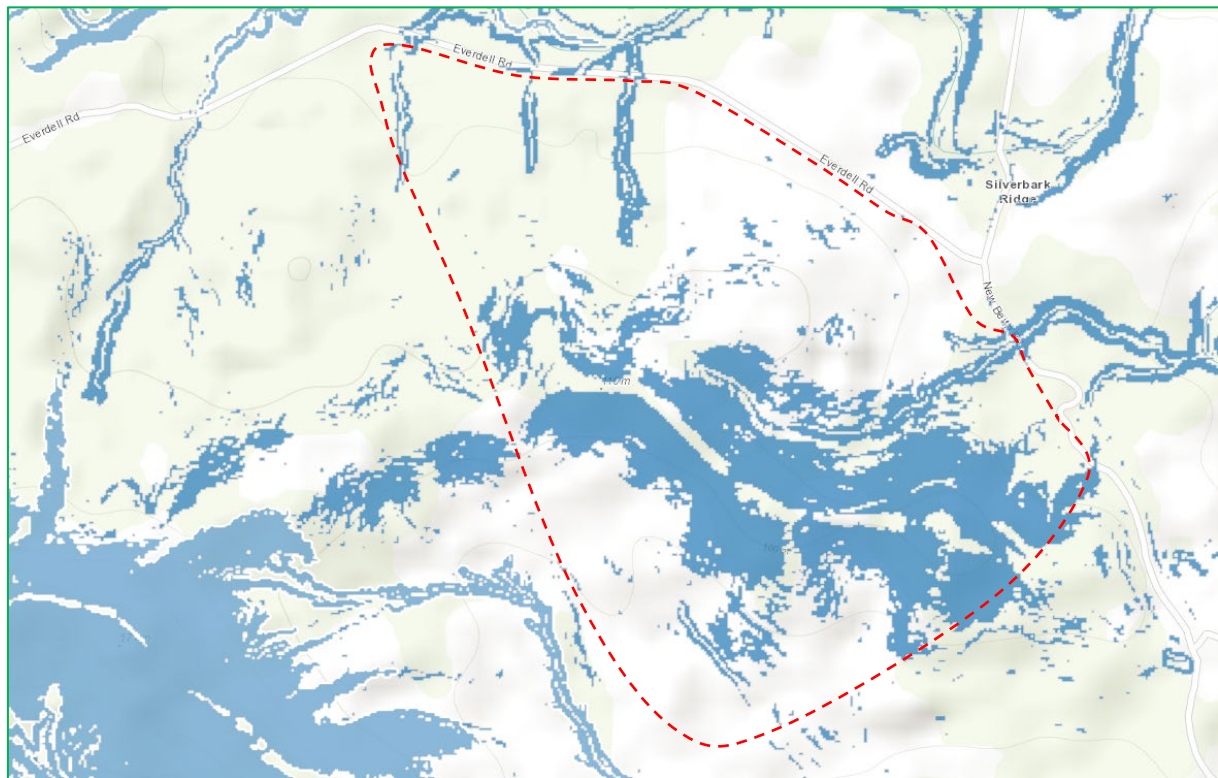
Figure 10: Logan City Council Landslide Hazard and Steep Slope Area Trigger – The Approximate Location of The Site Highlighted in Red

Logan City Council's online Landslide Hazard Overlay Map has identified the site as having a landslide risk potential (> 15% slope).

An extract from the Landslide Overlay map showing the site is presented in *Figure 9* and highlighted in red.
