| Issue | Description | Date | Client | Project Name | Project No. |
|---|---|---|---|---|---|
| C | For Issue | 14/05/2025 | Yamaton Pty Ltd C/- Plan A Town Planning Pty Ltd | 673 Silverwood Drive, Flagstone | S523052 |
| Drawing Name | VEGETATION CLEARING AND FAUNA MANAGEMENT PLAN | | | | VCFMP001 |

PLANS AND DOCUMENTS  
referred to in the PDA  
DEVELOPMENT APPROVAL

Approval no: DEV2022/1358

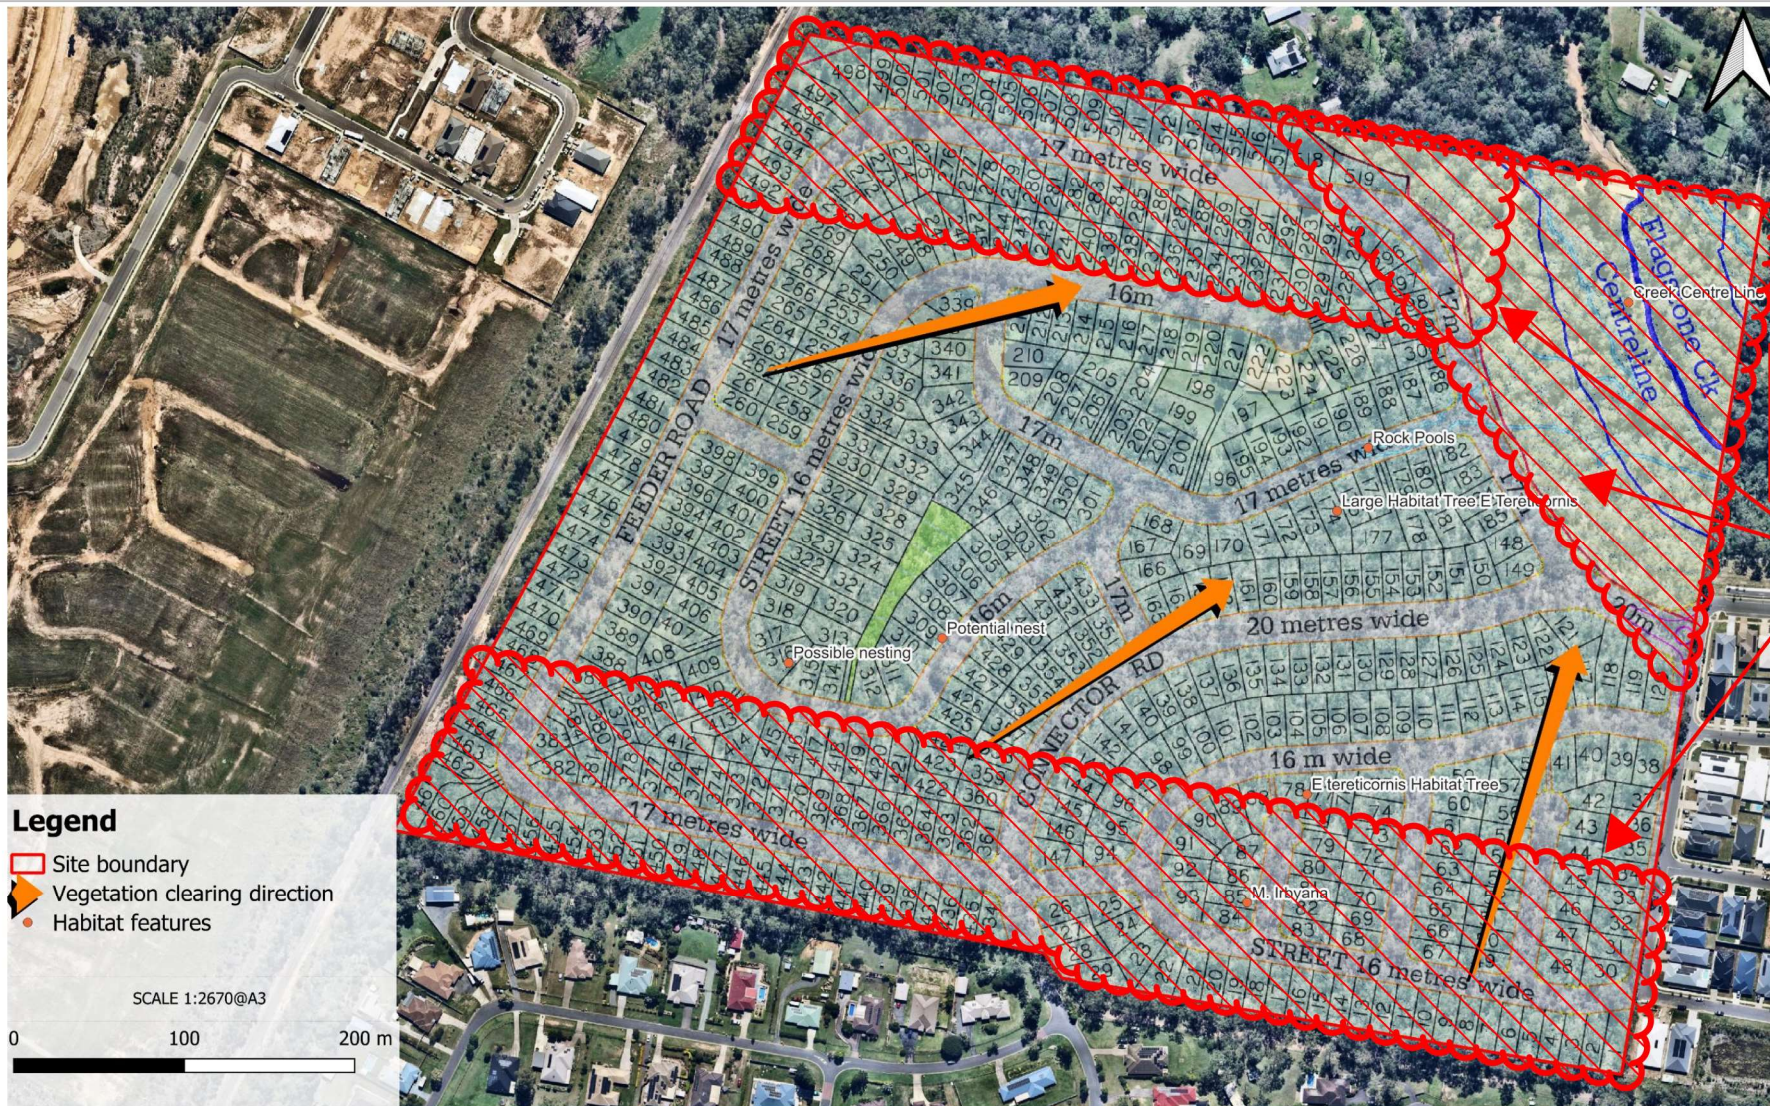
### Legend

- Site boundary
- Vegetation clearing direction
- Habitat features

Clearing is not permitted  
within 100m of the rural  
residential properties as  
shown in the hatched  
area, or within 100m of  
the top of bank of  
Flagstone Creek

- Sensitive tree clearing techniques are to be implemented. Directional clearing will occur, generally beginning in disturbed areas, and working towards vegetated refuge areas. Refer to **Page 001** of this Plan;

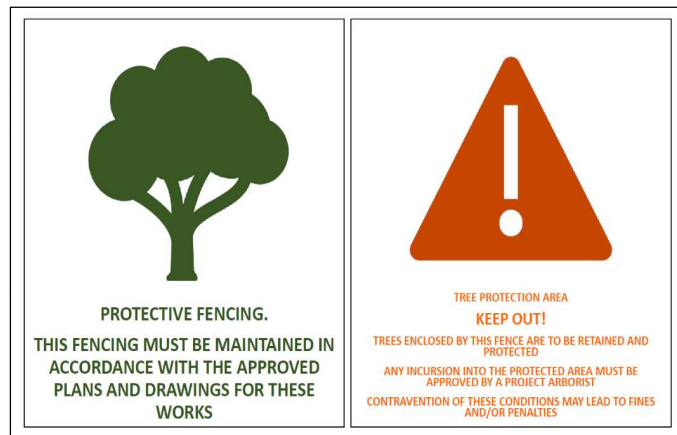
Figure 3: Tree Protective Fencing Signage

Suitable signage must be attached to the Tree Protection Fencing at suitable intervals. Tree Protection Signage should clearly identify the nature and purpose of the fencing and clearly indicate that all activities are excluded from within the fenced area. Examples of suitable TPZ Exclusion Signage are shown below.

All vegetation to be retained is to be clearly identified and adequately protected prior to vegetation clearing commencing using appropriate tree protection fencing (refer to **Figure 2**) and signage (refer to **Figure 3**);
