# Geotechnical Investigation Report

## Rail Bridge Crossing

### Mountain Ridge Road, New Beith

**Report Number:** J001800-003-R-Rev0

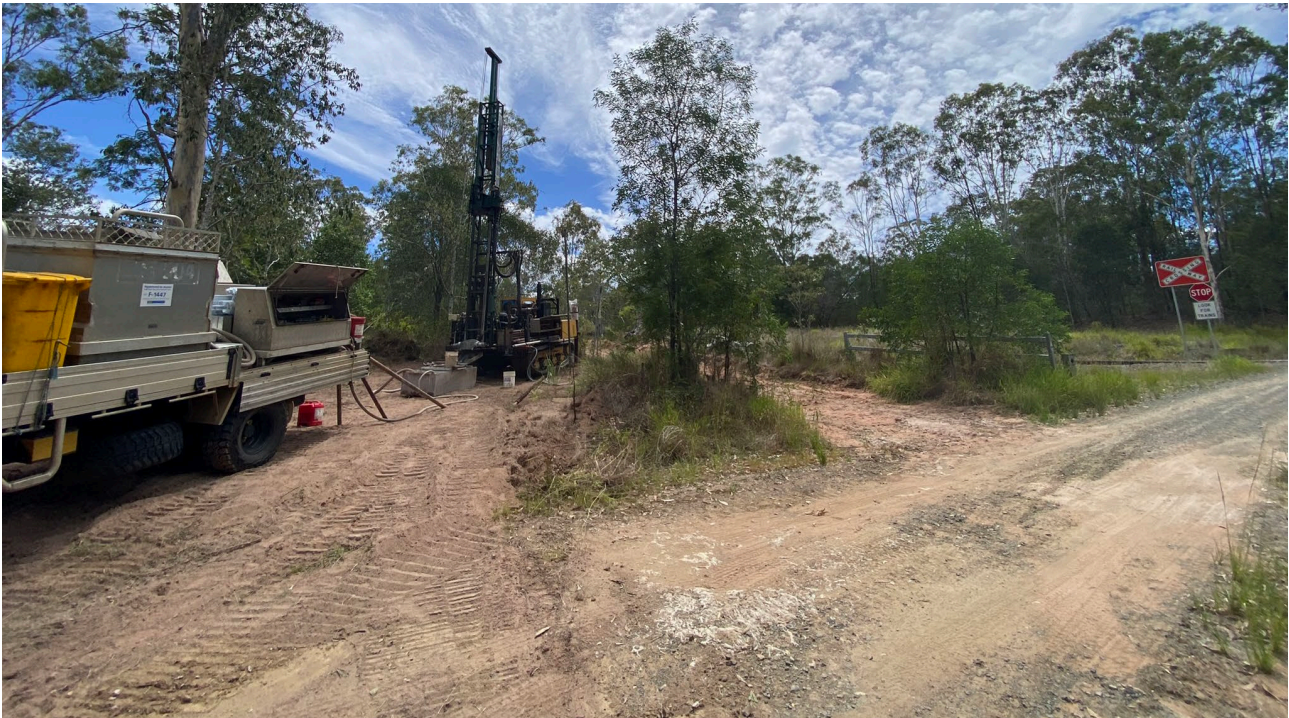
**Photograph 1: General site conditions (view looking northeast towards borehole BHB and rail line)**

General site conditions during our investigation are shown in Photograph 1.

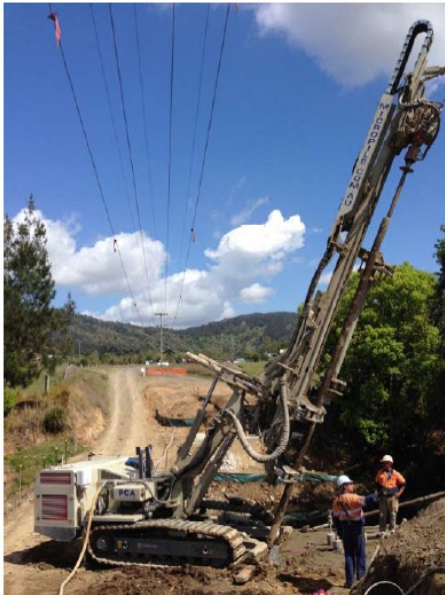
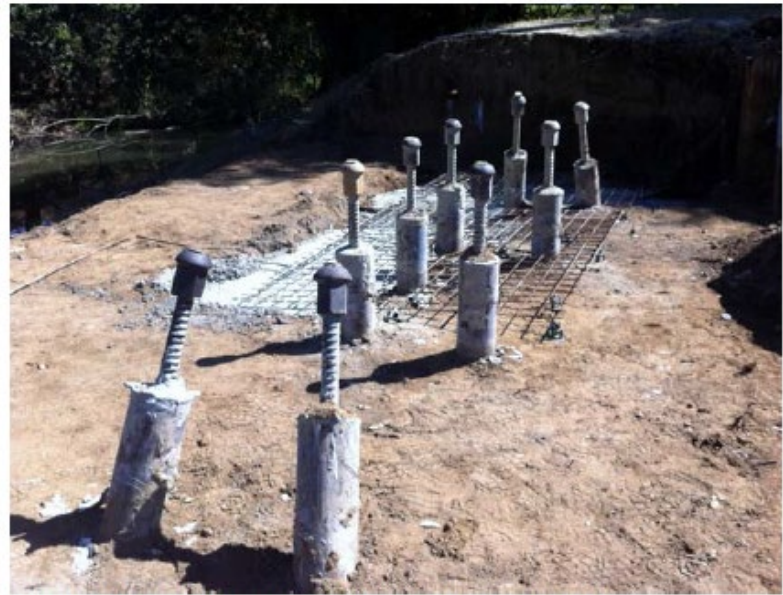
**Photographs 2 and 3: Micropile installation equipment and view of micropiles installed in a bridge abutment**

The use of high-capacity grout injected micropiles tied into the high-level foundations could be considered. The rock drilling technology used in the construction of micropiles enables the micropiles to be drilled and bonded within the underlying rock without the need for additional specialist equipment or drilling techniques.

Tungsten carbide drill bits are generally adopted to enable the micropiles to be drilled through high strength rock and other obstructions (such as cobbles, if encountered) to achieve the required rock socket length.

The piles are installed with a relatively small drill rig (or excavator) reducing the requirement for a specialist piling platform to support the rig. Photographs 2 and 3 below displays the use of micropiles for a bridge abutment.
