## GEOTECHNICAL REVIEW & GLOBAL STABILITY ASSESSMENT:

Proposed Water Storage Basin & Biobasins, Interim Batters, Creek  
Crossing Road Embankments and Bulk Earthwork Embankments

Various locations within Precinct 5, 6, 8 and 13

PG-5335-I

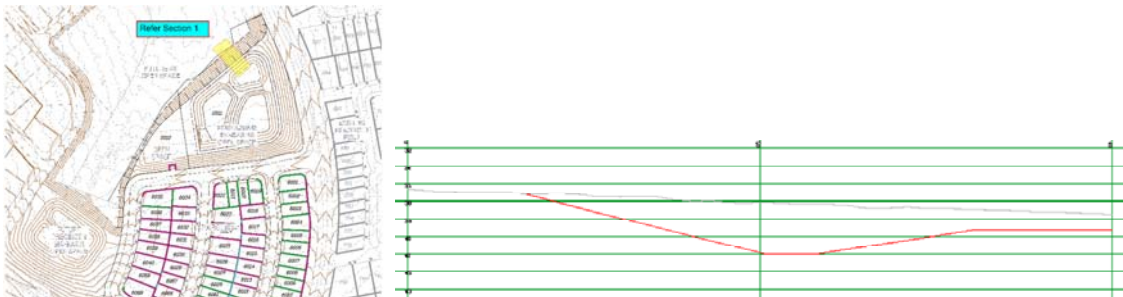
**FIGURE 1 – Section 1: P6 Bio-basin Embankment**

| Section | Phreatic Conditions | FOS for Proposed Batter | Comment |
|---|---|---|---|
| P6 Bio-basin embankment | Construction | >1.5 | Silty Sand must be removed from under embankment to expose underlying natural very stiff or better clay as per <b>Section 4.5</b> of this report to achieve required FOS |

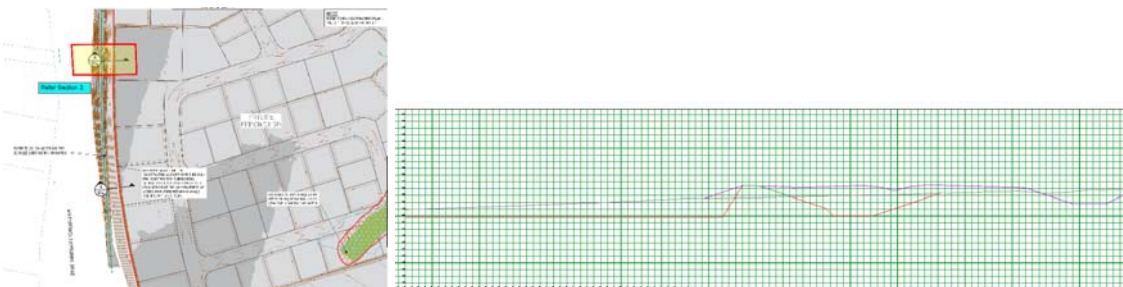
**FIGURE 2 – Section 2: P5 MIBA South Interim Batter – Waterford Tamborine Road**

| Section | Phreatic Conditions | FOS for Proposed Batter | Comment |
|---|---|---|---|
| P5 MIBA South Interim Batter – Waterford Tamborine Rd | Construction | <1.5 | Embankment must be flattened back to no steeper than 26° as per <b>Section 4.5</b> of this Report to achieve required FOS |

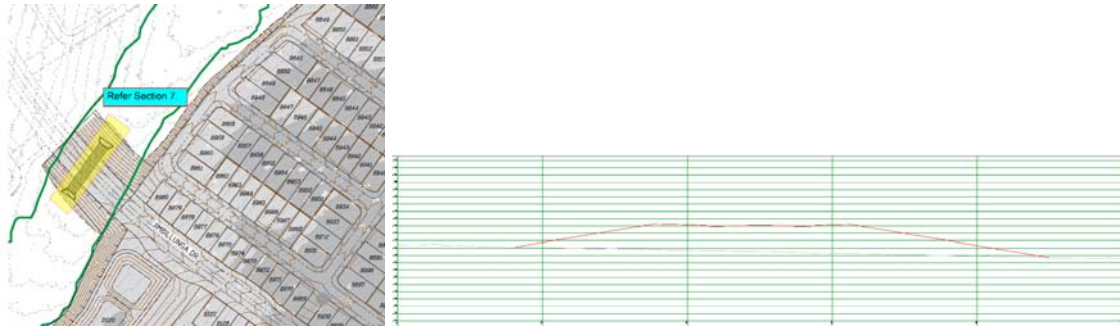
**FIGURE 7 – Section 7: P8 Stage 823 Culvert/ Creek Crossing**

| Section | Phreatic Conditions | FOS for Proposed Batter | Comment |
|---|---|---|---|
| P8 Stage 823 Culvert Crossing | Construction | >1.5 | Achieves required FOS as per <b>Section 4.5</b> of this Report |

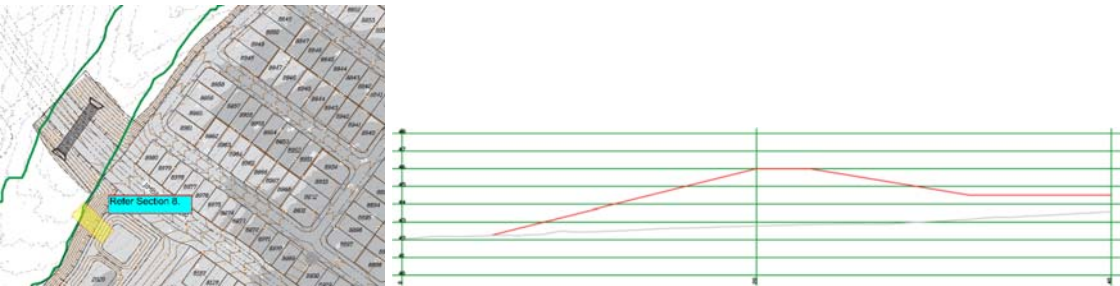
**FIGURE 8 – Section 8: P8 Stage 829 Basin North**

| Section | Phreatic Conditions | FOS for Proposed Batter | Comment |
|---|---|---|---|
| P8 Stage 829 Basin North | Construction | >1.5 | Embankment must be founded into the underlying natural clay as per <b>Section 4.5</b> of this Report to achieve required FOS. |

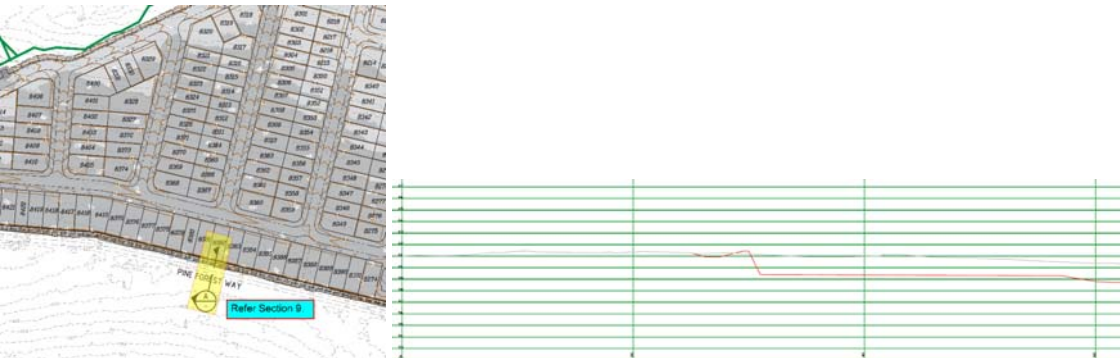
**FIGURE 9 – Section 9: P8 Lot 8382 Interim Batter – Pine Forest Way**

| Section | Phreatic Conditions | FOS for Proposed Batter | Comment |
|---|---|---|---|
| P8 Lot 8382 Interim Batter – Pine Forest Way | Construction | <1.5 | Embankment must be battered back to no steeper than 26° as per <b>Section 4.5</b> of this report to achieve required FOS |

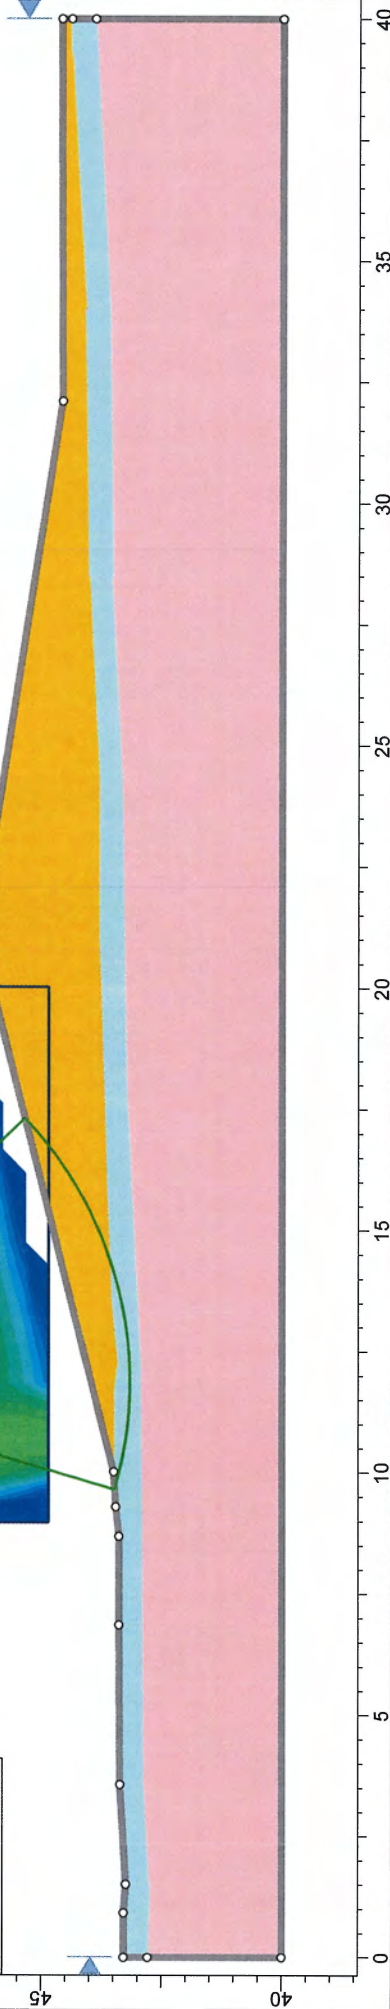
| Group Name | 4. STG829 BASIN STH | Analysis | Construction |

| Material Name | Color | Unit Weight (kN/m <sup>3</sup> ) | Strength Type | Cohesion (kPa) | Phi (°) | Water Surface | Ru Value |
| Embankment Fill | | 18 | Mohr-Coulomb | 3 | 26 | None | 0 |
| Natural Sands - Loose to Medium Dense | | 18 | Mohr-Coulomb | 0 | 28 | None | 0 |
| Natural Clay - Very Stiff | | 19 | Mohr-Coulomb | 5 | 26 | None | 0 |

| Date | 10/09/2025, 5:49:17 PM | File Name | PG-5335-I - Stability Assessment - 11.09.25.slmnd |

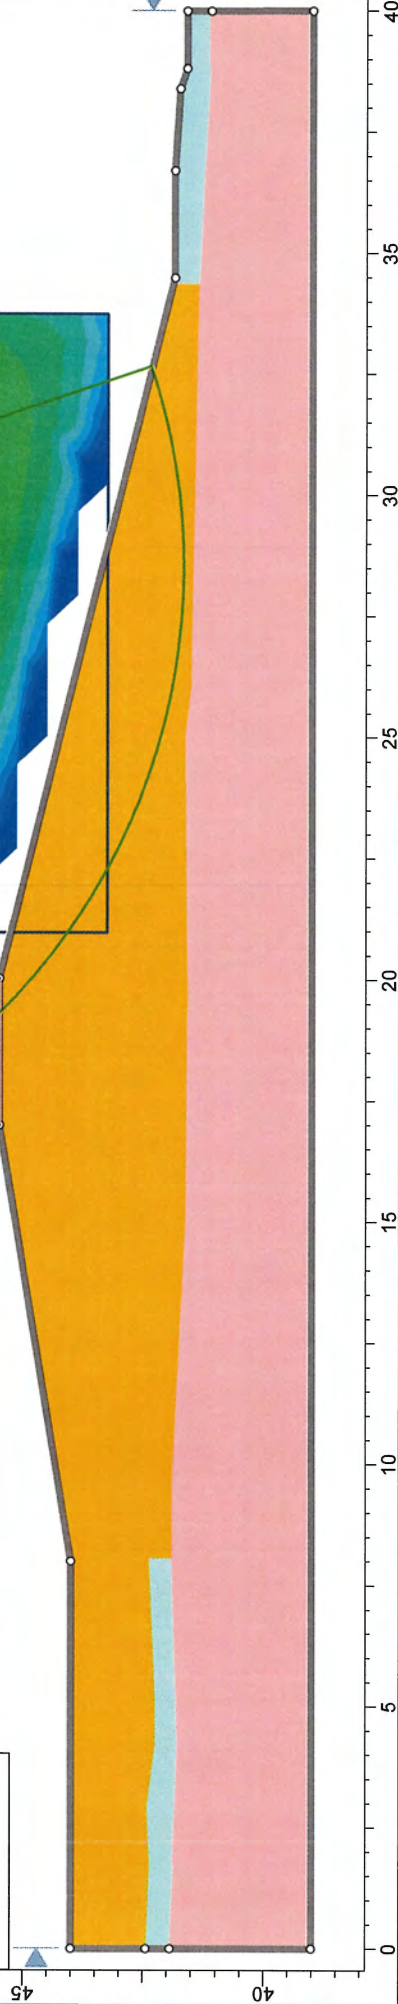
5.00 kN/m2

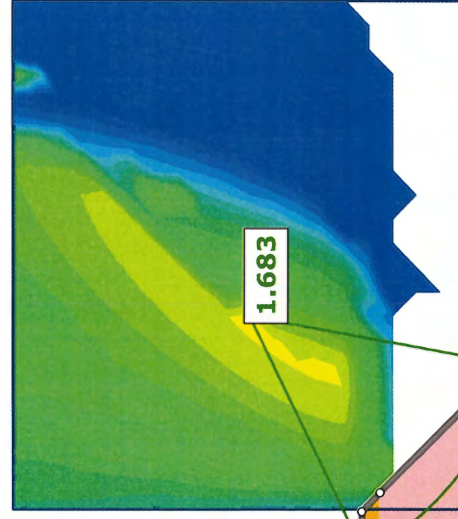
| Material Name | Color | Unit Weight (kN/m3) | Strength Type | Cohesion (kPa) | Phi (°) | Water Surface | Ru Value |
|---|---|---|---|---|---|---|---|
| Embankment Fill | | 18 | Mohr-Coulomb | 3 | 26 | None | 0 |
| Natural Clay - Very Stiff | | 19 | Mohr-Coulomb | 5 | 26 | None | 0 |
