ACID SULFATE MANAGEMENT PLAN

825 STANLEY PTY LTD

APARTMENT BUILDINGS

825 STANLEY STREET, WOOLLOONGABBA

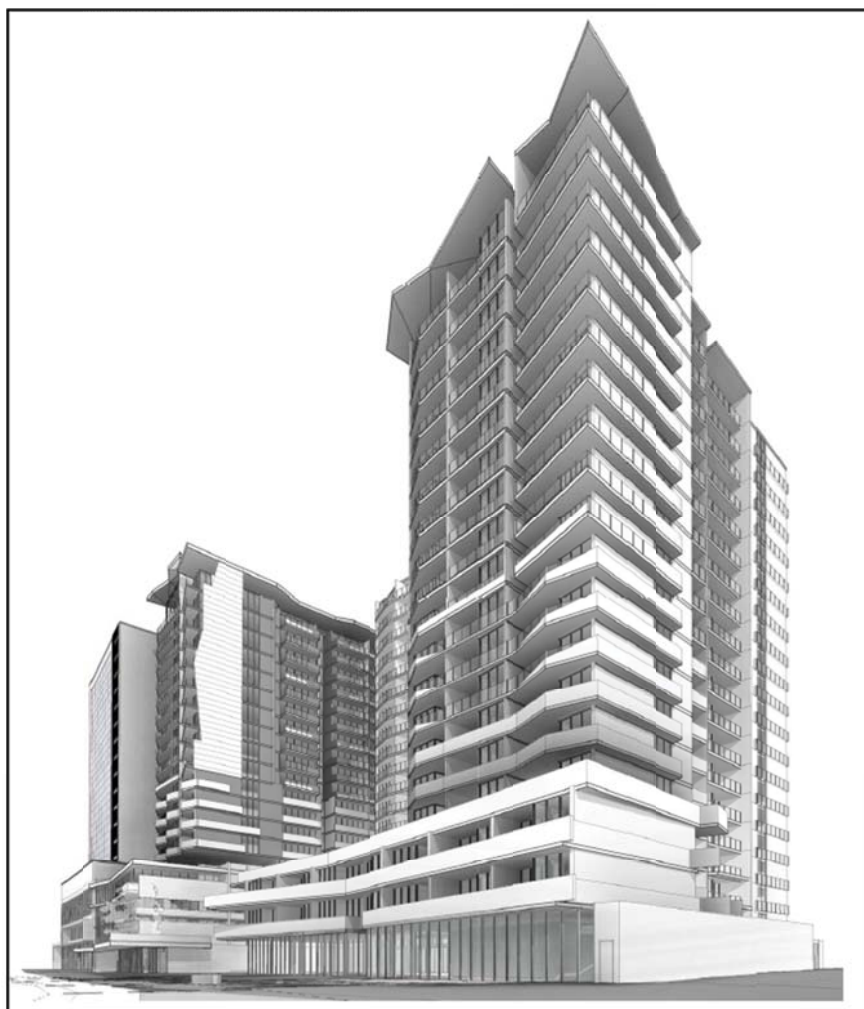
FIGURE 1 – STANLEY STREET PERSPECTIVE

- Three, twenty level towers, constructed in three stages.
- Buildings 2 and 3 will incorporate three levels of basement carparking. Earthworks will comprise excavations of up to 9.5m to form the lower basement level of RL - 4.5m.
- No basement is proposed for Building 1. However, excavation to RL 3.0m is proposed at Building 1 location to create a lined detention basin beneath ground floor.

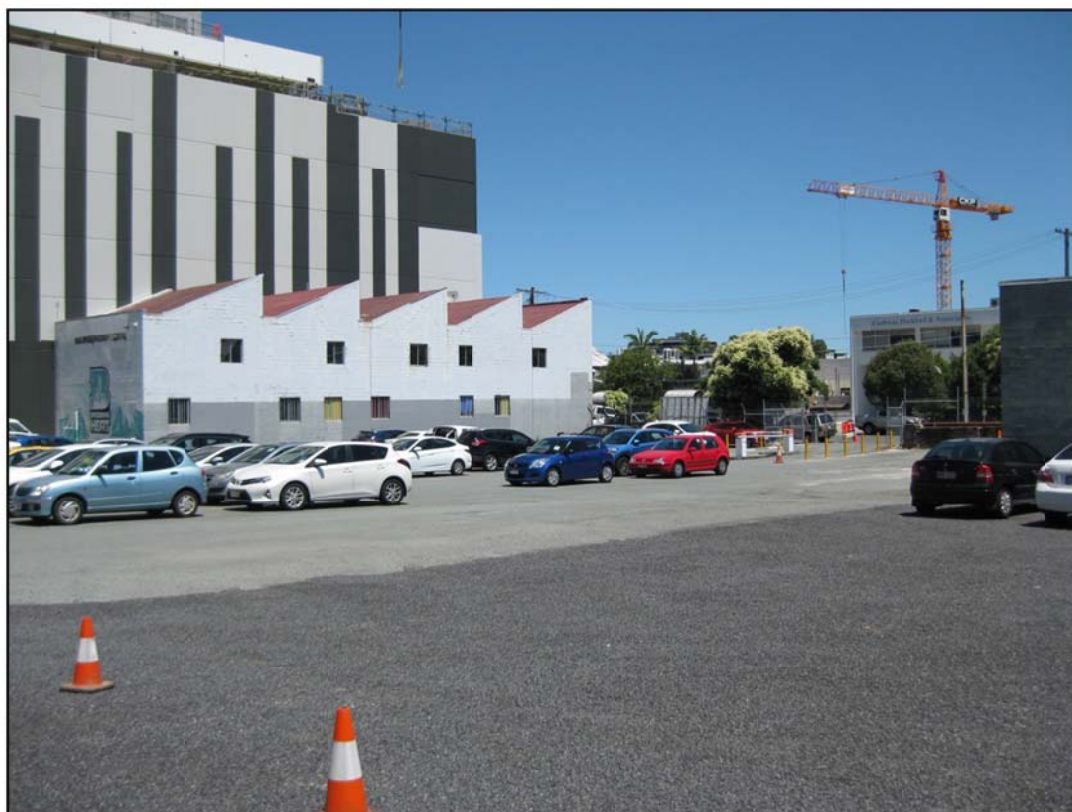
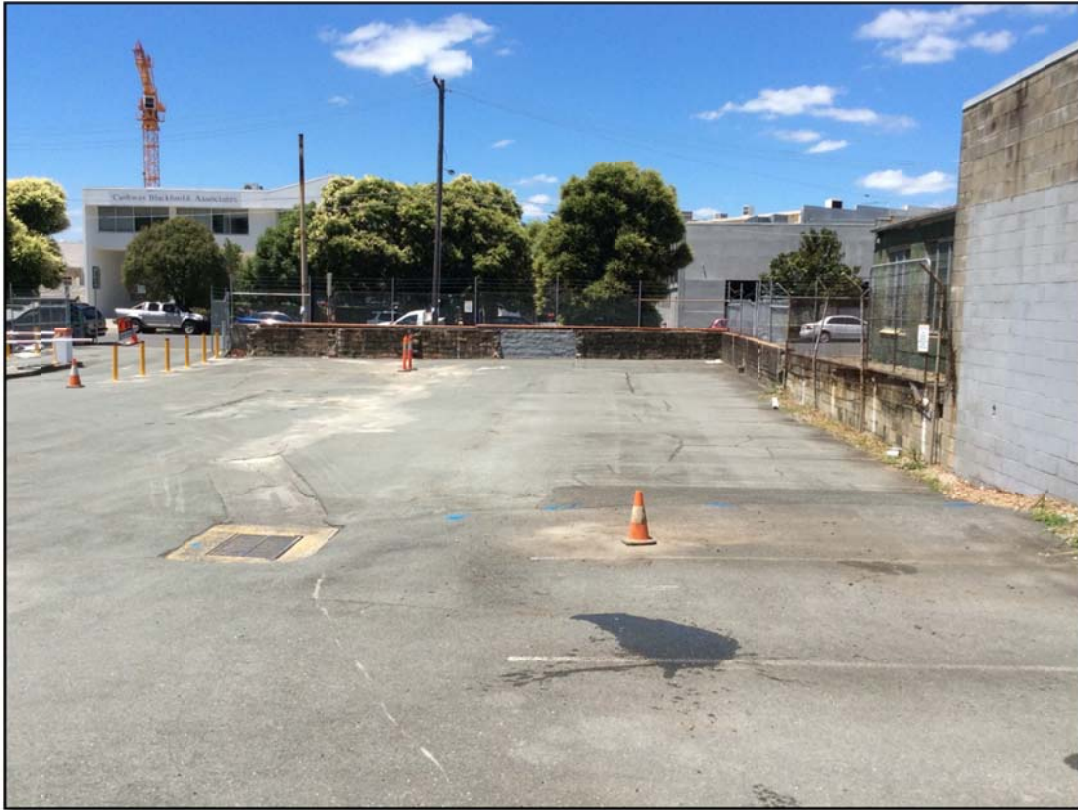
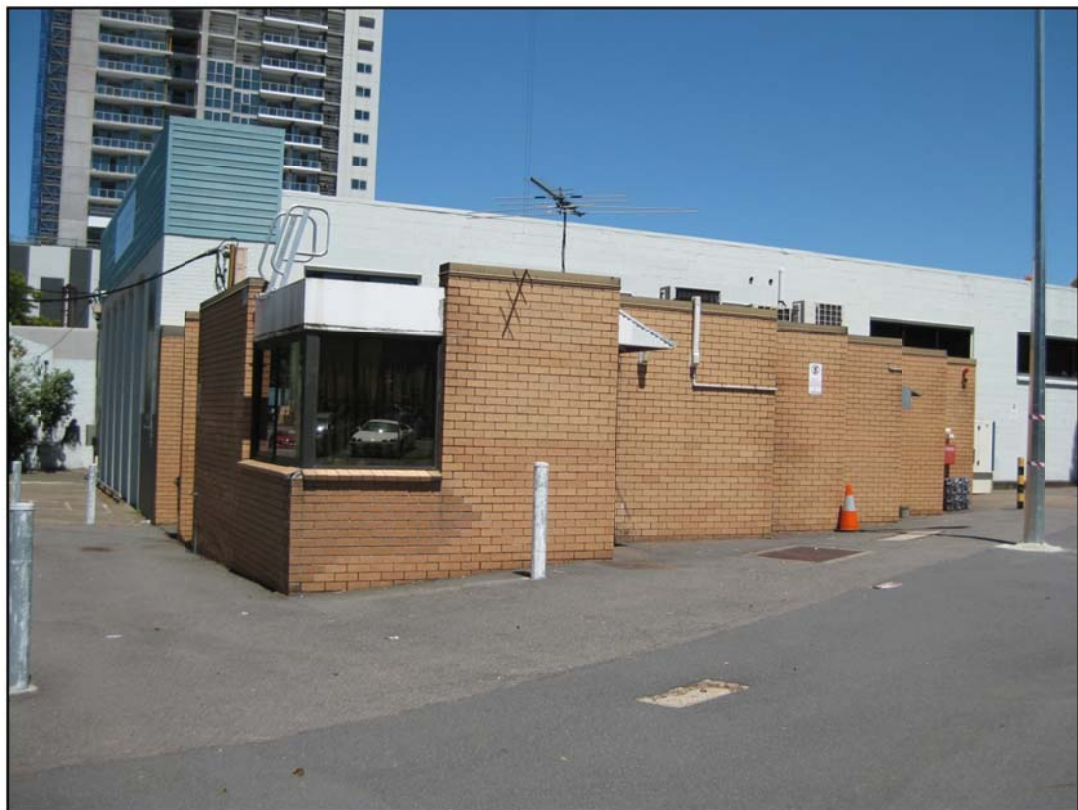
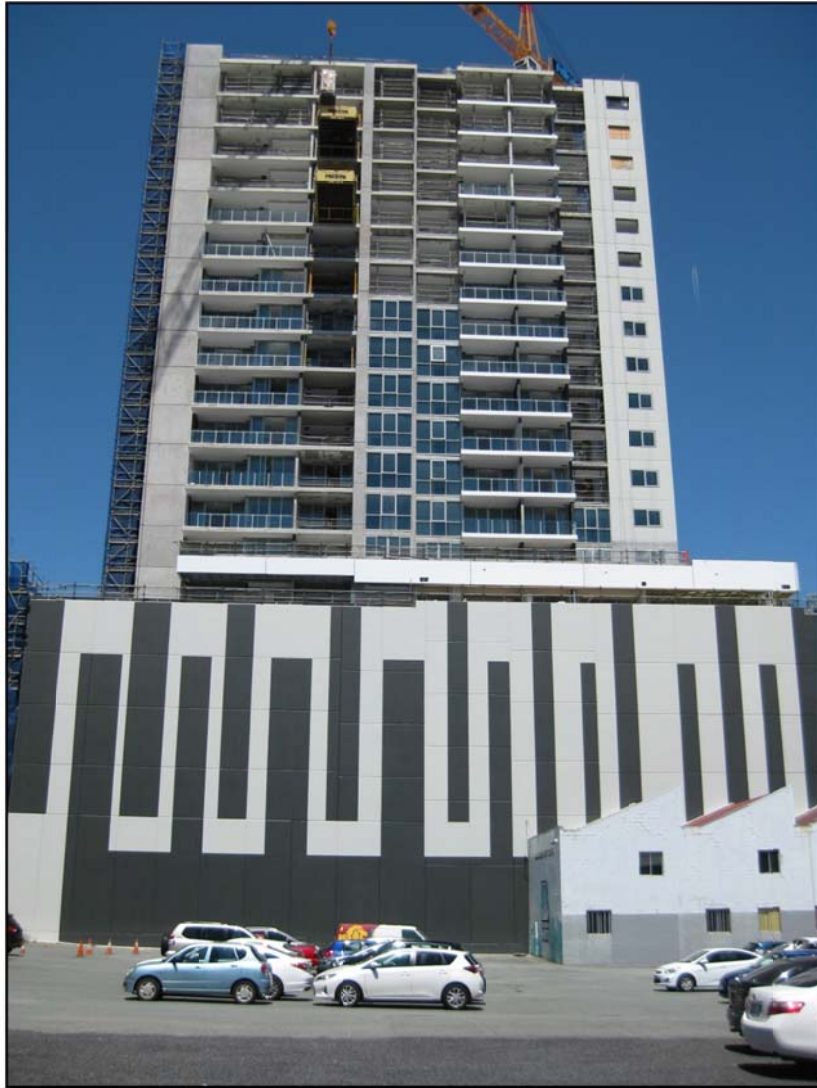
- Northern Boundary – Stanley Street
- Eastern Boundary – residential tower, currently under construction (refer Photographs 1 and 4).
- Southern Boundary – Trafalgar Street.
- Western Boundary – Jurgen Street, with a single storey brick veneer “BCC Building” (refer Photograph 3) located adjacent the north western corner of the development site.

Photographs 1 to 4 indicate typical site conditions. Please also refer Detailed Survey prepared by Jensen Bowers (Appendix D).

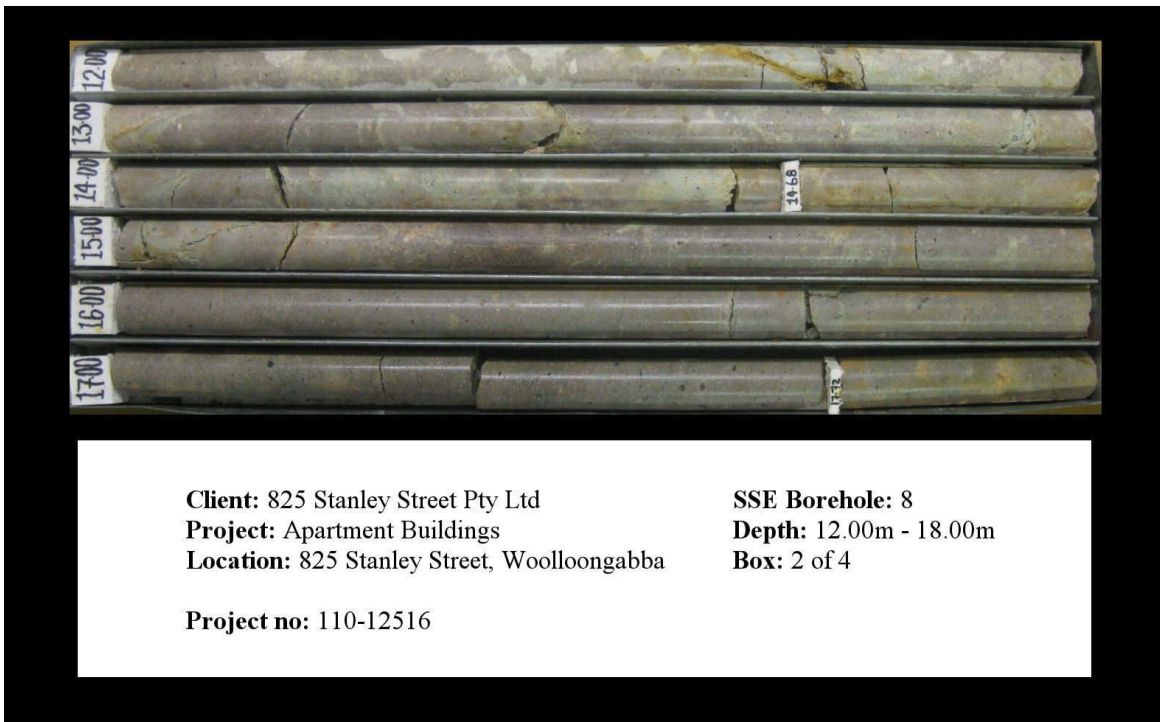
TITLE
 825 Stanley Pty Ltd
 825 Stanley Street, Woolloongabba
 Apartment Buildings
 Core Photo - BH 08

SSE Borehole: 8
Depth: 6.10m - 12.00m
Box: 1 of 4

SSE Borehole: 8
Depth: 12.00m - 18.00m
Box: 2 of 4

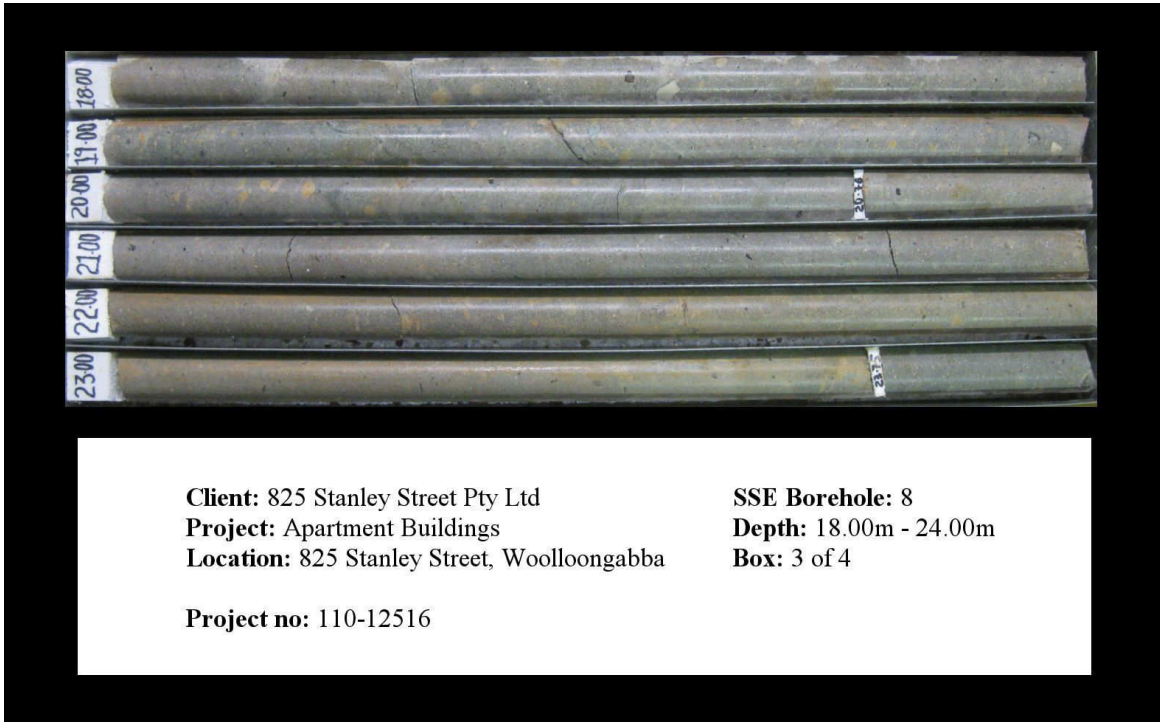
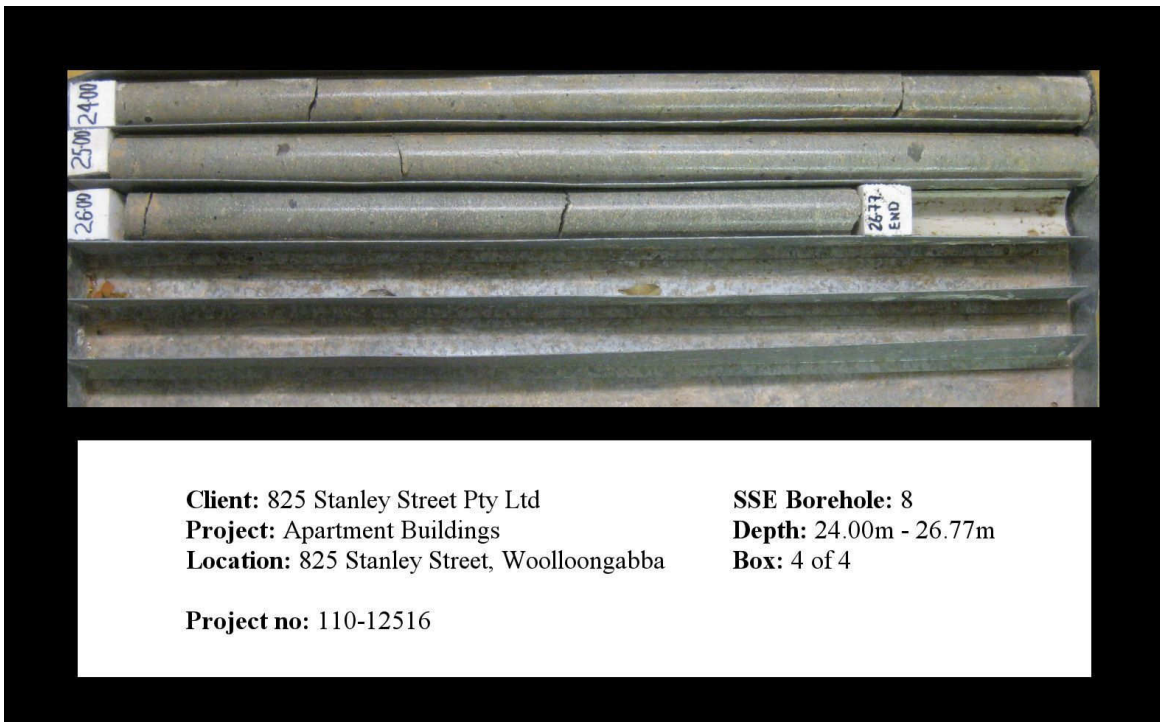
TITLE 825 Stanley Pty Ltd 825 Stanley Street, Woolloongabba Apartment Buildings Core Photo - BH 08	DRAWN CB	DATE 18/01/2016	
		CHECKED GB	DATE 18/01/2016	
		SCALE Not To Scale		A4
		PROJECT No 110-12516	FIGURE No 2/2

PointID : BH 08 Depth Range: 24.00 - 26.77 m

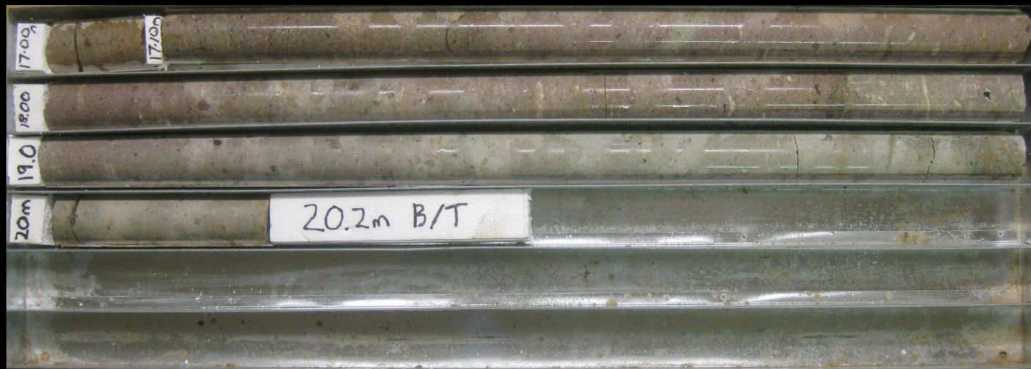
TITLE
 825 Stanley Pty Ltd
 825 Stanley Street, Woolloongabba
 Apartment Buildings
 Core Photo - BH 09

SSE Borehole: 9
Depth: 5.80m - 11.00m
Box: 1 of 3

SSE Borehole: 9
Depth: 11.00m - 17.00m
Box: 2 of 3

SSE Borehole: 9
Depth: 17.00m - 20.20m
Box: 3 of 3

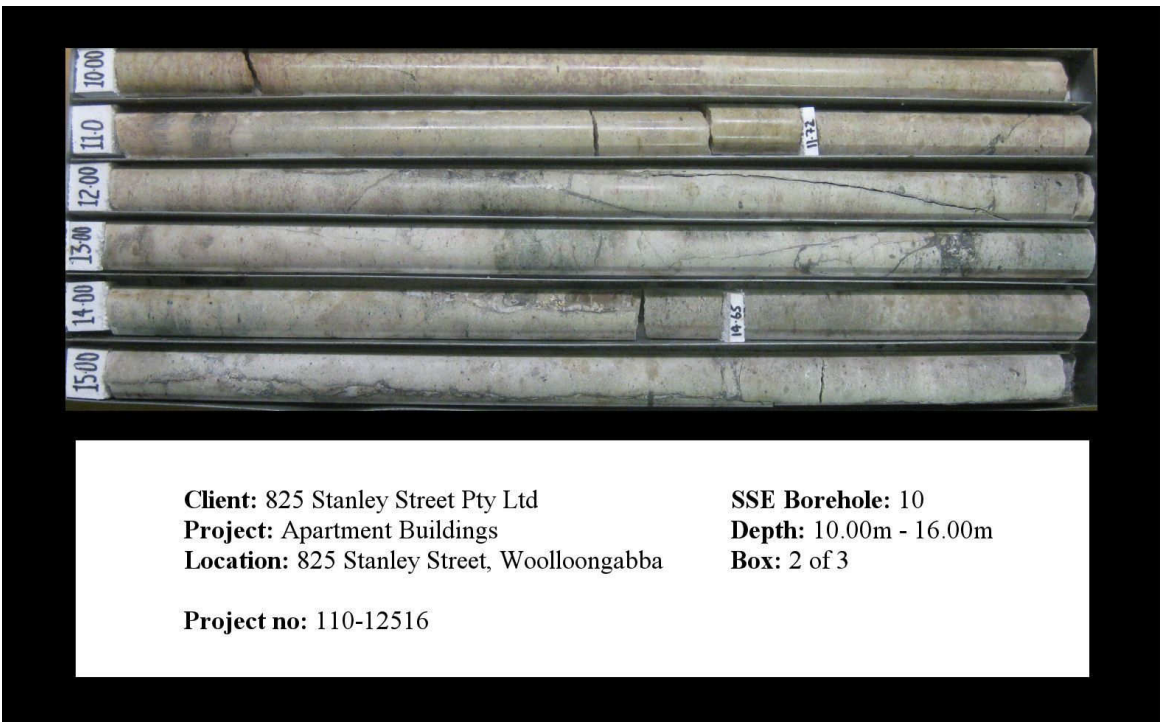
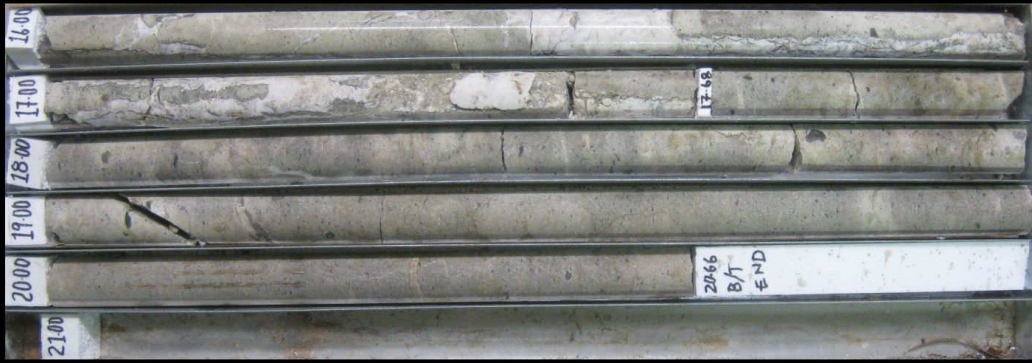
TITLE
 825 Stanley Pty Ltd
 825 Stanley Street, Woolloongabba
 Apartment Buildings
 Core Photo - BH 10

SSE Borehole: 10
Depth: 4.60m - 10.00m
Box: 1 of 3

SSE Borehole: 10
Depth: 10.00m - 16.00m
Box: 2 of 3

SSE Borehole: 10
Depth: 16.00m - 20.66m
Box: 3 of 3
