# Geotechnical Investigation Report

Precinct B Subdivision

Mountain Ridge Road, New Beith

**Report Number:** J001800-005-R-Rev0

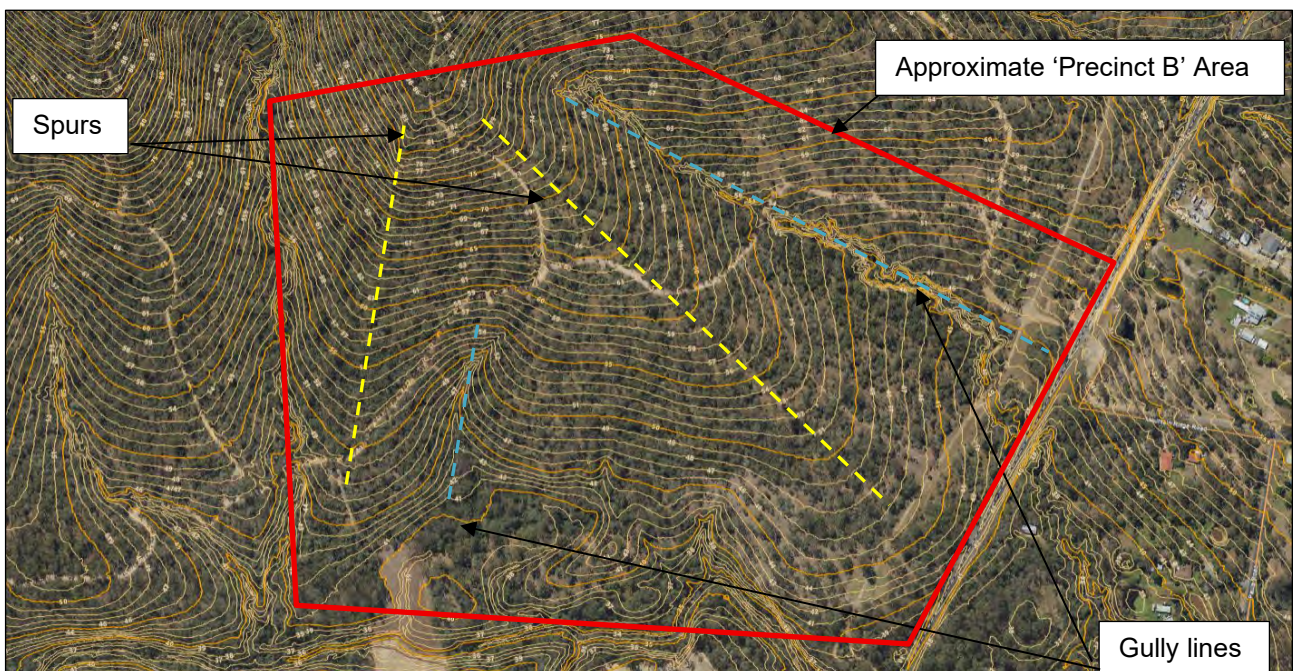
Image 1: Aerial image of the site

At the time of our investigation, the 'Precinct B' and greater Master Planned Community area was mostly covered with dense bushland. Several unsealed tracks traversed through the vegetation which were marginally trafficable in parts during our initial site visit due to heavy erosion. The eastern boundary is adjoined by the ARTC rail corridor, while to the south another residential subdivision was under construction (ref. Image 1).

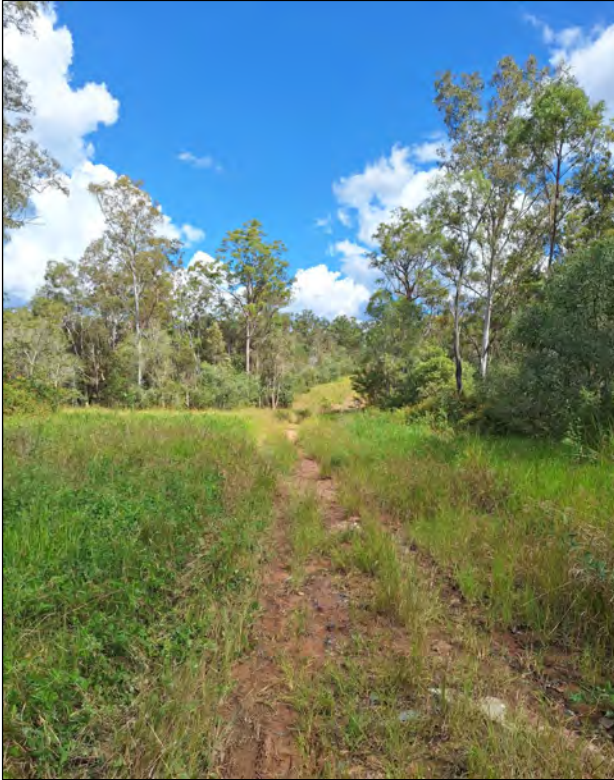
**Photograph 1: Looking south towards Borehole 6**

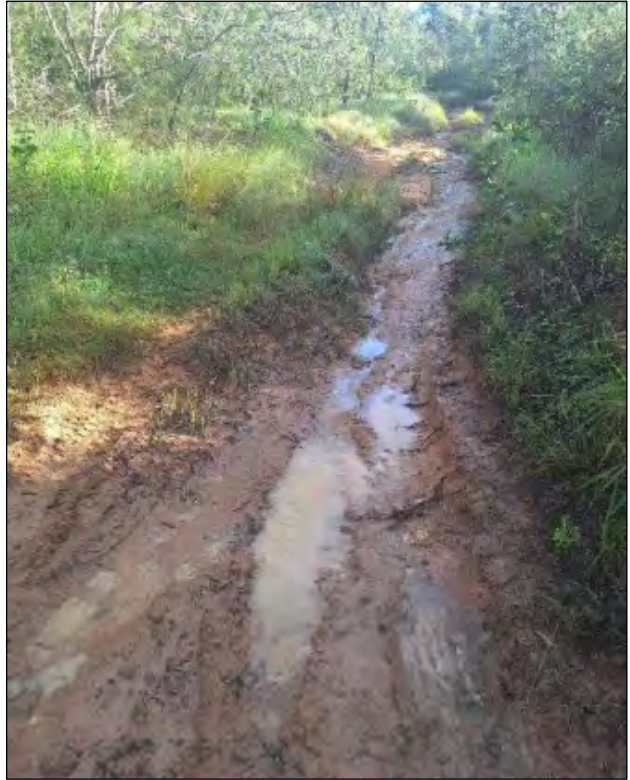
**Photograph 2: Looking North towards Borehole 2 from track intersection.**

The existing subsurface profile generally comprised a clayey / silty sand overlying with residual clay soils and/or weathered rock. When undisturbed (i.e. vegetation remaining intact) only minor erosion is observed. However, once these sandy surface soils and subsoil layers are exposed to water and disturbed, erosion is likely to become a significant issue, as exemplified earlier in Photographs 2 to 4.

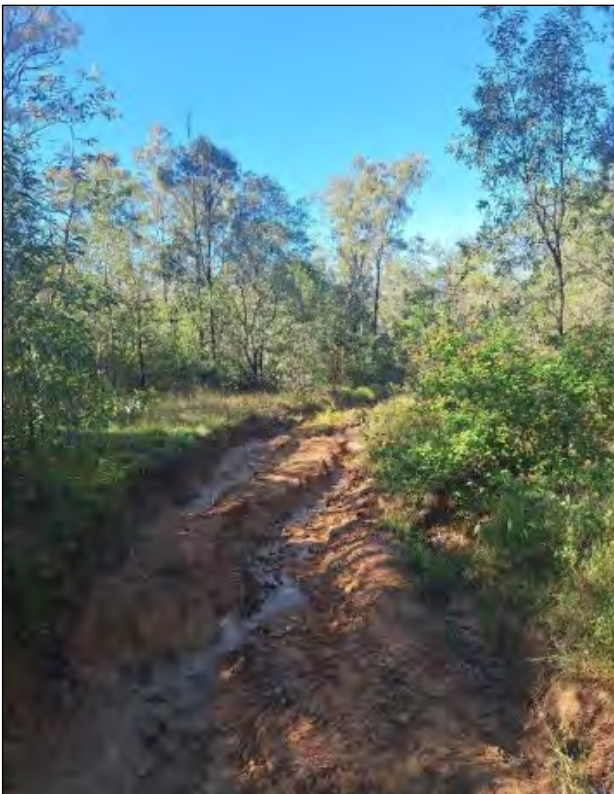
**Photograph 3: Looking south from Borehole 2.**

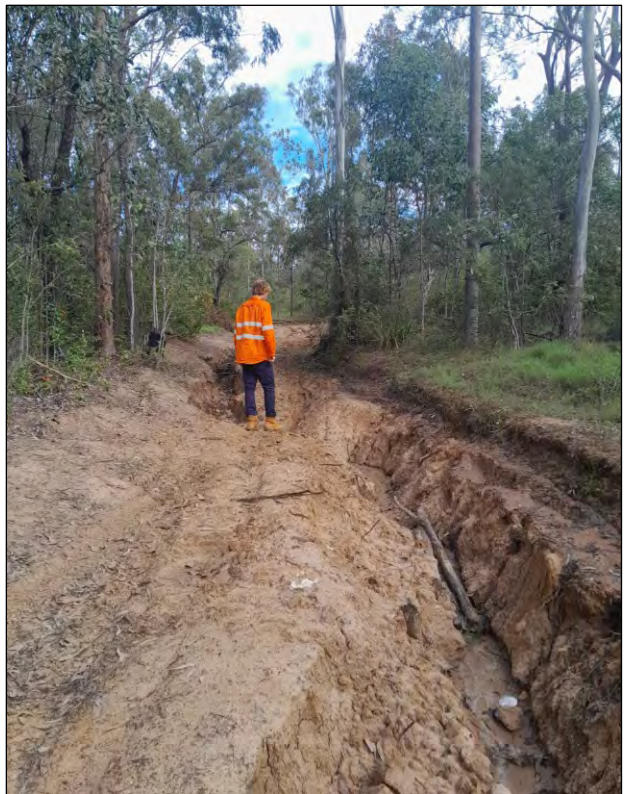
**Photograph 4: Unsealed track to Bores 1 and 2 displaying signs of significant erosion.**

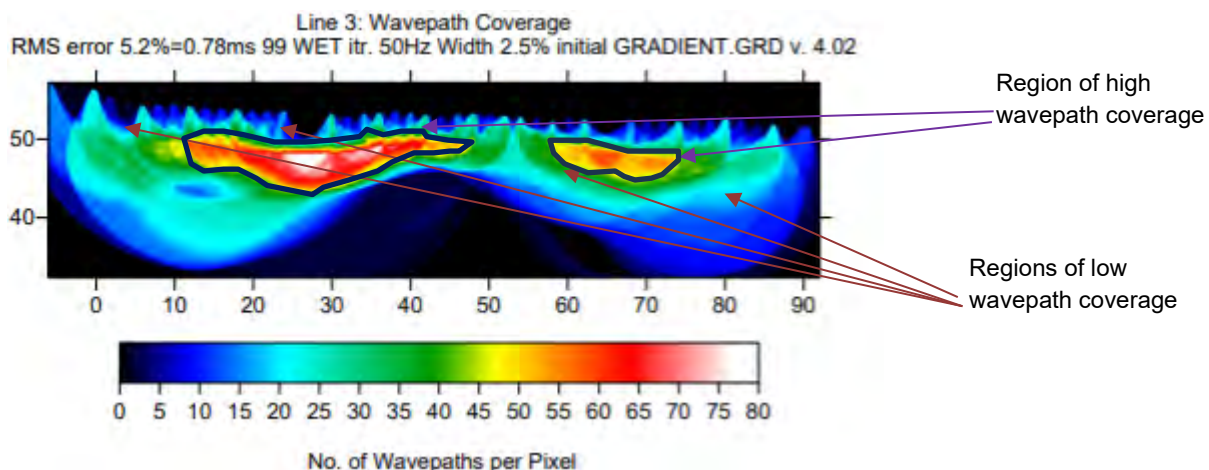
**Diagram 1: Wavepath Coverage Diagram for Line 3**

Wavepath coverage diagrams (produced from *Rayfract* for each processed survey) are provided with the SRT profiles attached. These diagrams show the subsurface coverage by WET wavepaths (i.e., the number of wavepaths per pixel of a particular finite-difference solution to the seismic eikonal equation). Higher coverage means a more reliable analysis for that subsurface region, as shown in Diagram 1. Regions of low wavepath coverage are indicative of less reliable analysis of subsurface regions.

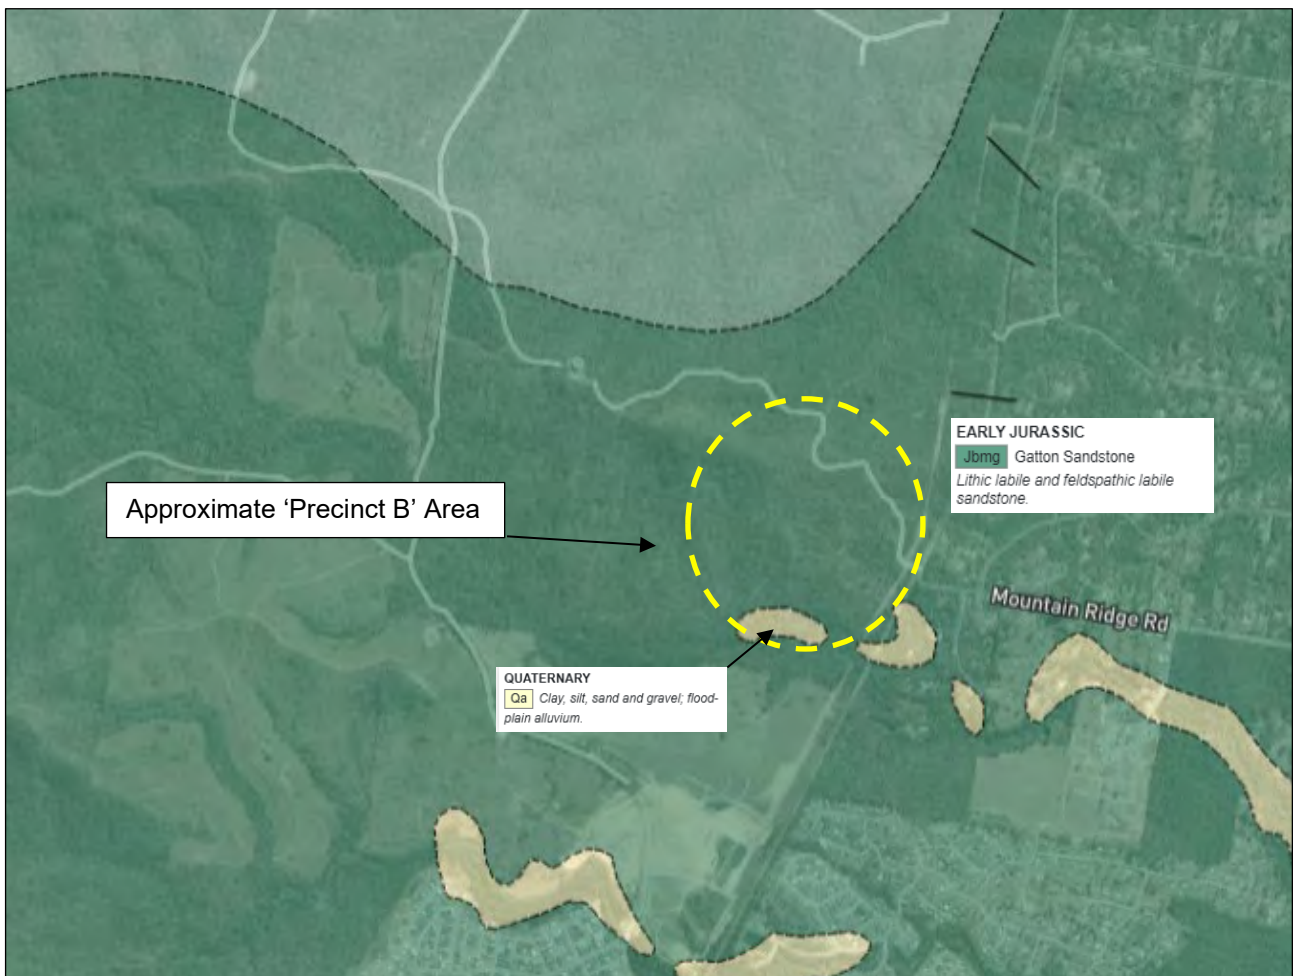
Image 2: Extract from geology mapping

Published information<sup>1</sup> indicates that the majority of the site is underlain by Early Jurassic Age Gatton Sandstone comprising '*Lithic labile and feldspathic labile sandstone*'. A small pocket of Quaternary aged alluvium is also located to the south of the proposed precinct area. An extract of the geological map is shown in Image 2. The subsurface conditions encountered in the boreholes (described below) generally confirm the published geology.

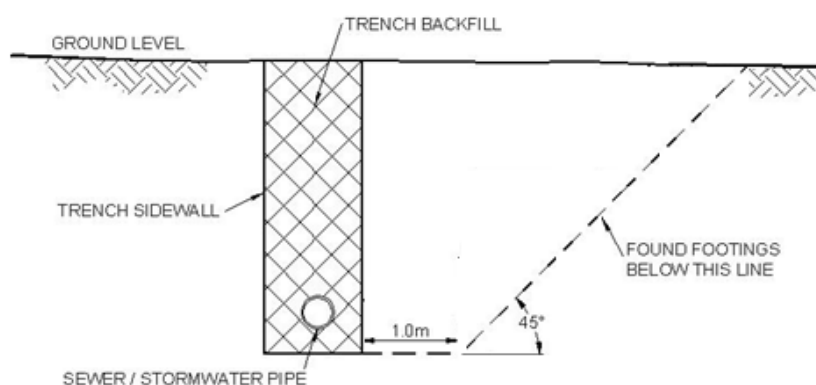
**Diagram 2**

All proposed footings should be founded such that they are not adversely affected by any adjacent excavations, batter slopes, trenches, or retaining walls that are not designed to support structure/equipment loads. To minimise the potential for any adverse interaction effects, footings should be founded at least below a plane extending 1 m horizontally from the base of trenches/batter slopes/excavations/retaining walls, then rising up at 1V:1H, as illustrated in Diagram 2.

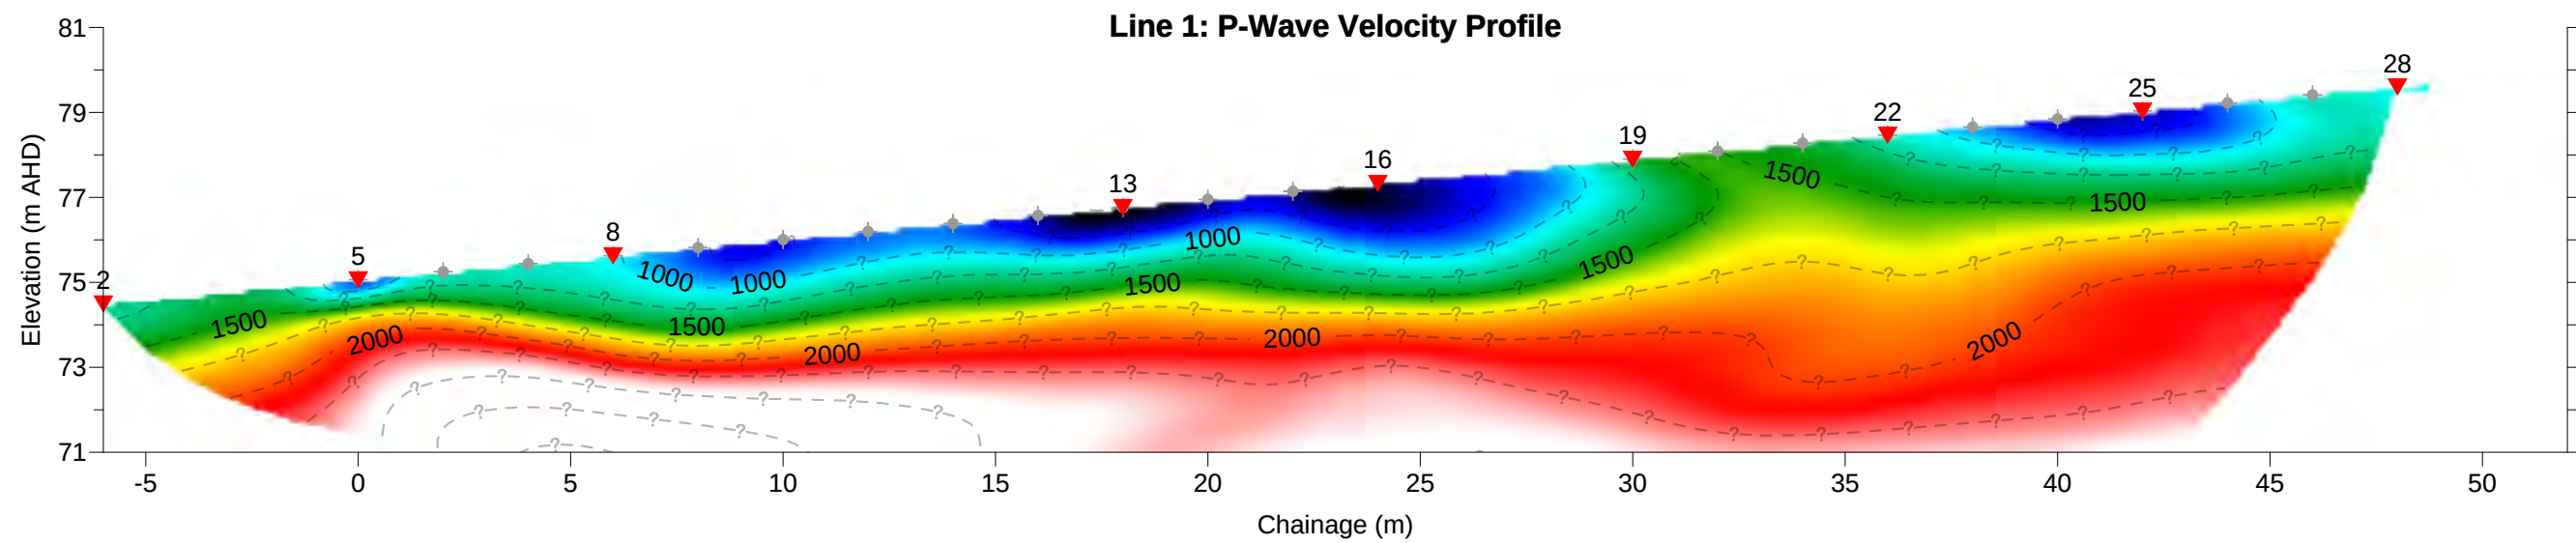
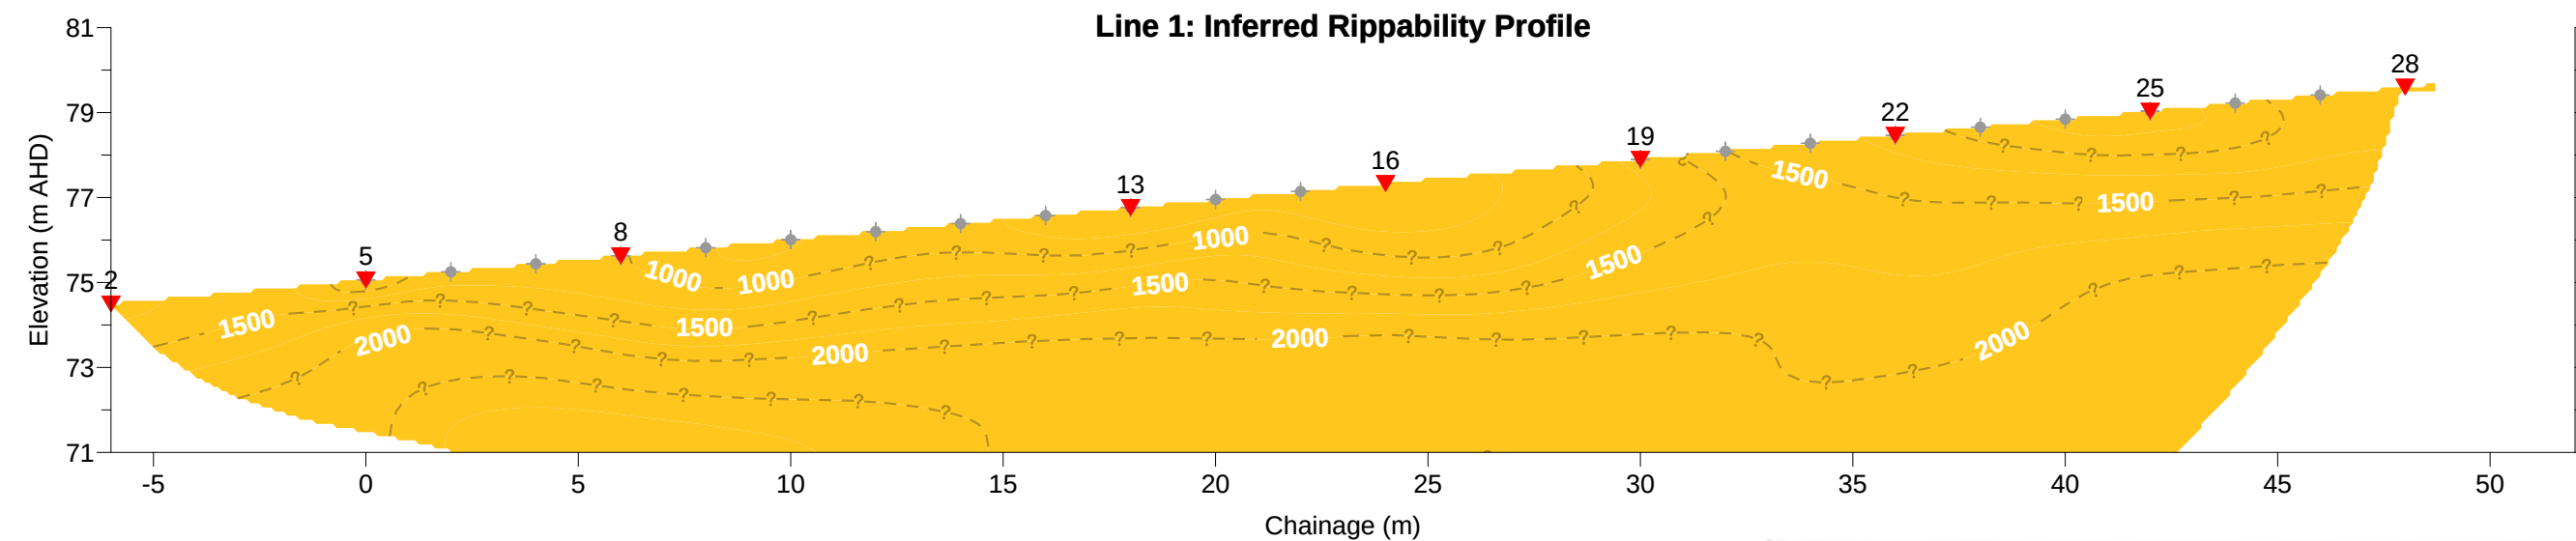
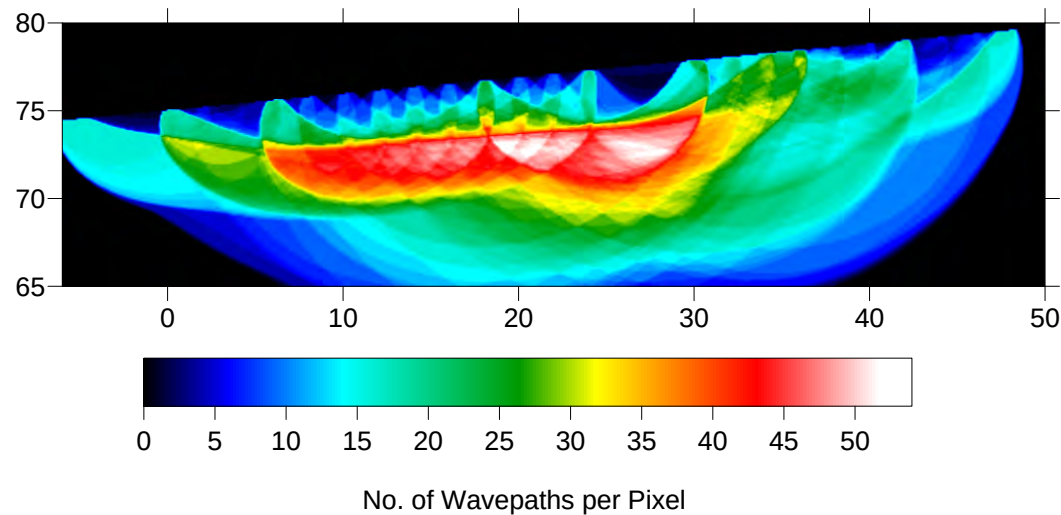
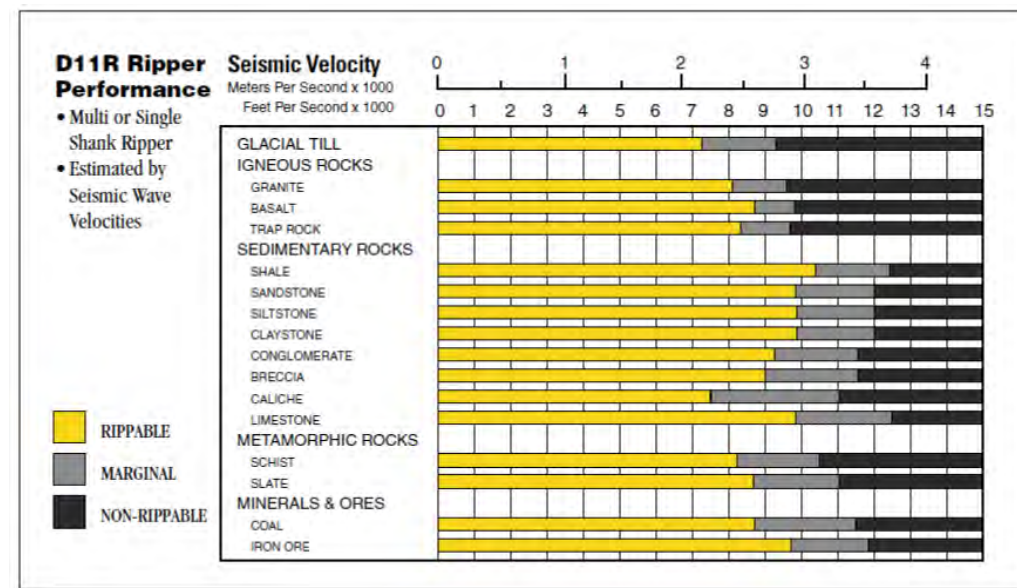
### **Figures 2 to 4: SRT Profiles**

The final P-Wave SRT profiles generated within *Rayfract* were gridded using Golden Software's *Surfer 22*. The resultant profiles are shown on the attached Figures 2 to 4, and the inferred subsurface conditions discussed in Section 5.3.

Line 1: Wavepath Coverage  
RMS error 1.9%=0.20ms 13 WET itr. 50Hz Width 2.2% initial GRADIENT.GRD v. 4.02

The results of the geophysical testing (refer Figures 2 to 4) indicate some variability in the P (compression) wave velocity profiles, with velocities generally ranging between 2,000 m/s to 4,000 m/s from depths of approximately 1 m to 6 m. The variability and troughs of lower velocity materials shown on some of the lines are possibly indicative of a more weathered profile in parts of the site or could be due to the prevalence of joint sets impeding the compression wave transmission and it is important that these results not be viewed or relied on in isolation from the geological conditions and the other parts of the investigation.

The SRT profiles (ref. Appendix C, Figures 2 to 4) generally agree with the above assessment that the majority of the proposed cut earthworks are within the 'Rippable' (up to about 3,000 m/s) range based on the rippability chart for a D10 dozer as published in the Caterpillar Handbook of Ripping. Small zones approximately 5m below the ground level were identified to be within the 'marginal' to 'non-rippable' range on two SRT profiles (ref. Figures 3 and 4). The rippability of such materials will depend on the fracture frequencies and orientation. Ripping direction should also be oriented to take best advantage of the fracturing/bedding. Excavation below the marginal zone and into the non rippable layer will require further assessment and planning.

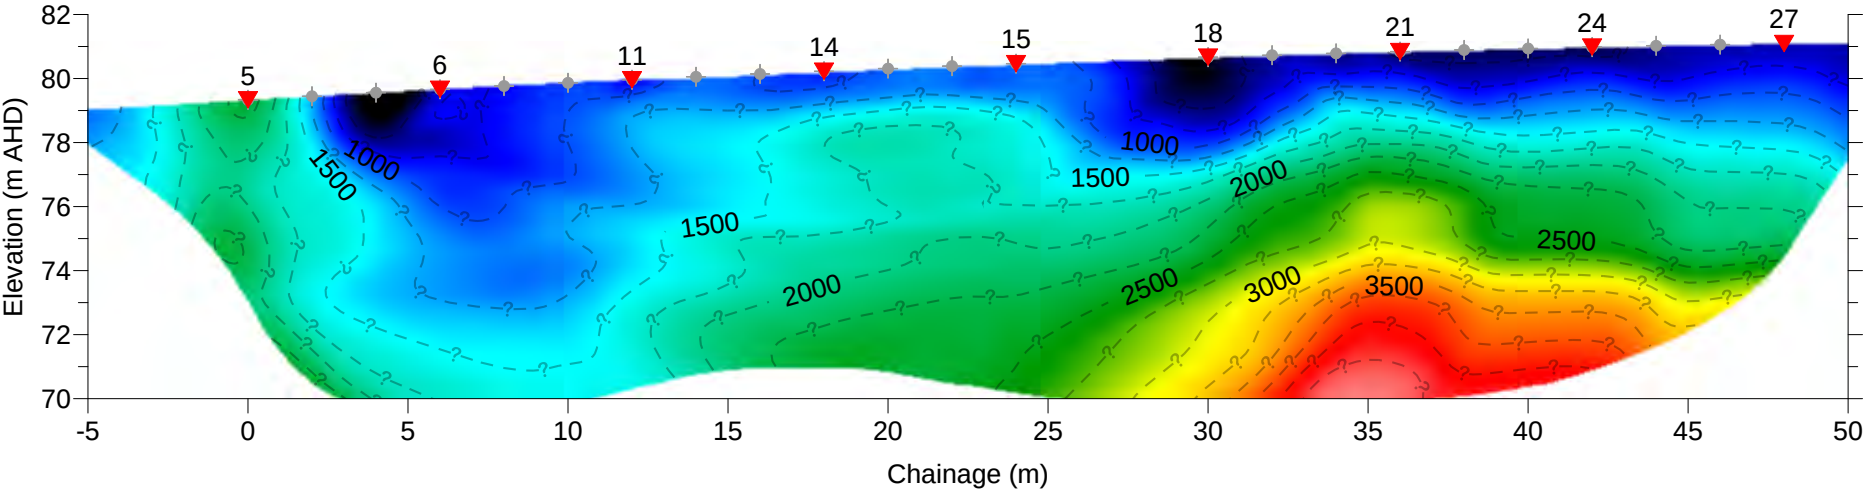
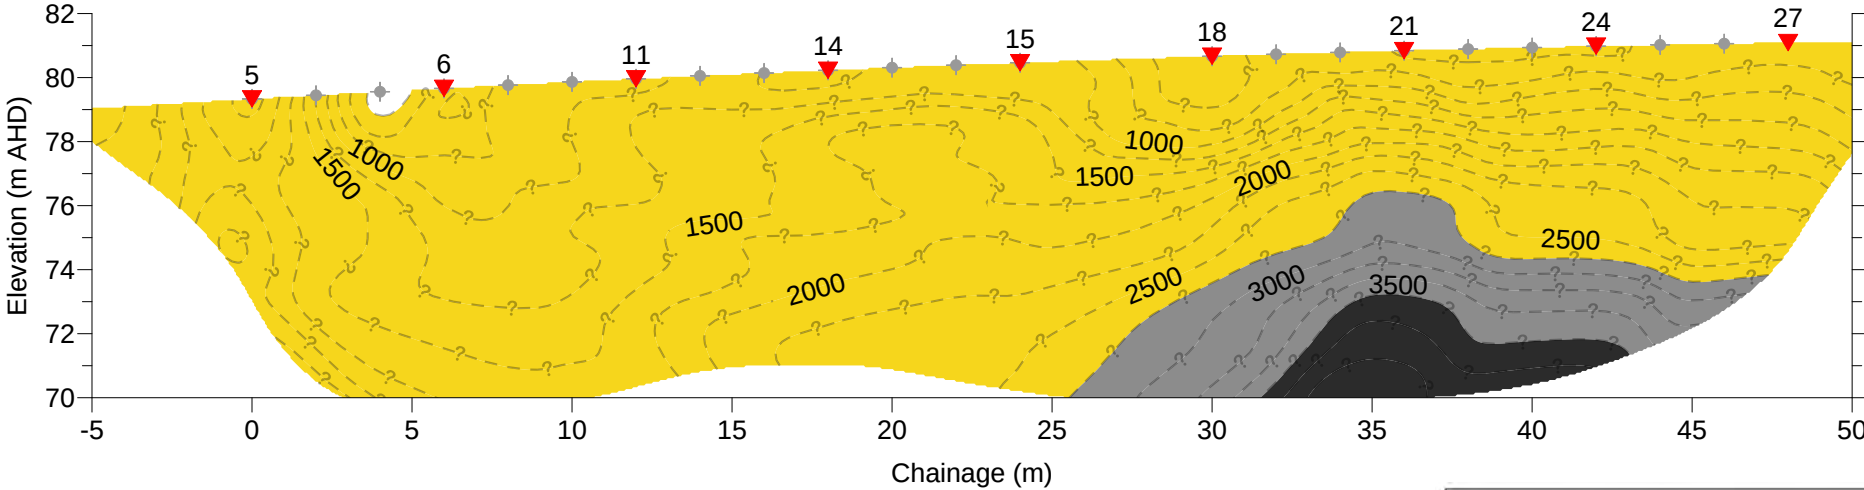
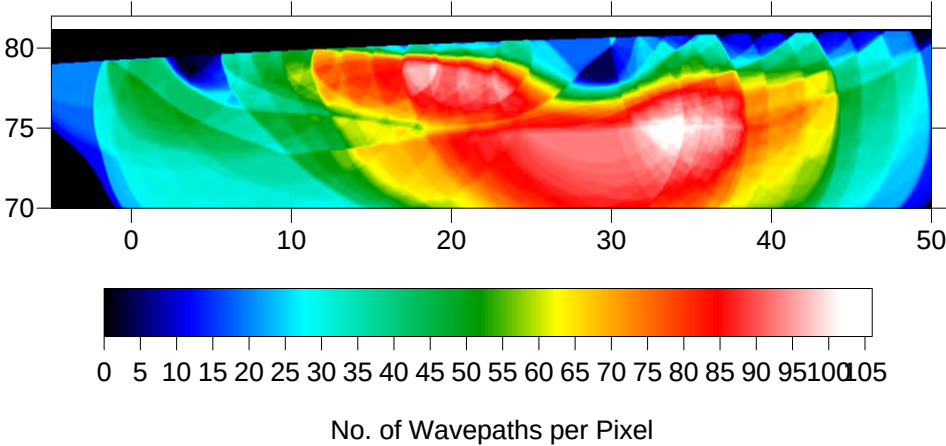
Line 2: P-Wave Velocity Profile

Line 2: Inferred Rippability Profile

LINE2 RMS error 44.8%=6.79ms 26 WET itr. 50Hz Width 6.0% initial GRADIENT.GRD v. 4.02

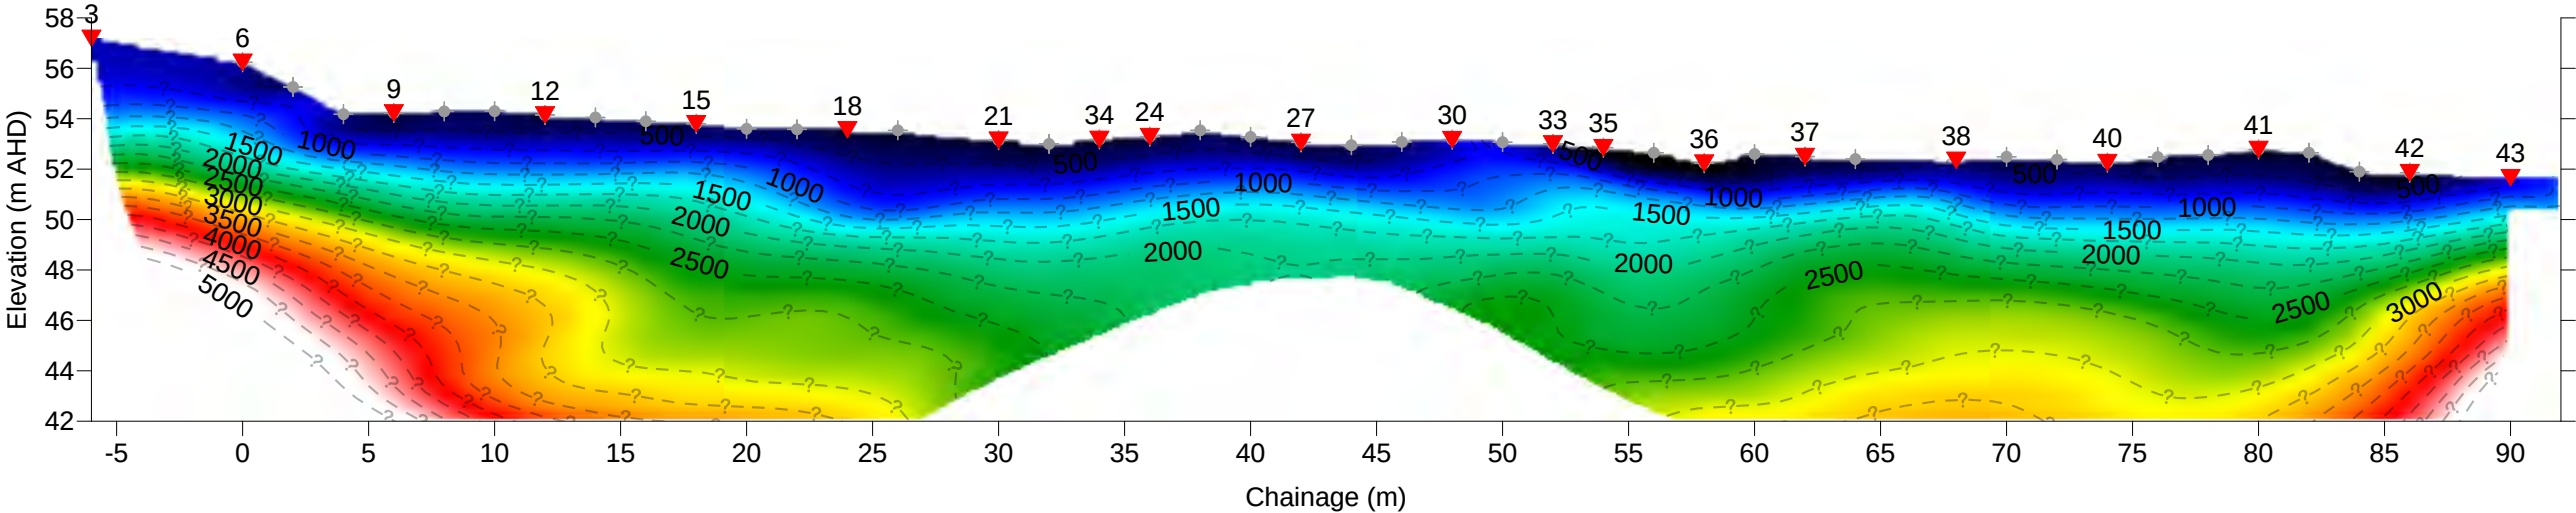
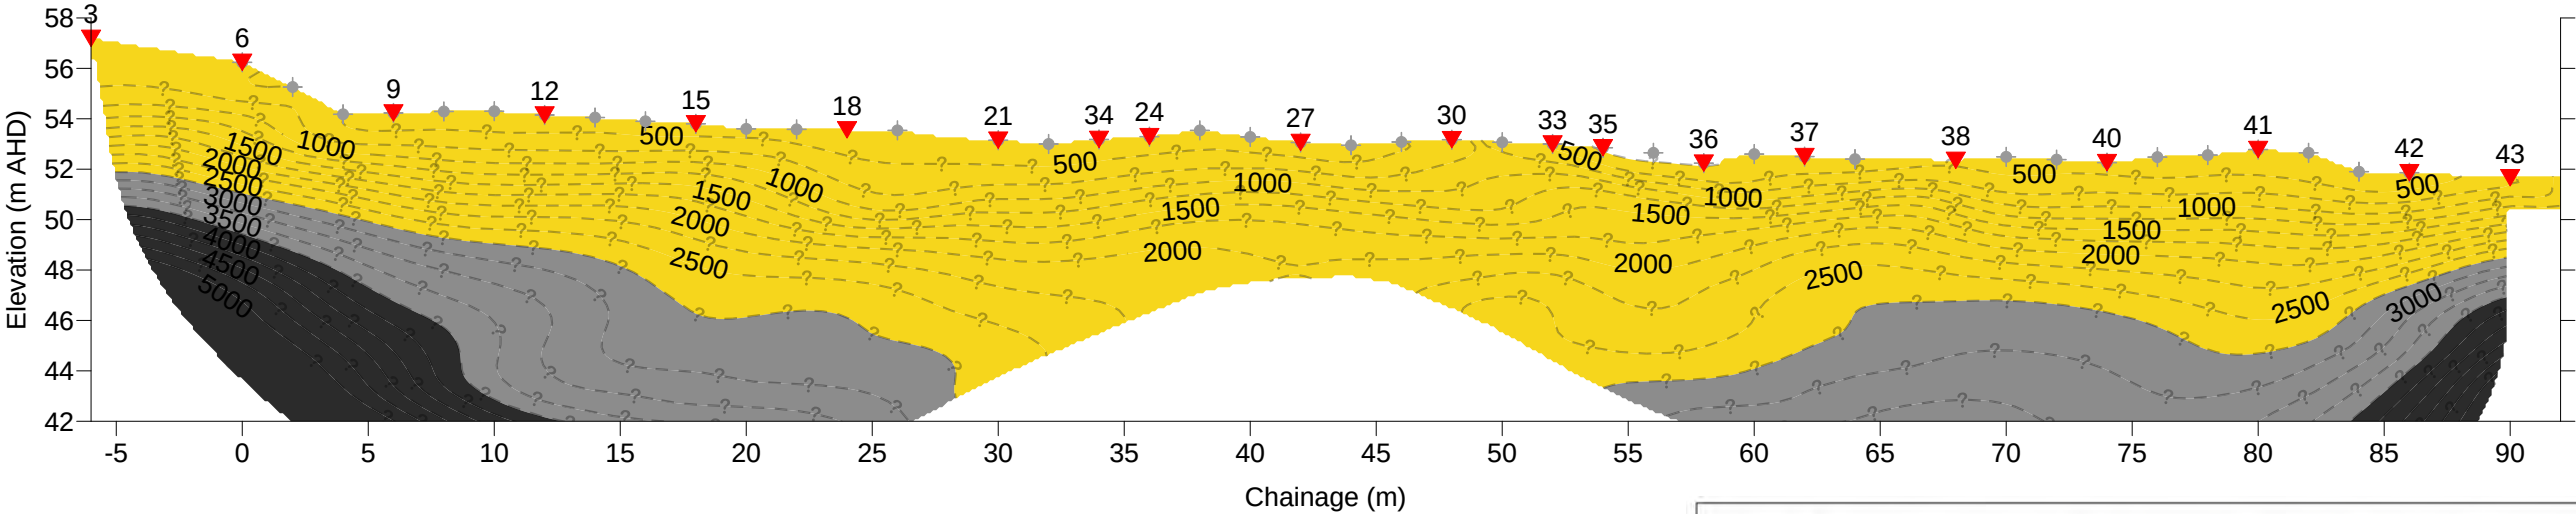
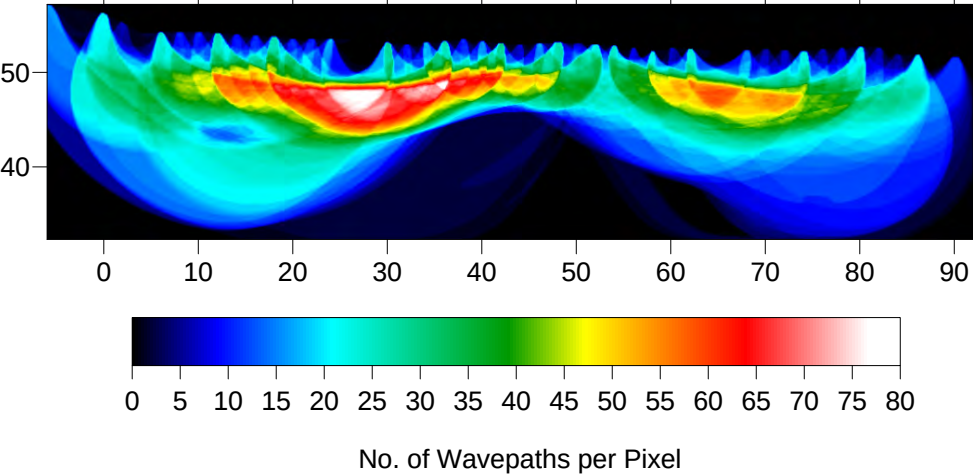
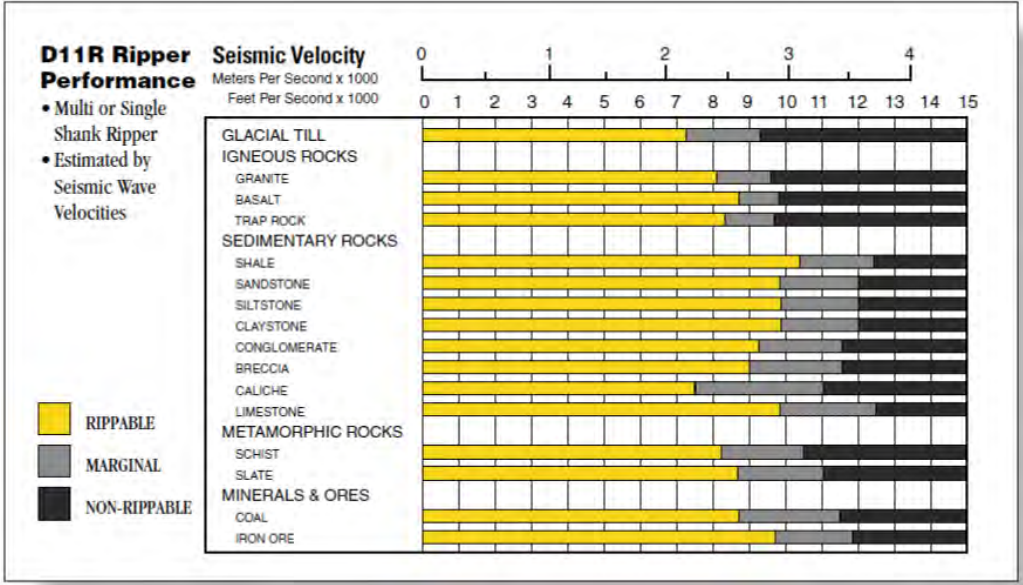
Line 3: P-Wave Velocity Profile

Line 3: Inferred Rippability Profile

Line 3: Wavepath Coverage  
RMS error 5.2%=0.78ms 99 WET itr. 50Hz Width 2.5% initial GRADIENT.GRD v. 4.02

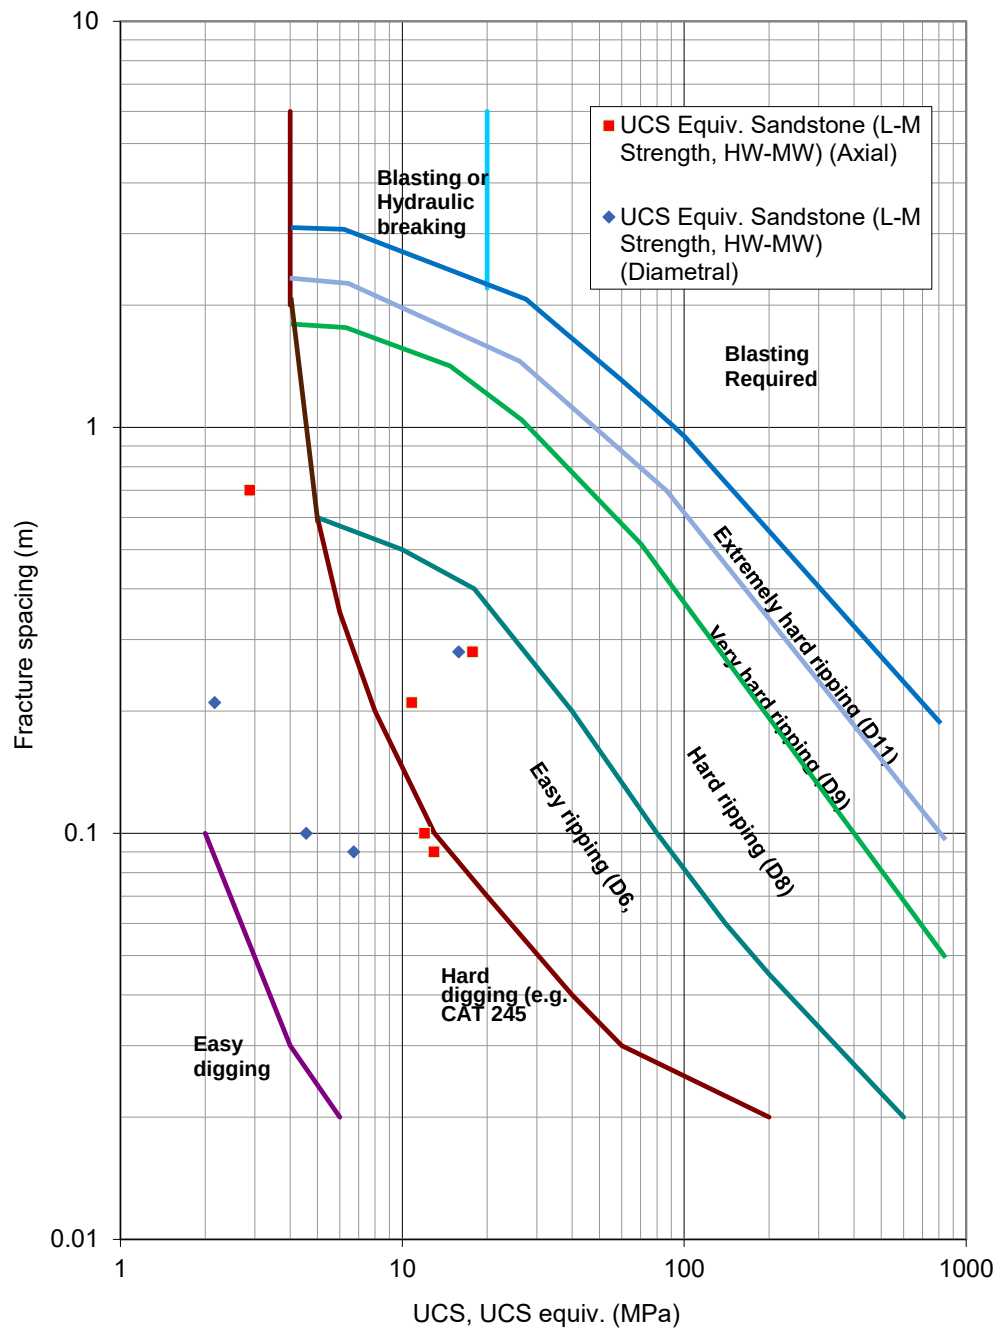
### **Figure 5: Pettifer and Fookes Rock Excavatability Chart**

# Rock Excavability (Pettifer & Fookes, 1994)

This empirical estimate of rock excavatability indicates that the very low to low strength sandstone within the proposed cut excavation depths is mostly within the 'Hard digging and / or Easy Ripping' and CAT 245 Backhoe to D8 dozer are recommended.

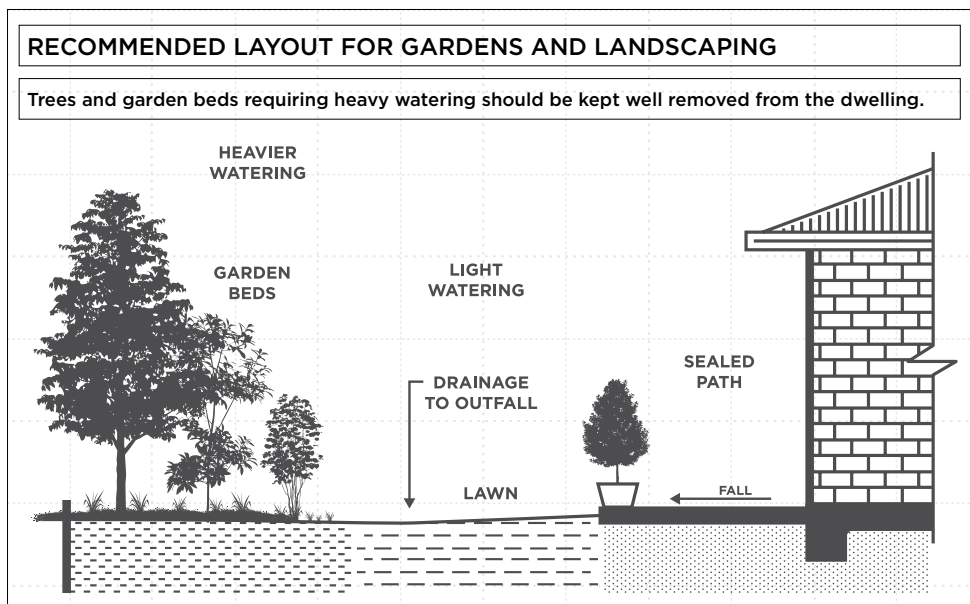
## 2. Paths, patios and driveways

Paths should be laid hard against brickwork or footings with a fall away from the house to a stormwater discharge point.

Concrete pavements should be constructed in a way that will not impede surface water flowing away from the building or cause water to pond adjacent to the footings causing clay foundations to swell.

On “H” & “E” site classifications, particular detail is required to prevent pavement from moving away from the building. Movement in paths could cause stress on pipes and inspection openings and/or breakages in pipes. Resulting leakages may cause movement and damage as a result of clay soils under the house swelling.

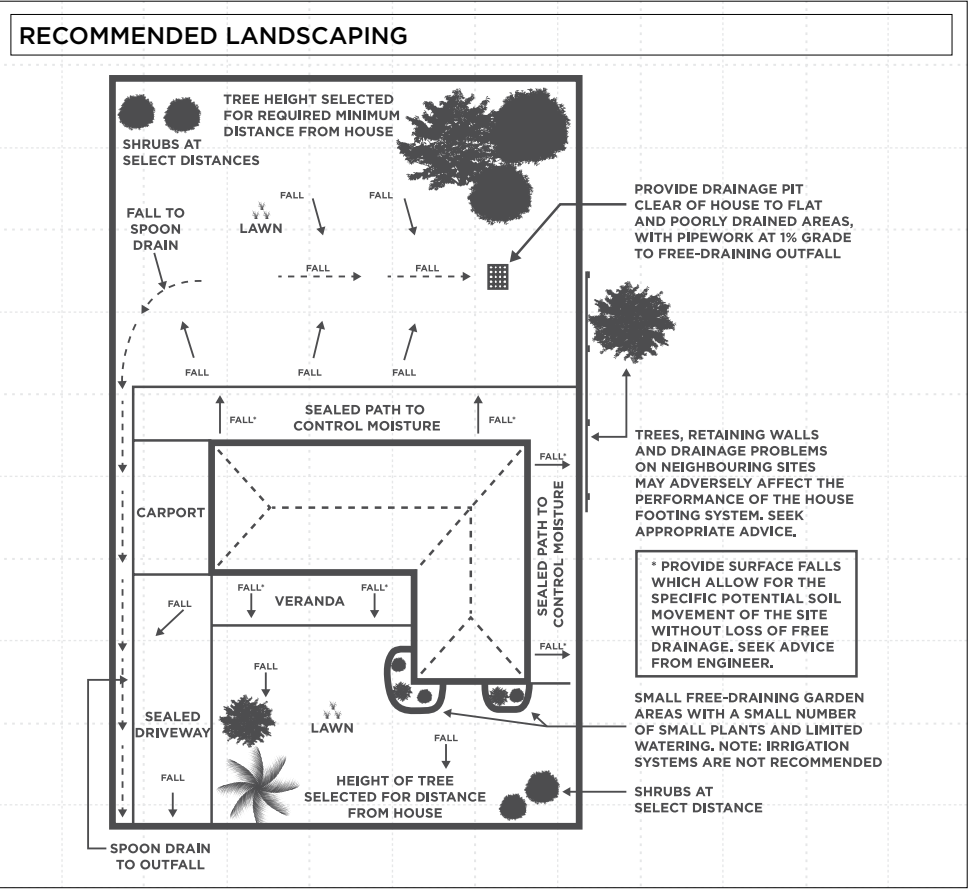
### 3. Lawns

If placing lawn areas against the house, ensure that filling built up against the wall is graded away and will not allow ponding of water to occur. The filling should be impervious clay soil and not sandy loam.

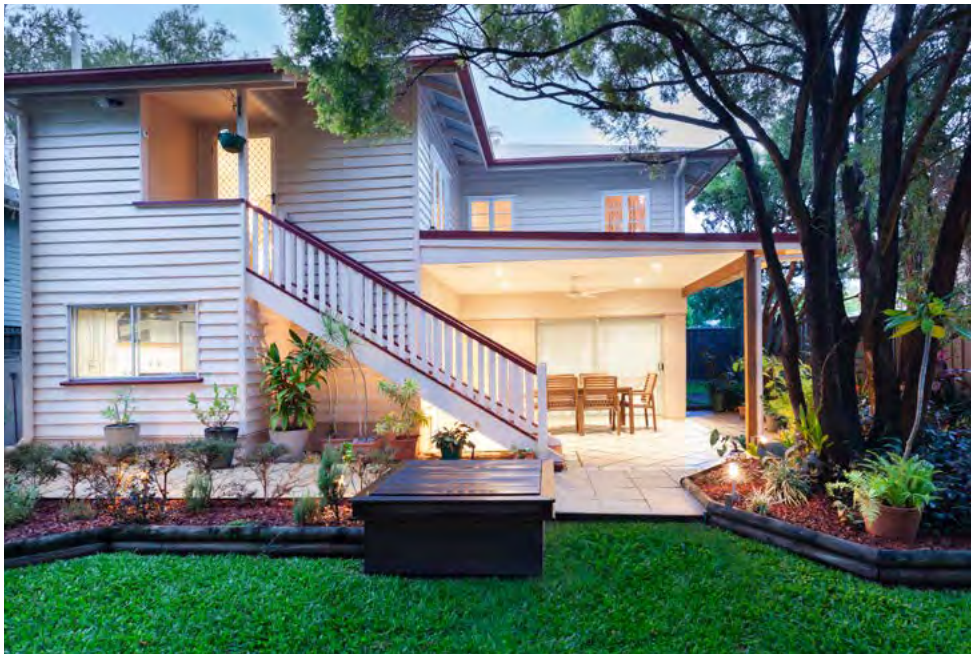
## 6. Site drainage and sloping sites

Design for site conditions, location of retaining walls, paths, swimming pools, future structures or proposed extensions etc. should all be considered when preparing the site for correct surface water flow.

1. To ascertain surface falls which allow for the specific potential soil movement of the site without loss of free drainage
2. To provide correct mechanical connection of perimeter paths of footings
