# STORMWATER MANAGEMENT MEMO

**RE: EVERLEIGH PRECINCT 5.3 – STORMWATER QUANTITY AND STORMWATER QUALITY ANALYSIS**

**RE: EVERLEIGH ROL13 – STORMWATER QUANTITY AND STORMWATER QUALITY ANALYSIS**

| Subject: | ROL13 Rapid Waterway Geomorphic Assessment | | |

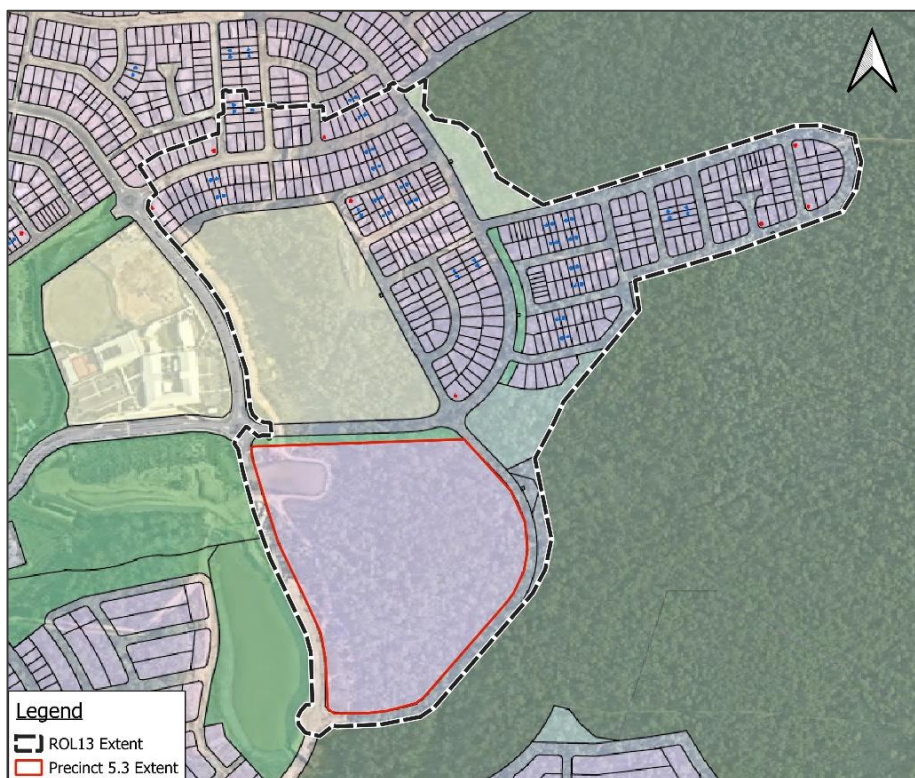
**Figure 1: Precinct 5.3 Extent**

This letter outlines the stormwater quantity and quality treatment strategy for Precinct 5.3 (also referred to as ROL21) of the Everleigh development (the Site). This precinct falls within the previously titled ROL13, for which a detailed stormwater analysis was previously completed and issued to Economic Development Queensland (EDQ) outlining the proposed bioretention, riparian revegetation, and peak flow analysis elements to meet the stormwater management requirements. This previous ROL13 stormwater analysis was outlined in the *Everleigh ROL13 – Stormwater Quantity and Quality Analysis* (ROL13 SW Letter) (Engeny, 2024) letter, which is enclosed. Refer to Figure 1 for the locality of Precinct 5.3 within ROL13.

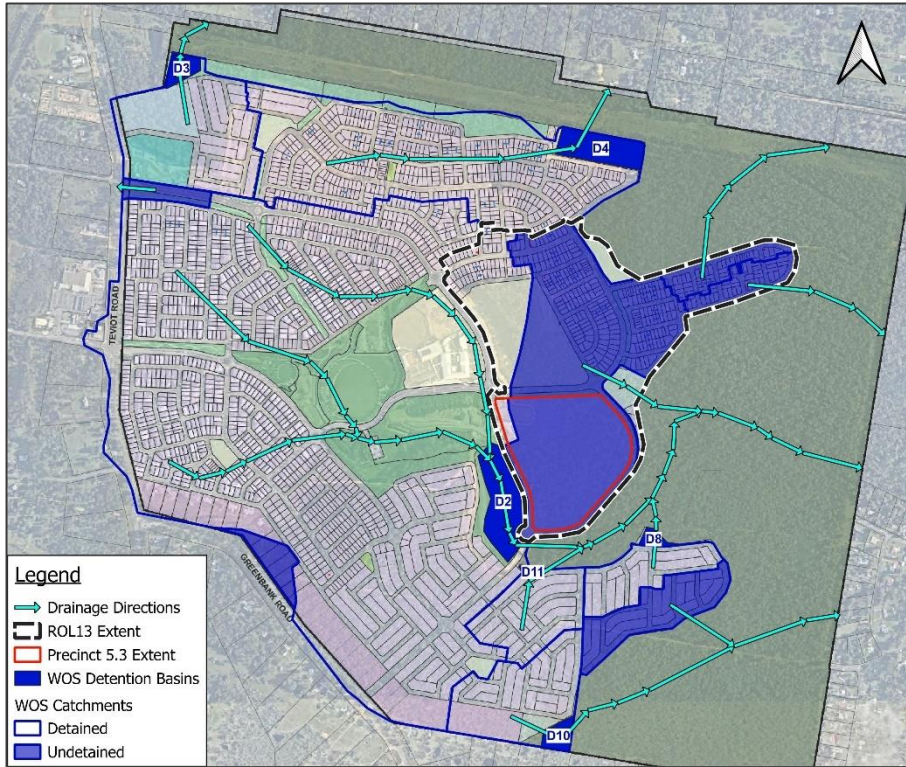
Figure 2: WOS Detention Strategy

The WOS SWMP 2025 and the ROL13 SW Letter demonstrates that stormwater detention is not required for the majority catchment for which Precinct 5.3 falls within in order to meet peak flow mitigation requirements at the Site boundary. Therefore, the majority of Precinct 5.3 will flow in an easterly direction towards the Site boundary. A small portion of Precinct 5.3 will flow towards the Central Wetland (D2) where flows will be detained. The location of Precinct 5.3 in the context of the WOS SWMP 2025 is shown in Figure 2. The catchment areas and flow directions outlined in the WOS SWMP 2025 and ROL13 SW Letter has not changed since the development of these documents.

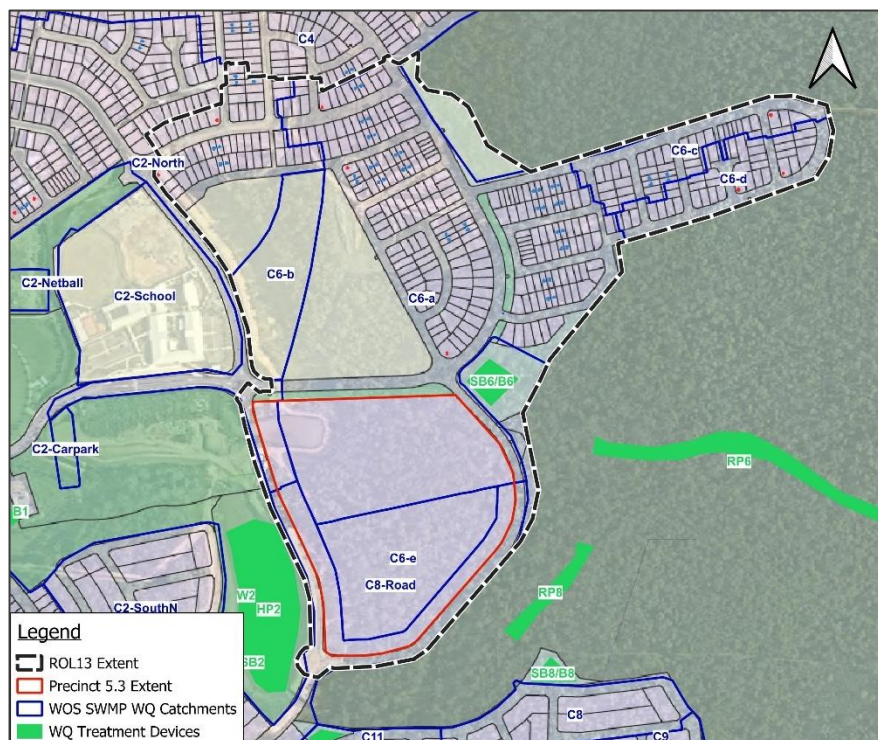
**Figure 3: Precinct 5.3 Stormwater Quality Catchments**

The WOS SWMP 2025 and the ROL13 SW letter demonstrates the water quality treatment strategy for the catchment for which Precinct 5.3 falls within. The WOS SWMP 2025 catchments that Precinct 5.3 are contained in are C6-a, C6-b, C2-North and C8-Road. The location of Precinct 5.3, ROL13, and the WOS SWMP 2025 catchments are shown in Figure 3.

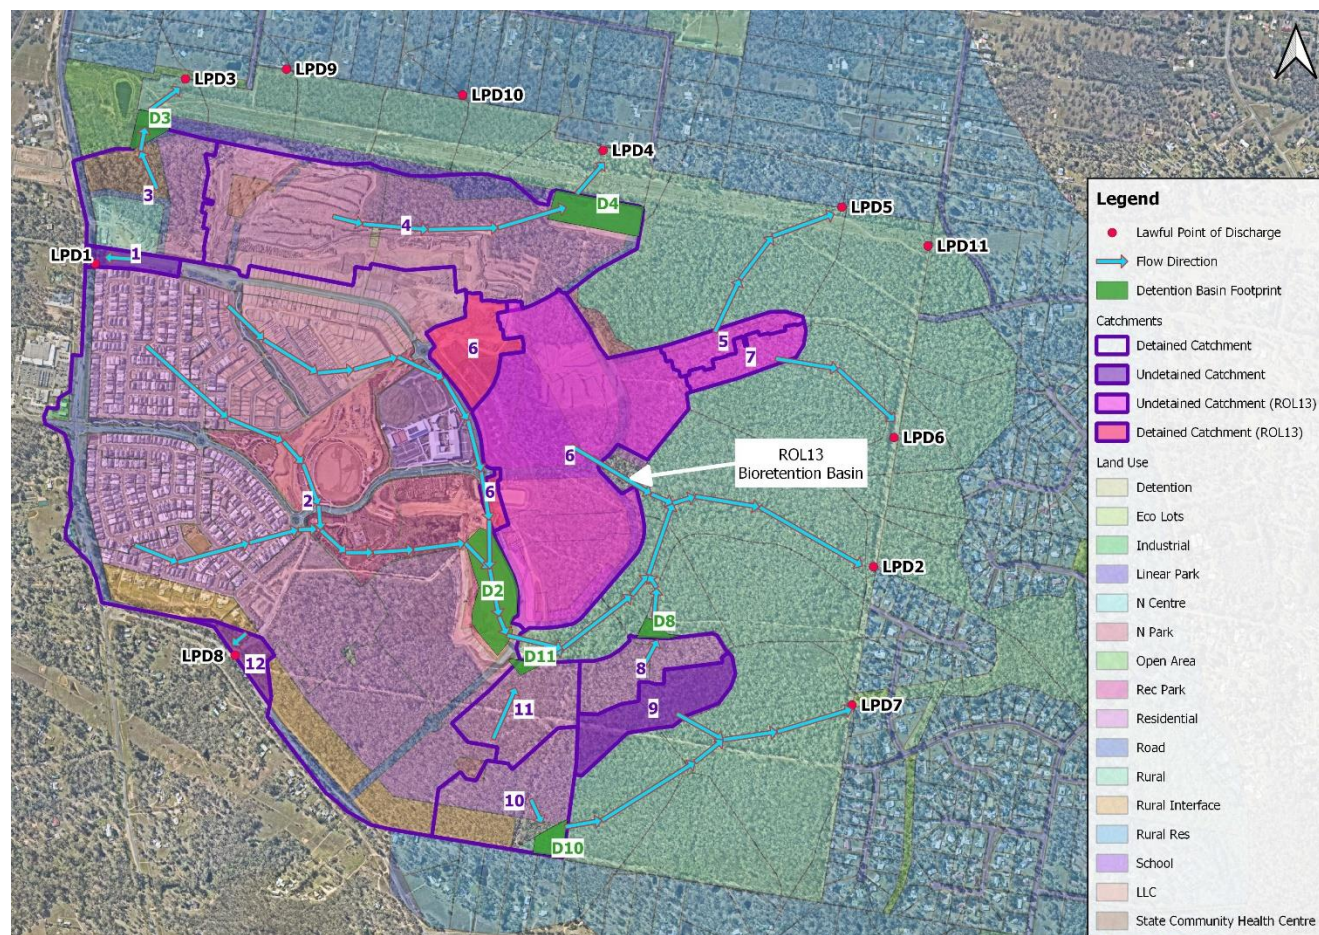
Figure 2: Catchment and Land Use Delineation

The WOS SWMP 2023 demonstrates that detention is not required for the ROL13 catchment as shown in Figure 2 which has been extracted from the WOS SWMP. The ROL 13 catchment area outlined in the WOS SWMP has not changed.

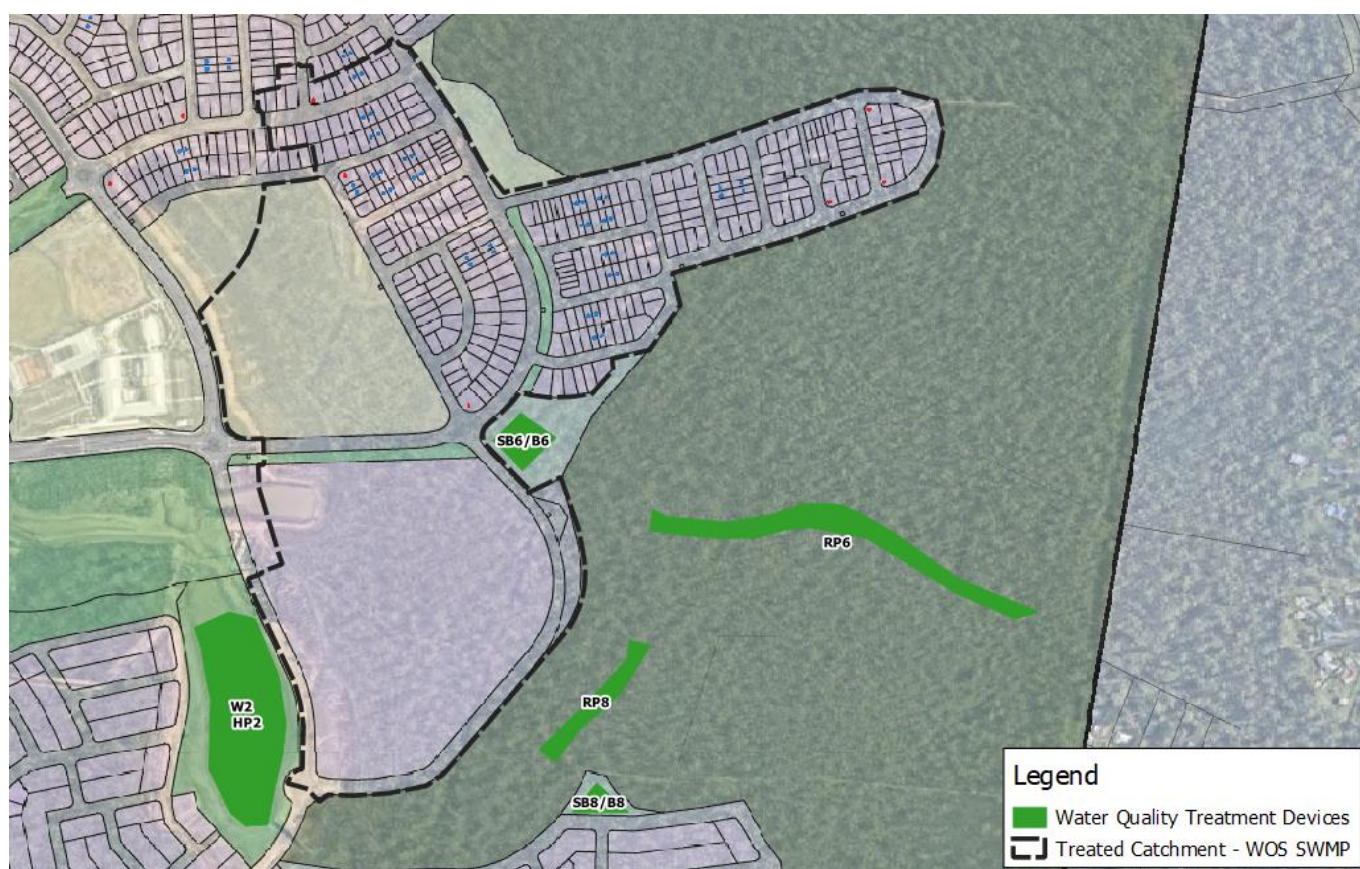
Figure 3: Stormwater Quality Catchment

The catchment reporting to the ROL13 basins and riparian vegetation is referred to as waterway quality catchment 6 in the WOS SWMP (Engeny 2024 – ‘Everleigh Stormwater Masterplan Report – Version 3 Rev 2’) and has an area of 40.8 ha. No changes have been made to the catchment area. Refer Figure 3 for the stormwater quality catchment plan.
