**PRELIMINARY GEOTECHNICAL ASSESSMENT  
RIPLEY VALLEY – URBAN CORE**

# Preliminary Geotechnical Assessment Ripley Valley – Urban Core

Job Number 9287gs.10

Prepared for Sekisui House Development Service

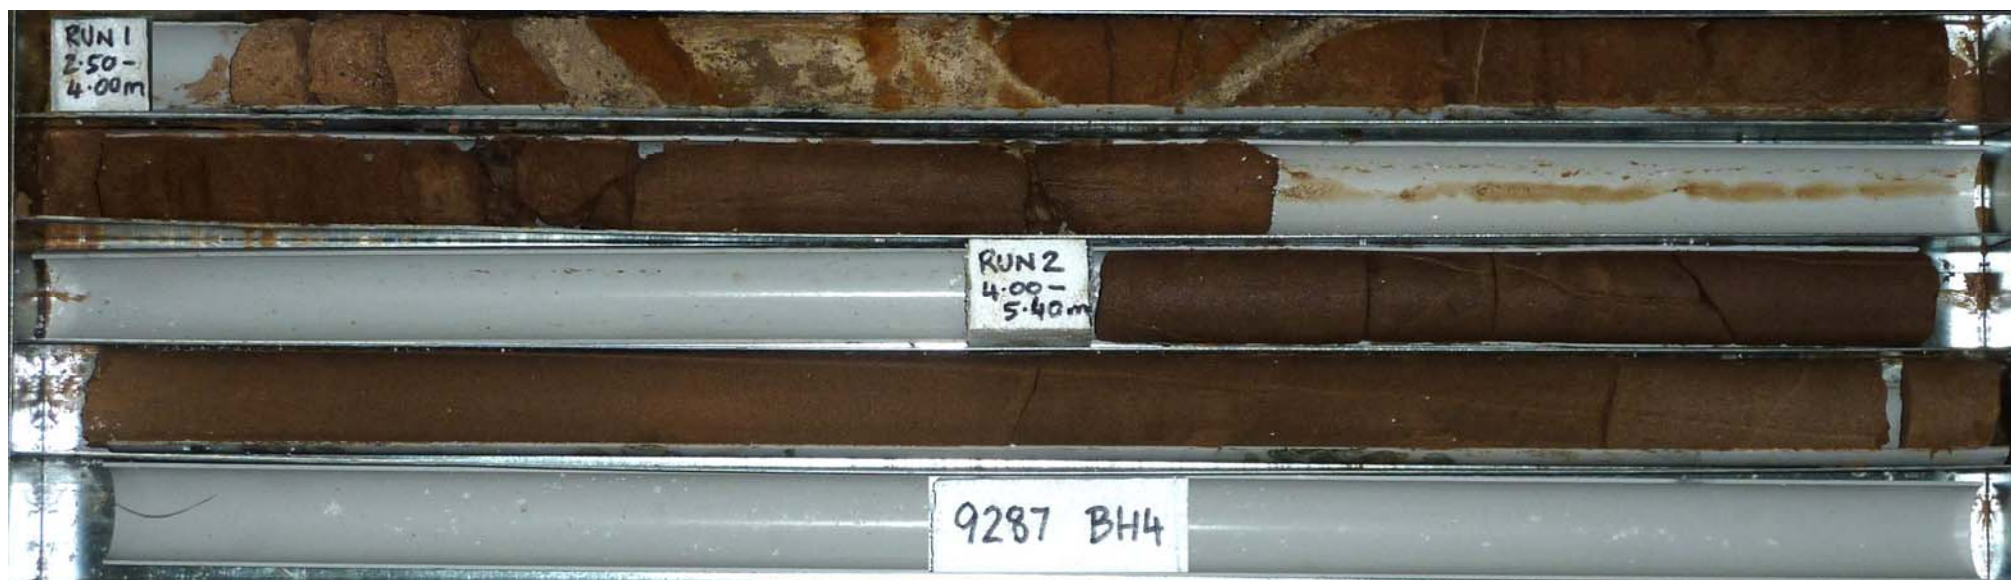
Borehole Number: BH4  
Box 1 of 1  
2.5m to 5.4m

| Drilling | | | | Core Recovery (%) | Samples & Field Tests | Depth (m) | Groundwater (m) | Graphic Log | Description<br>SOIL TYPE: SYMBOL, SOIL NAME, plasticity/particle characteristics, colour, minor components, moisture, consistency, ORIGIN ROCK TYPE: Grain size, texture, colour, strength, weathering, fracturing, joint spacing | Weathering | Inferred Strength<br>IS <sub>(50)</sub> MPa | NATURAL FRACTURES | | | |
|---|---|---|---|---|---|---|---|---|---|---|---|---|---|---|--|
| | | | | 100% | | 3.5 | | | SANDSTONE, coarse grained, granular, orange brown, medium strength, fractured, distinctly weathered | DW | EL 0.03<br>VL 0.1<br>L 0.3<br>M 1<br>H 3<br>VH 10<br>EH | 20<br>40<br>100<br>300<br>1000 | 22% | 2.90 - 3.67 m: FZ | |

Annex A Fieldwork Results and Photographs of Rock Core
