# ENGINEERING SERVICES REPORT

## AURA PRECINCT 15 'WEST'

Prepared for **Stockland Development Pty Ltd**

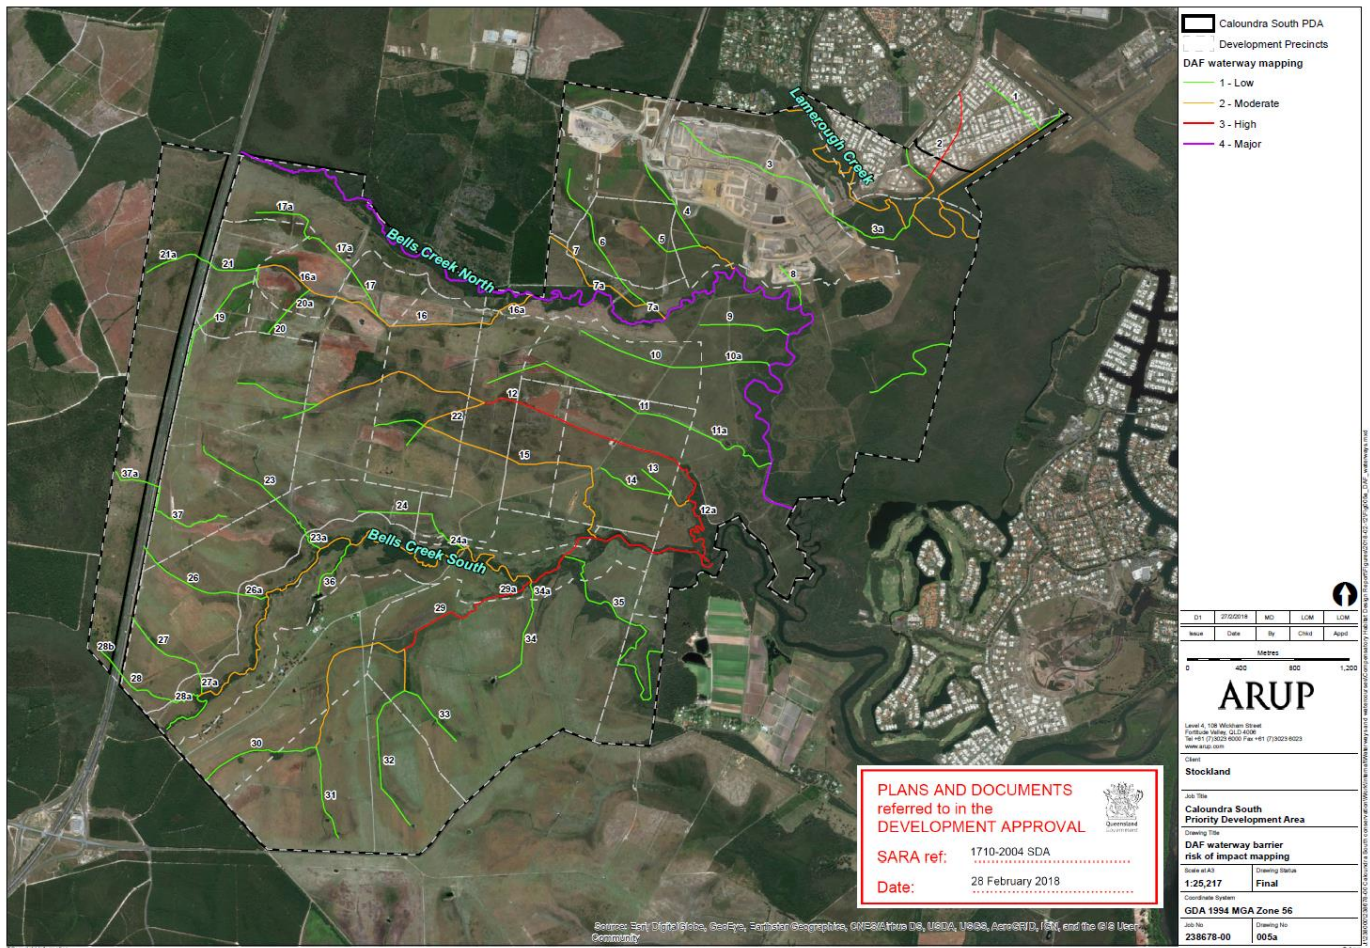
**FIGURE 2. DAF WATERWAY BARRIER RISK OF IMPACT**

Mapping indicates that there is no declared fish habitat anywhere in the vicinity of Aura. There is, however, Waterway Barrier mapped tributaries within Precinct 15 (with a rating of 'low'). The treatment and removal of these waterways is required to be strictly in accordance with the existing DAF approval conditions. Risk to impact to waterway barriers in accordance with the DAF waterway approval have been identified in the image below.

Reference has been made to the Department of State Development, Manufacturing, Infrastructure and Planning approval (1710-2004 SDA dated 28 February 2018) which provides a conditional approval for the proposed earthworks across the site. Figure 2 below is a snapshot of the DAF identified waterway barrier risk of impact mapping.

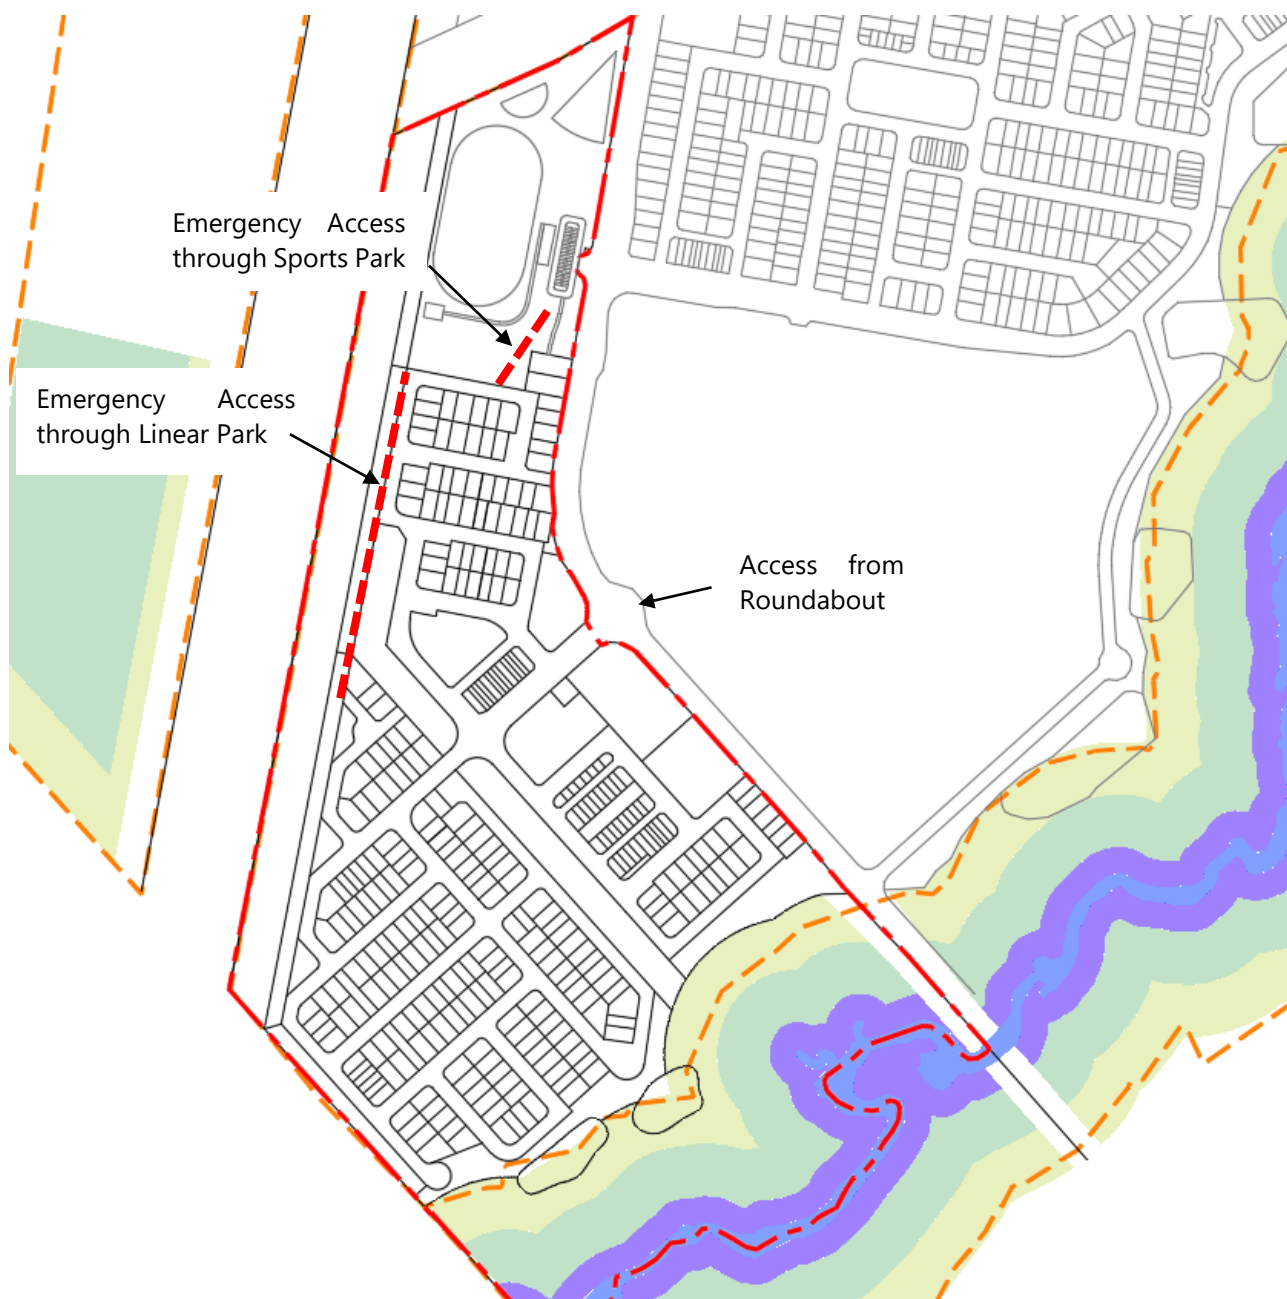
**FIGURE 4. ACCESS LOCATIONS**

The western enclave of Precinct 15 West is proposed to be serviced by one road connection across the open channel. To satisfy Sunshine Coast Planning Scheme Schedule 6 Section 17 Table SC6.17E, a secondary egress is proposed via the linear park. The 3m path will be designed to facilitate the emergency access, be trafficable in a 1% AEP plus climate change flood event and will provide access for emergency vehicles only. Bollards/lockrails are proposed to prevent day to day access for residents, with details to be provided at the design compliance phase.

Refer to Figure 4 below for the location of the proposed accesses and to drawing 3058-DA058 in Appendix E.

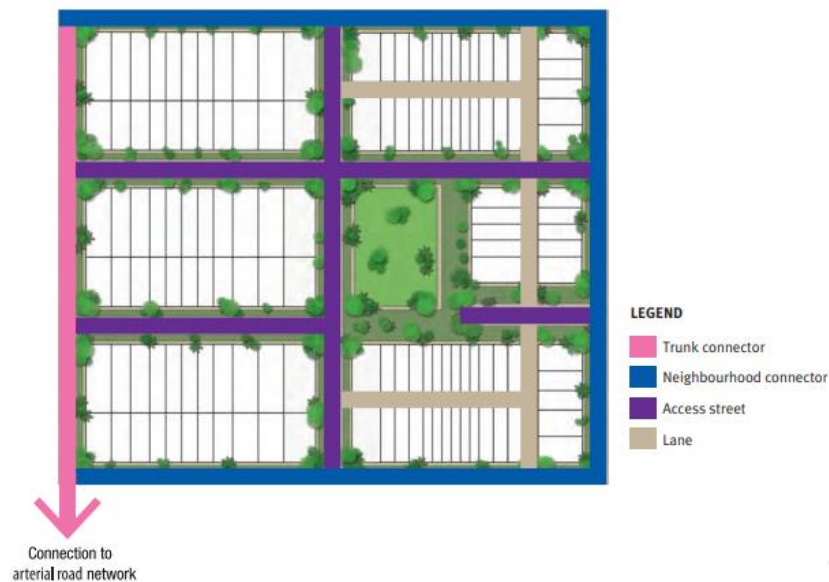
**FIGURE 6. EXTRACT FROM ECONOMIC DEVELOPMENT QUEENSLAND PDA GUIDELINE NO. 0.6**

These proposed intersections are consistent with Economic Development Queensland PDA Guideline No. 06 which indicates that four-way intersections of access streets are typical for neighbourhoods (refer to extract below in Figure 6) where they are situated a minimum depth of two lots away from the closest intersection.

Four-way intersection #1 is proposed to be a priority yield intersection, where traffic signs will be required on the lessor priority road to provide clarity to drivers on who has right of way. Confirmation of the lessor priority road will be made during the Design Compliance Phase by providing a 'Signs and Linemarking' drawing, including traffic signs and surface treatments on the lessor priority road as necessary. Sight distances will also be reviewed during the Design Compliance Phase to determine whether parking limits will be required on the higher priority road, to ensure adequate sight distance for the lessor priority road.

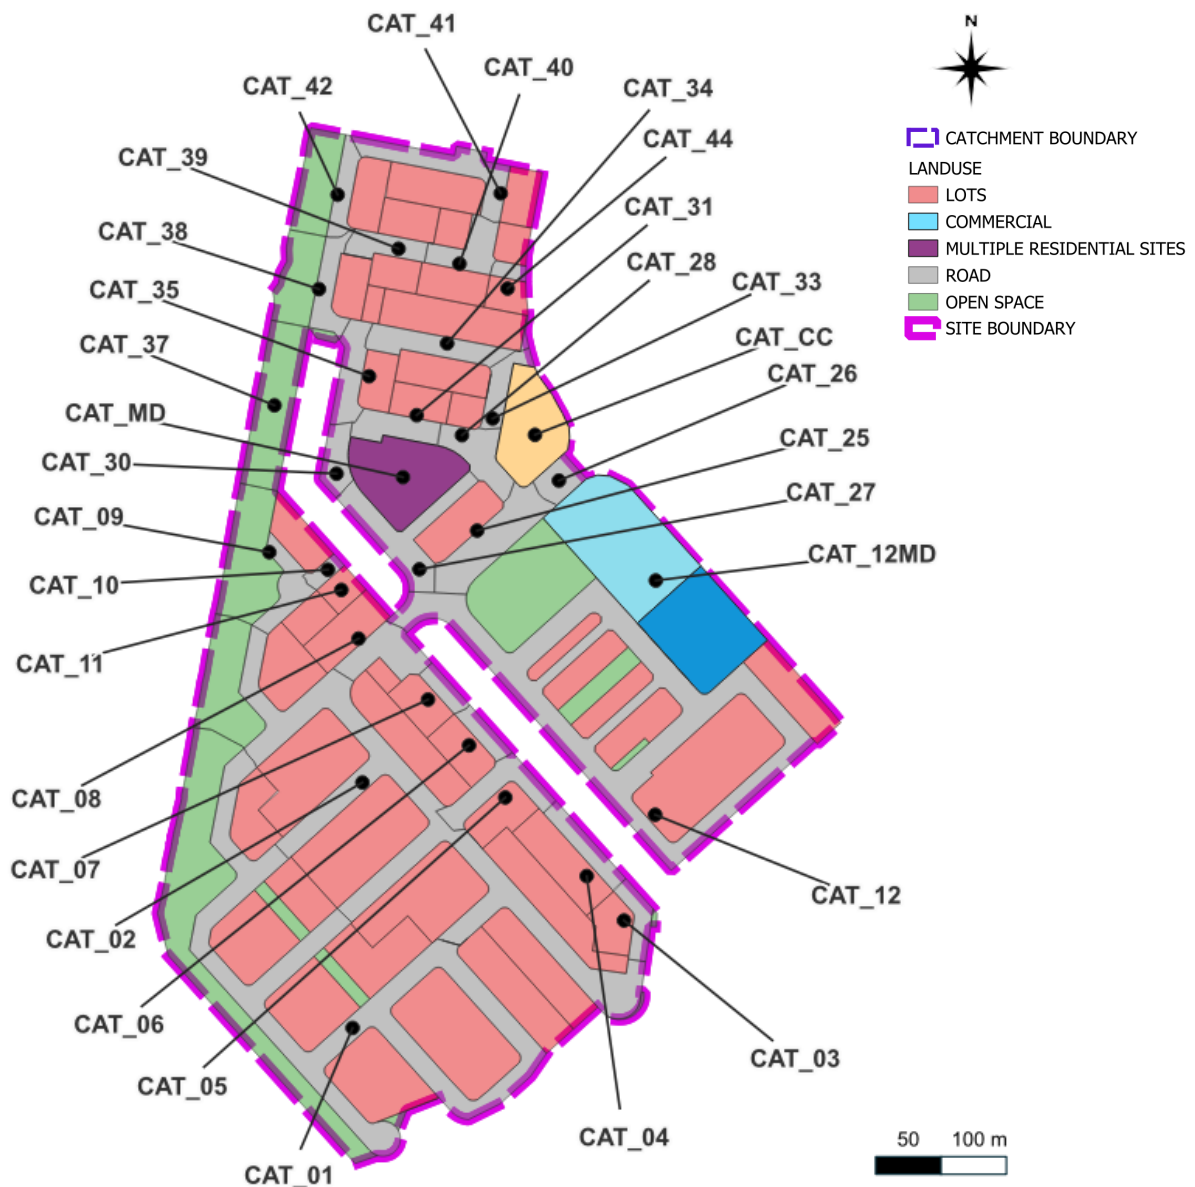
FIGURE 4-1 MUSIC SOURCE NODE CATCHMENTS & LANDUSE(UPDATED)

The MUSIC model catchment delineation and surface types that have been adopted for configuring source nodes are presented on **Figure 4-1** above and in **Table 4-1**.

The updated layout of the MUSIC model is presented in **Appendix A** (*..\SF\P15\_West\_SWQMP\_Nov2024\MUSIC\AuraP15\_WQ\_Model\_update\_241217\_pref.sqz*).

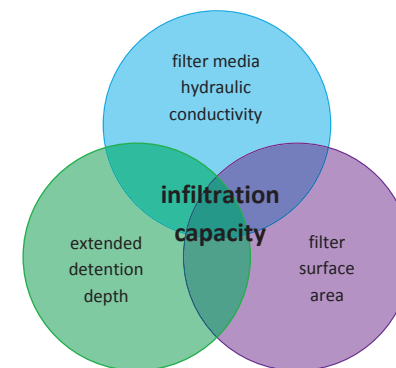
Figure 1. Design elements that influence infiltration capacity.

Where one of these design elements falls outside the recommended range, the infiltration capacity can still be maintained by offsetting another of the design elements. For example, a filter media with a lower hydraulic conductivity may be used, but the surface area or the extended detention depth would need to be increased in order to maintain the treatment capacity. Similarly, if the available land were the limiting design element, the system could still treat the same size storm if a filter media with a higher hydraulic conductivity were installed. Where a hydraulic conductivity greater than 300 mm/hr is prescribed, potential issues such as higher watering requirements during the establishment should be considered. Biofiltration systems with a hydraulic conductivity greater than 600 mm/hr are unlikely to support plant growth due to poor water retention, and may also result in leaching of pollutants. However plant survival might be possible if the outlet pipe were raised to create a permanently submerged zone.

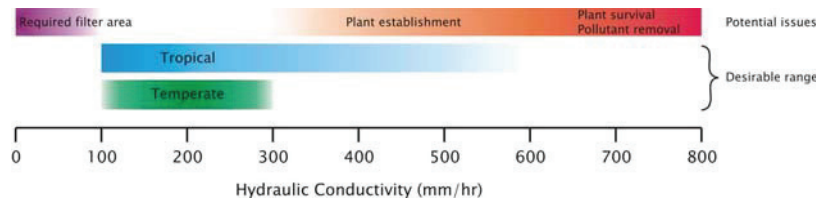
Figure 2. Recommended filter media hydraulic conductivity range and potential issues

The infiltration capacity of the biofiltration system will initially decline during the establishment phase as the filter media settles and compacts, but this will level out and then start to increase as the plant community establishes itself and the rooting depth increases (see Appendix A). In order to ensure that the system functions adequately at its eventual (minimum) hydraulic conductivity, a safety co-efficient of 2 should be used: i.e., **designs should be modelled using half the prescribed hydraulic conductivity**. If a system does not perform adequately with this hydraulic conductivity, then the area and/or ponding depth should be increased. It may also be desirable to report sensitivity to infiltration rate, rather than simply having expected rate. This is important when assessing compliance of constructed systems as systems should ideally meet best practice across a range of infiltration rates.

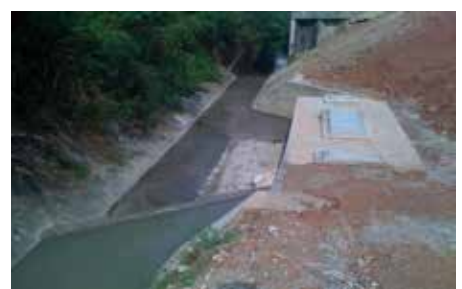
The unit is also suitable for installation off-line adjacent to large open channels or drains.

The Ecosol™ GPT is able to be custom designed specific to you application. We can vary the loading class, pit depth and accommodate varying pipe types and sizes.

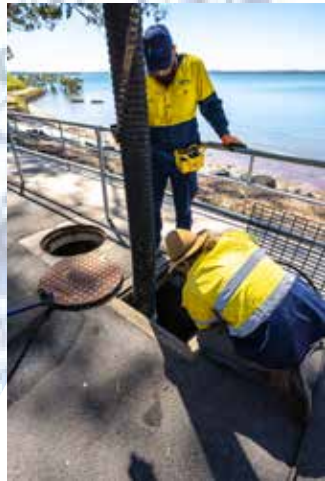
Removal of floating pollutants:

- Open surface access lids
- Lower the vacuum hose into the central capture silo chamber and position over retained floating debris
- Commence removal of floating materials, including hydrocarbons, by moving the vacuum hose over the floating material at water level
- Once all visible floating debris and hydrocarbons (free floating oils and grease) have been removed stop the vacuum

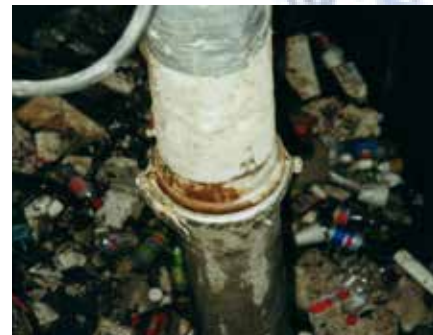
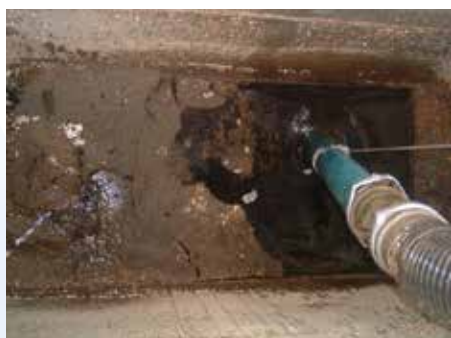
- Start the vacuum truck and position the vacuum hose over the capture silo access openings
- The vacuum truck hose operator is to wear a safety harness and must be tethered to reduce risk of falling prior to commencing with the removal of pollutants
- Lower the vacuum hose into GPT and position over pollutants
- Commence moving the vacuum hose over the material to commence removal of pollutants

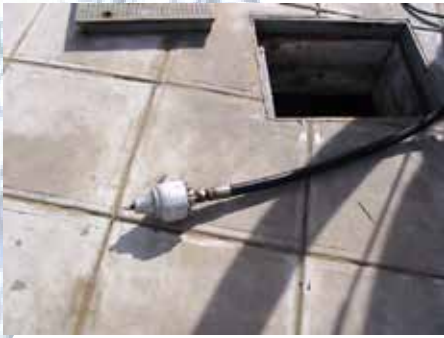
- Start the vacuum and position the vacuum hose into the bottom of the clean chamber to remove any fine sediment as it is flushed from behind the screens (again ensure the operator is wearing a safety harness and is tethered prior to commencing with the removal of pollutants)
- From the surface, hose down all of the filtration screens using a high pressure hose
- Whilst this is occurring, continue to remove sediment flushed out by vacuum hose
- On completion, remove the vacuum hose and pack up equipment

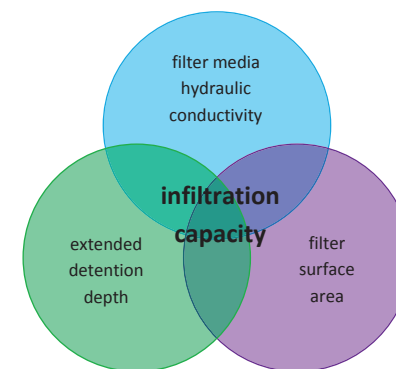
Figure 1. Design elements that influence infiltration capacity.

Where one of these design elements falls outside the recommended range, the infiltration capacity can still be maintained by offsetting another of the design elements. For example, a filter media with a lower hydraulic conductivity may be used, but the surface area or the extended detention depth would need to be increased in order to maintain the treatment capacity. Similarly, if the available land were the limiting design element, the system could still treat the same size storm if a filter media with a higher hydraulic conductivity were installed. Where a hydraulic conductivity greater than 300 mm/hr is prescribed, potential issues such as higher watering requirements during the establishment should be considered. Biofiltration systems with a hydraulic conductivity greater than 600 mm/hr are unlikely to support plant growth due to poor water retention, and may also result in leaching of pollutants. However plant survival might be possible if the outlet pipe were raised to create a permanently submerged zone.

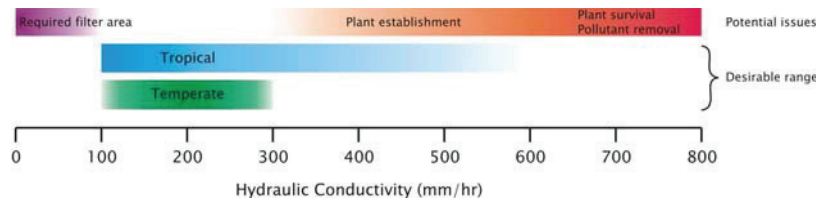
Figure 2. Recommended filter media hydraulic conductivity range and potential issues

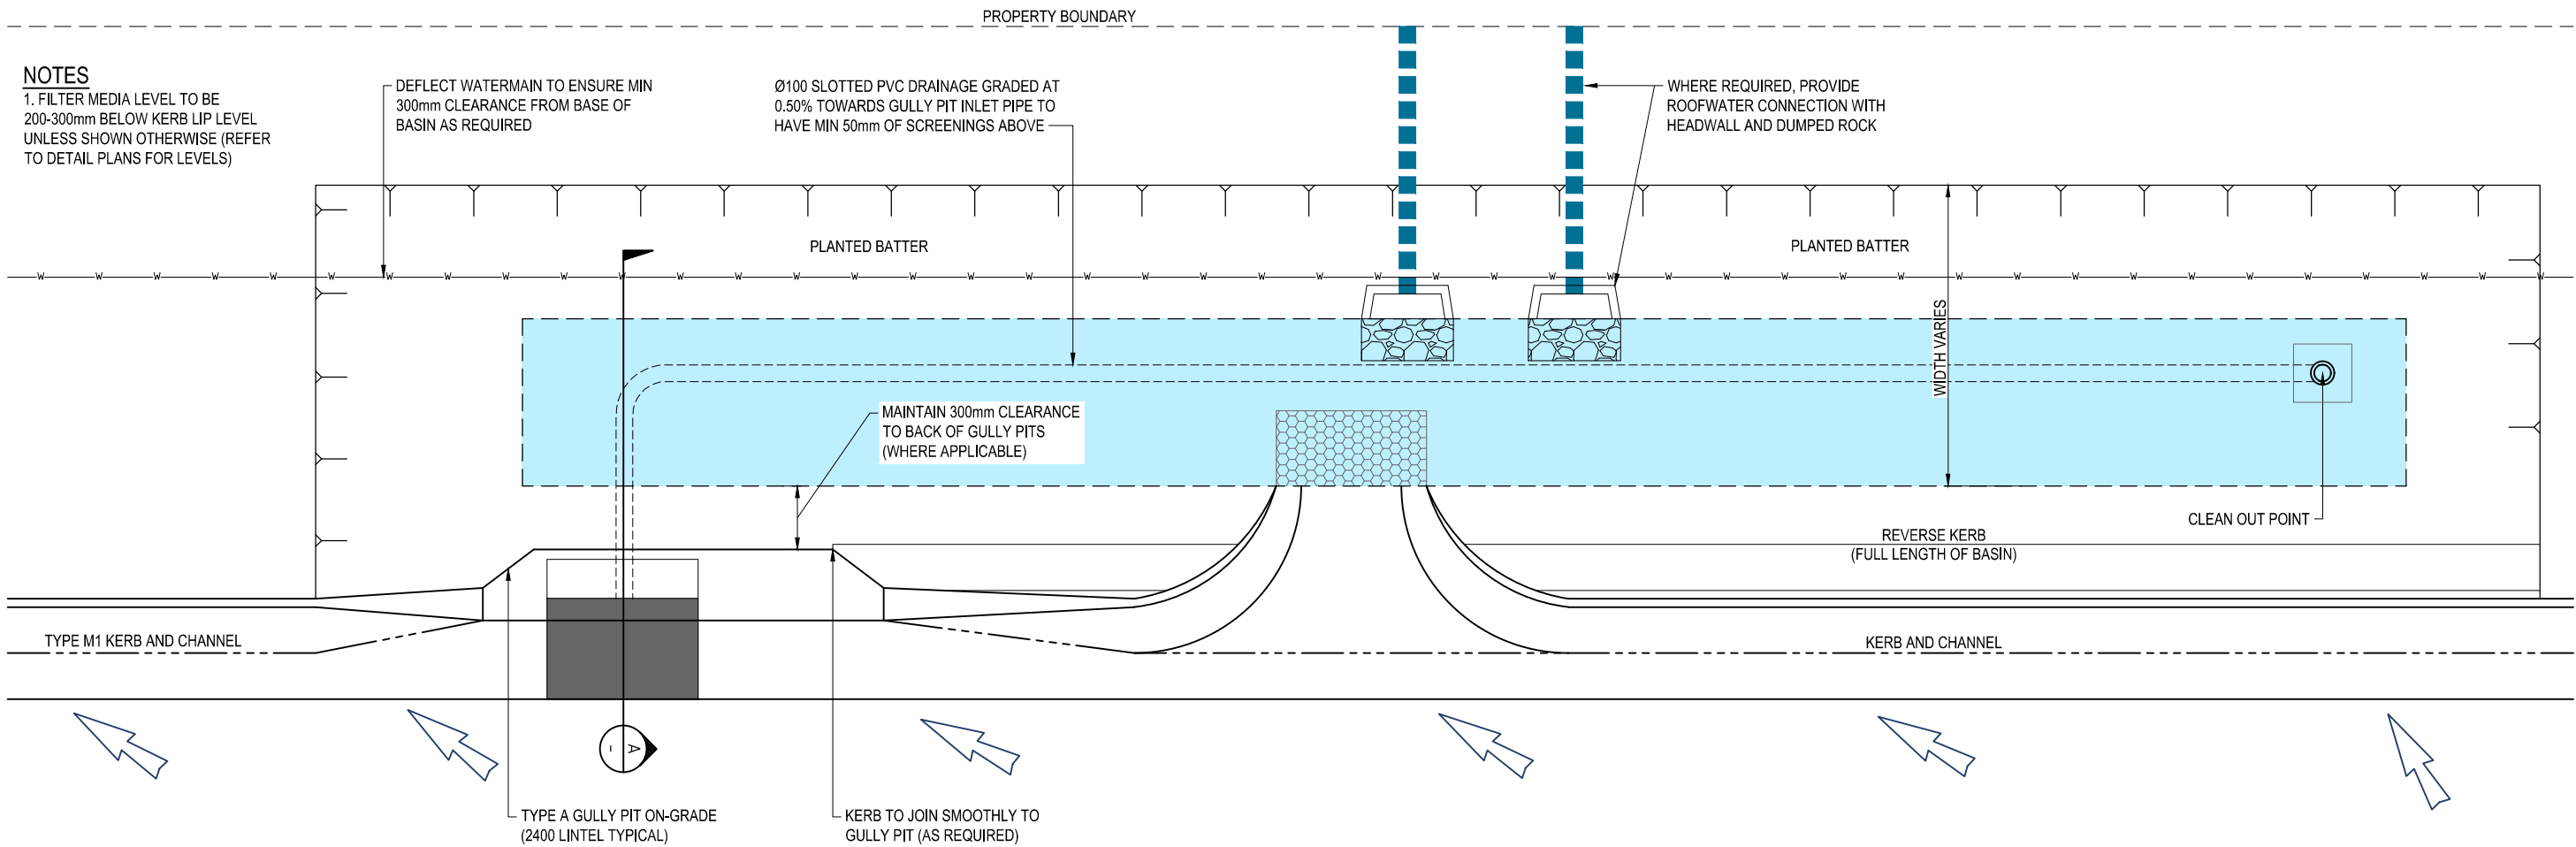
TYPICAL BIO-POD ARRANGEMENT WITH GULLY PIT  
1:20 @ A1 | 1:40 @ A3

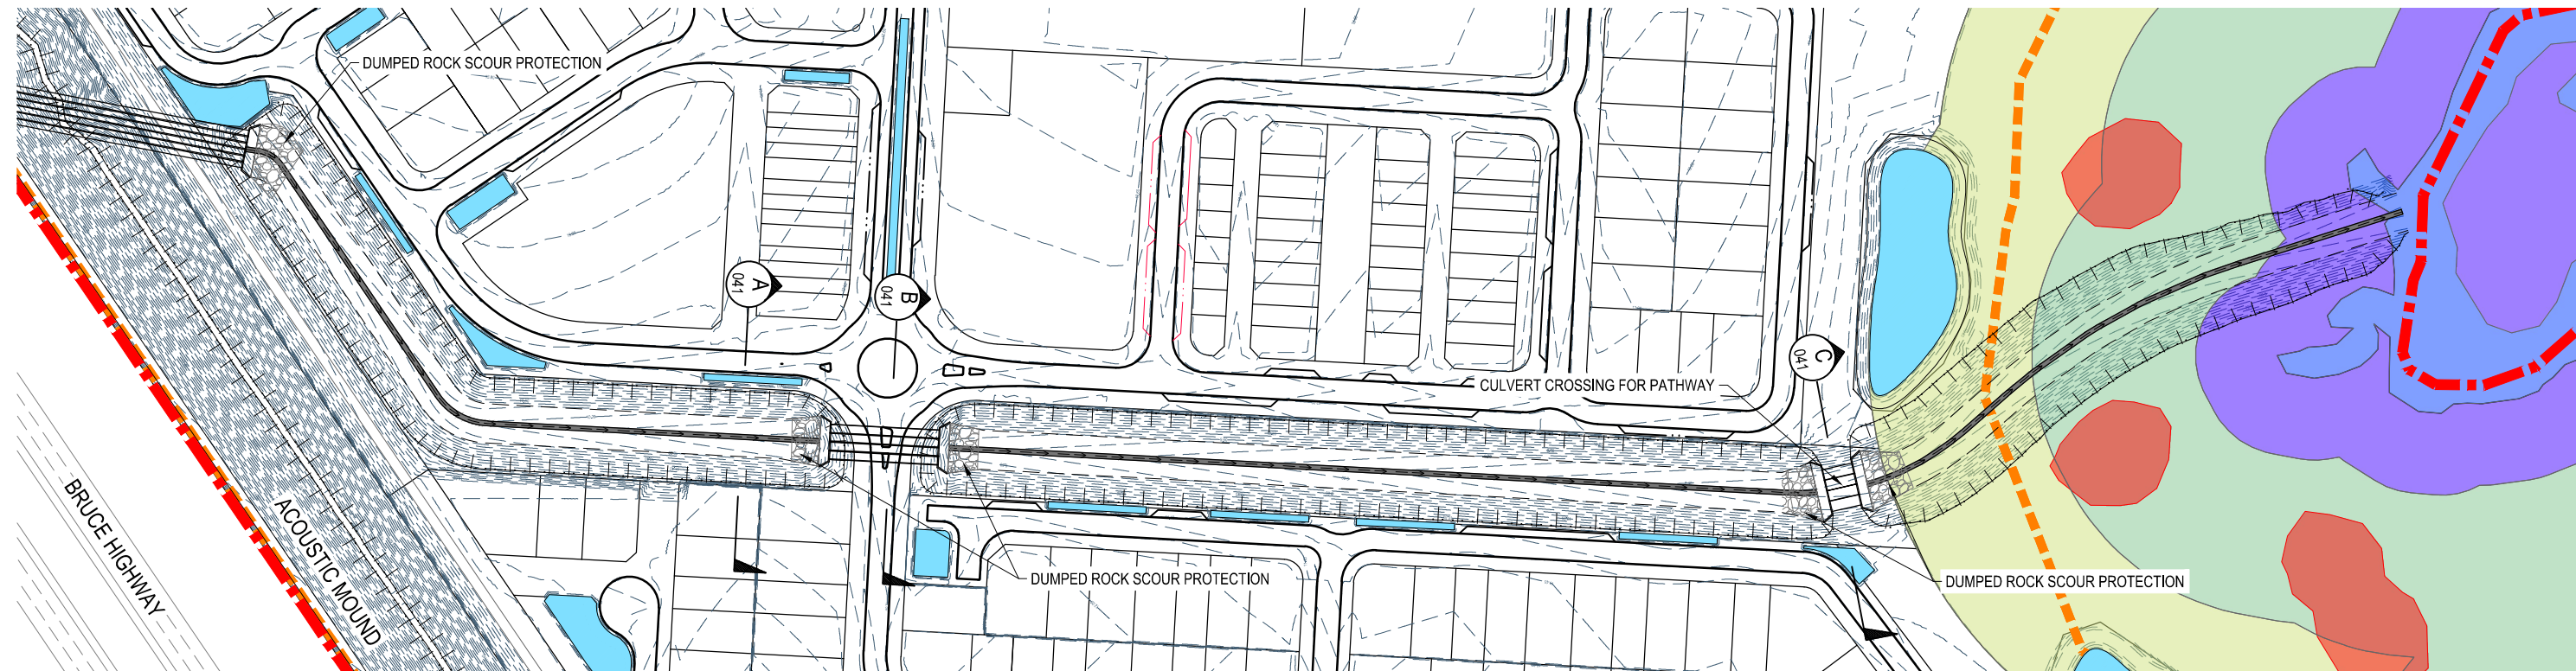
DRAINAGE SWALE LAYOUT

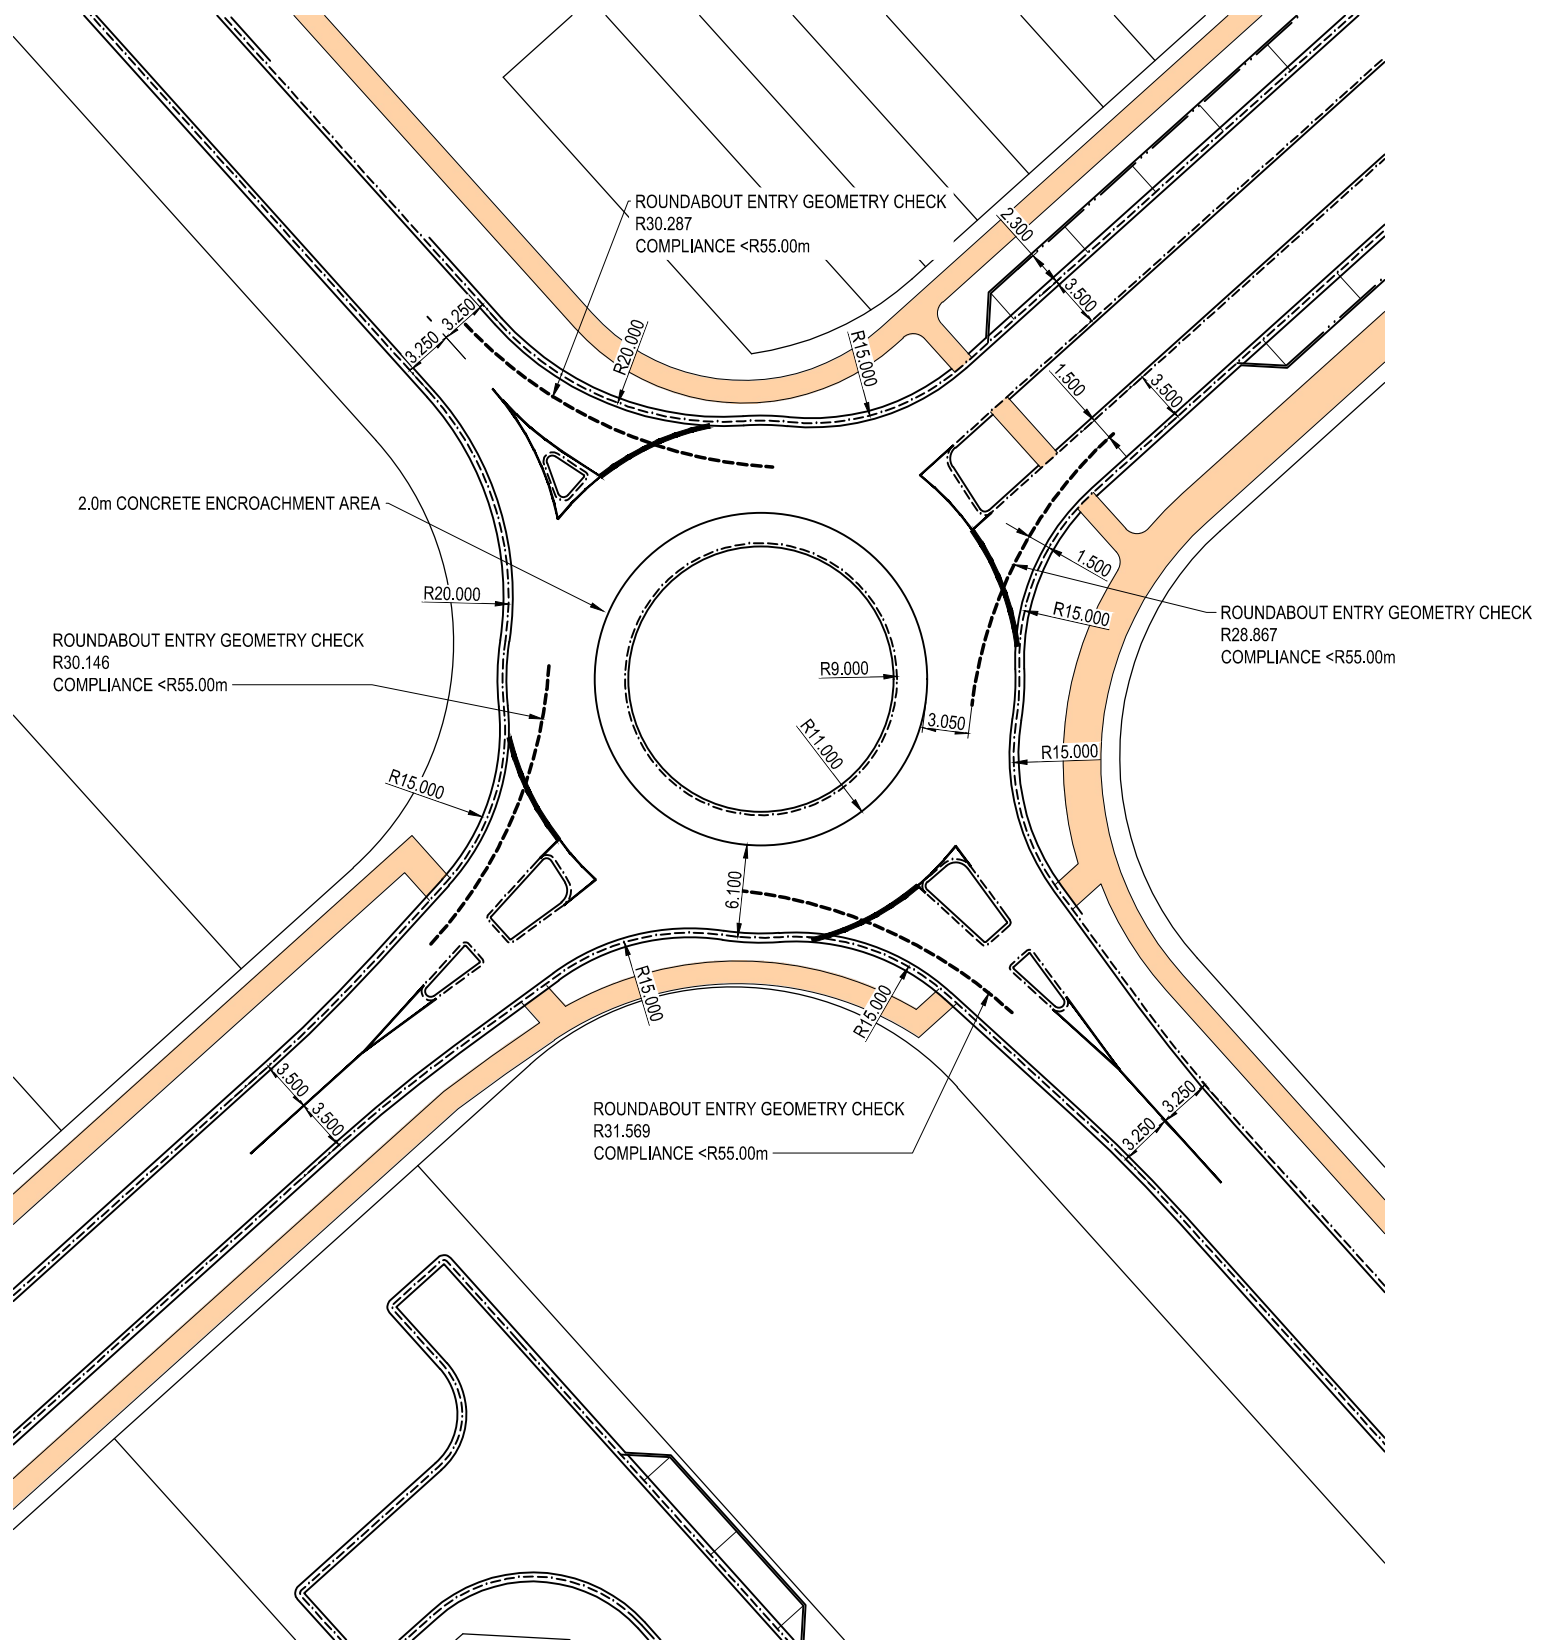
**INTERSECTION 1551 LAYOUT PLAN**  
SCALE: 1:250 (A1)  
SCALE: 1:500 (A3)

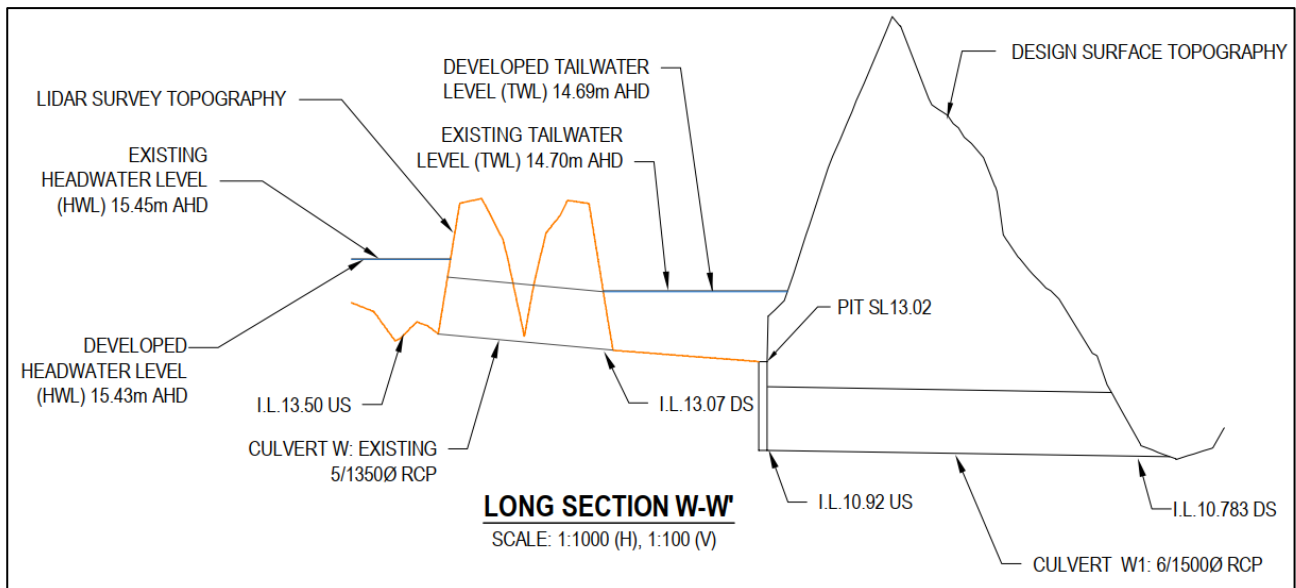
**FIGURE 4-1 CULVERT W AND W1 LONGITUDINAL SECTION**

The results of the XP-SWMM modelling for the existing and ultimate development conditions are presented on **Figure 4-1** and **Figure 4-2** below, which depict the existing (pre-development) and developed 1% AEP+CC water surface levels on longitudinal sections at TMR Culvert W and Culvert X, respectively.

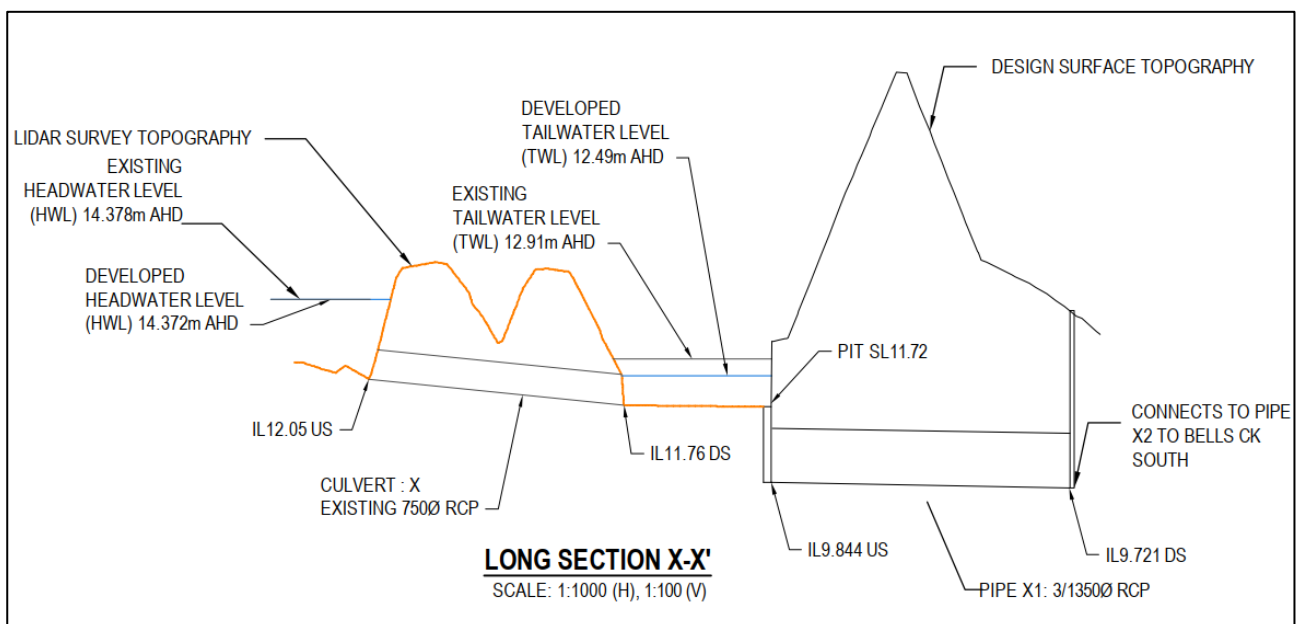
**FIGURE 4-2 CULVERT X AND PIPE X1 LONGITUDINAL SECTION**
