# Waterway Barrier Works State Code 18 Response Package

Flagstone West - Context Area 4, Flagstone,  
Queensland, 4280

Prepared for Peet Flagstone City Pty Ltd

Document: Waterway Barrier Works State code 18 Response for Flagstone West - Context Area 4, Flagstone, prepared by Saunders Havill for Peet Flagstone City Pty Ltd.

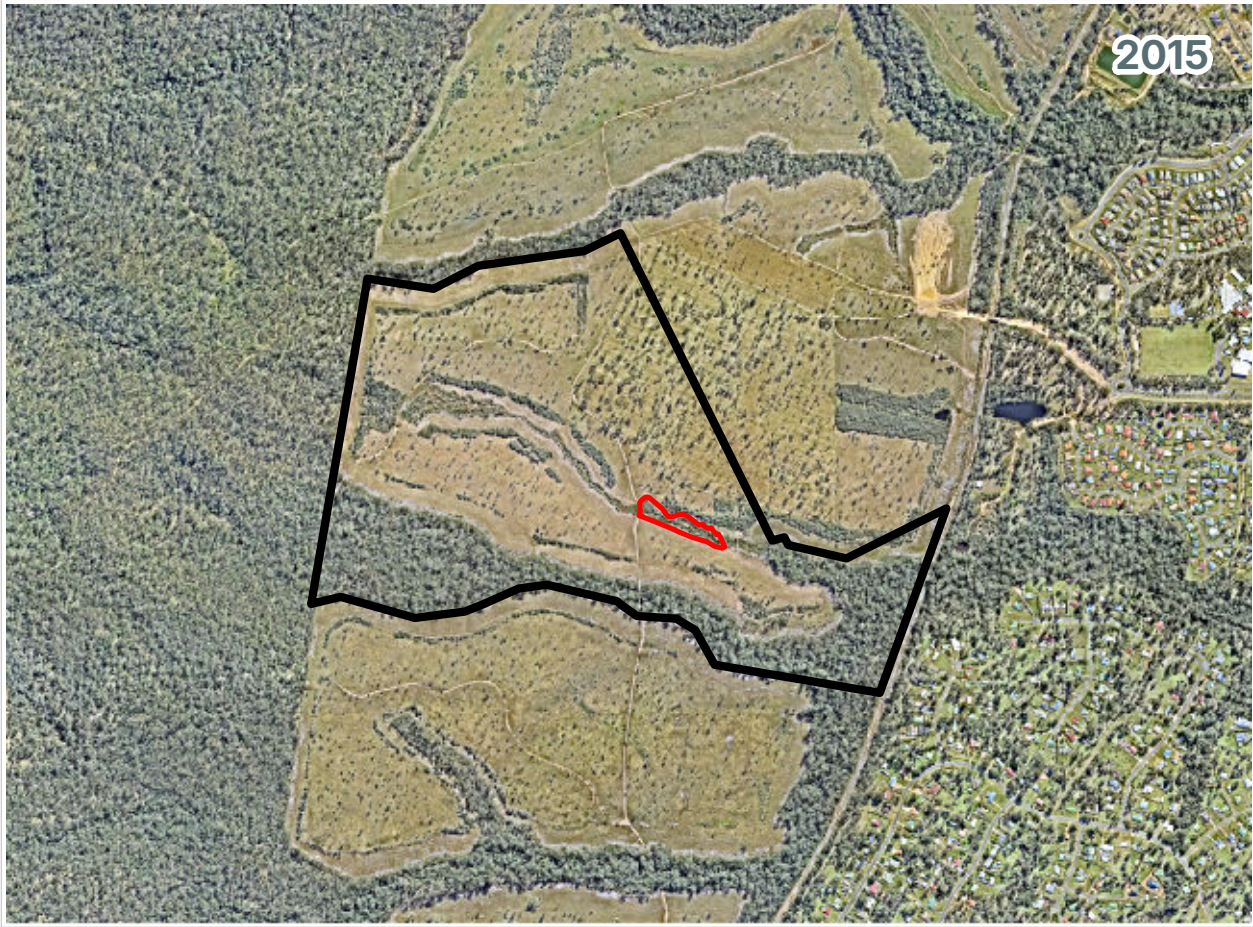
# 01. HISTORICAL AERIAL IMAGERY

In the late 1990s this vegetation is again notably disturbed, with the appearance of vehicle tracks that are still present on the site today. This includes the three (3) vertical tracks that intersect the centrally mapped waterway, and bound the western edge of the proposed impact area. As such, barriers to water flow and potential fish movement have been present and likely degrading the waterway channel and general condition for approximately thirty (30) years. The adjoining lots east of the railway line also experienced notable clearing and urbanisation through the 1990s for residential and rural development, reducing connectivity and potential habitat for fauna. The southern-most paddock lot associated with the Flagstone West area is also seen to be cleared up to and adjoining the waterway by this time.

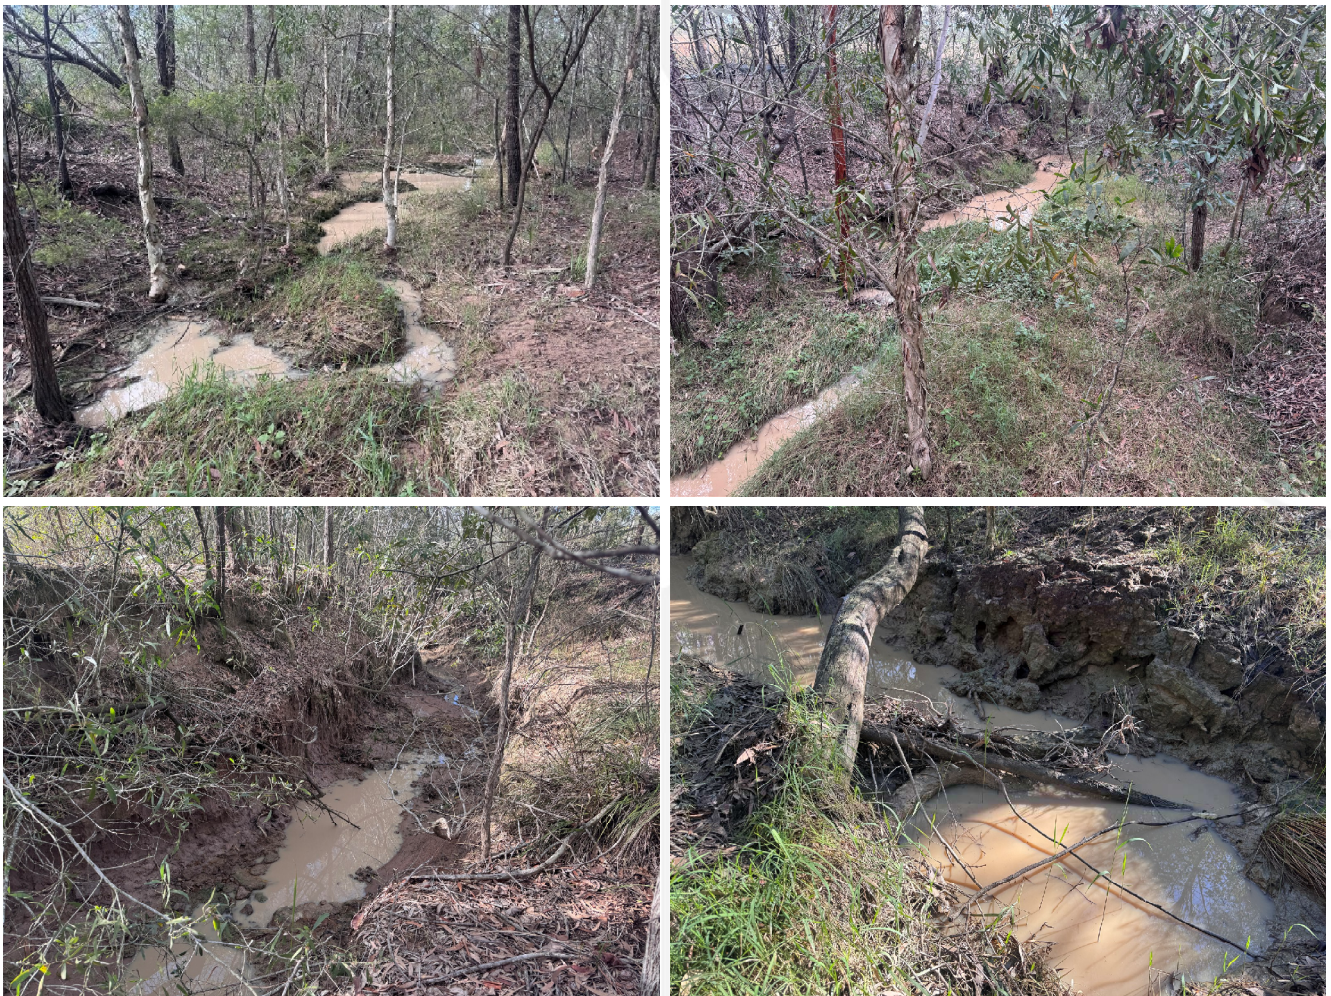
On-ground, the feature exists slightly more north of the mapped line. Generally, the waterway is highly disturbed, with a moderate-high level of erosion and scouring (refer **Photo set 1**). Banks, though discontinuous, were observed along most of the channel, with deep erosion in some sections resulting in upper banks  $\geq 4$  m. The channel substrate comprises a mixture of rocks, soil, and grass. Surveys confirmed there is no culvert to connect the waterway upstream across the intersecting road. Water was present during field survey as pooled water and low, narrow flow through the channel. Pooled water typically has a high level of turbidity despite some observed past attempts at sediment control, including rocks, geo-fabric, and degraded fencing (refer **Photo set 2**). At multiple points the low flow transitions into overland flow across grass between narrow, eroded channels (refer **Photo set 3**). Habitat features are

Photo set 1: General characteristics of mapped waterway impact area.

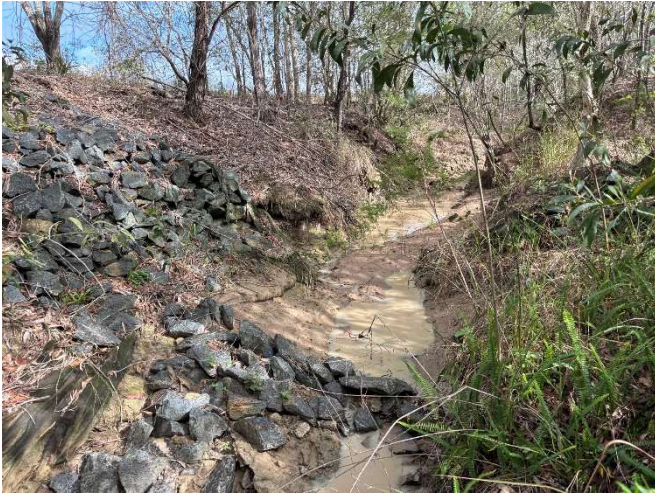
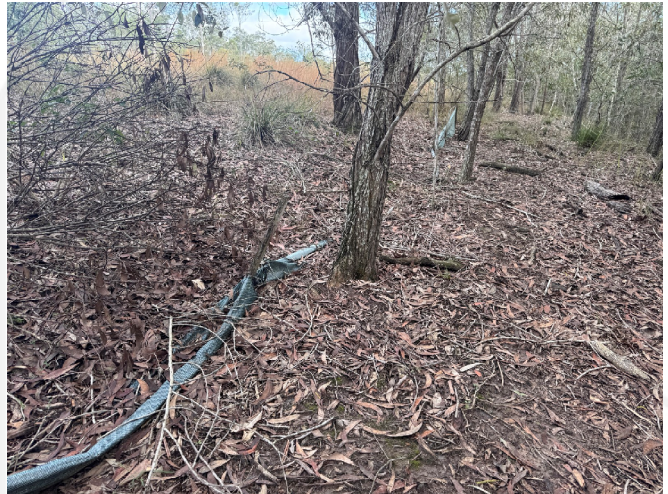
*Photo set 2: Evidence of old sediment control techniques along mapped waterway impact area (Right - rocks and geofabric; Left - old sediment fencing).*

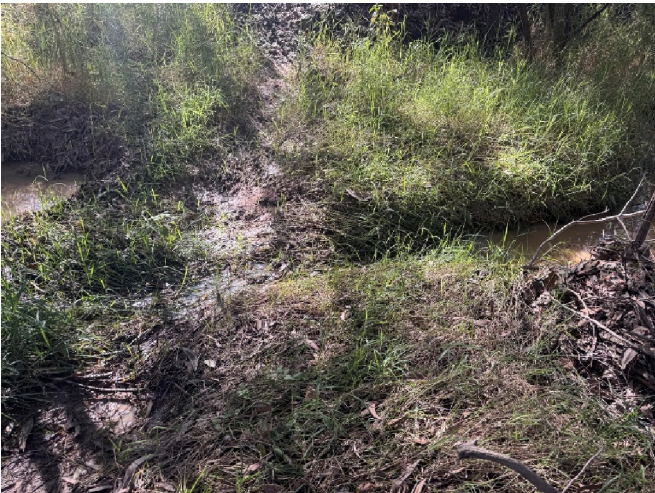
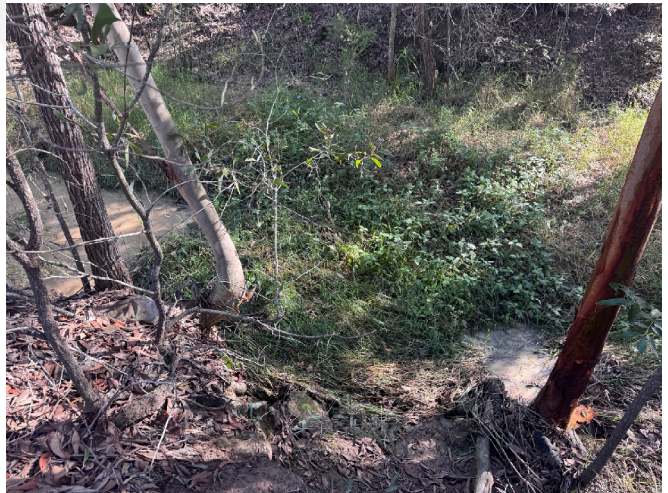
*Photo set 3: Overland flow across grassed sections of the mapped waterway impact area.*

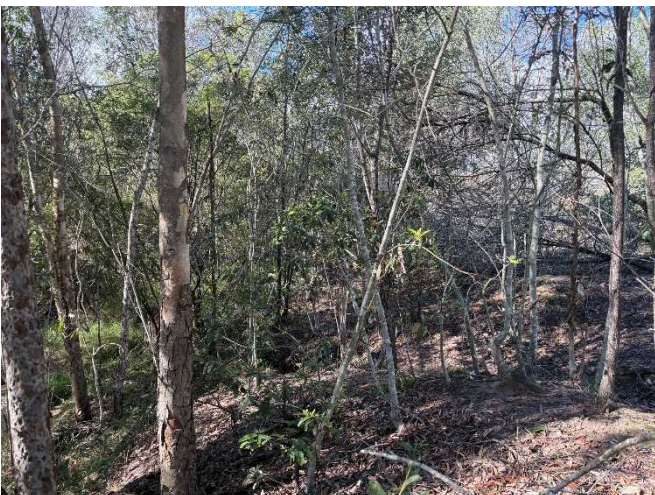
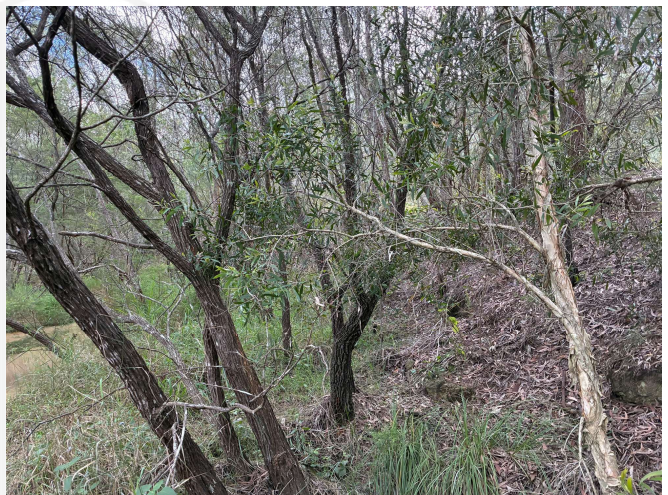
Adjoining vegetation is similarly disturbed. No macrophyte or riparian vegetation is present, though vegetation is generally water-tolerant, indicating flow is ephemeral. Vegetation is generally dominated by regrowth *Melaleuca quinquenervia* (Broad-leaved Paperbark), *Corymbia citriodora* (Spotted Gum), and *Lophostemon suaveolens* (Swamp Box), with *Acacia* and *Casuarina* spp. through the understory (refer **Photo set 4**). There is a moderate coverage of non-native species such as *Conyza sumatrensis* (Tall Fleabane), *Passiflora suberosa* (Corky Passion Vine), and *Lantana camara* (Lantana).

*Photo set 4: Vegetation adjoining the mapped waterway impact area.*

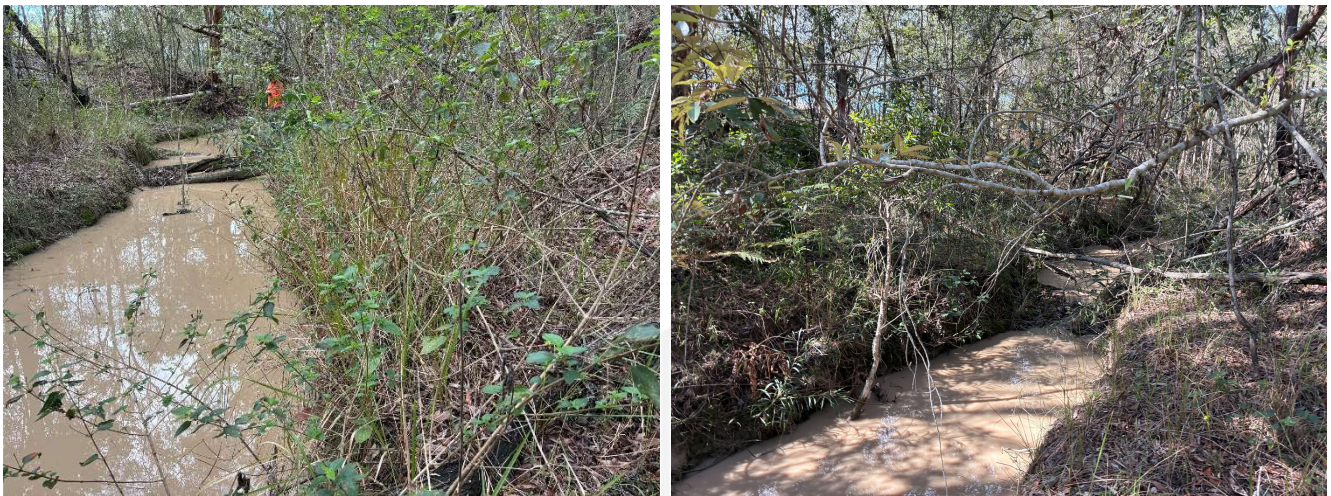
East of the proposed impact area the mapped *low-risk* (green) WWBW continues in a similar condition as within the impact area, with pooling and low flow water with moderate weed infestation and areas of high erosion (refer **Photo set 5**). A cleared easement runs vertically through the mapped waterway, and east of this cleared area is a higher abundance of sediment deposit, despite similar sediment control techniques implemented (refer **Photo set 6**) noting heavy preceding rains. Vegetation becomes denser along the eastern boundary of CA4. Weed infestations also become more prevalent, with notable patches of *Solanum mauritianum* (Wild Tobacco), *Thunbergia alata* (Black-eyed Susan), and *Lantana camara* (Lantana). In the centre of the eastern CA4 boundary vegetation the *low-risk* (green) waterway joins the southern mapped *high-risk* (red) WWBW and continues east off the property.

**Photo set 5:** General condition of the eastern portion of the mapped *low-risk* WWBW, east of the impact area.

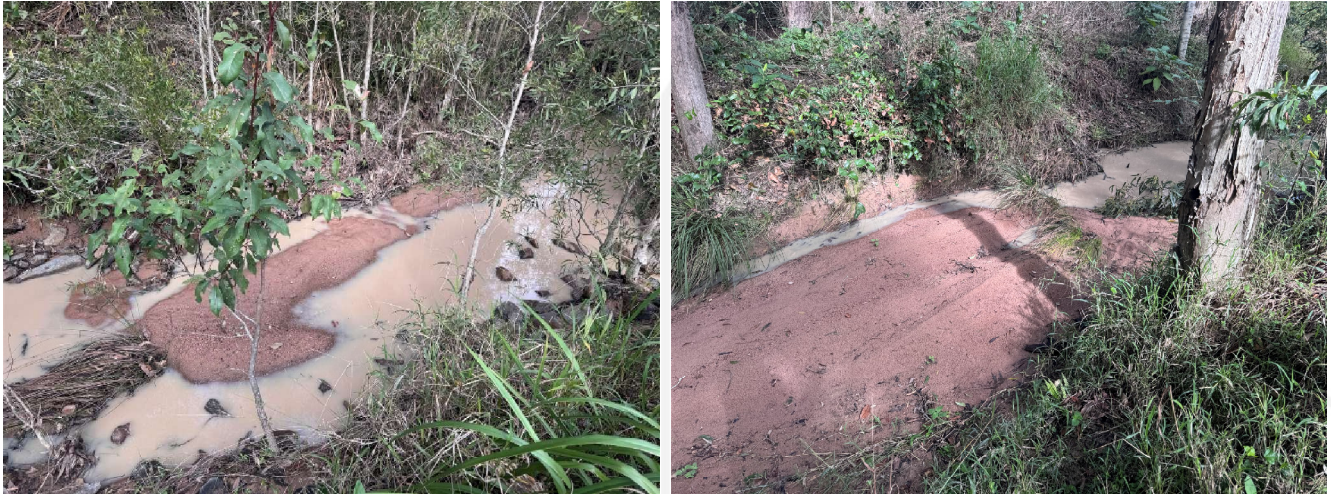
*Photo set 6: Sediment deposits present along the mapped WWW within the eastern CA4 boundary vegetation.*

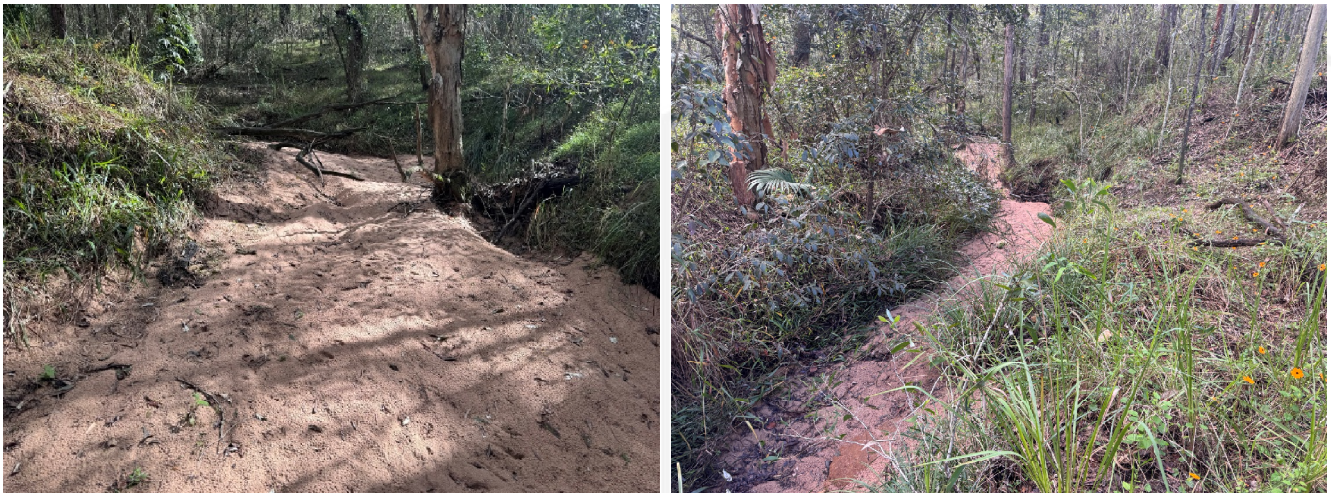
The southern mapped *high-risk* (red) WWBW is mapped vertically through the eastern CA4 boundary vegetation. It appears to be ephemeral, with very little water present at the time of survey, and similarly as disturbed as the *low-risk* WWBW (refer **Photo set 7**). However, for much of this mapping the bed and banks are clearly defined, and the channel is on average wider than the *low-risk* mapped waterway. Field surveys noted only isolated pools of water. *Lanata camara* (Lantana) infestation is most severe in the southern extent of this waterway (refer **Photo set 8**). In the south-eastern portion of the CA4 area this waterway transitions into two *moderate-risk* (amber) waterways that runs south beyond the CA4 area and west through the CA4 area, in parallel with the *low-risk* (green) waterway.

*Photo set 7: General condition of the mapped high-risk WWBW south-east of the impact area.*

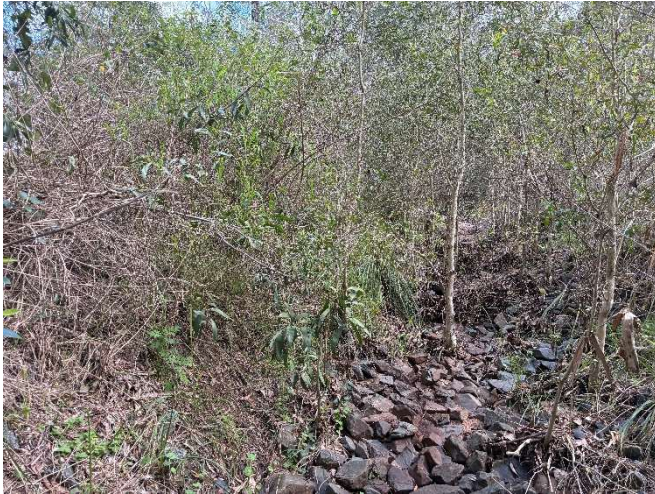
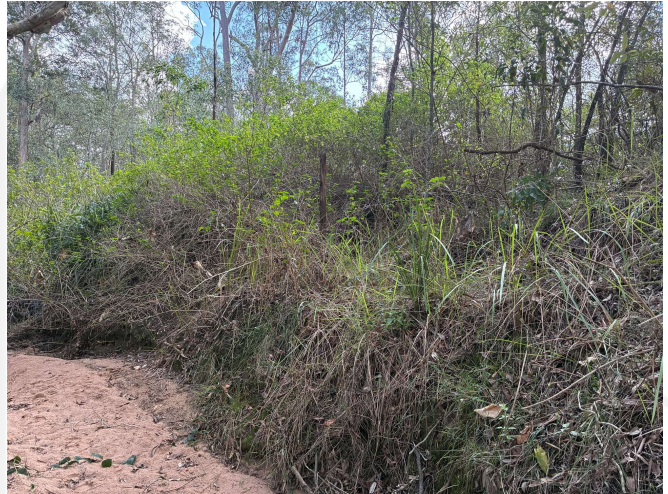
**Photo set 8:** Heavy infestation of *Lantana camara* in the south-east of CA4, along the high-risk WWBW.

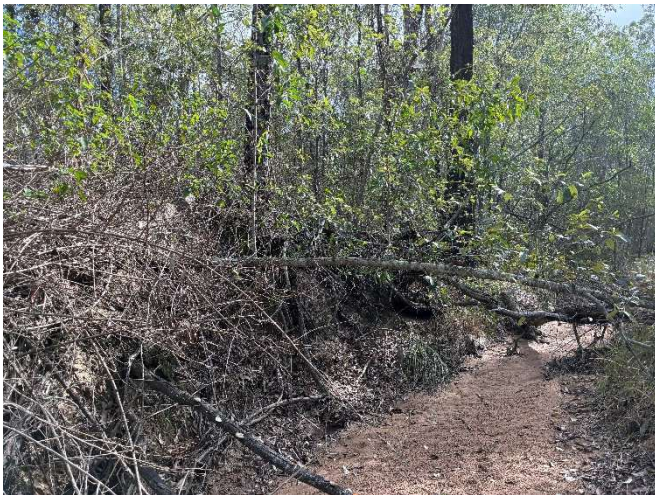
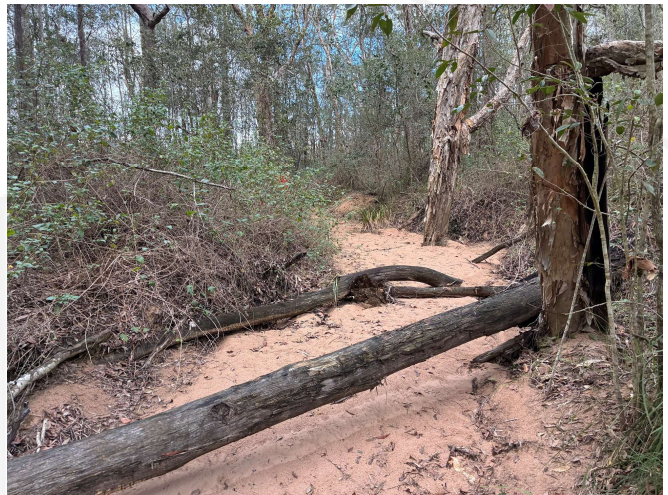
This mapped waterway runs west-east through CA4, approximately 165 m south of the impact area. It is generally highly disturbed and comprises an eroded drainage channel (refer **Photo set 9**). This waterway is disturbed by heavy weed infestations, namely *Lantana camara* (Lantana) along the banks. Erosion is highest through the centre of this mapping, with sediment deposits also noted near the intersecting vehicle track (refer **Photo set 10**). The pre-lodgement SARA advice determined that the upper limit point to this waterway occurs just as it splits into two *low-risk* (green) WWBW that fork west through CA4. Field surveys assessed these flow paths for rehabilitation potential.

**Photo set 9:** General condition of the mapped moderate-risk WWBW south of the impact area.

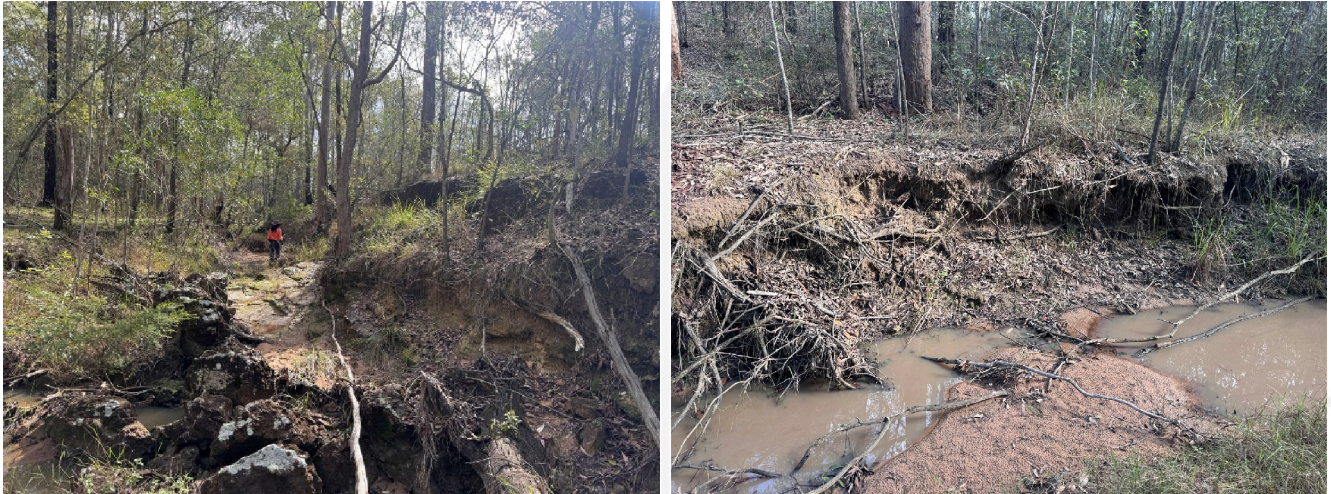
Photo set 10: Erosion present along the mapped moderate-risk WWBW south of the impact area.

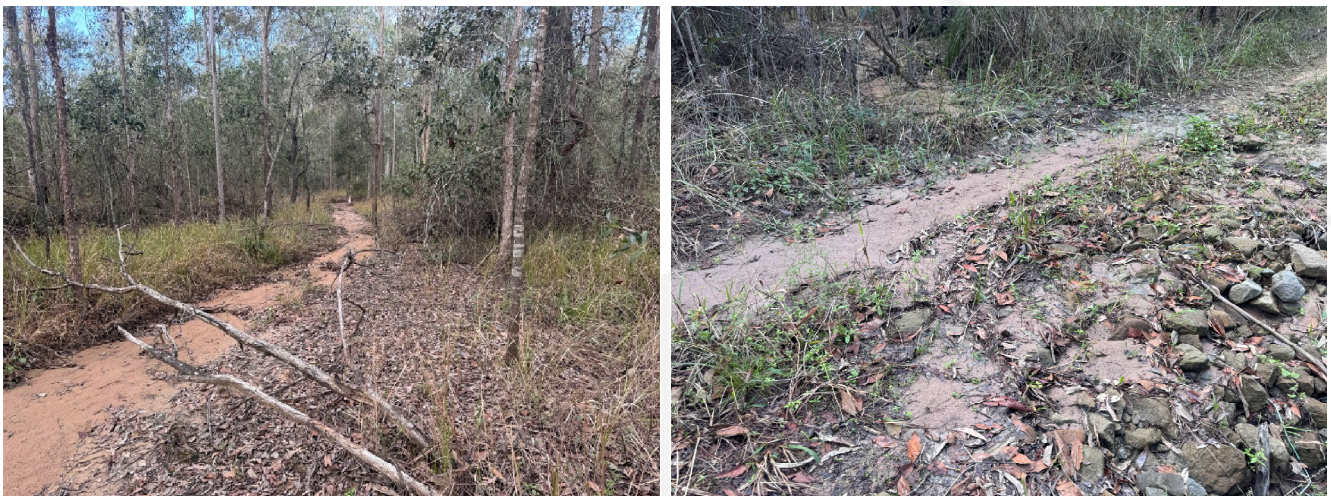
These waterways were confirmed to have some of the lowest values of the waterways assessed. Bed and bank features are discontinuous and often not present. The channel is relatively small, often less than 1 m wide. Water was present only as very isolated standing pools. Where banks are present there is a high level of erosion, with sediment and woody debris deposits and tall unstable banks. Weed infestation also remains high, dominated by *Lantana camara* (Lantana) along the banks.

Photo set 11: General condition of the mapped low-risk WWBWs south of the impact area.

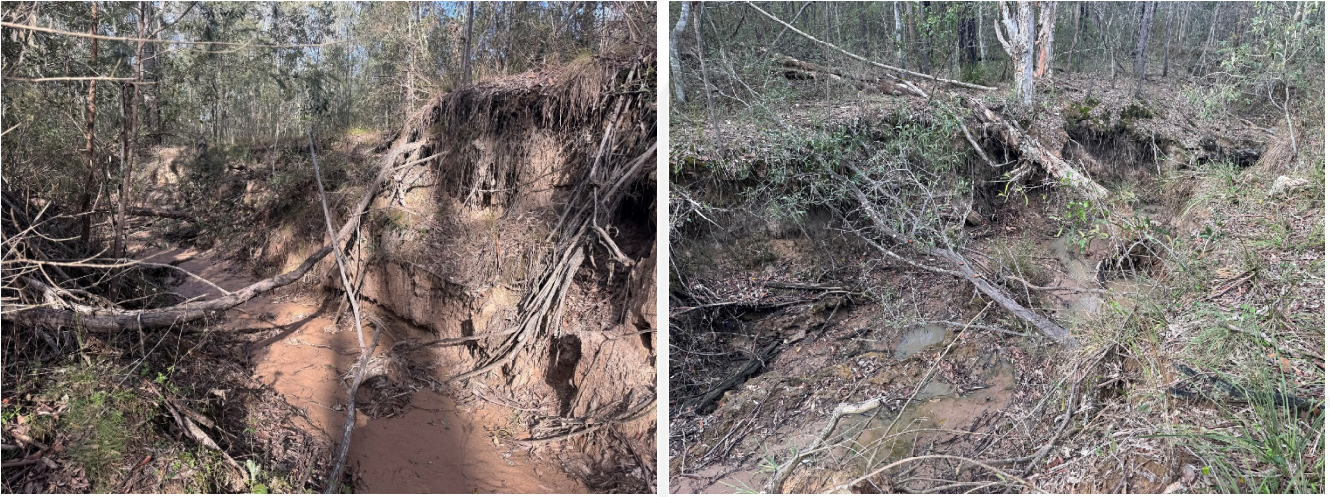
*Photo set 12: Erosion present along the mapped low-risk WWBWs south of the impact area.*
