**RE: CONTAMINATED SOIL INVESTIGATION, REMEDIATION AND VALIDATION  
HIGH RISE DEVELOPMENT  
19 HERCULES STREET, HAMILTON**

**STAGE 1 & 2 ENVIRONMENTAL SITE  
ASSESSMENT  
PROPOSED EXTENSION OF PORTSIDE WHARF  
19 HERCULES STREET  
HAMILTON**

**Prepared for**  
Multiplex Developments Australia Pty Ltd

Project No. 03900F  
October 2006

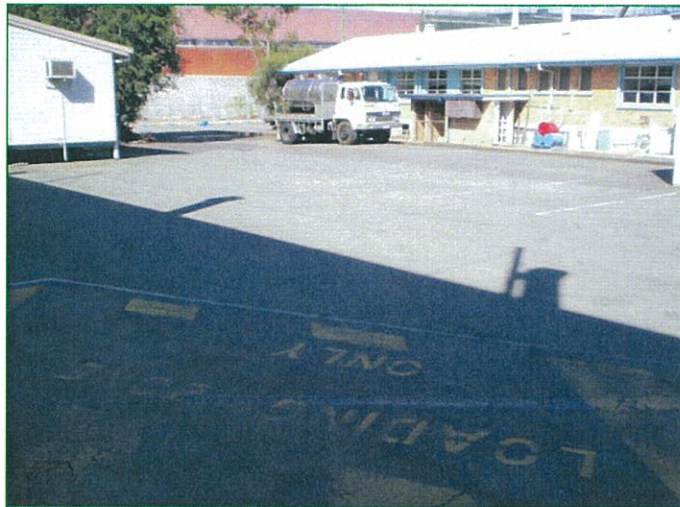
Photograph 2: View looking southeast from the centre of the site

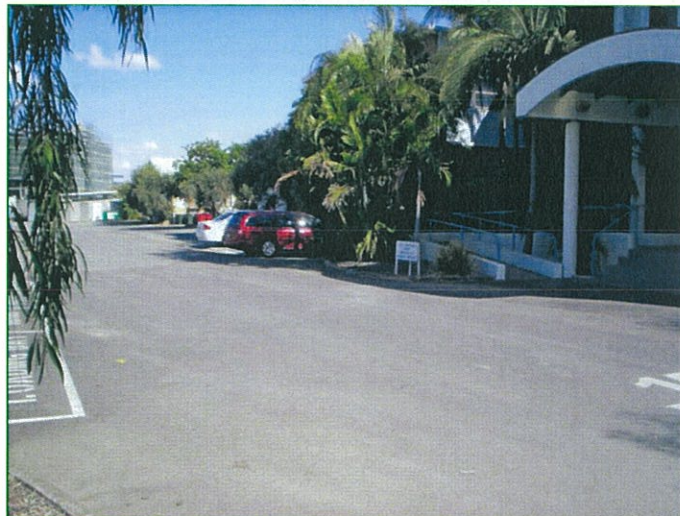
Photograph 3: View looking south from the northeast corner of the site

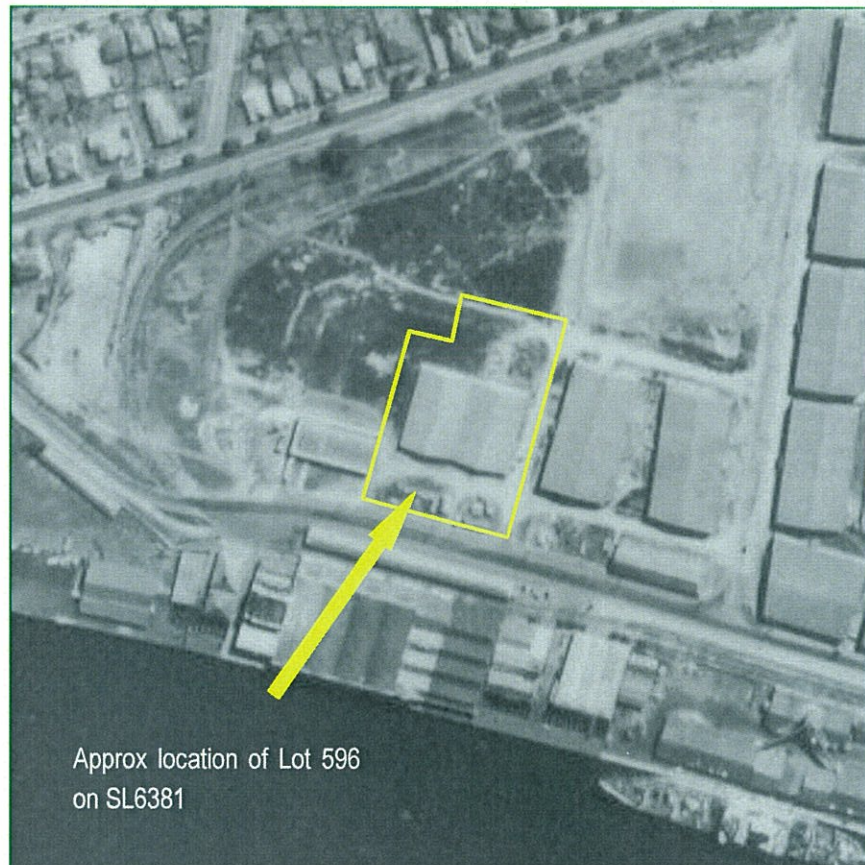
1951 – The site is occupied by two adjacent buildings located centrally within the site and a number of small buildings within the southern portion of the site; an unsealed road traverses the eastern boundary; and the northern portion of the site is vacant land. Two large warehouses are located east of the site. A building is also located near the southeast corner of the site on the adjacent lot and the Hamilton Wharf Cold Stores are located to the south fronting the Brisbane River. An extract of the 1951 aerial photograph is provided in Photograph 4.

Photograph 4: Extract from 1951 Aerial Photograph

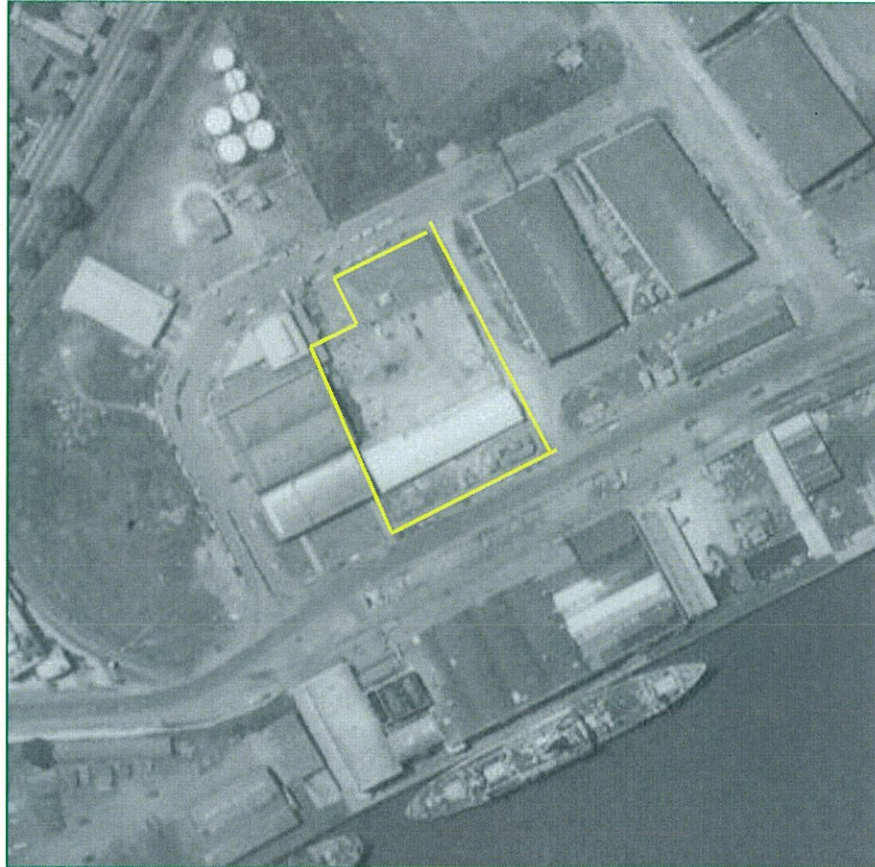
1960 – The buildings that occupied the site in 1951 have been replaced by a single rectangular building located along the southern boundary with the remainder of the site being vacant. The majority of the site is vacant. A number of buildings have been constructed on the lot west of the site and a sealed road (Hercules Street) fronts the northern site boundary. An extract of the 1960 aerial photograph is provided in Photograph 5.

Photograph 5: Extract from 1960 Aerial Photograph

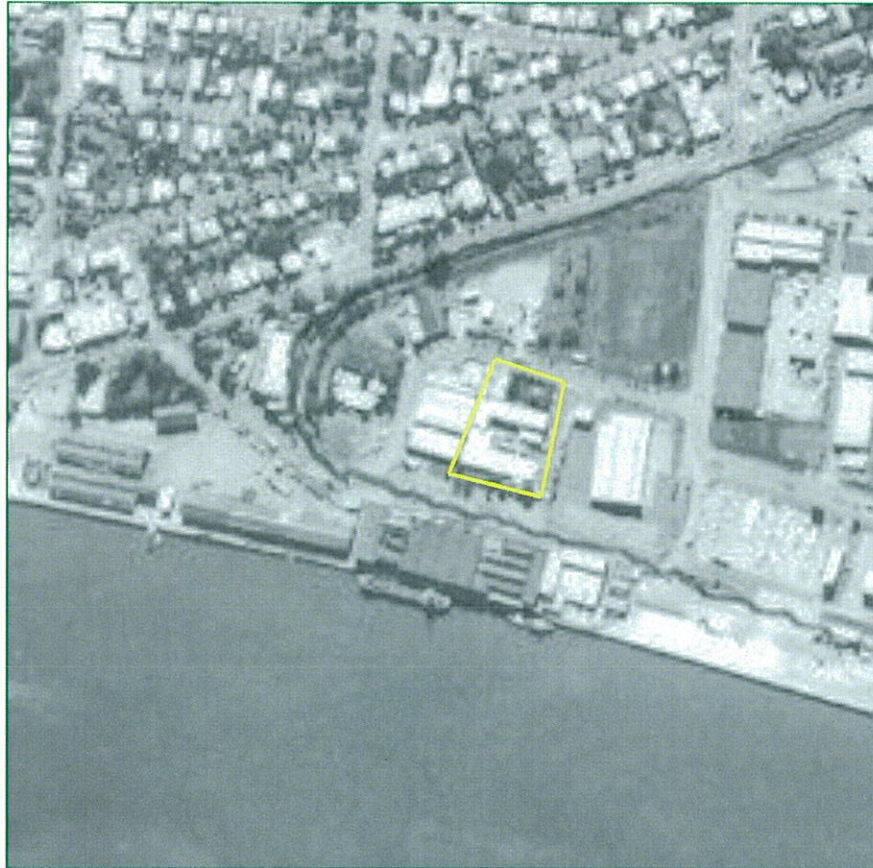
1991 – Similar to the photograph taken in 1981, although additional small buildings have been constructed in the former car park between the two existing buildings. An extract of the 1991 aerial photograph is provided in Photograph 7.

Photograph 7: Extract from 1991 Aerial Photograph

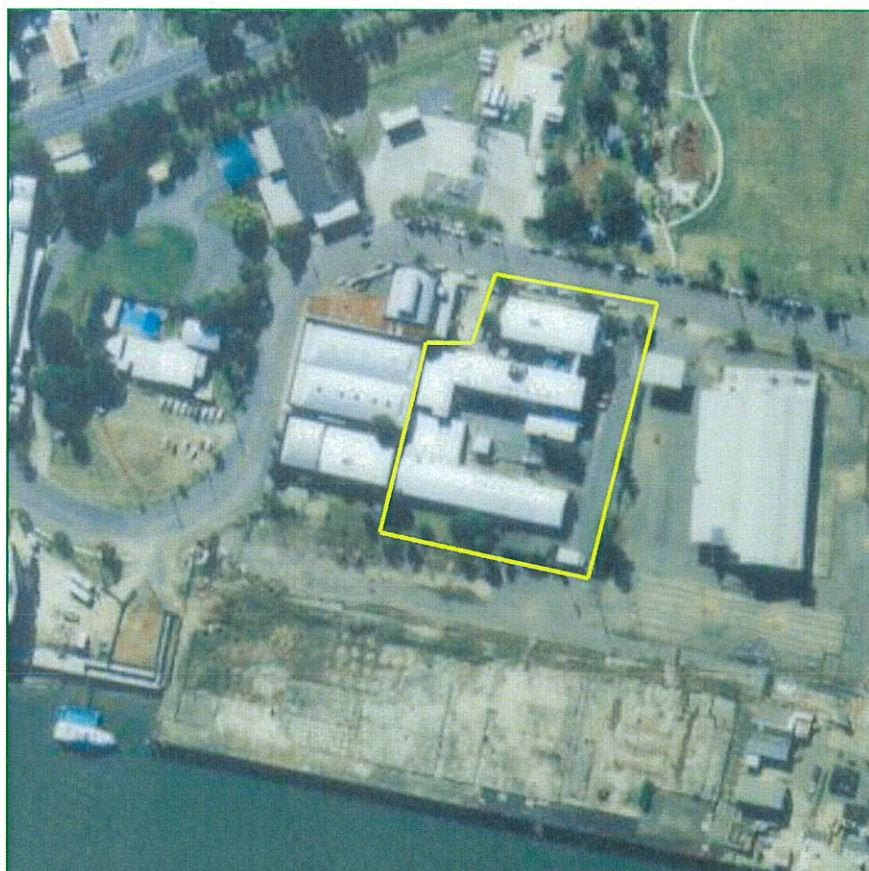
2004 – Similar to the photograph taken in 1991, except a third building now occupies the vacant land in the northern portion of the site fronting Hercules Street. An extract of the 2004 aerial photograph is provided in Photograph 8.

Photograph 8: Extract from 2004 Aerial Photograph
