# YARRABILBA PRECINCT 3

## WATERWAY STABILITY ASSESSMENT

DesignFlow & Hydrobiology  
Prepared for Lend Lease  
July 2016

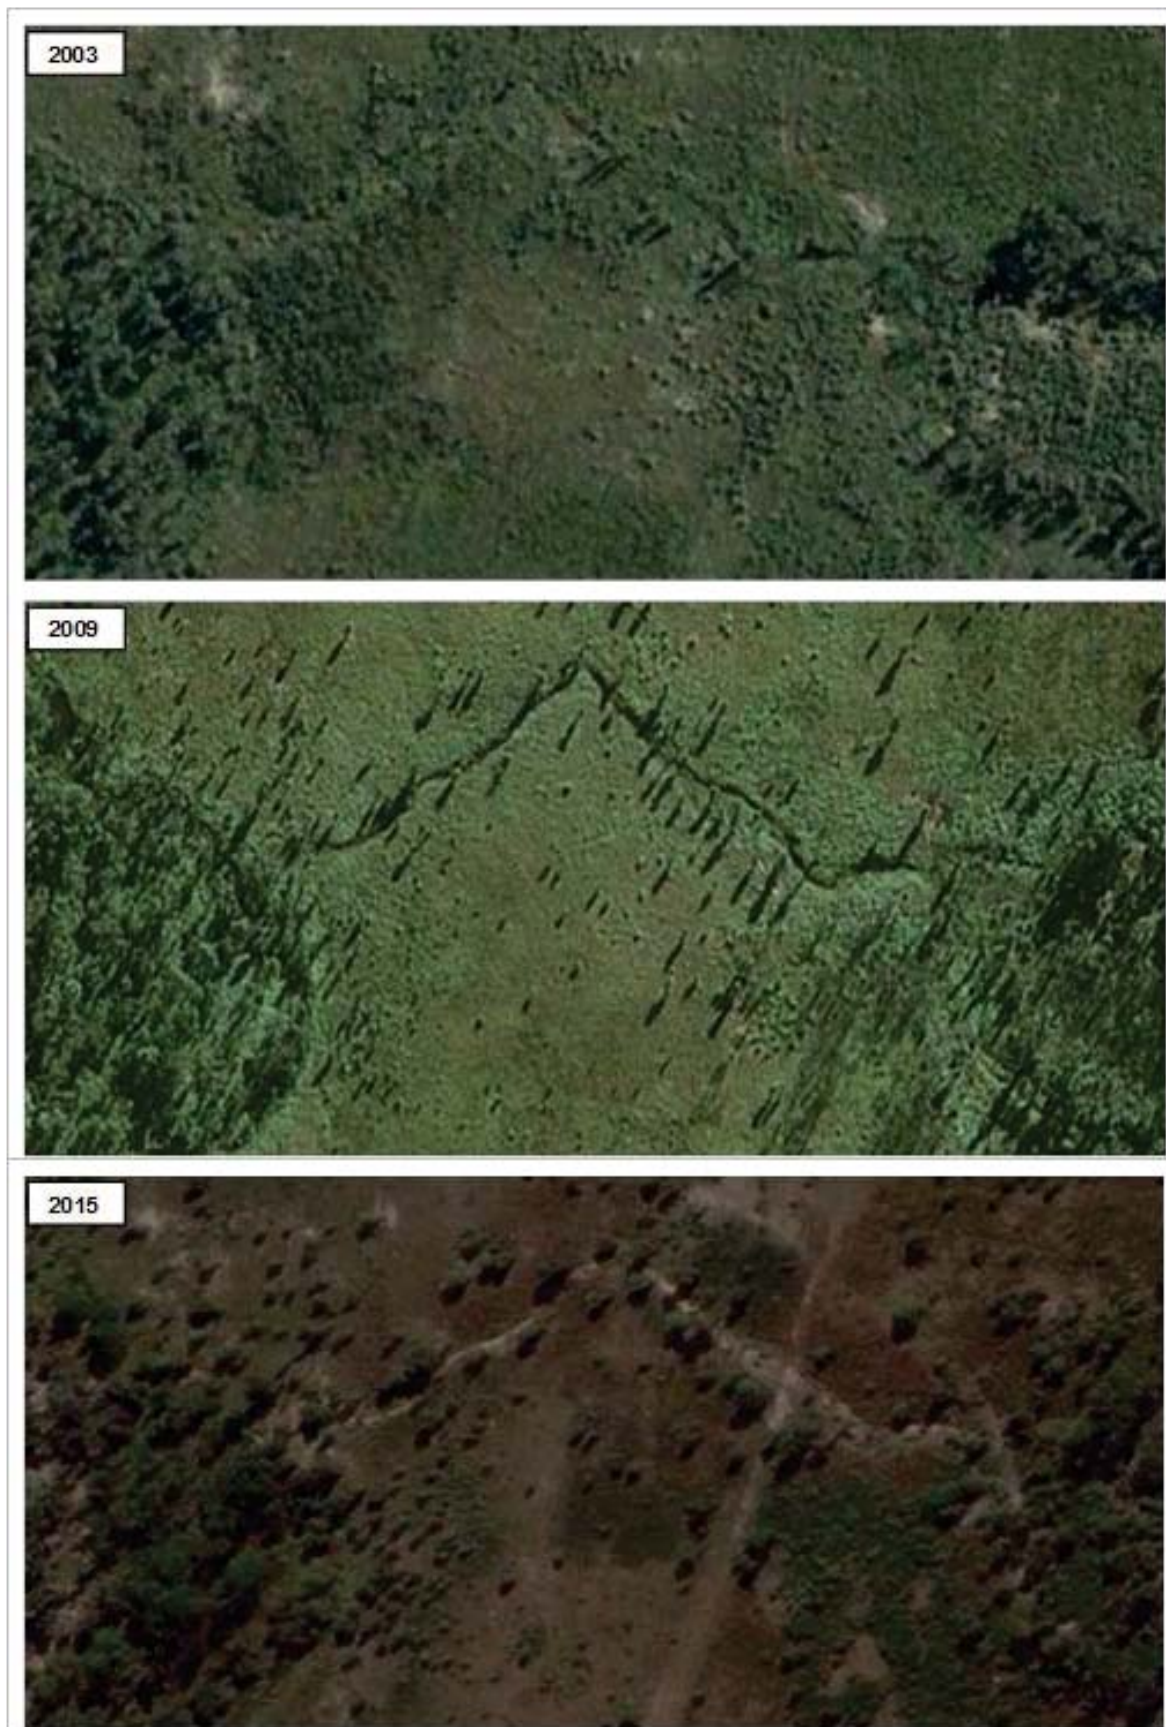
Any historical changes along the lengths of the waterways were masked by dense vegetation along the channel margins. As such, little could be deduced about their long-term stability. One section of Stream 5 downstream of its confluence with Stream 4 was visible in multiple images with different acquisition dates (2003, 2009, 2015). These are shown in Figure 11. They show a small meandering stream across an unconfined landscape. It is also evident from the sequence of photographs that the channel has been in a phase of degradation/deepening (2003-2009) and combined degradation/deepening and widening (2009-2015), suggesting that there has been upstream migration of incision, since 2003 at least. The channel appears to have incised into an 'outwash' zone at the base of the Stream 5 valley. Lidar analysis and field assessments support the incision theory, with multiple head cuts and over-steepened sections observed. These are discussed further in ensuing sections.

Figure 11 Historical aerial imagery Stream 5 (source: Google Earth)

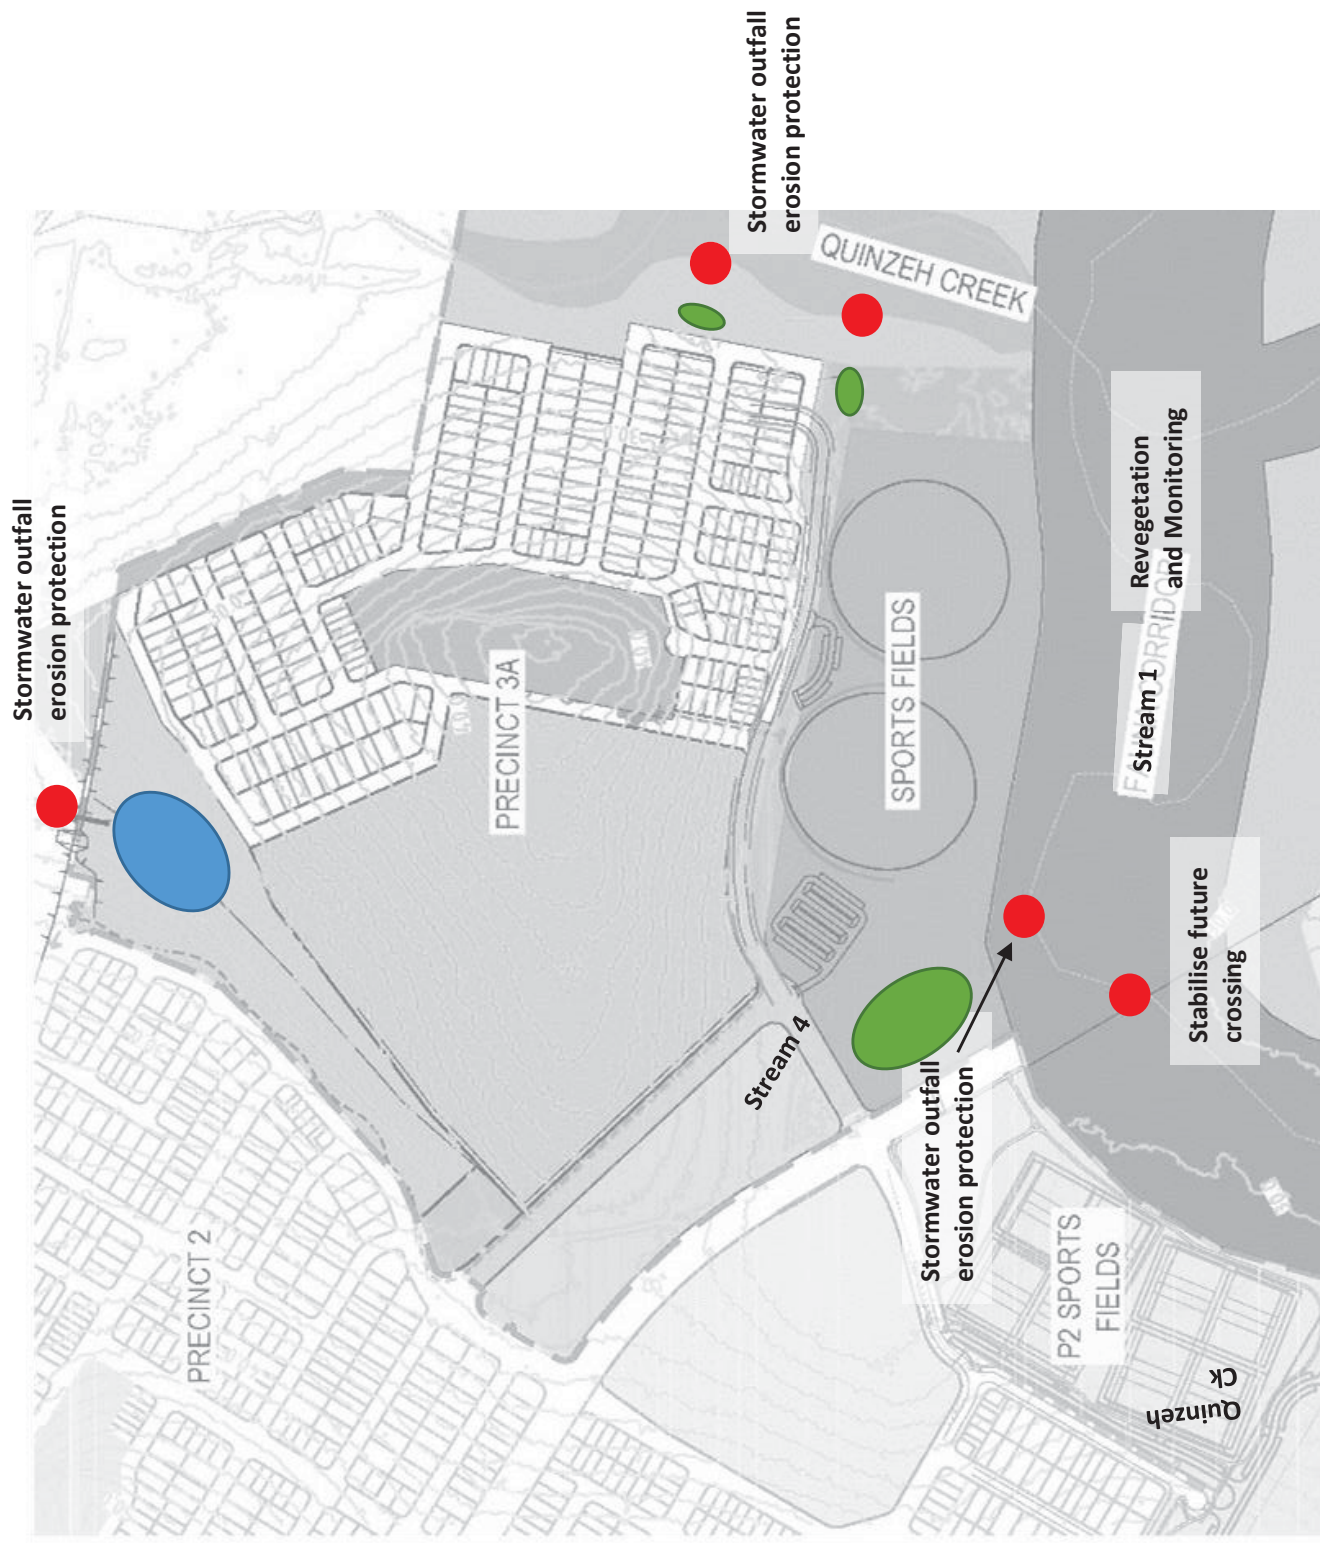
Figure 18 illustrates the waterway stability measures applicable to Precinct 3A development which include:

- Management of drainage outfalls to Quinzeh Creek from the stormwater management systems (wetland and bioretention systems)
- Provide scour protection and bank stabilisation at culvert crossing
- Revegetation in accordance with *Yarrabilba Development: Natural Environment Site Strategy* (Natura Consulting, 2012)
- Monitor Quinzeh Creek channel stability as the development proceeds and respond to instability where required.

Figure 18: Precinct 3A watershed stability measures

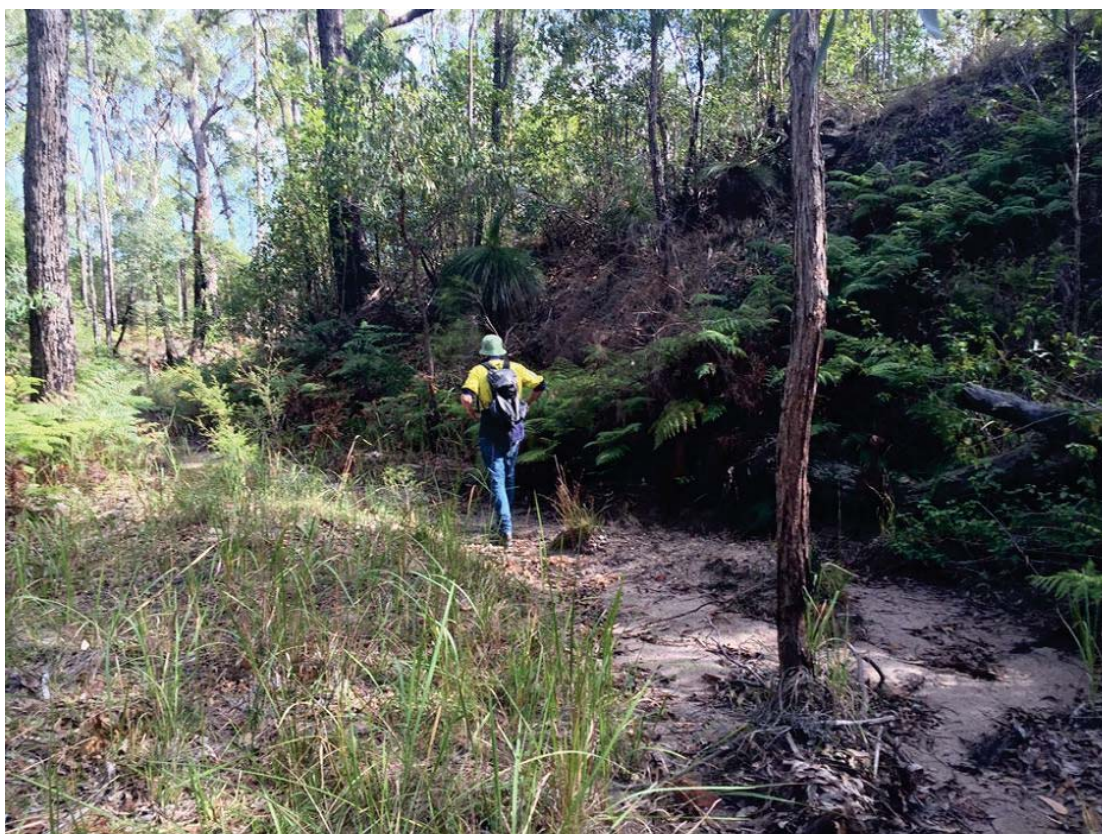
**Note:** Field observations indicated little evidence of bank undercutting along the length of streams within the study area. This indicates that future bank stability risks are most likely related to unmanaged overland flows, that subsequently erode dispersive soils, causing rilling and unstable banks. Management of overland flows will be critical to minimising future bank stability issues. Retention of minimum waterway buffer widths from top of bank will also play a significant role in retaining bank stability.

Figure 21 Example of low flow channel with stable adjacent bank along Precinct 3 streams

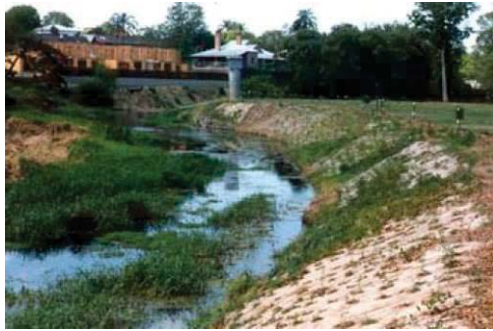
- over-excavation to form stable batter e.g. 2H:1V maximum
- treatment of the dispersive soils (e.g. gypsum). This should be ripped into the newly formed stable batter
- placement of non-dispersive topsoil (200-300 mm minimum) over exposed dispersive soils
- vegetation installation and establishment.

**Figure 22 Battering and revegetation**
