POD VOLUME 3:  
ATTACHMENT D.5:  
HARRIS TERRACE  
CONSERVATION  
MANAGEMENT PLAN

PREPARED BY: URBIS PTY LTD

QUEEN'S  
WHARF  
BRISBANE

DATE OF ISSUE: 24.11.2017

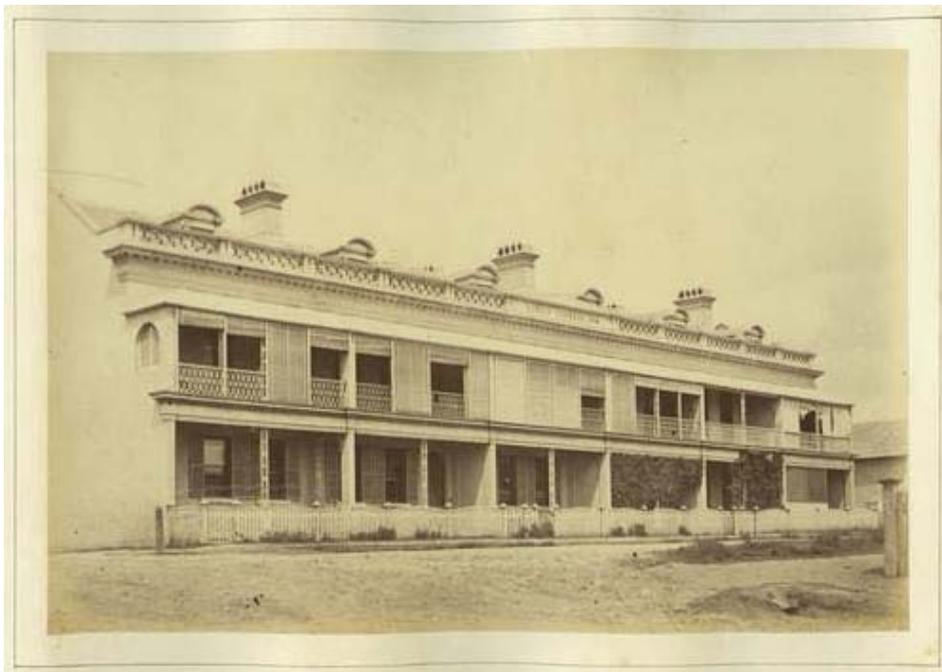
Figure 3 – Original Photo of Harris Terrace, Corner of George and Margaret Street c. Late 1860s

Constructed of masonry, the building contained two storeys with an attic level within the roof space. The ground floor comprised the drawing and dining rooms, while bedrooms were found on the first floor and within the attic space. The outbuildings were also of two storeys and contained the kitchen, bathroom and maid's room. Originally the roof of the building was slate, punctuated by dormer windows into each dwelling and a series of brick chimneys. A balustraded parapet ran the length of the building partly obscuring this roof. The name of the building and its date of completion - "HARRIS TERRACE 1866" were inscribed into the central section of the parapet. The upper balcony had cast iron balustrading with full length venetian blinds to most of the units.

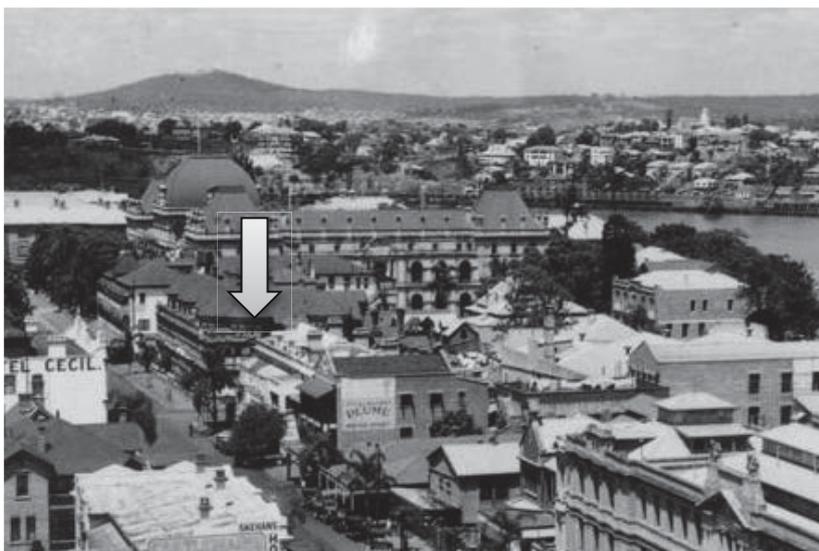
Figure 4 – Harris Terrace with Enclosed Verandas c. 1935

The Lingleys retained the corner unit and converted it into a cafe with an extension built to the line of the footpath, established no doubt to serve the student population of George Street. Another unit was bought by the Royal Queensland Art Society in 1930. Photographs of the building around this time indicate that the balcony was partly enclosed (see **Figure 4**). Documentary evidence also suggests that unit no. 5 (fifth from the Margaret Street corner) was altered in the 1940s with the construction of a two-storey extension to the street alignment and awning over the footpath.

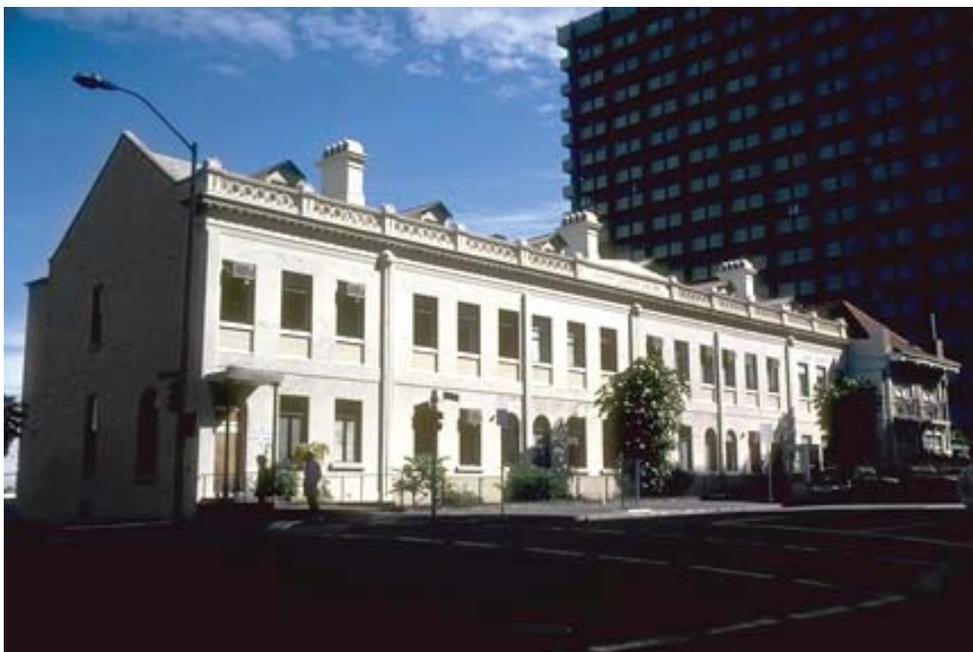
Figure 5 – Harris Terrace in 1983 Prior to the Construction of 80 George Street

As part of the redevelopment of the proposed Government Precinct, renovations and major reconstructions were undertaken at Harris Terrace involving architects from the Department of Public Works in association with Conrad and Gargett Architects (**Figure 5**). The work was extensive and involved the removal of much of the 1960s work, but also some earlier building fabric including lath and plaster ceilings and original joinery.

- Reconstruction of the ground floor verandah and upper floor balcony;
- New iron columns and balustrade on the balcony using a pattern found at Glengallan homestead on the Darling Downs thought to be similar to the original;
- Relocation of the ionic columns used for the front porch in the 1960s to the rear of the building and a new awning constructed over;
- Reinstatement of six entry doors to match the original configuration, with the door in the middle of the building becoming the main entrance;
- Removal of the corrugated iron roof and replacement with a new slate roof to match the original;

- Removal of the gabled dormers and reinstatement of vaulted dormers (dormers to the rear of the building were originally smaller than those to the front; however the 1980s refurbishment made both the same size);
- Installation of French doors to balcony;
- Installation of new doors, windows, architraves and skirtings of earlier forms and profiles;
- New moulded ceilings on the ground and first floors; and
- Installation of air conditioning with ducting running throughout the building.

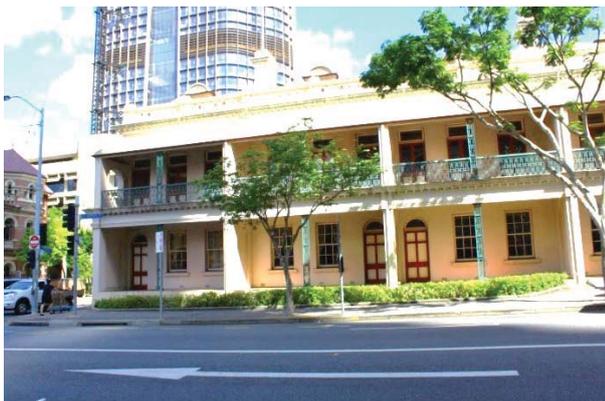
Figure 8 – George Street Frontage

Harris Terrace is a two-storey rendered and painted masonry building with a transverse gabled roof covered in slate tiles (**Figure 8**).

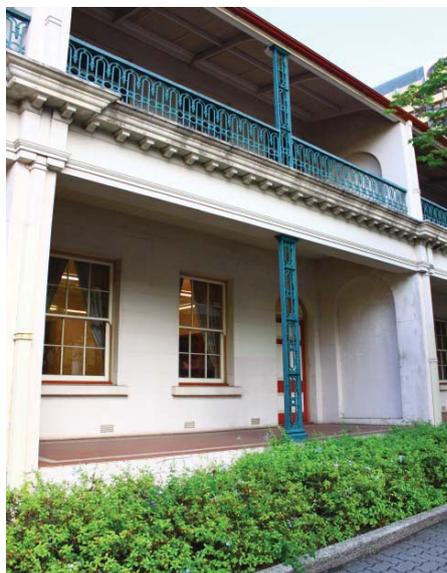
Figure 9 – Verandahs at George Street Elevation

A ground floor verandah and first-floor balcony are located at the front of each of the houses (**Figure 9**). These elements have been reconstructed to match the originals. The verandah and balcony floors are finished in square ceramic tiles.

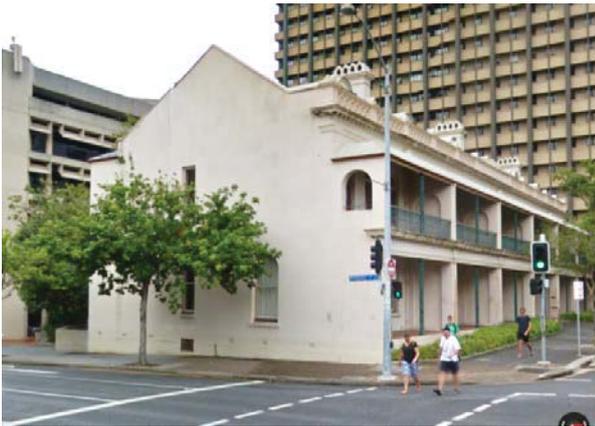
Figure 10 – Margaret Street Elevation

The side elevation to Margaret Street (**Figure 10**) features an arched window at the ground floor closest to George Street and square headed windows to the ground and first floors to light the stairwell. While these are early and perhaps original locations for windows, these elements have been rebuilt.

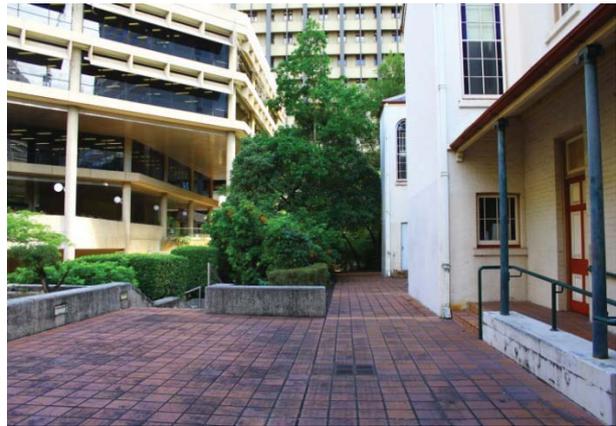
Figure 11 – Rear Elevation, with Protruding Wings and Courtyard

Currently to the rear of Harris Terrace there is a landscaped courtyard area (**Figure 11**). This area was developed during the works commissioned in the late 1970s and completed in the early 1980s in replacement of the demolished rear annexes to the building. This landscaped area is not original and does not contribute to the heritage significance of Harris Terrace.

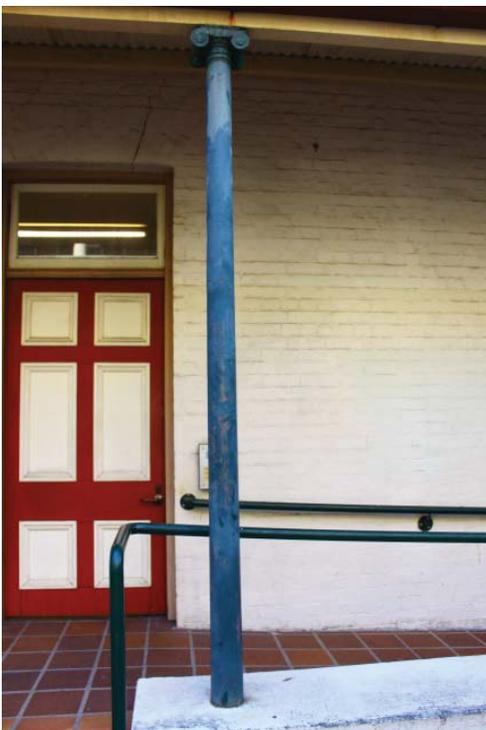
Figure 12 – Column at Rear of Building

At the rear are a series of the iron columns (**Figure 12**) that were relocated to this location from the front elevation of the building in the 1980s work.

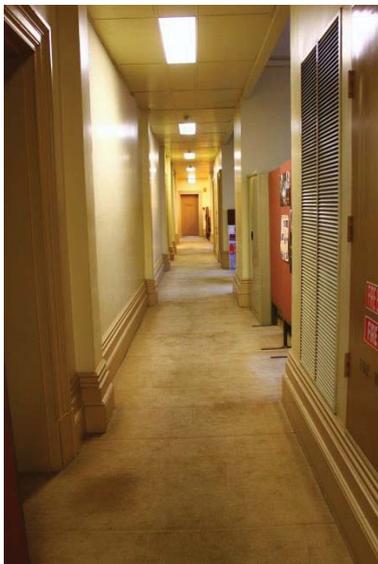
Figure 13 – Internal Corridor

The building is accessed via a single entrance door which then provides access to the various office spaces via the transverse corridor (**Figure 13**). While the separate entrance doors survive to each of the six houses, these are not operable. There is no access to the building from these separate entrances and doors.

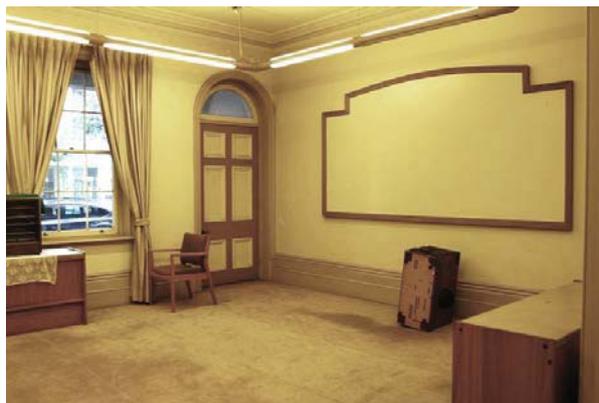
Figure 14 – Interior Space

The building interior features rendered and painted masonry with plaster ceilings and decorative elements, extensive timber skirtings and architraves, and timber panelled doors (**Figure 14**). The floors to the building are constructed of timber with floor finishes of modern carpet.

Generally plaster ceilings and cornices, timber skirtings and architraves and timber panelled doors are located throughout the building. These elements have all been reconstructed. A suspended ceiling runs along the new access corridor concealing air conditioning and other services above.

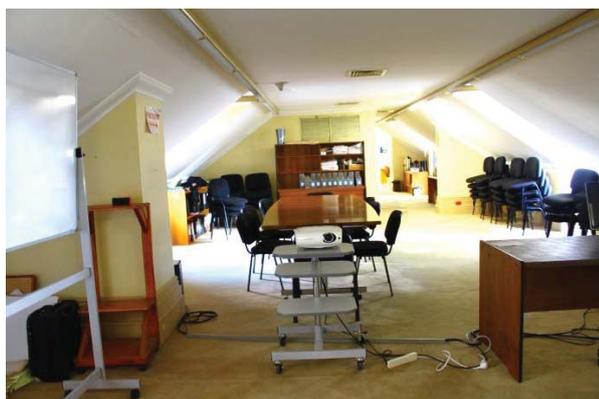
Figure 15 – Attic

The attic floor (**Figure 15**) of the building has been equally modified. Party walls have been removed as well as all evidence of former layouts or spaces and the attic floor is essentially one large space. Air conditioning plant is located on this floor to the rear of the building with a new partition wall constructed to conceal this plant. This new wall also features timber skirtings similar to the skirtings on the other floors of the building.

The attic floor has seen all party walls removed and new walls constructed to accommodate the air-conditioning plant.

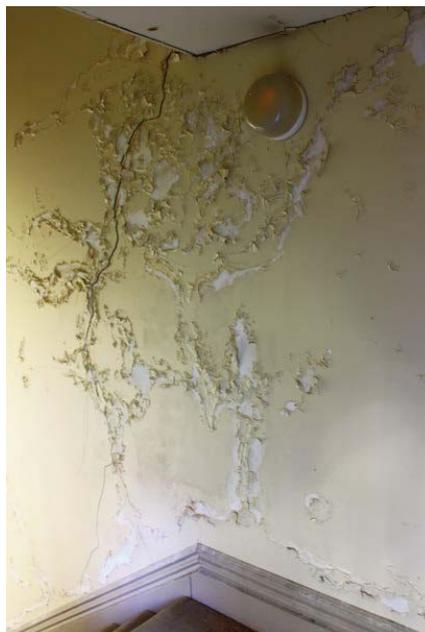
Figure 16 – Showing Internal Cracking and Peeling of Paint

Fairly major cracking of the render and the brickwork is apparent in many places in the interior of Harris Terrace (and the exterior) caused by settling of the foundations of the building (**Figure 16**), and cornices have become detached in a number of locations. There are also numerous instances of paint and render peeling and deteriorating due to water penetration issues and rising damp.

As noted above the building features relatively extensive cracking to the masonry walls in many places in the exterior and interior.

The floors are sagging to the middle of the building along the transverse corridor with an overall fall across the building from George to William Street. There is also significant cracking of the internal partition walls and separation of these internal walls to the external wall.

Engineering advice suggests that structural investigation and possible remediation and/or strengthening work need to be undertaken to the foundations of the building.

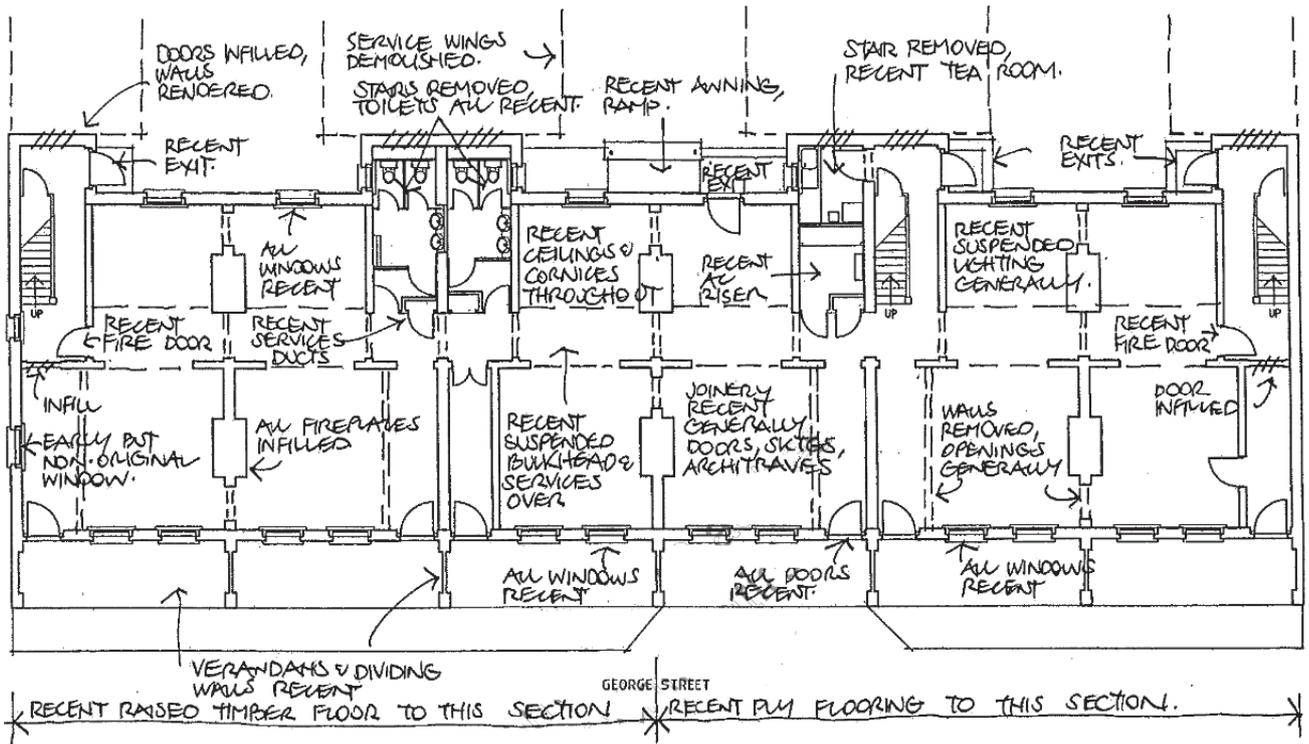
Figure 17 – Ground Floor Changes to Harris Terrace

A summary of changes to the building as at 2002 is at **Figures 17 to 19**. The internals to the building are largely unchanged since that time.

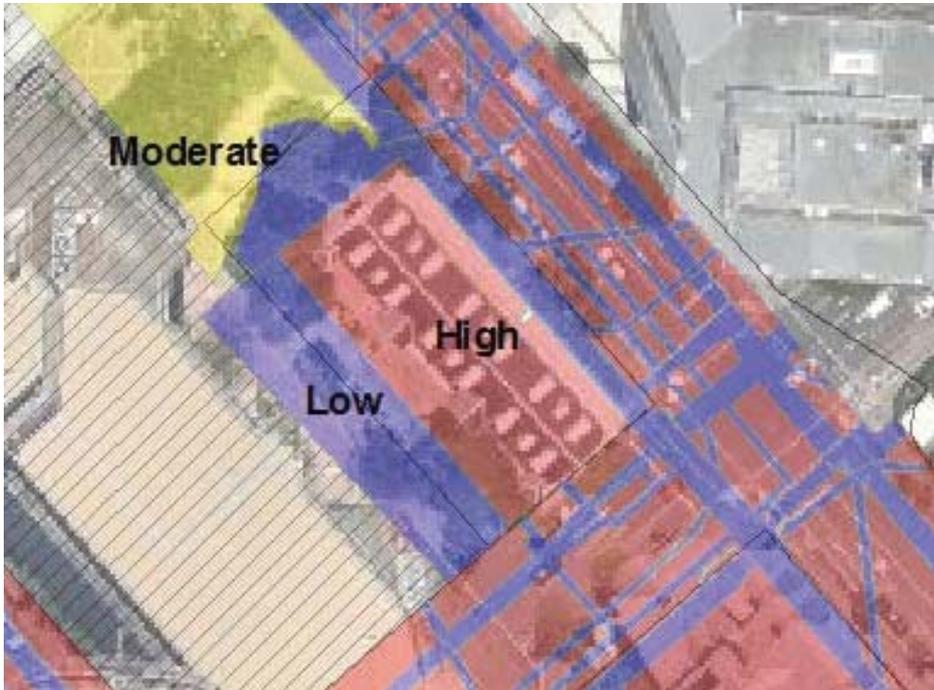
Figure 20 – Archaeological potential of Harris Terrace (Urbis 2016)

The area immediately behind Harris Terrace may contain archaeological evidence including the foundations of the service wings and 1960s building additions. There is also the potential for sub-floor deposits to remain. As the QHR Entry states:

Areas to north-west and south-west of the site have had significant ground disturbance related to the adjacent redevelopment and landscaping of the site in the 1980s and is therefore considered to only have a low archaeological potential.

The archaeological potential of the building and surrounds is shown at **Figure 20**.

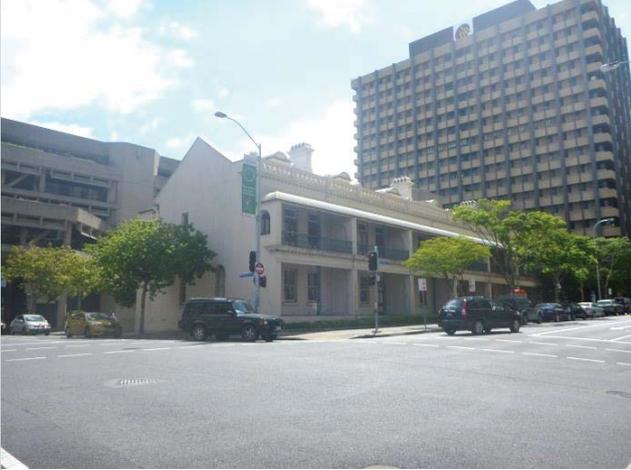
Structure, Space or Element	Location	Photograph	Level
<b>EXTERIOR</b>			
The external form and scale of the building in general, including Margaret Street elevation.	Viewed from corner of George and Margaret Streets

High

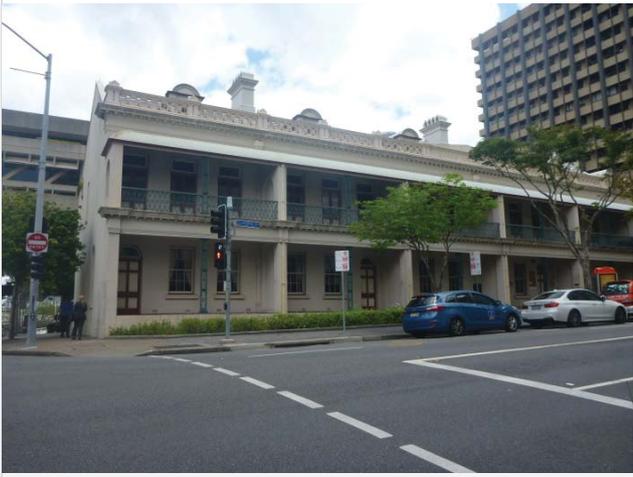
Structure, Space or Element	Location	Photograph	Level
The George street elevation (notwithstanding fabric not all original).	Viewed from George Street

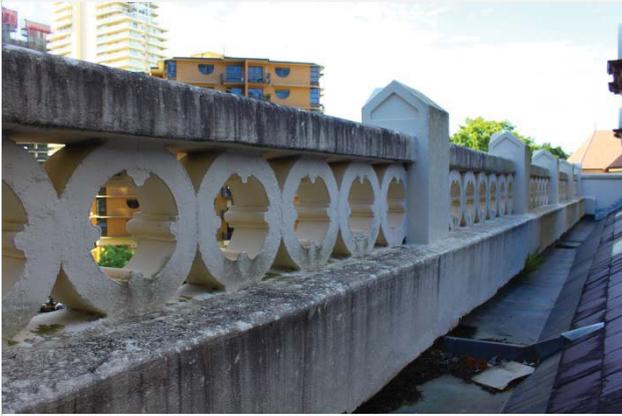
High
Rendered and painted masonry external walls from original construction, including parapets and chimneys.	External walls

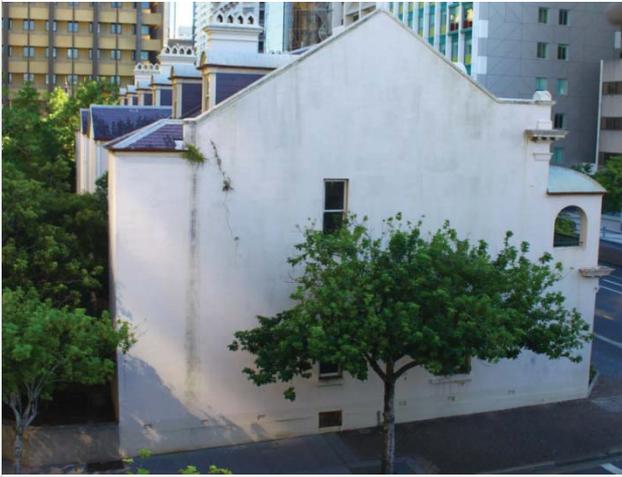
High
The original window locations facing Margaret Street.	Margaret Street

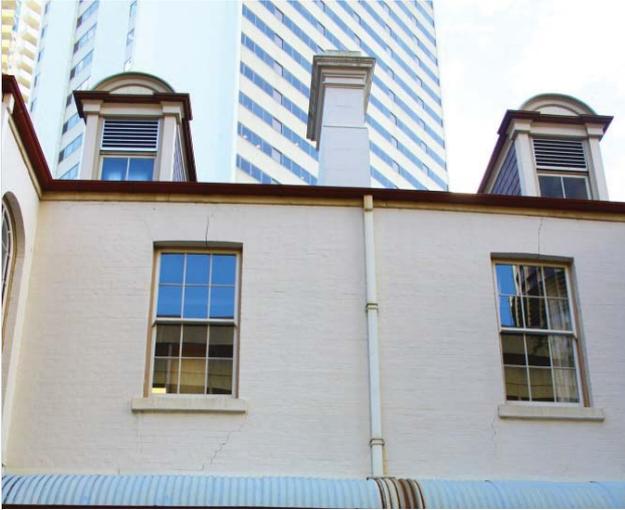
Structure, Space or Element	Location	Photograph	Level
Reconstructed dormer windows, awning to N-W attic windows	Roof

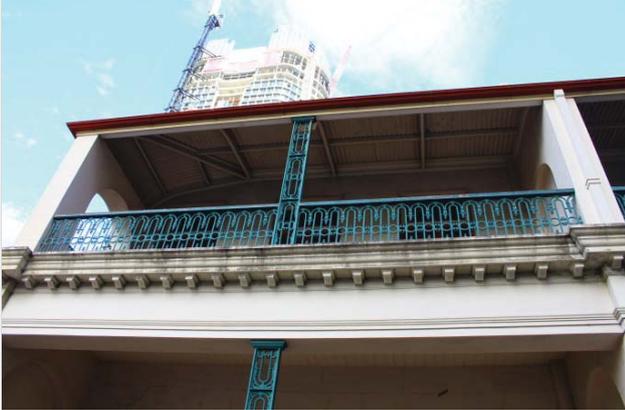
Moderate
New iron columns and balustrade	Front elevation

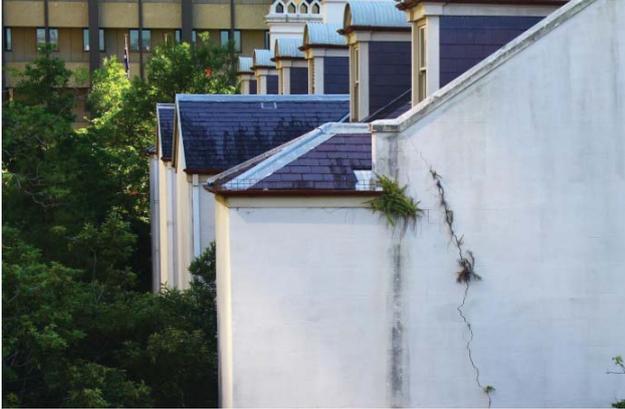
A roof condition report was prepared by Project Services in 2001. The slate roof constructed in the mid-1980s had failed in places by cracking and spilling. The slate used at that time was noted as being of poor quality. Some slates had slipped out of place and fallen into the gutters or onto the ground.

Moderate
Slate roof tiles	Roof

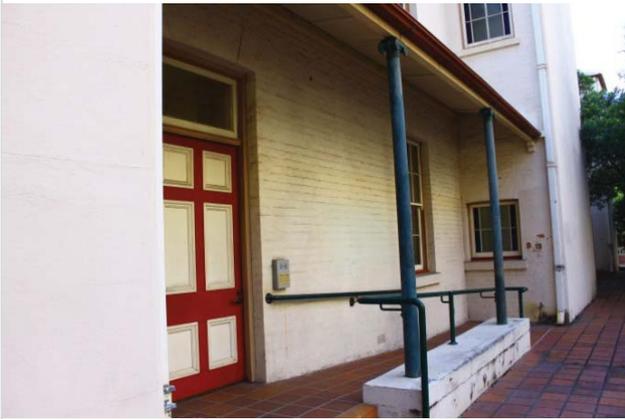
Structure, Space or Element	Location	Photograph	Level
The rear porch/verandah and ramp	Rear elevation

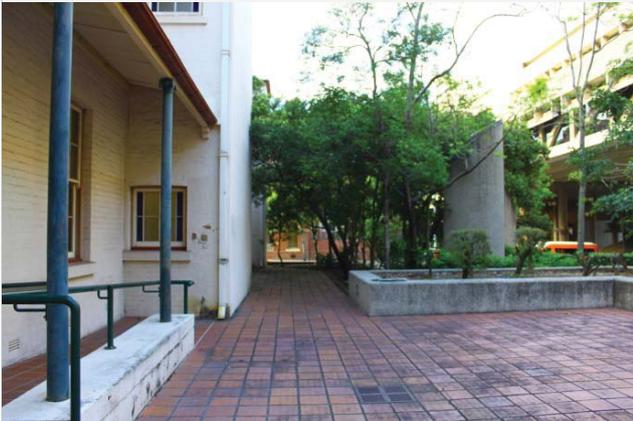
Moderate
Tiled surround to the rear and sides of the plaza area	Rear and side elevations

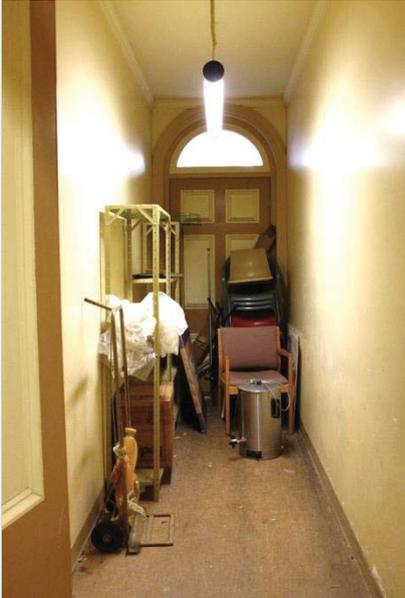
Intrusive
<b>INTERIOR</b>			
Remaining early roof framing and structure	Within roof space	No photo available	High
Rendered and painted internal party walls, chimney breasts, hallway walls	Internally across both ground and first floors

High

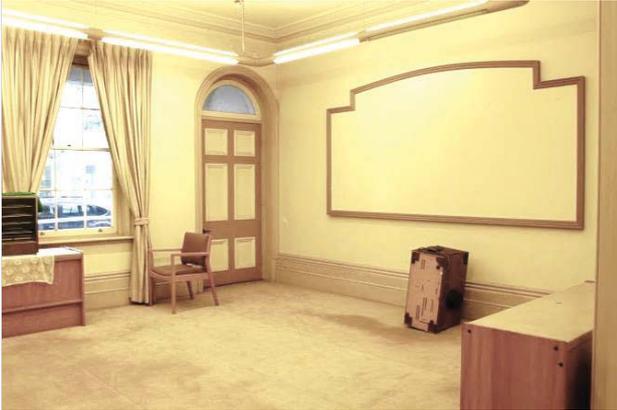
Structure, Space or Element	Location	Photograph	Level
Reconstructed joinery (doors and windows)	Externally to all elevations and internally on both ground and first floors

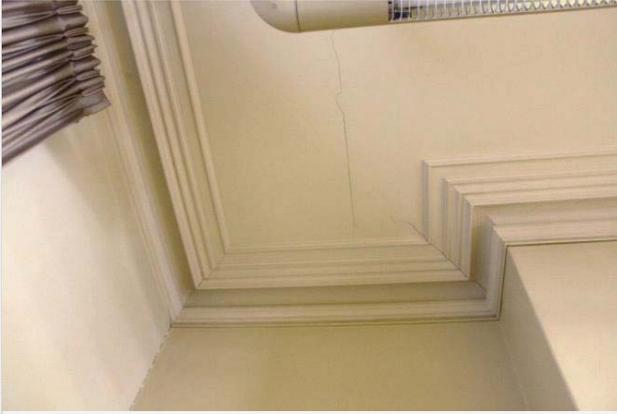
Moderate
Reconstructed plaster ceilings	Internally to both floors

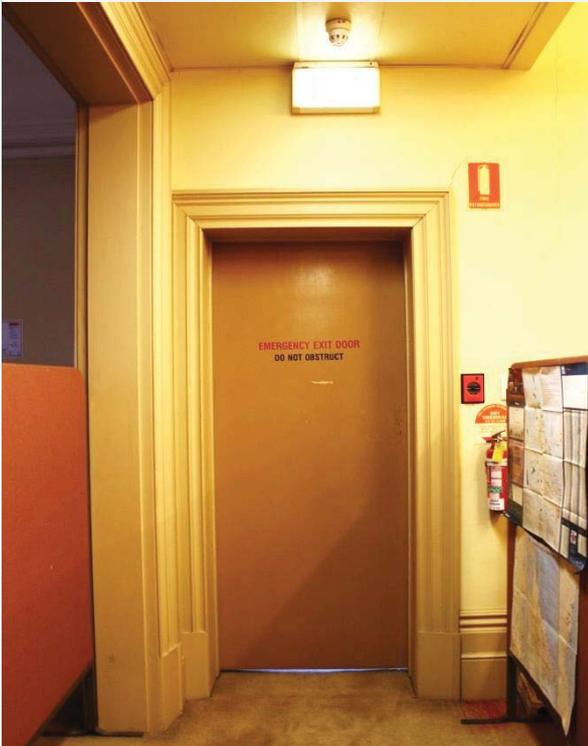
Moderate
Timber skirtings and architraves	Internally to both floors

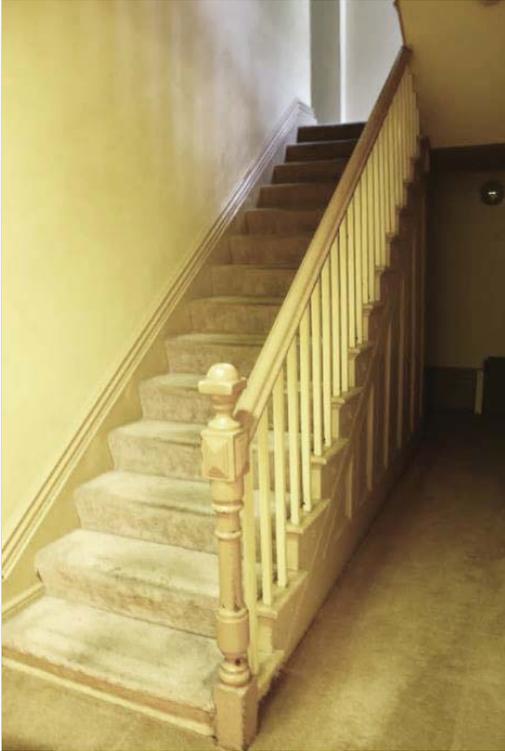
Structure, Space or Element	Location	Photograph	Level
Early timber staircases including risers, treads, stringers, balustrading and newels, panelling (x3)	Ground, first and attic floors

High/ <del>Moderate</del> (some risers and treads appear to be reconstructed)
Timber doors under staircase	Ground floor

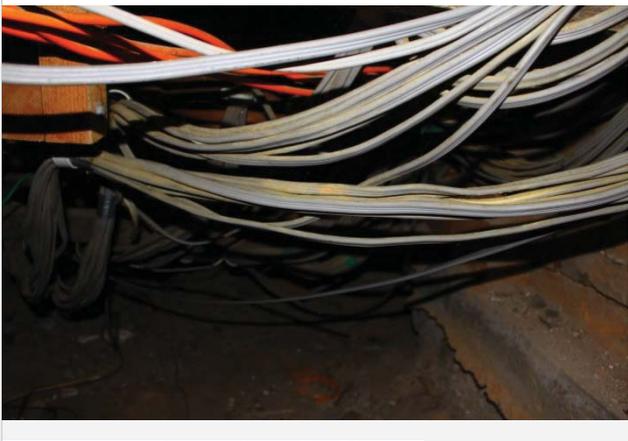
Structure, Space or Element	Location	Photograph	Level
Building services, plant equipment, ducts, risers, grilles	Internally

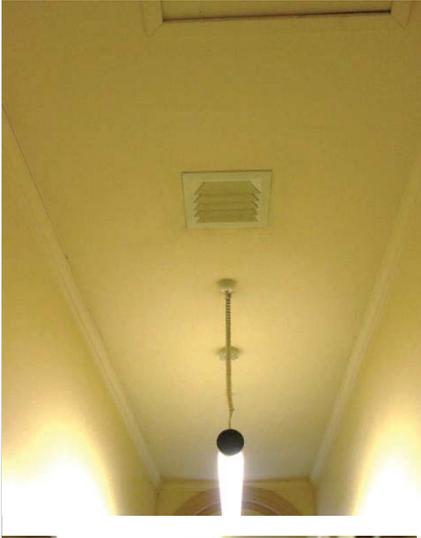
Intrusive
Suspended ceilings	Ground and first floors

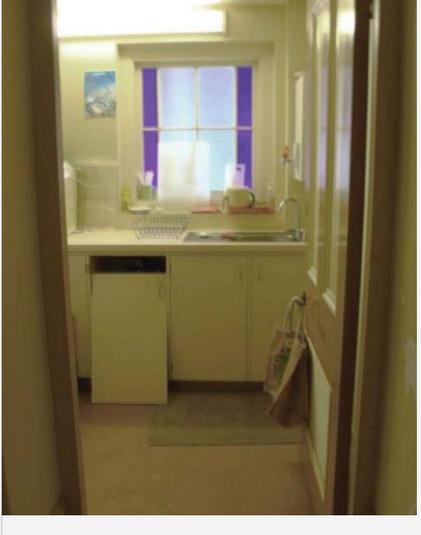
Intrusive
Tea room and toilet fit outs.	Ground and first floors

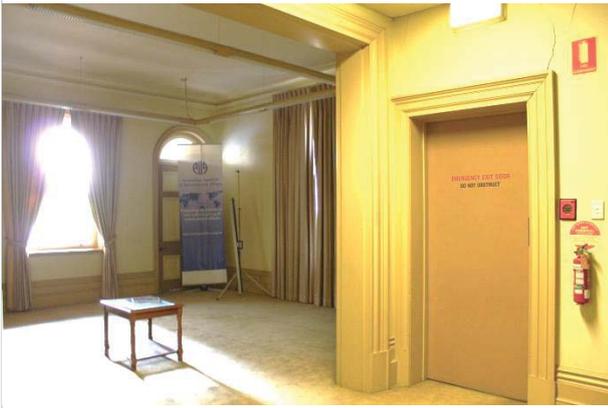
Structure, Space or Element	Location	Photograph	Level
Fire doors to stairwells and fire exit doors to rear elevation	Ground and first floors

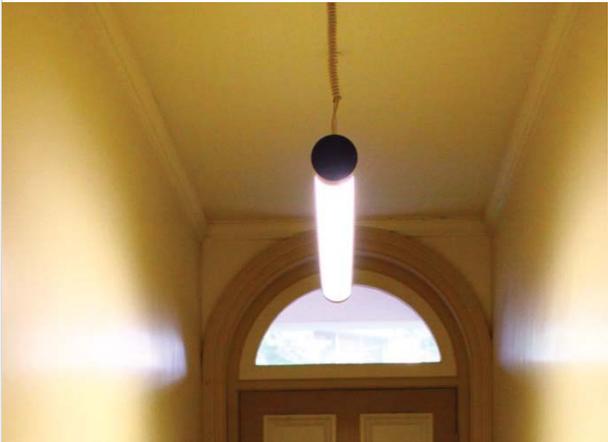
Intrusive
Suspended lighting	Ground and first floors

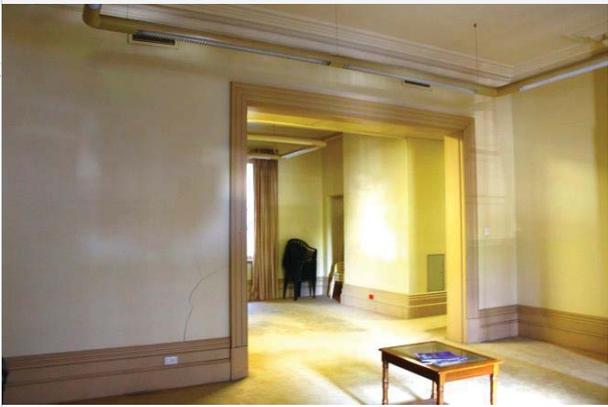
Intrusive
Openings in original walls	Internally throughout

Intrusive

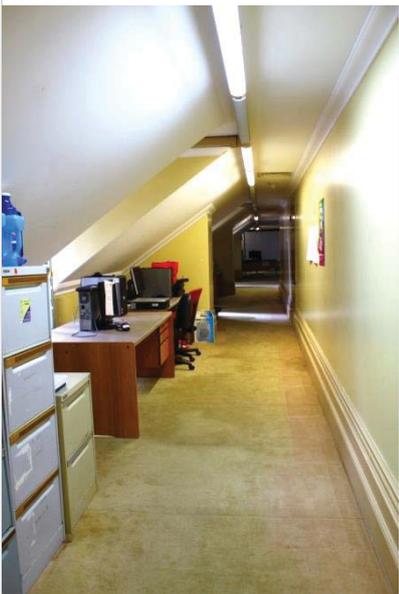
Structure, Space or Element	Location	Photograph	Level
Partition for air-conditioning plant	Attic floor

Intrusive

Air-conditioning is provided in the building. The plant is located in the attic floor of the building and the presence of these facilities on site is intrusive. The provision of air-conditioning has been carried out with little regard for the internal fabric of the building. The air-conditioning was installed some 30 years ago and may need upgrading.
