## VEGETATION MANAGEMENT ASSESSMENT

**ASSESSMENT NO.: J14535A**

**Report Conducted on 29 August 2017**

**Property Address:** Go Print, 371 Vulture Street, Woolloongabba

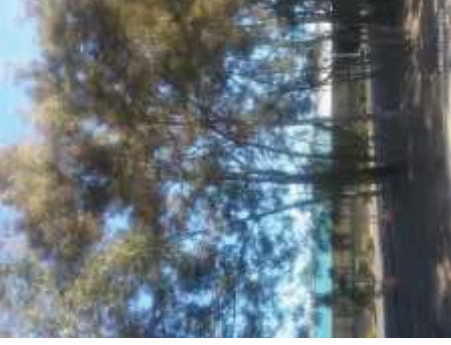
Photo 5: T005-T008

T008	<i>Casuarina glauca</i>	Swamp She Oak	17.0	2.04	5.80	8	No	Fair	Fair to poor	Semi-Mature	Suppressed crown with a bias to the North.
T009	<i>Casuarina glauca</i>	Swamp She Oak	19.5	2.34	6.20	7	No	Good	Fair to poor	Semi-Mature	Suppressed crown with a bias to the North.
T010	<i>Casuarina glauca</i>	Swamp She Oak	16.4	2.00	5.70	5	No	Fair	Poor	Semi-Mature	Suppressed crown with a bias to the North East.
T011	<i>Casuarina glauca</i>	Swamp She Oak	15.5	2.00	6.10	6	No	Good	Fair to Good	Semi-Mature	Suppressed crown with a bias to the North.
T012	<i>Casuarina glauca</i>	Swamp She Oak	16.5	2.00	6.20	6	No	Good	Fair to good	Semi-Mature	Suppressed crown with a bias to the North.
T013	<i>Casuarina glauca</i>	Swamp She Oak	19.4	2.33	9.20	6	No	Good	Good	Semi-Mature	Good crown density.
T014	<i>Casuarina glauca</i>	Swamp She Oak	17.9	2.15	7.60	6	No	Fair	Poor	Semi-Mature	Suppressed crown with a bias to the North East.

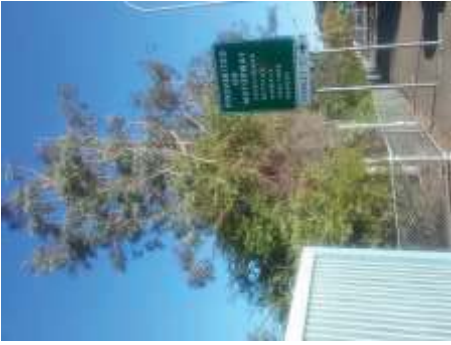
Photo 51: T115

T115	<i>Eucalyptus tereticornis</i>	Forest Red Gum	30.8	3.70	15.90	7	No	Fair	Fair	Semi-Mature	Major deadwood is present. Bauhinia is strangling the tree.
T116	<i>Jacaranda mimosifolia</i>	Jacaranda	30.0	3.60	8.20	8	No	Fair	Fair to good	Semi-Mature	Tips are overhanging the boundary.
T117	<i>Jacaranda mimosifolia</i>	Jacaranda	27.0	3.24	8.70	7	No	Fair	Fair to good	Semi-Mature	Tips are overhanging the boundary.
T118	<i>Jacaranda mimosifolia</i>	Jacaranda	30.0	3.60	8.50	10	No	Good	Fair to good	Semi Mature	Tips are overhanging the boundary. Tree is currently seeding.
