Herston Quarter Heritage Precinct

Heritage Building
Dilapidation Report

Prepared for Australian Unity

24 May 2019

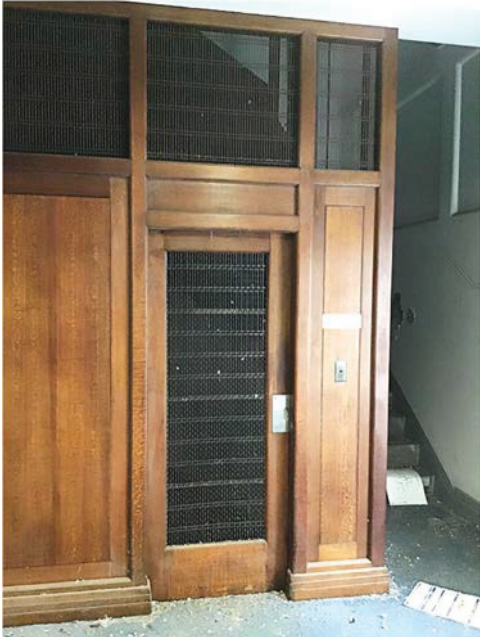
<p style="text-align: center;">Photo 9</p>

<p>Comments: View of silky oak lift timber cladding. Some general wear of timber present.</p> <p>From location report: B1.NT.L1.L01</p>	<p>Comments: View of a large common room wall partition. Some minor wall sheeting damage surface marks and minor penetrations.</p> <p>From location report: B1.NT.L1.R03</p>
<p style="text-align: center;">Photo 11</p>

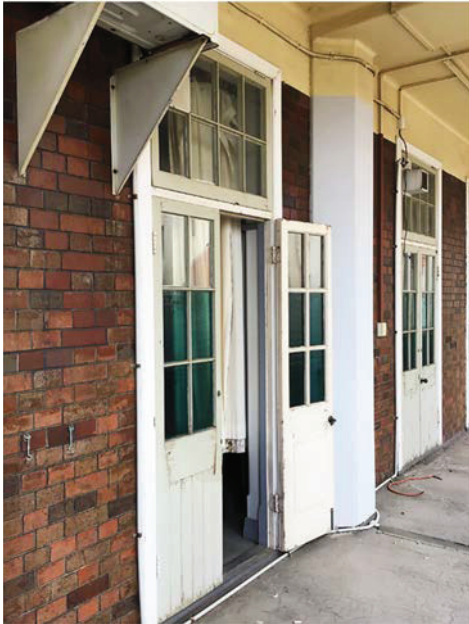
<p>Comments: External view of outer balcony wall. General wear of finishes and timber surfaces. Some isolated areas have damaged glazing.</p> <p>From location report: B1.NT.L1.B02</p>	<p>Comments: Internal view of façade glazing. Some minor isolated cladding penetrations. Some minor damage, cracking of isolated glazing.</p> <p>From location report: B1.NT.B.R01</p>

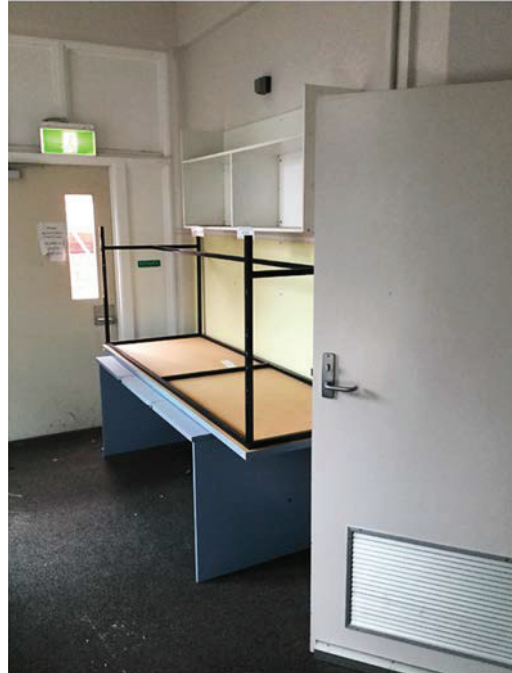
Photo 14

Comments: General view of wall partition. Some areas were covered by fit-out items.
From location report: B1.NT.B.R11

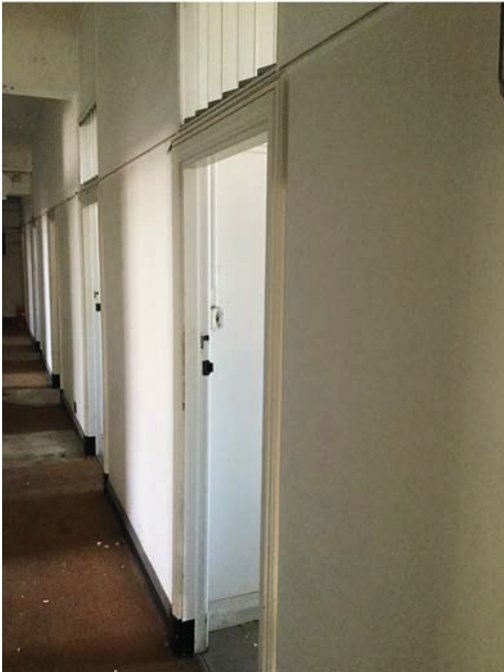
Photo 15

Comments: Internal view of hallway walls.
From location report: B1.ST.L5.H01

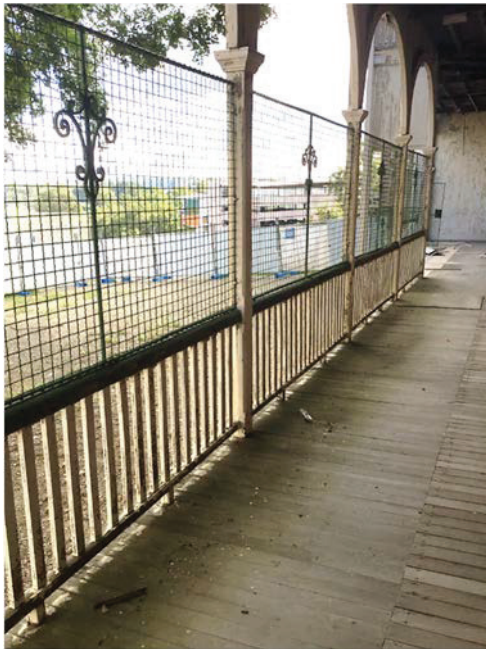
Photo 19

Comments: External fence / balustrade. General wear of finishes.

From location report: B1.1896.GF.B02

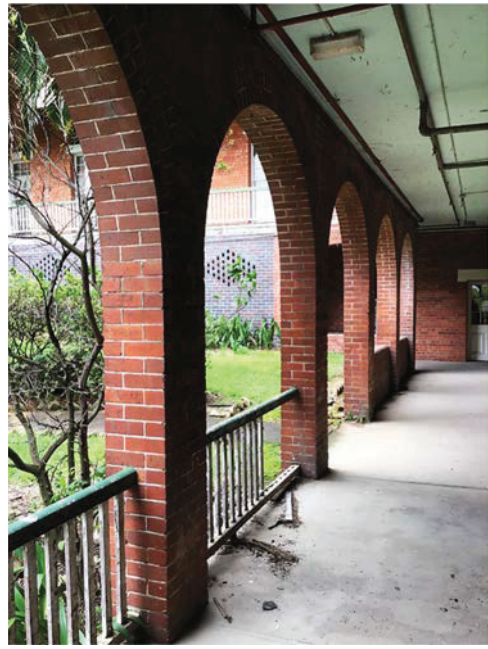
Photo 20

Comments: External brick arches + timber balustrades. Minor wear to finishes, damaged timber balustrade sections.

From location report: B1.1914.B.B02

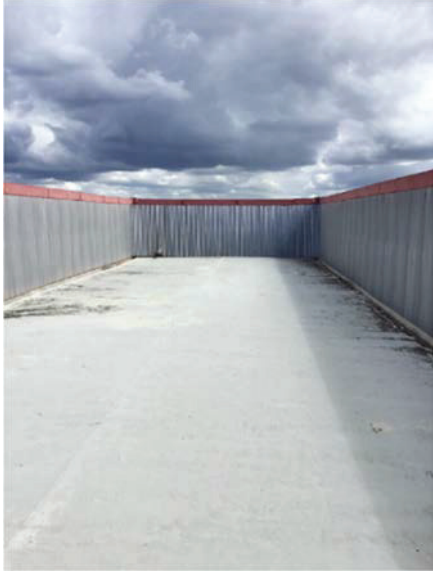
<p style="text-align: center;">Photo 21</p>

<p>Comments: Tower roof level. General view of floor. From location report: B1.NT.L7.R01</p>	<p>Comments: View of internal tower stairs. General debris present. Wear of timber handrails. Some concrete cracking. From location report: B1.NT.GF.ST01</p>
<p style="text-align: center;">Photo 23</p>

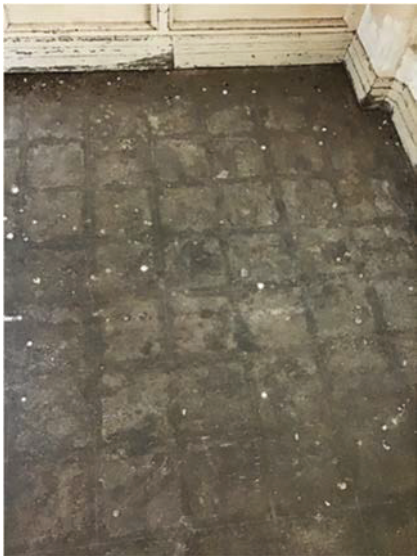
<p>Comments: View of internal floor. Stripped finishes. Concrete floor exposed. From location report: B1.NT.L6.R01</p>	<p>Comments: Internal hallway flooring. Wear of finishes. Debris present. Floor structure covered. From location report: B1.NT.L6.H01</p>

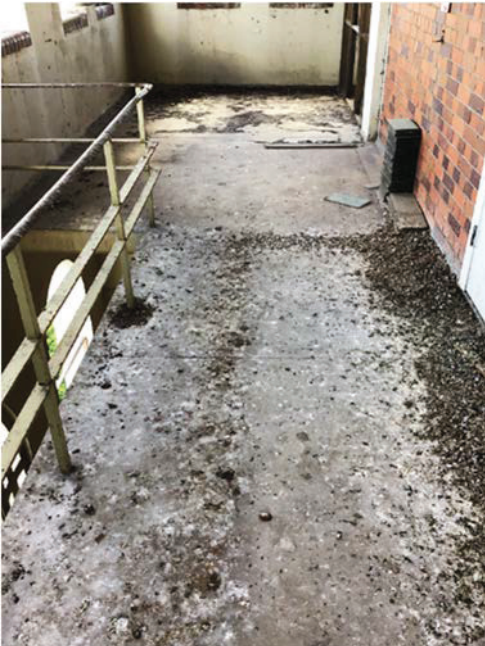
<p style="text-align: center;">Photo 25</p>

<p>Comments: View of external balcony flooring. General wear of surfaces and finishes. Debris present.</p> <p>From location report: B1.NT.L6.B03</p>	<p>Comments: View of external balcony timber stairs. Wear of timber surfaces, debris.</p> <p>From location report: B1.NT.L6.ST02</p>
<p style="text-align: center;">Photo 27</p>

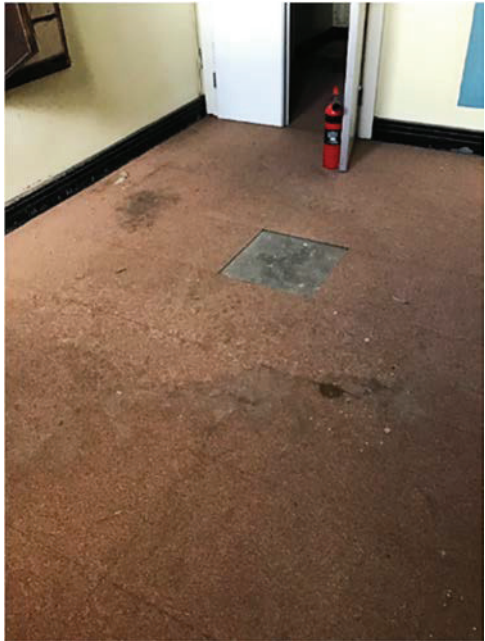
<p>Comments: Internal lobby flooring. Covered by finishes. Wear to finishes, sections missing.</p> <p>From location report: B1.NT.L3.L01</p>	<p>Comments: View of internal flooring. Surface staining, concrete cracking, debris. Some areas covered by fixtures.</p> <p>From location report: B1.NT.L3.R18</p>

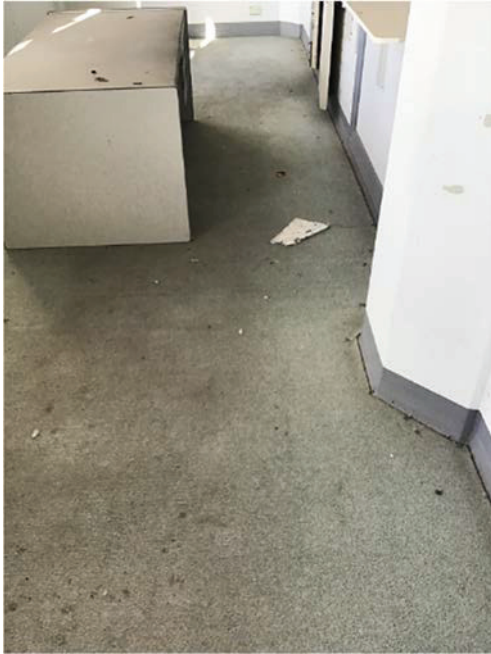
<p style="text-align: center;">Photo 29</p>

<p>Comments: View of internal office area. Flooring covered by finishes / fixtures. General wear of finishes, debris.</p> <p>From location report: B1.NT.L2.R06</p>	<p>Comments: View of internal hallway. Wear of timber surfaces, debris. Flooring covered by finishes. General wear of finishes.</p> <p>From location report: B1.NT.L2.H01</p>
<p style="text-align: center;">Photo 31</p>

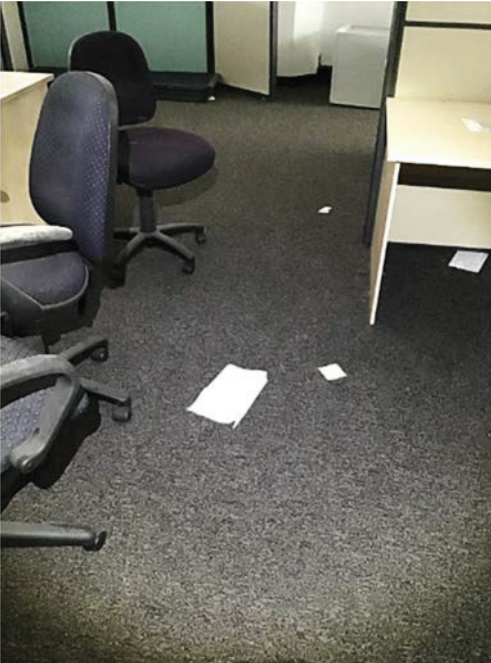
<p>Comments: View of internal office area. Flooring covered by finishes / fixtures.</p> <p>From location report: B1.NT.B.R01</p>	<p>Comments: View of internal flooring. Flooring covered by finishes / fixtures. Staining of finishes, debris.</p> <p>From location report: B1.ST.L5.R11</p>

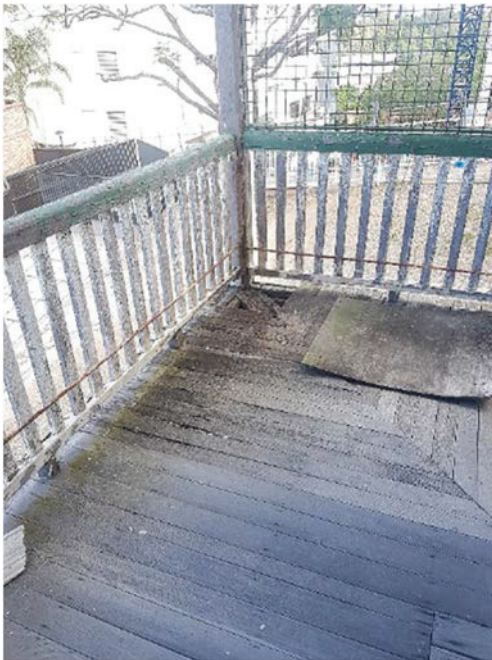
Photo 33

Comments: View of external timber balcony. Wear of timber. Damaged timber flooring.

From location report: B1.1896.GF.B03

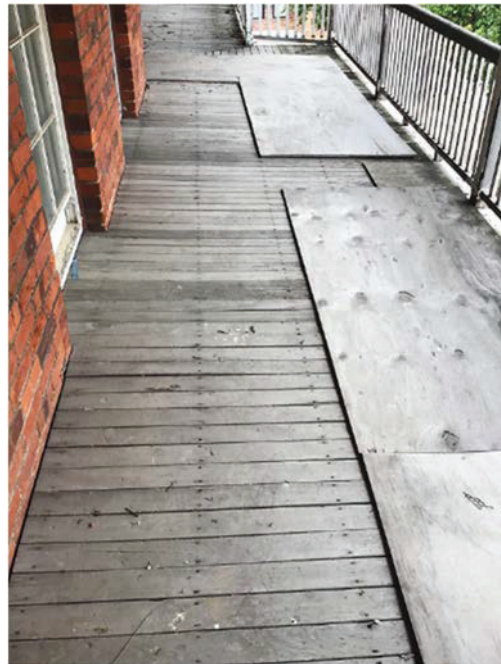
Photo 34

Comments: View of external timber balcony. Wear of timber. Areas covered by ply panels. Potential damage to structure underneath.

From location report: B1.1896.L1.B02

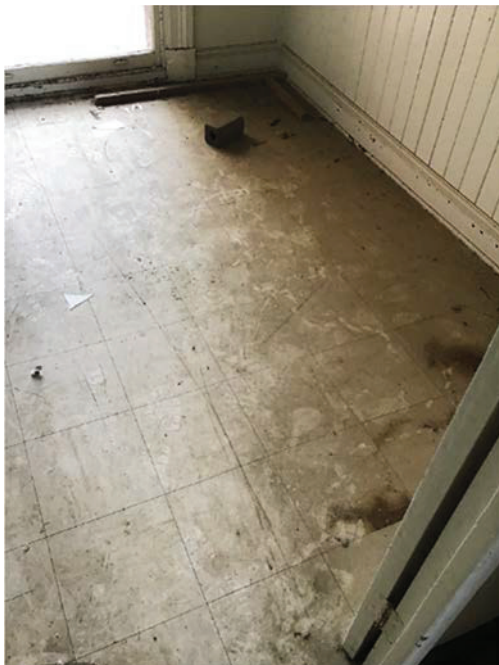
Photo 35

Comments: General view of internal flooring. Debris present.

From location report: B1.1914.GF.R24

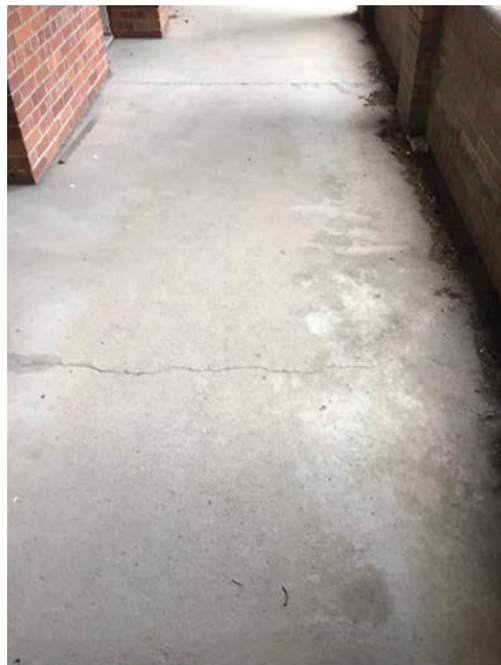
Photo 36

Comments: External concrete flooring. Concrete cracking present.

From location report: B1.1914.B.B02

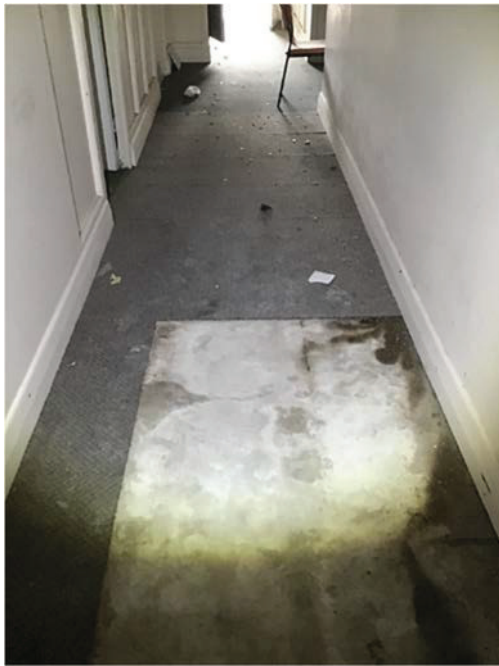
Photo 37

Comments: View of internal hallway. Covered by finishes. Wear of finishes. Surface staining.

From location report: B1.1931.SB1.H02

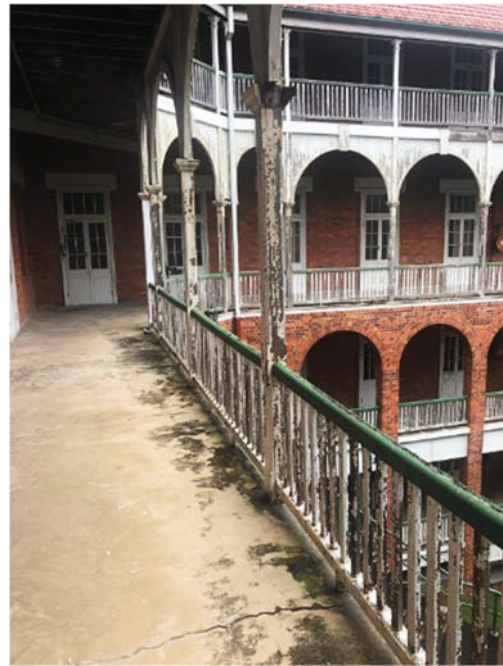
Photo 38

Comments: View of external balcony. Surface staining, concrete cracking.

From location report: B1.1914.GF.B04

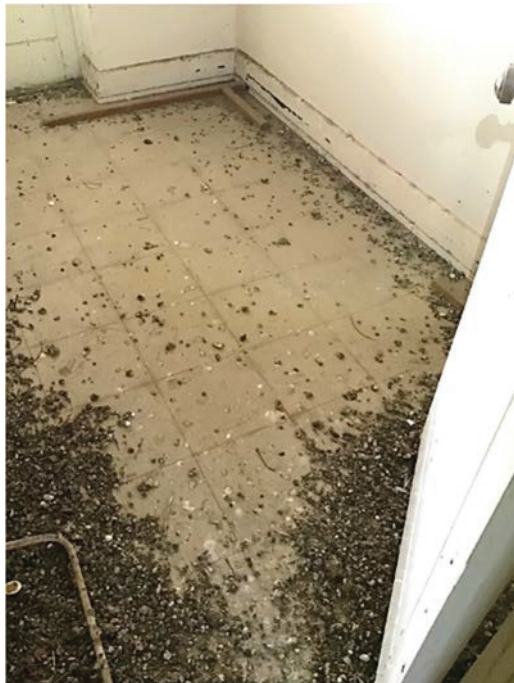
Photo 39

Comments: General view of internal flooring. Debris present.

From location report: B1.1931.L1.R28

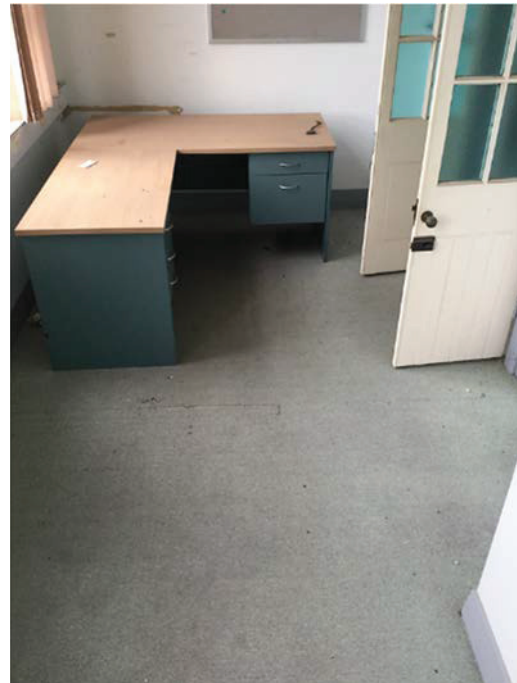
Photo 40

Comments: General internal office floor.

From location report: B1.NT.L1.R06

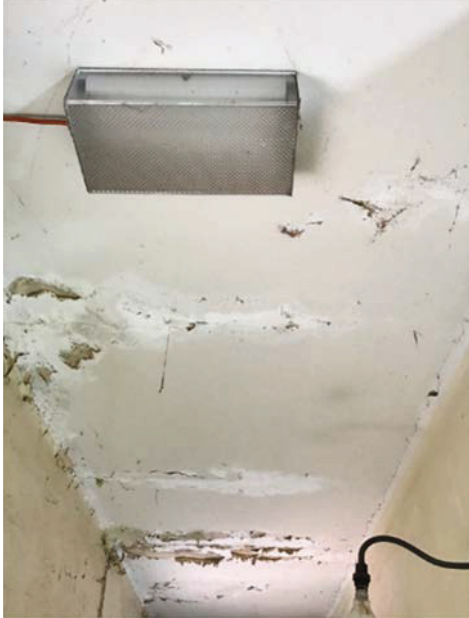
<p style="text-align: center;">Photo 41</p>

<p>Comments: Tower section concrete ceiling external view at roof level. General wear of finishes.</p> <p>From location report: B1.NT.L7.ST01</p>	<p>Comments: Internal ceiling view. Wear of finishes. Surface staining, cracking.</p> <p>From location report: B1.NT.L6.R04</p>
<p style="text-align: center;">Photo 43</p>

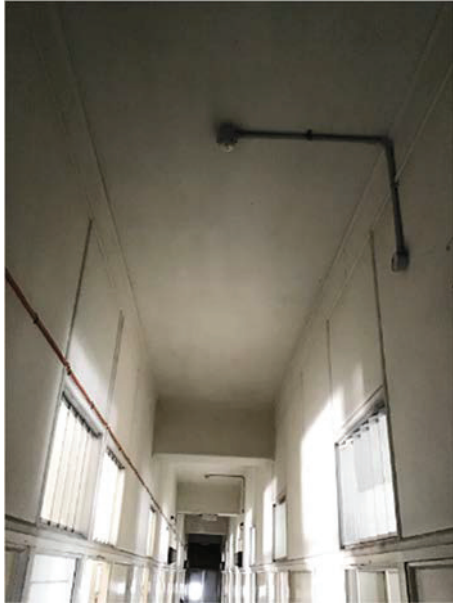
<p>Comments: View of internal hallway ceiling. Some areas have wear of finishes, peeling.</p> <p>From location report: B1.NT.L6.H01</p>	<p>Comments: View of external balcony ceiling. Wear of finishes, cracking, concrete spalling. Exposed reinforcement corroded.</p> <p>From location report: B1.NT.L6.B01</p>

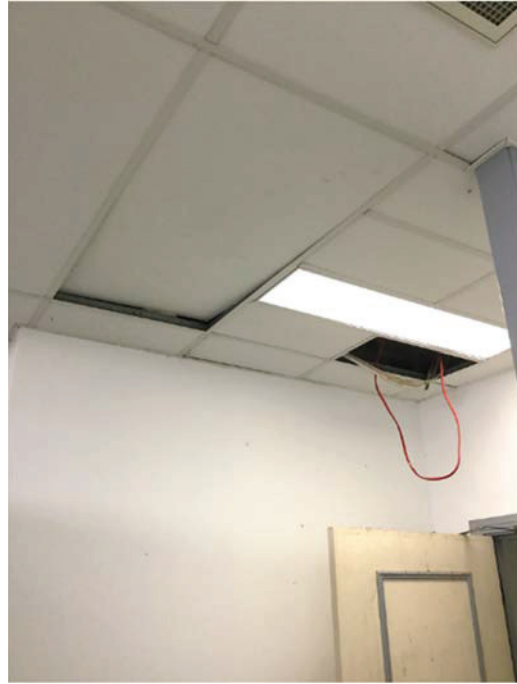
Photo 46

Comments: View of internal office ceiling. Structure covered by hung ceiling panels.
From location report: B1.NT.L2.R13

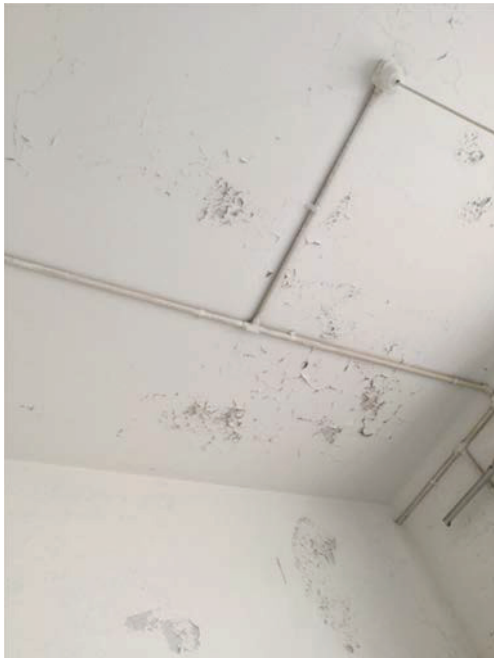
Photo 47

Comments: General view of internal ceiling. Wear of finishes, peeling.
From location report: B1.ST.L5.R30

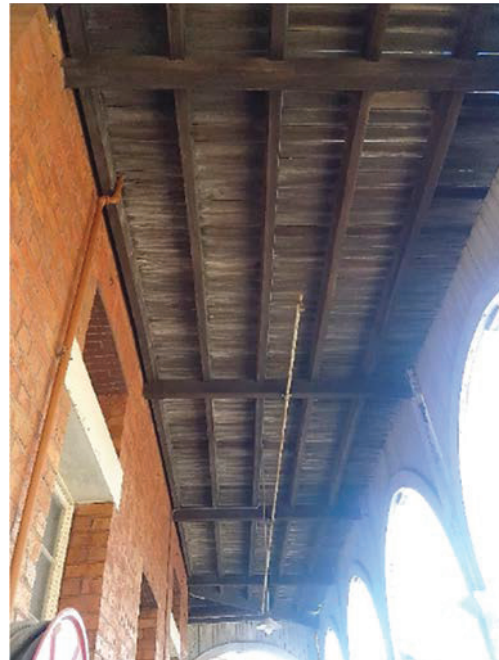
Photo 48

Comments: View of timber balcony floor from below.
From location report: B1.1896.GF.B03

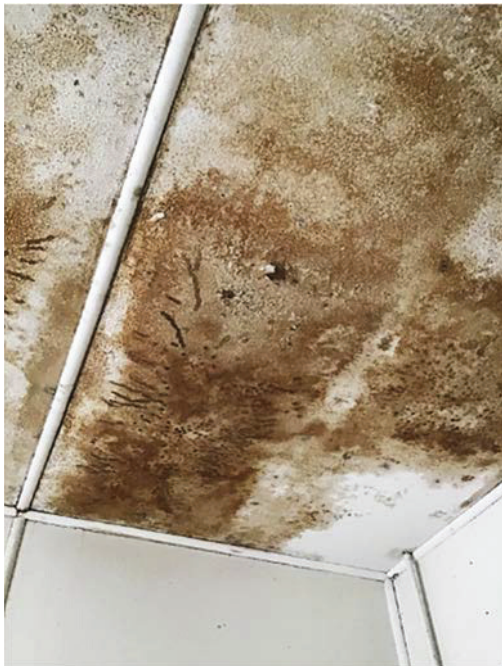
<p style="text-align: center;">Photo 49</p>

<p>Comments: View of internal common room ceiling. Major surface staining.</p> <p>From location report: B1.1914.L1.R26</p>	<p>Comments: View of internal room ceiling. Wear of finishes, peeling.</p> <p>From location report: B1.1914.GF.R15</p>
<p style="text-align: center;">Photo 51</p>

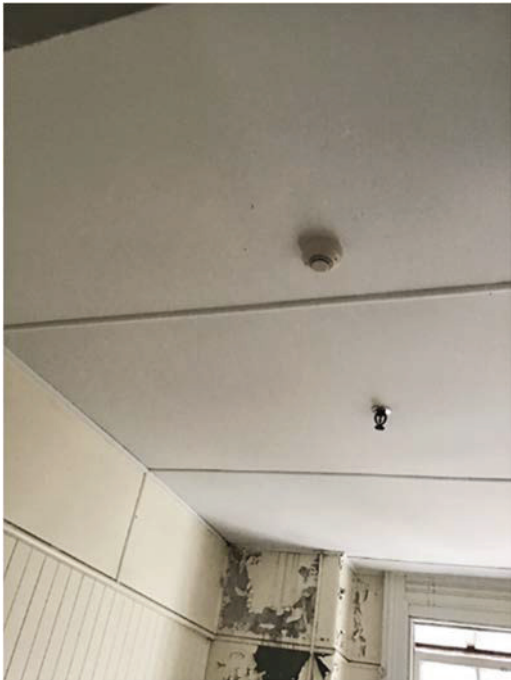
<p>Comments: General view of internal ceiling.</p> <p>From location report: B1.1896.L1.R27</p>	<p>Comments: View of external ceiling. Wear of finishes.</p> <p>From location report: B1.1914.B.B02</p>

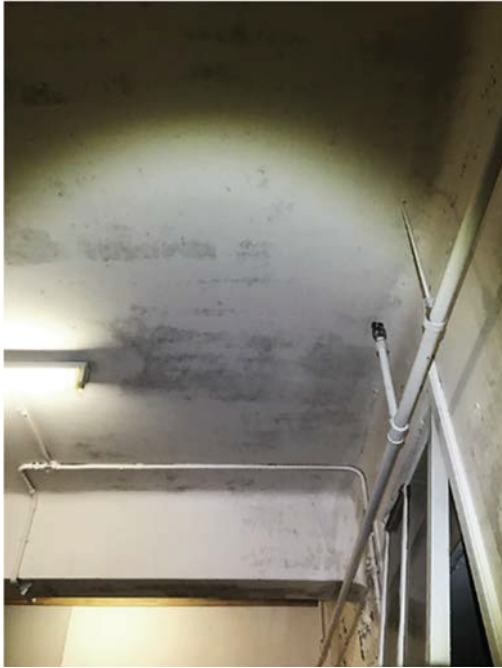
Photo 53

Comments: View of internal common room ceiling. Surface staining.

From location report: B1.1931.SB1.R15

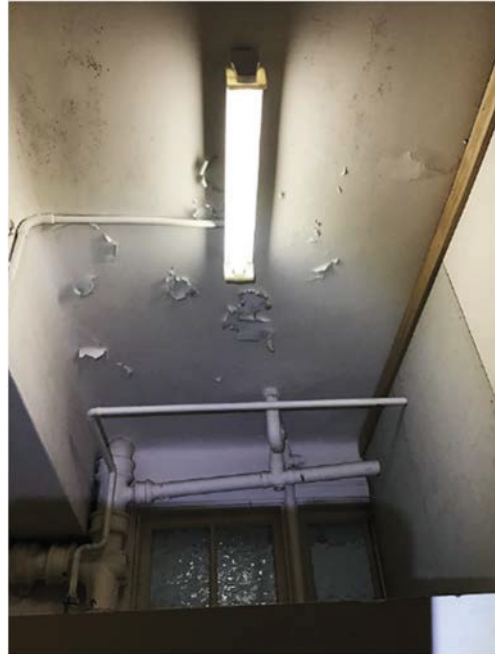
Photo 54

Comments: View of internal room ceiling. Wear of finishes, peeling.

From location report: B1.1931.SB1.R15

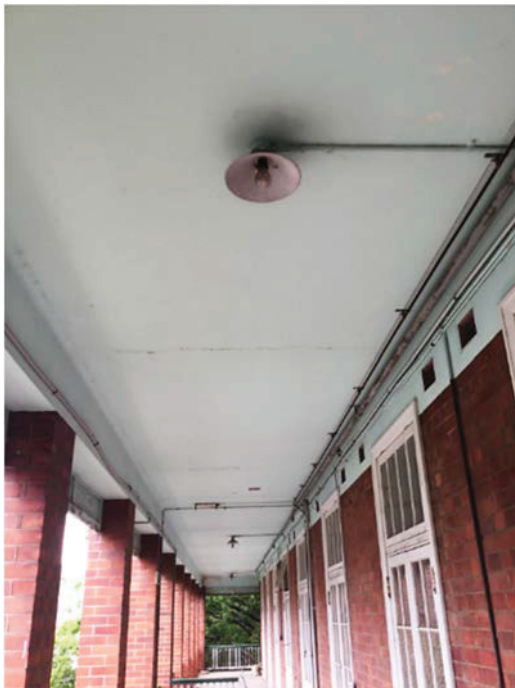
Photo 55

Comments: General view of external ceiling.

From location report: B1.1931.SB1.B01

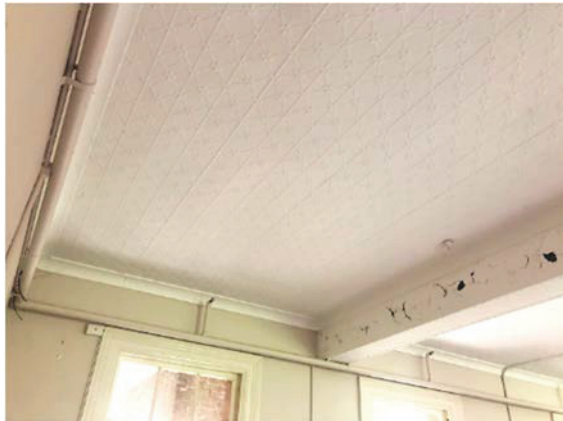
Photo 57

Comments: View of internal common room, feature ceiling. Some wear of finishes, peeling.

From location report: B1.1914.B.R02

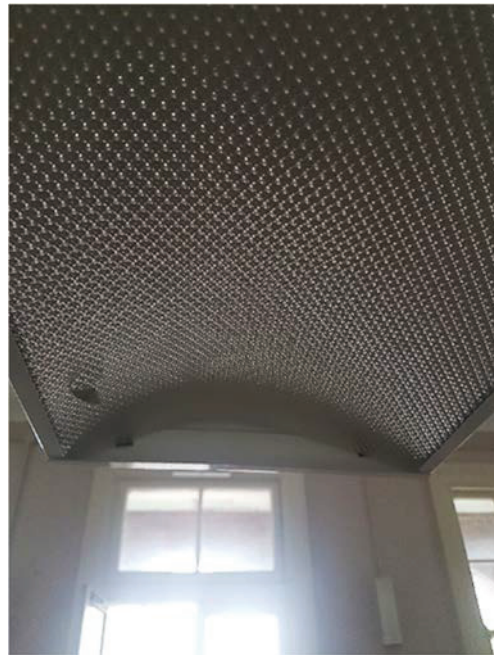
Photo 58

Comments: View of internal room, feature ceiling.

From location report: B1.1914.B.R01

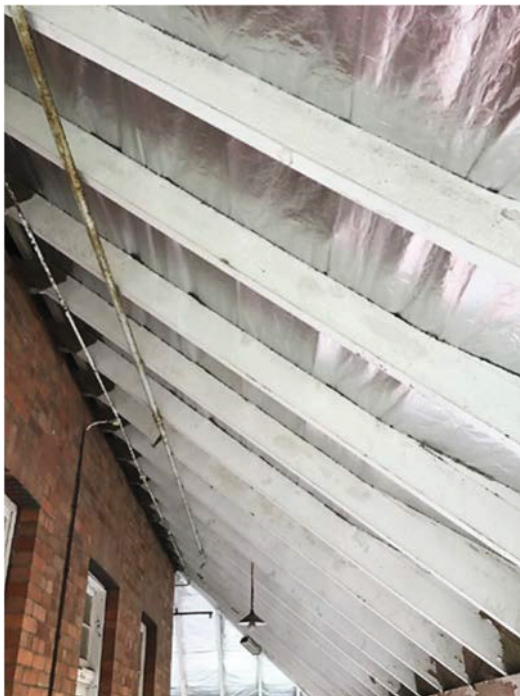
Photo 59

Comments: View of external balcony roof from below.

From location report: B1.1914.L1.B03

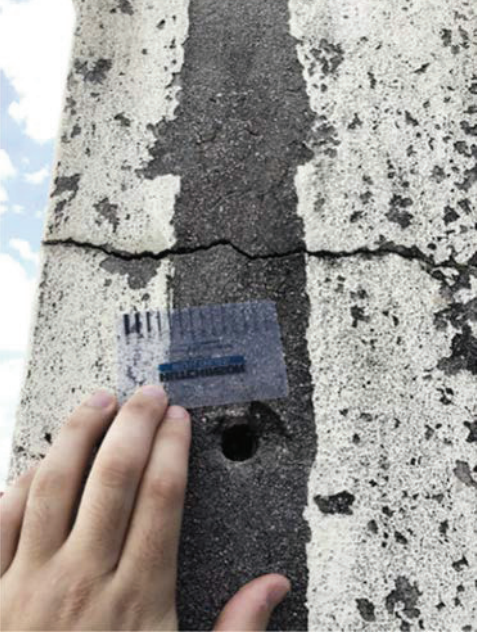
<p style="text-align: center;">Photo 61</p>

<p>Comments: Tower wall external view at roof level. Concrete cracking, penetration.</p> <p>From location report: B1.NT.L7.R01</p>	<p>Comments: Tower wall internal view. Surface peeling, concrete cracking.</p> <p>From location report: B1.NT.L7.ST01</p>
<p style="text-align: center;">Photo 63</p>

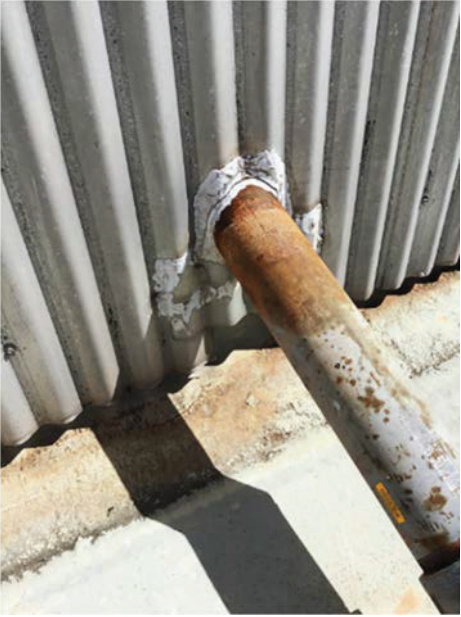
<p>Comments: Tower roof level. External view. Corrosion of steel. Cracking of sealant.</p> <p>From location report: B1.NT.L7.R01</p>	<p>Comments: Internal ceiling. Concrete cracking. Surface staining.</p> <p>From location report: B1.NT.L7.ST01</p>

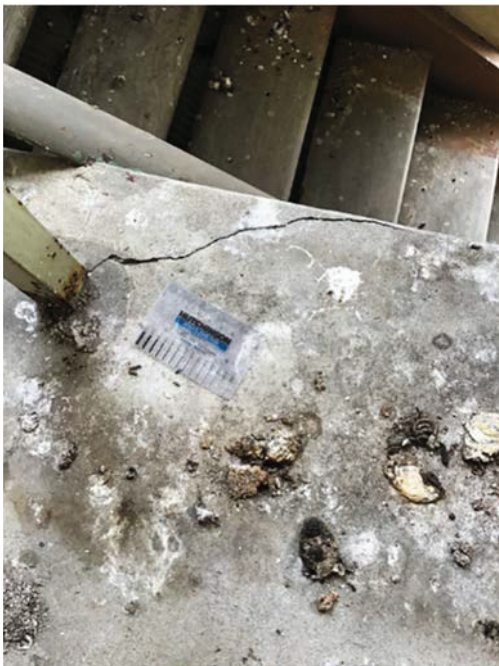
Photo 71

Comments: View of external balcony floor. Concrete cracking. Debris.

From location report: B1.NT.L4.B03

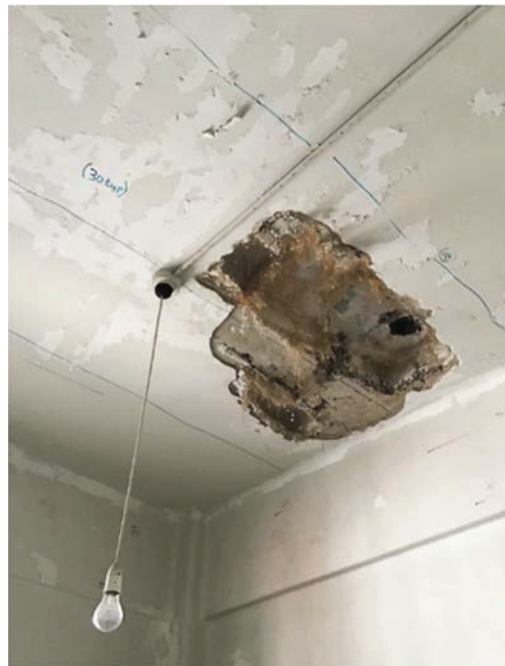
Photo 72

Comments: View of internal ceiling. Damage to ceiling cladding.

From location report: B1.NT.L3.R10

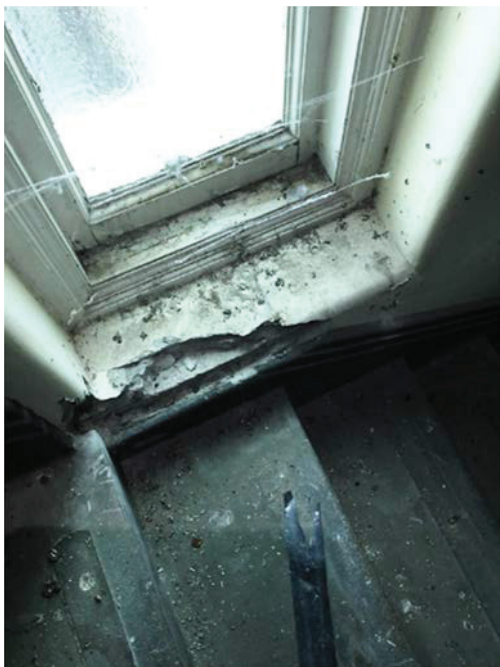
Photo 75

Comments: View of internal stair. Damage to concrete.

From location report: B1.NT.L4.ST01

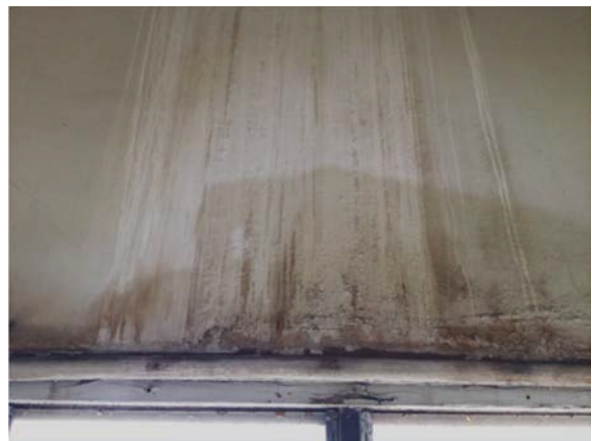
Photo 76

Comments: View of wall from inside. Surface / cladding staining, damage to cladding.

From location report: B1.NT.L3.R23

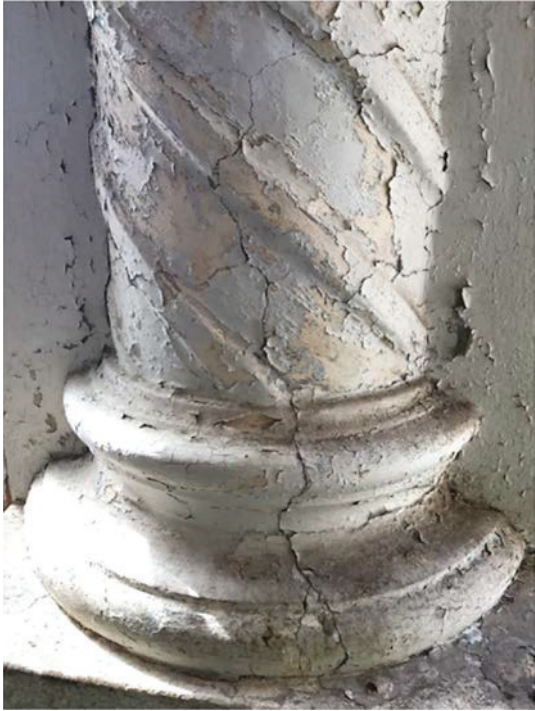
<p>Comments: View of external feature column. Damage to finishes, concrete cracking.</p> <p>From location report: B1.ST.L6.R29</p>	<p>Comments: View of external balcony ceiling. Concrete cracking, spalling, surface staining.</p> <p>From location report: B1.ST.L2.B02</p>

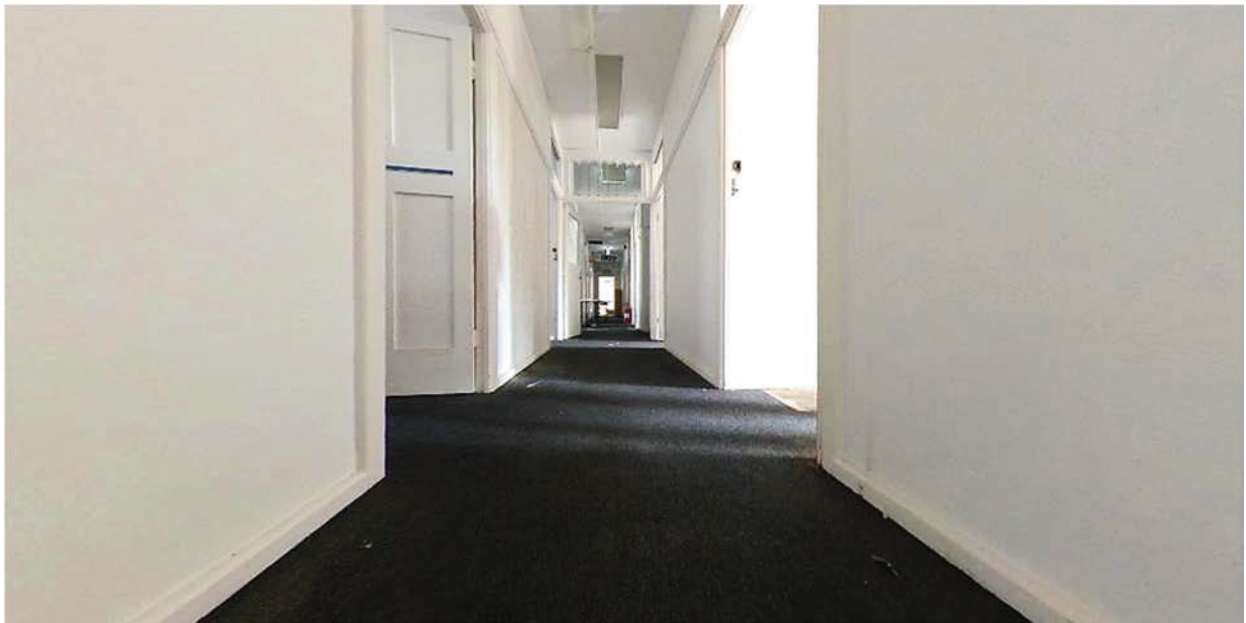
Photo 94

Comments: View of internal ground floor hallway.

From location: B2.GF.H01.01

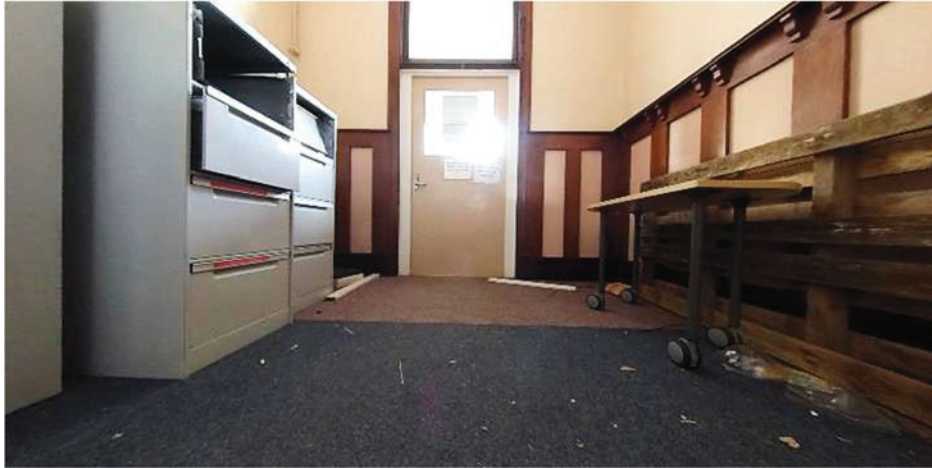
Photo 95

Comments: View of internal ground floor lobby. Some of the walls were not visible, blocked by objects.
From location: B2.GF.L01.02

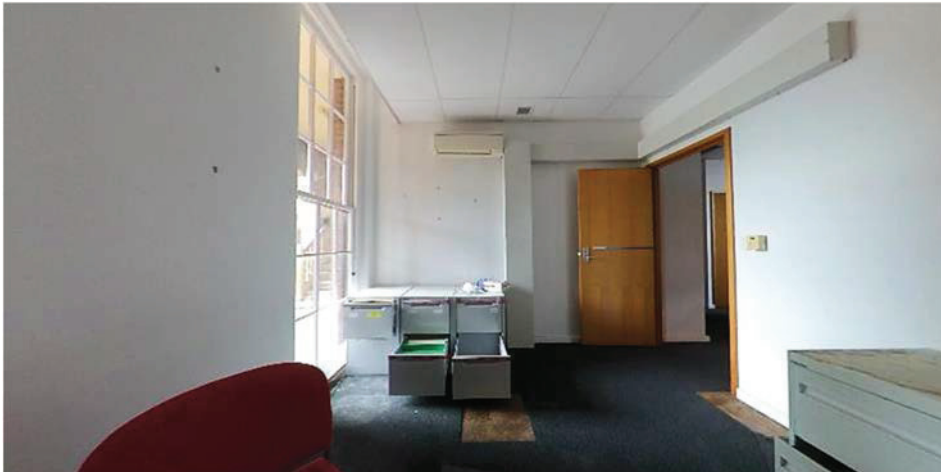
Photo 96

Comments: View of internal ground floor room.
From location: B2.GF.R02

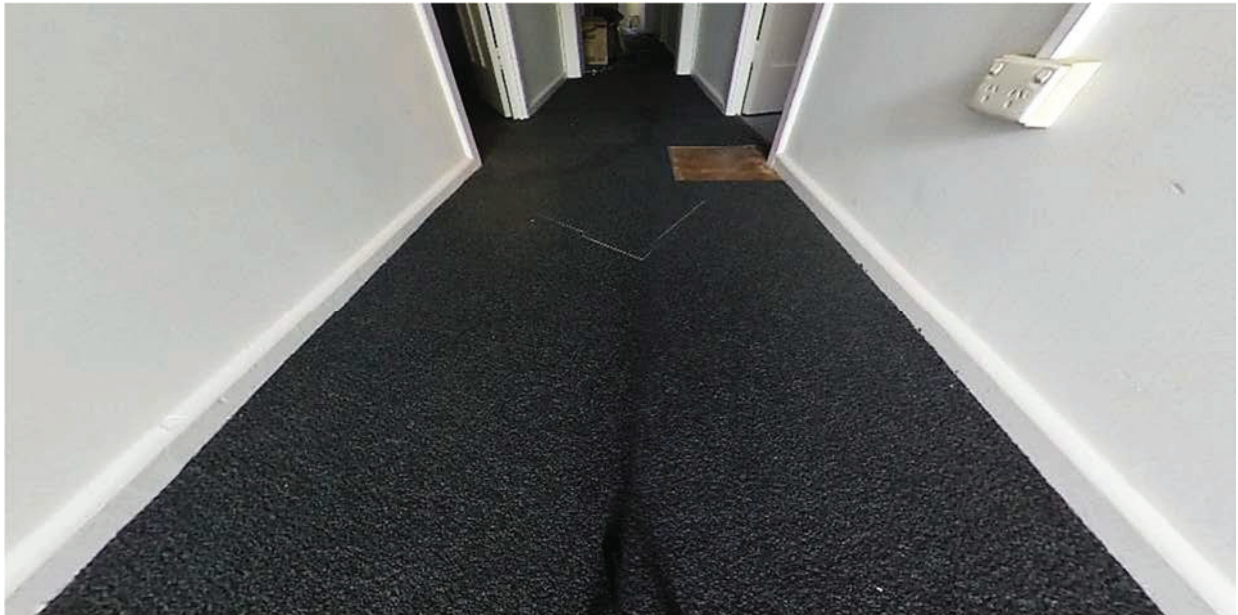
Photo 102

Comments: View of internal ground floor hallway. Carpet flooring.

From location: B2.GF.H03.04

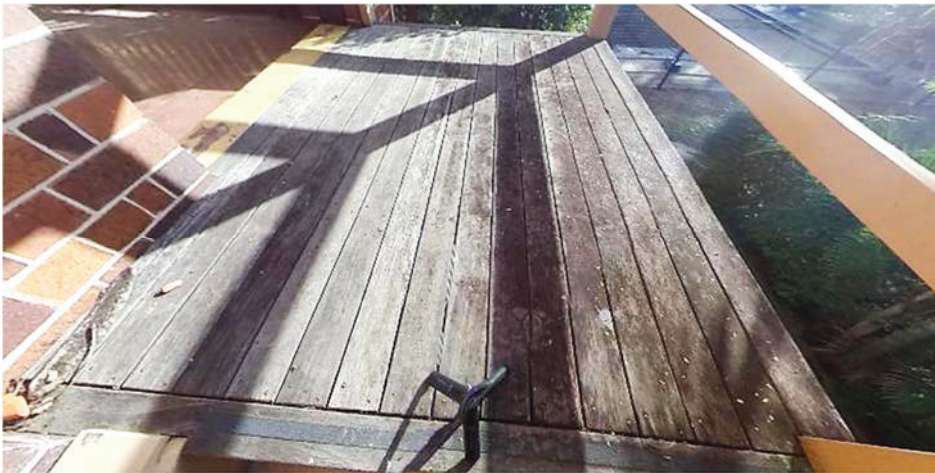
Photo 103

Comments: View of external stair landing timber floor. Signs of weathering of timber surface.
From location: B2.GF.ST05

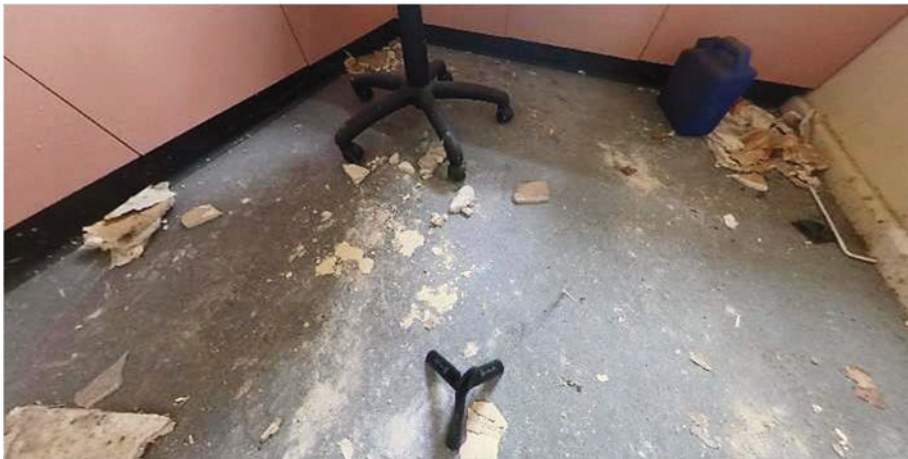
Photo 106

Comments: View of internal level 1 room flooring. Debris from collapsed section of ceiling over.
From location: B2.L1.R23

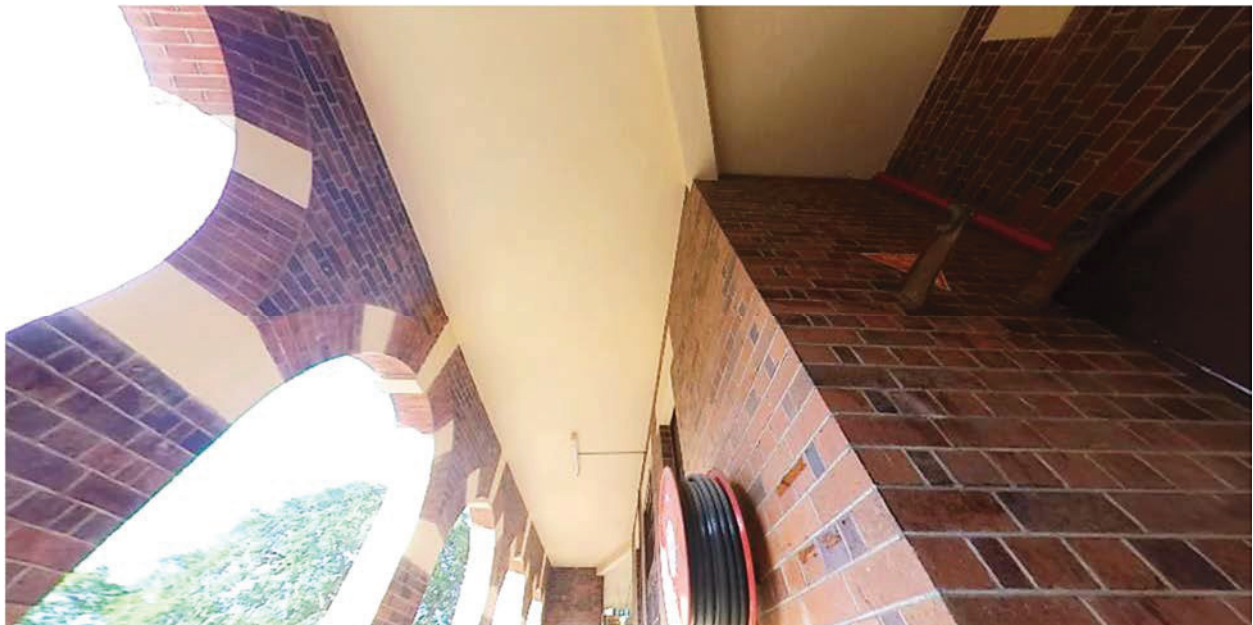
Photo 110

Comments: View of ground floor external balcony ceiling.

From location: B2.GF.B01.03

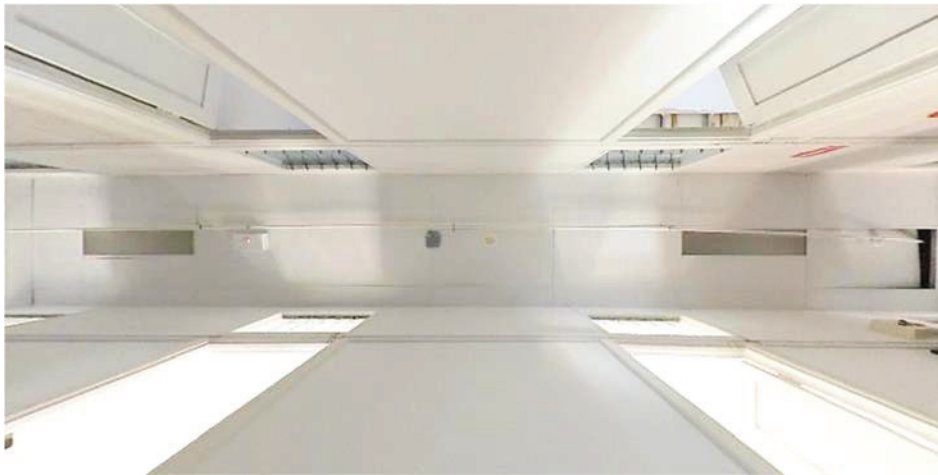
Photo 111

Comments: View of ground floor internal hallway ceiling.
From location: B2.GF.H01.01

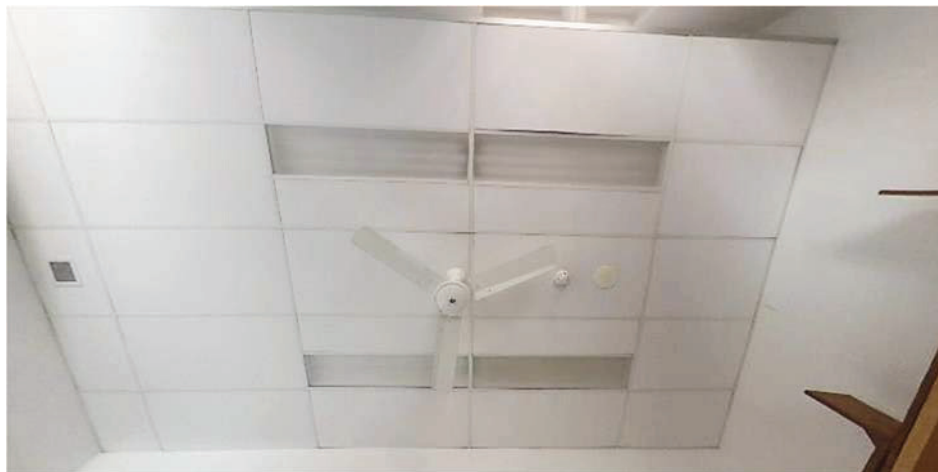
Photo 112

Comments: View of internal ground floor ceiling. General hung office ceiling.
From location: B2.GF.R02

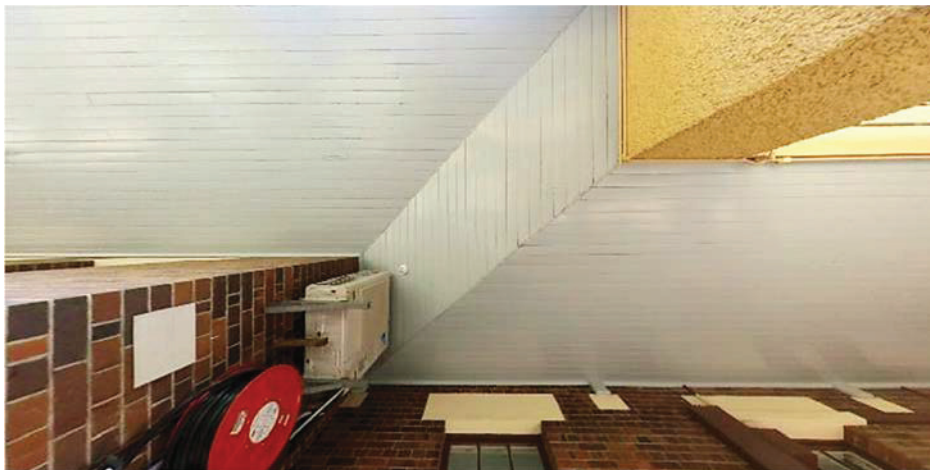
Photo 116

Comments: View of level 2 external balcony timber ceiling.

From location: B2.L2.B01.05

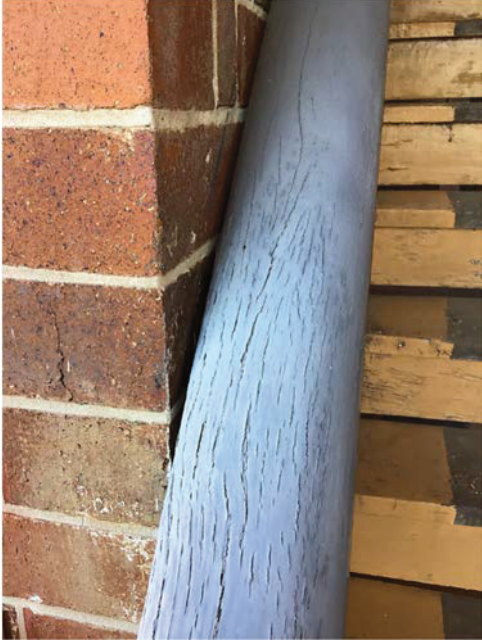
<p style="text-align: center;">Photo 117</p>

<p>Comments: Surface splitting of timber handrail. From location report: B2.L2.ST03</p>	<p>Comments: Surface damage, staining, mould damage. From location report: B2.L2.R31</p>
<p style="text-align: center;">Photo 119</p>

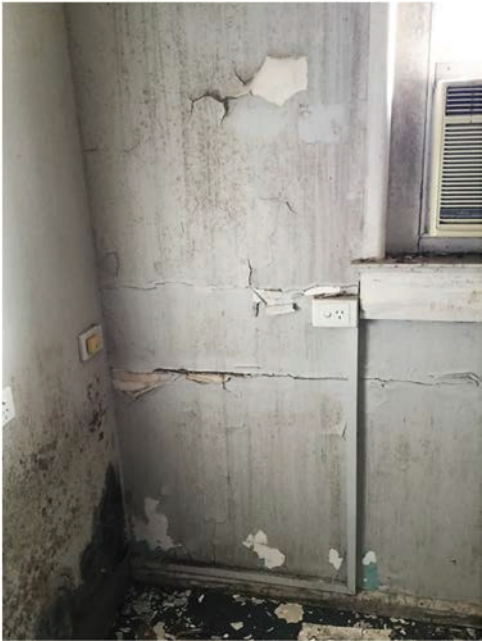
<p>Comments: Surface peeling, staining, mould damage. From location report: B2.L2.R23</p>	<p>Comments: Damage to wall, cracking. From location report: B2.L2.R20</p>

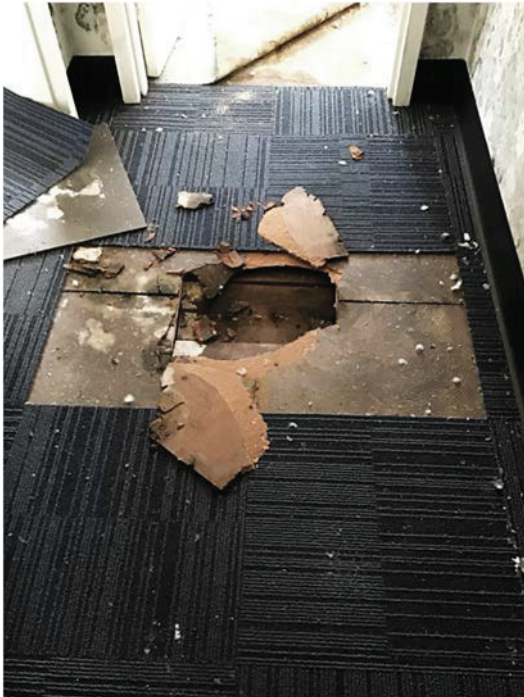
<p style="text-align: center;">Photo 125</p>

<p>Comments: Damaged floor finishes, flooring. From location report: B2.L2.H04</p>	<p>Comments: Damaged timber ceiling. From location report: B2.L2.B01</p>
<p style="text-align: center;">Photo 127</p>

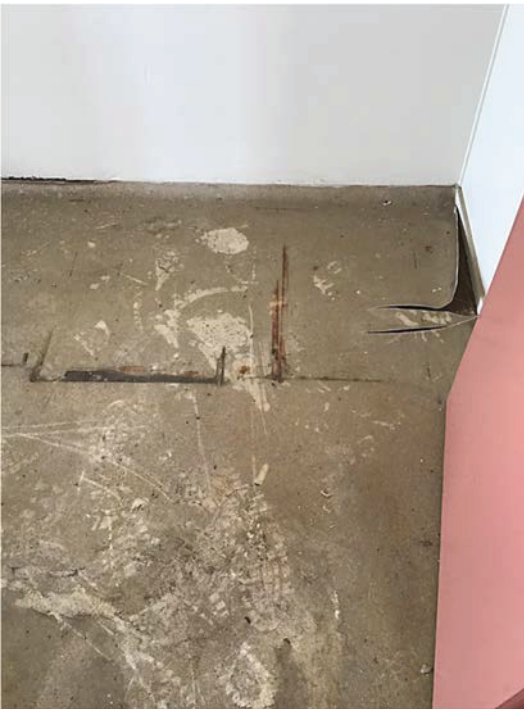
<p>Comments: Damage to floor finishes. From location report: B2.L1.R26</p>	<p>Comments: Ceiling damage, staining, mould. From location report: B2.L1.R23</p>

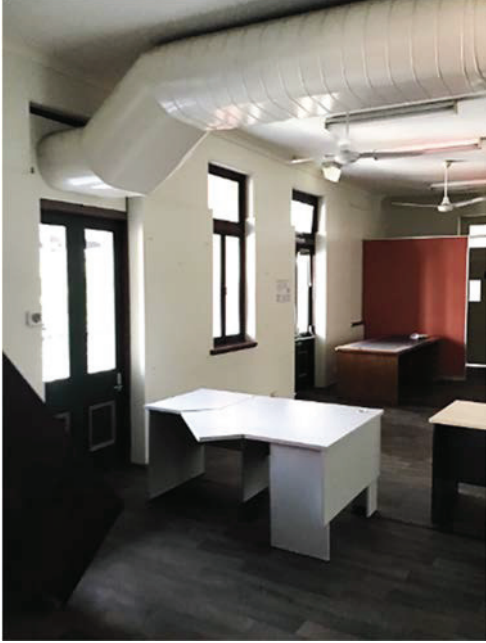
<p style="text-align: center;">Photo 133</p>

<p>Comments: General view of wall from inside. From location report: B3.GF.R13</p>	<p>Comments: View of external brick façade. Wear to surface finishes, peeling. From location report: B3.GF.R16</p>
<p style="text-align: center;">Photo 135</p>

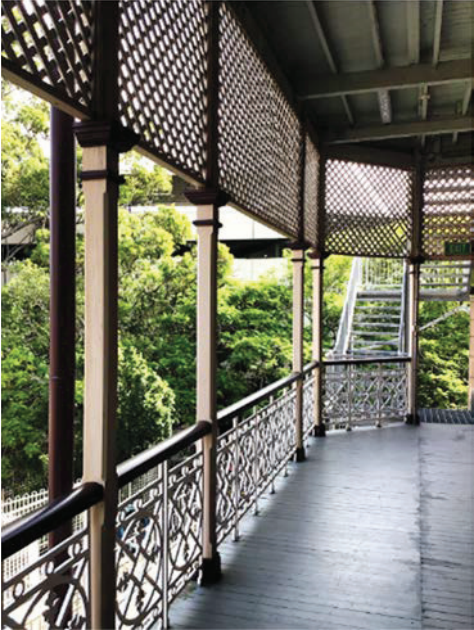
<p>Comments: View of external balcony balustrade. From location report: B3.GF.R16</p>	<p>Comments: View of internal timber stair balustrade. From location report: B3.L1.ST01</p>
