Herston Quarter Heritage Precinct

Heritage Building
Dilapidation Report

Prepared for Australian Unity

24 May 2019

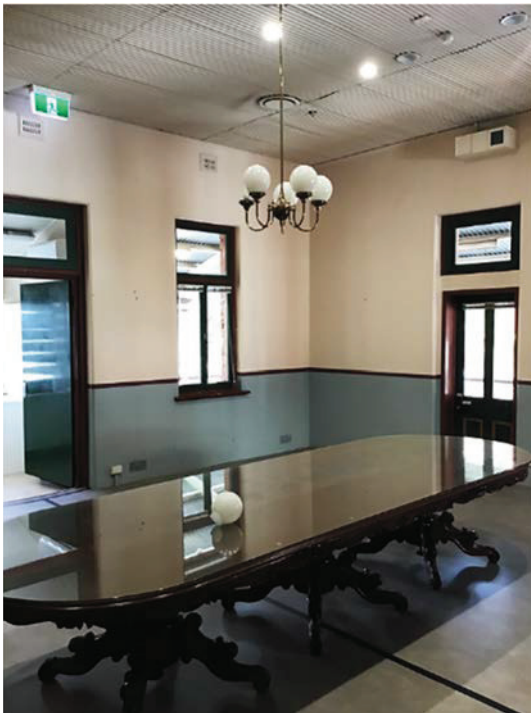
Photo 137

Comments: View of internal wall cladding.
From location report: B3.L1.R07

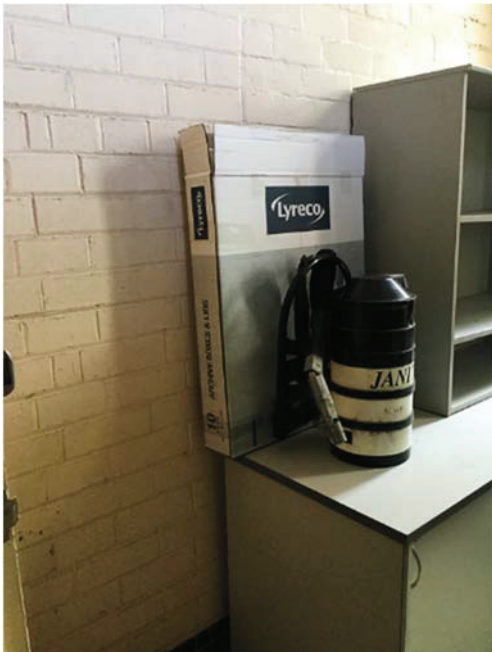
Photo 139

Comments: Internal view of brick wall. Areas partially covered up by fixtures.
From location report: B3.GF.R02

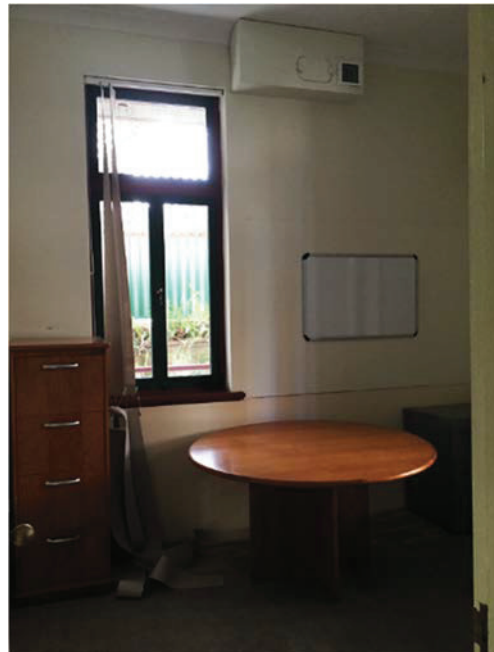
Photo 140

Comments: General view of wall from inside.
From location report: B3.GF.R09

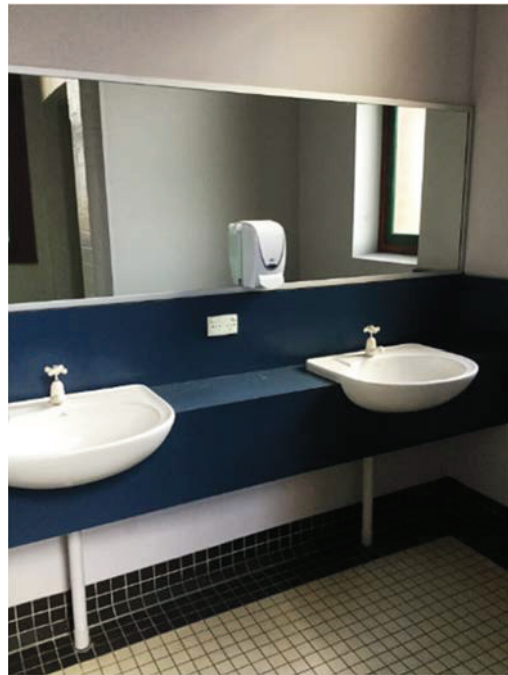
Photo 142

Comments: View of internal restroom wall.

From location report: B3.GF.R14

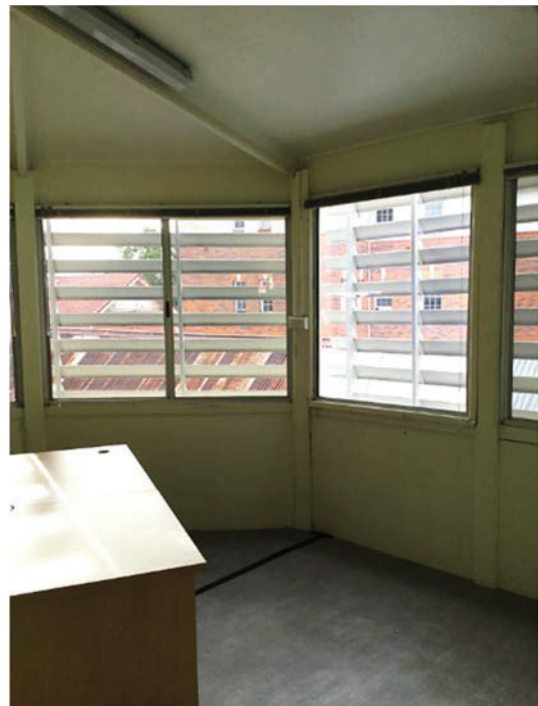
Photo 144

Comments: General view of wall from inside. Louvre system externally.

From location report: B3.L1.R14

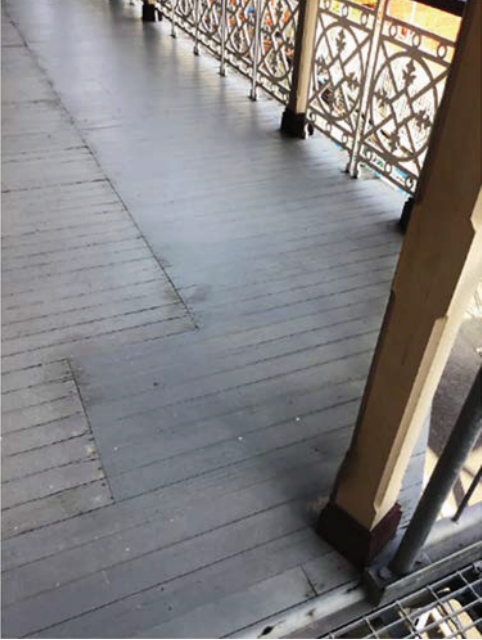
<p style="text-align: center;">Photo 146</p>

<p>Comments: Internal laminate flooring. From location report: B3.GF.R13</p>	<p>Comments: External balcony decking. Signs of wear. From location report: B3.GF.R16</p>
<p style="text-align: center;">Photo 147</p>

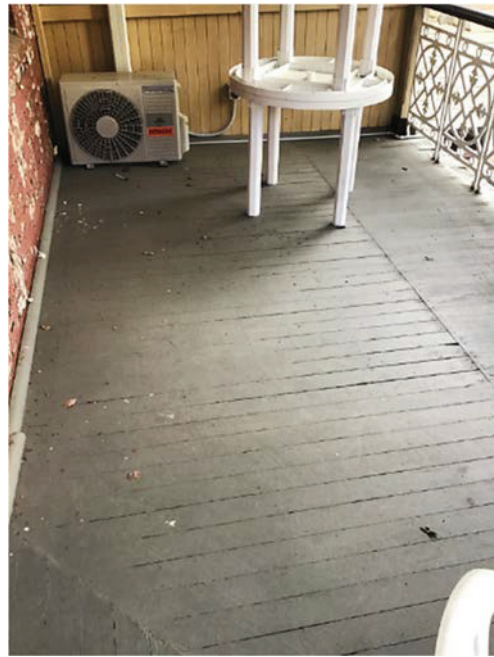
Photo 150

Comments: External balcony decking. Signs of wear.
From location report: B3.L1.R18

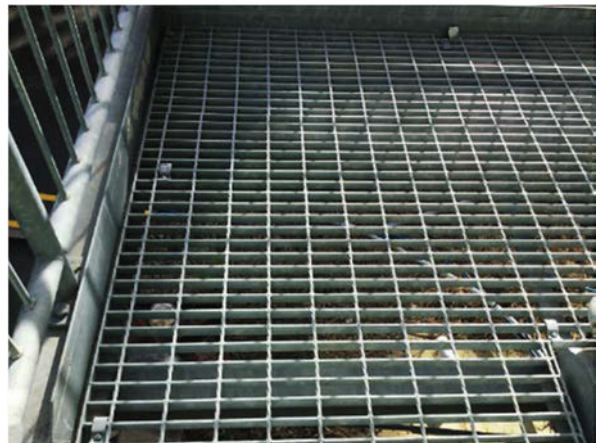
Photo 152

Comments: External stair floor grating, galvanised.
From location report: B3.GF.ST02

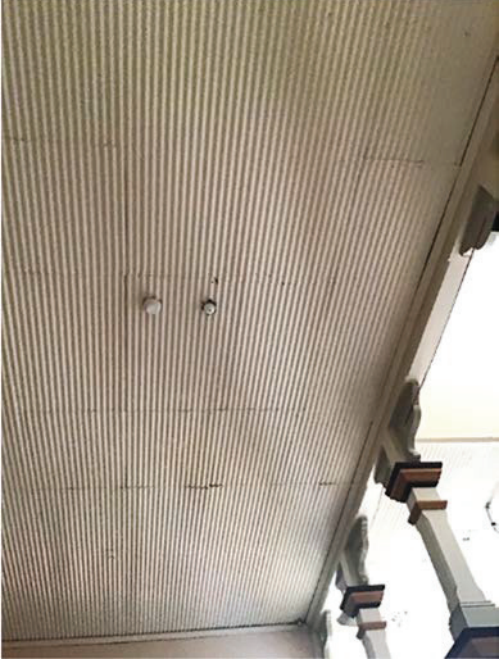
<p style="text-align: center;">Photo 160</p>

<p>Comments: External view of timber balcony ceiling. From location report: B3.GF.R16</p>	<p>Comments: Internal ceiling view at stairs. Minor sheeting separation. From location report: B3.L1.ST01</p>

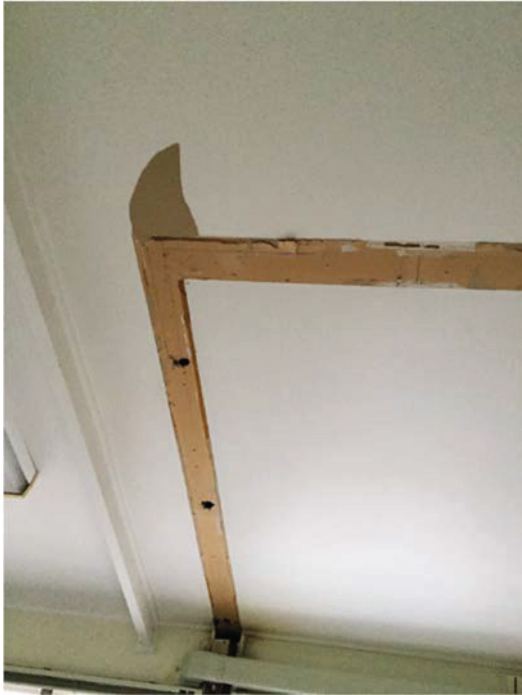
Photo 165

Comments: View of internal room ceiling with removed fixture.

From location report: B3.L1.R16

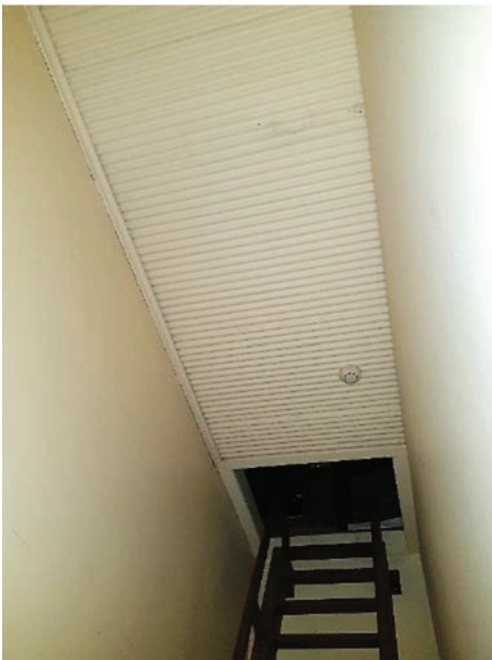
Photo 167

Comments: View of internal ceiling with access hatch + steel stairs.

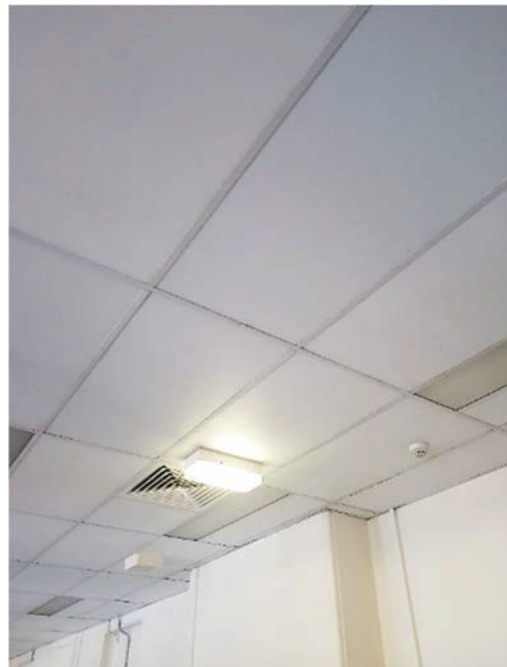
Photo 168

Comments: View of internal office ceiling. Hung ceiling.

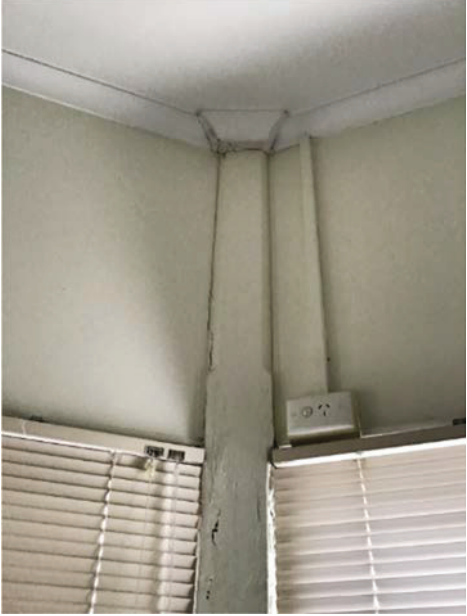
<p style="text-align: center;">Photo 169</p>

<p>Comments: Minor cracking of paintwork. From location report: B3.GF.R17</p>	<p>Comments: Cracking / peeling of external brick façade. Minor wear of timber door cladding at base. From location report: B3.GF.R16</p>
<p style="text-align: center;">Photo 171</p>

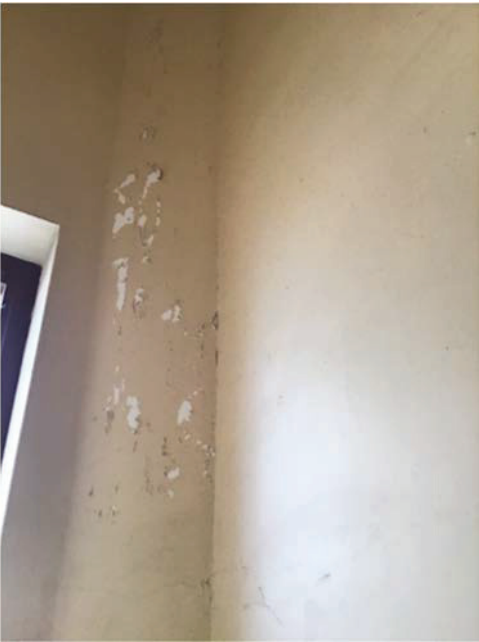
<p>Comments: Internal wall. Wear of finishes. Paint peeling. From location report: B3.L1.R02</p>	<p>Comments: Internal restroom floor. Removed tile. From location report: B3.GF.R15</p>

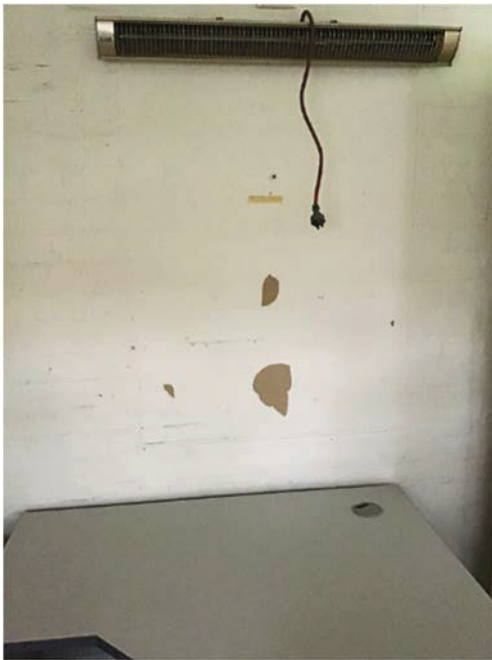
Photo 173

Comments: View of internal wall. Minor damage to finishes.

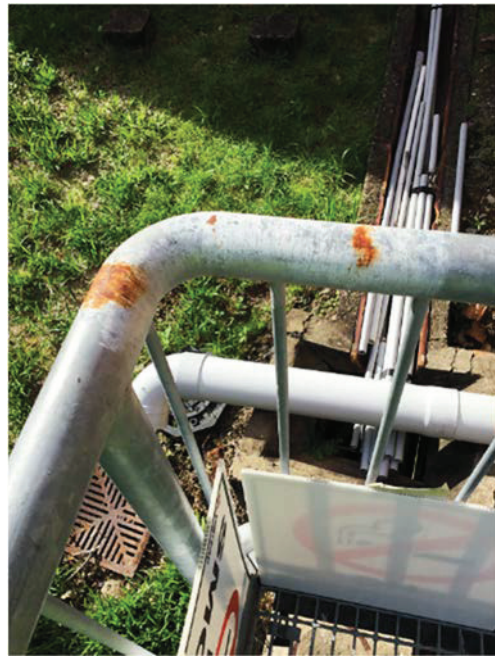
Photo 174

Comments: View of external steel stairs. Minor corrosion.

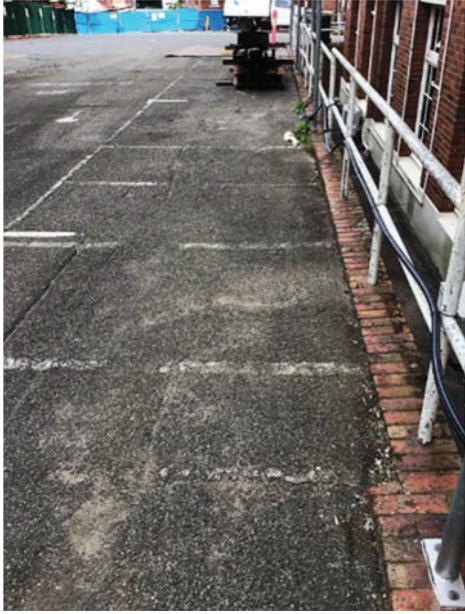
<p style="text-align: center;">Photo 193</p>

<p>Comments: Lady Lamington external barrier fence. General surface wear observed.</p> <p>From location report: E.Z14</p>	<p>Comments: Edith Cavell external barrier fence. General surface wear, rust stains.</p> <p>From location report: E.Z13</p>
<p style="text-align: center;">Photo 195</p>

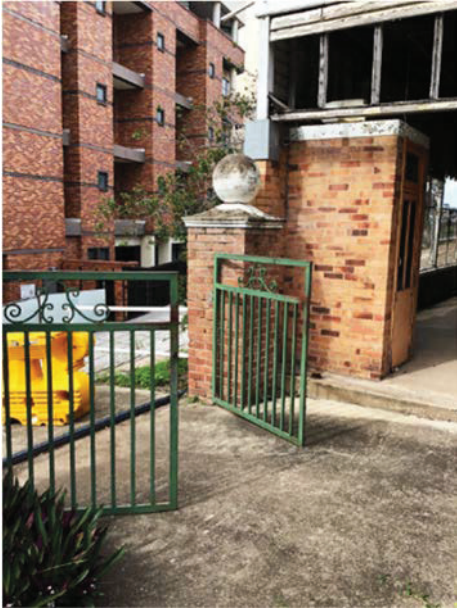
<p>Comments: External steel gates. Surface wear, rust marks.</p> <p>From location report: E.Z05</p>	<p>Comments: External chain wire fence near Edith Cavell building.</p> <p>From location report: E.Z28</p>

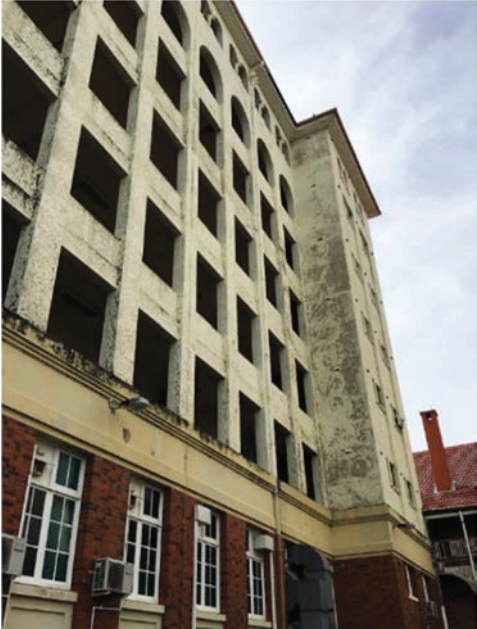
<p style="text-align: center;">Photo 209</p>

<p>Comments: General view of Lady Lamington tower façade. Visually noticeable wear of finishes.</p> <p>From location report: E.Z14</p>	<p>Comments: General view of Lady Lamington tower façade. Visually noticeable wear of finishes.</p> <p>From location report: E.Z13</p>
<p style="text-align: center;">Photo 211</p>

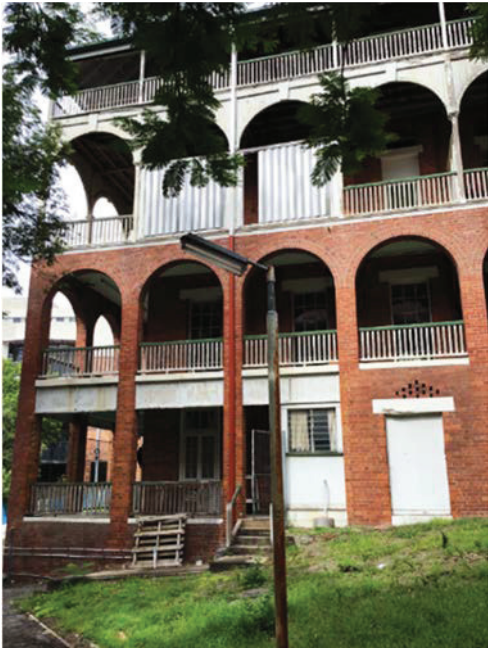
<p>Comments: General view of Lady Lamington wing façade.</p> <p>From location report: E.Z07</p>	<p>Comments: General view of Lady Lamington wing façade. Visible wear of finishes, timber.</p> <p>From location report: E.Z10</p>

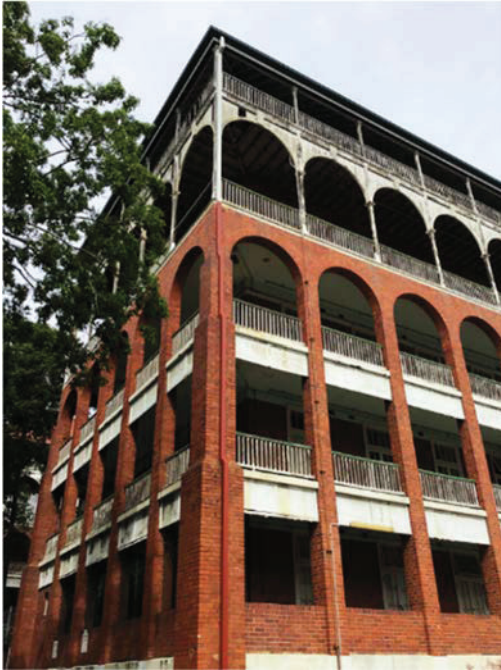
Photo 213

Comments: General view of Lady Lamington wing façade. Visible wear of finishes, timber.

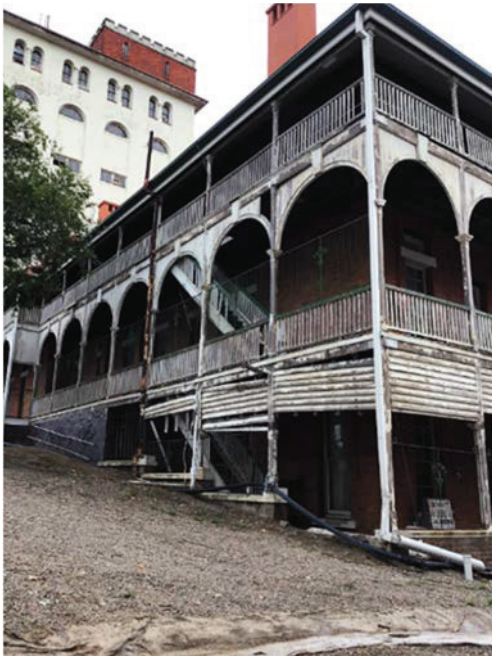
Photo 215

Comments: General view of Lady Lamington wing façade. Visible wear of finishes, timber. Damage to timber façade.

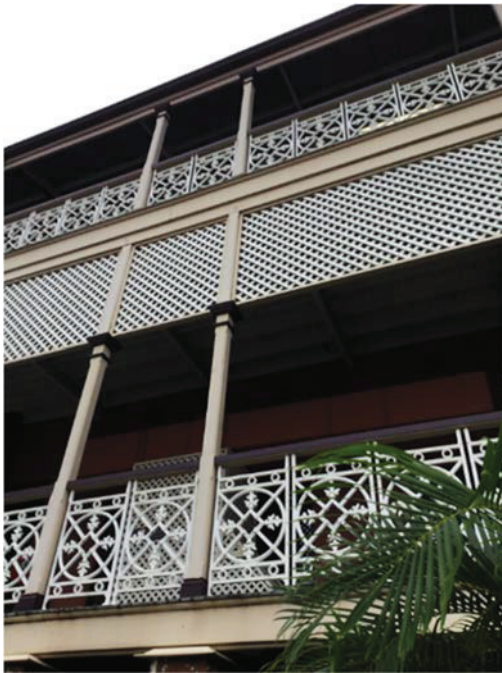
Photo 217

Comments: General view of Lady Norman wing façade.

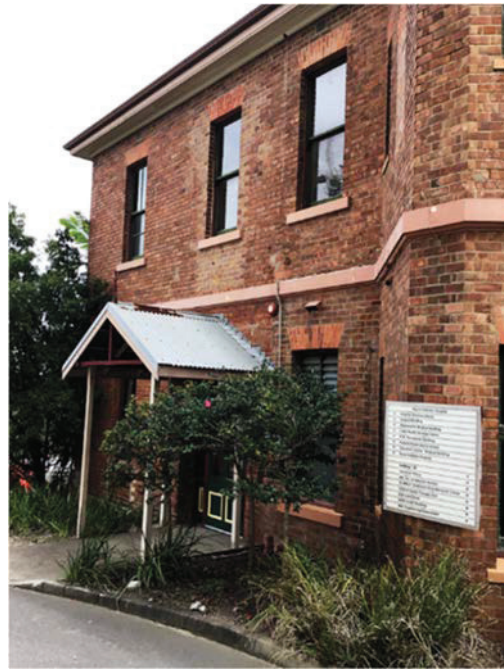
Photo 218

Comments: General view of Lady Norman wing façade.

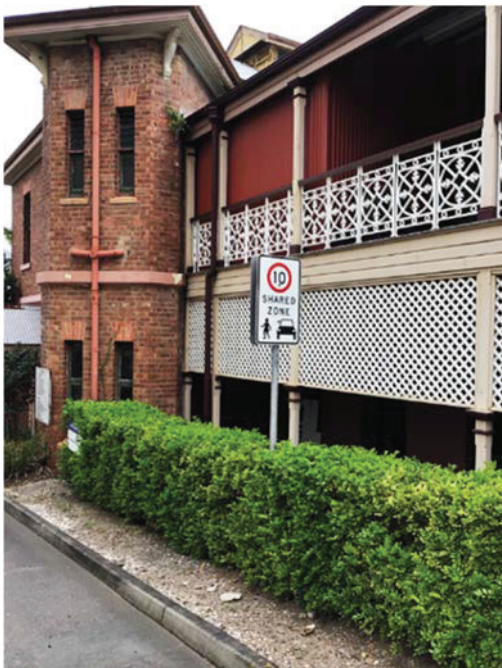
Photo 219

Comments: General view of Lady Norman wing façade.

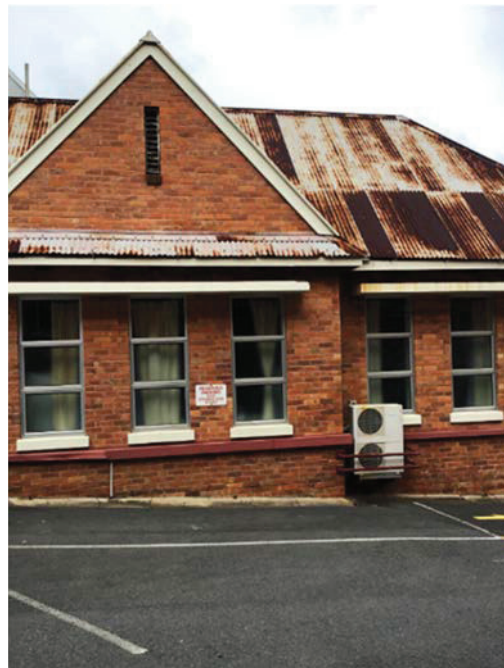
Photo 220

Comments: General view of Lady Norman wing façade. Visible wear to finishes, extensive rust to roof sheeting.

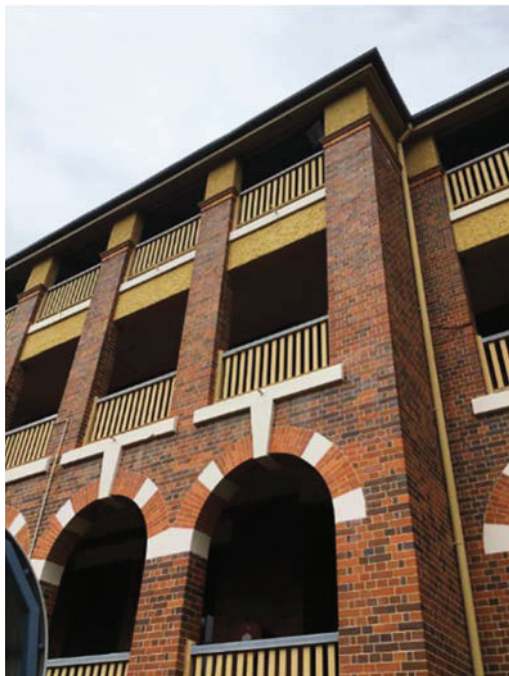
Photo 223

Comments: General view of Edith Cavell building façade.

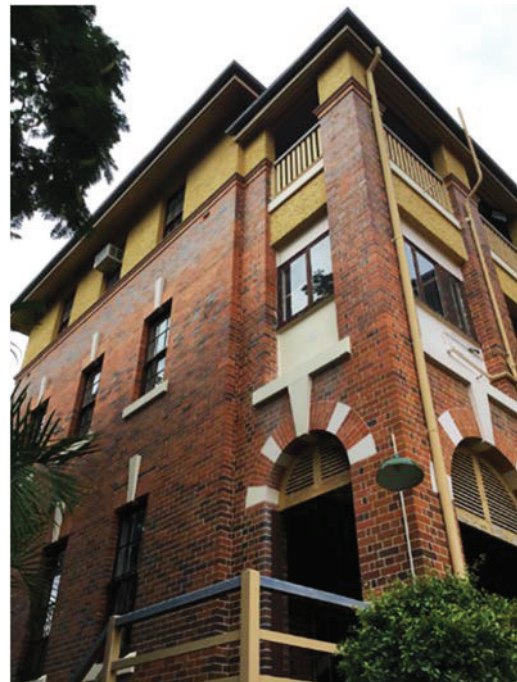
Photo 224

Comments: General view of Edith Cavell building façade.
