**RE: YERONGA TAFE VEGETATION SURVEY**

## ARBORIST REPORT

**Project Address:** Yeronga TAFE  
70 Park Road  
Yeronga, QLD, 4104

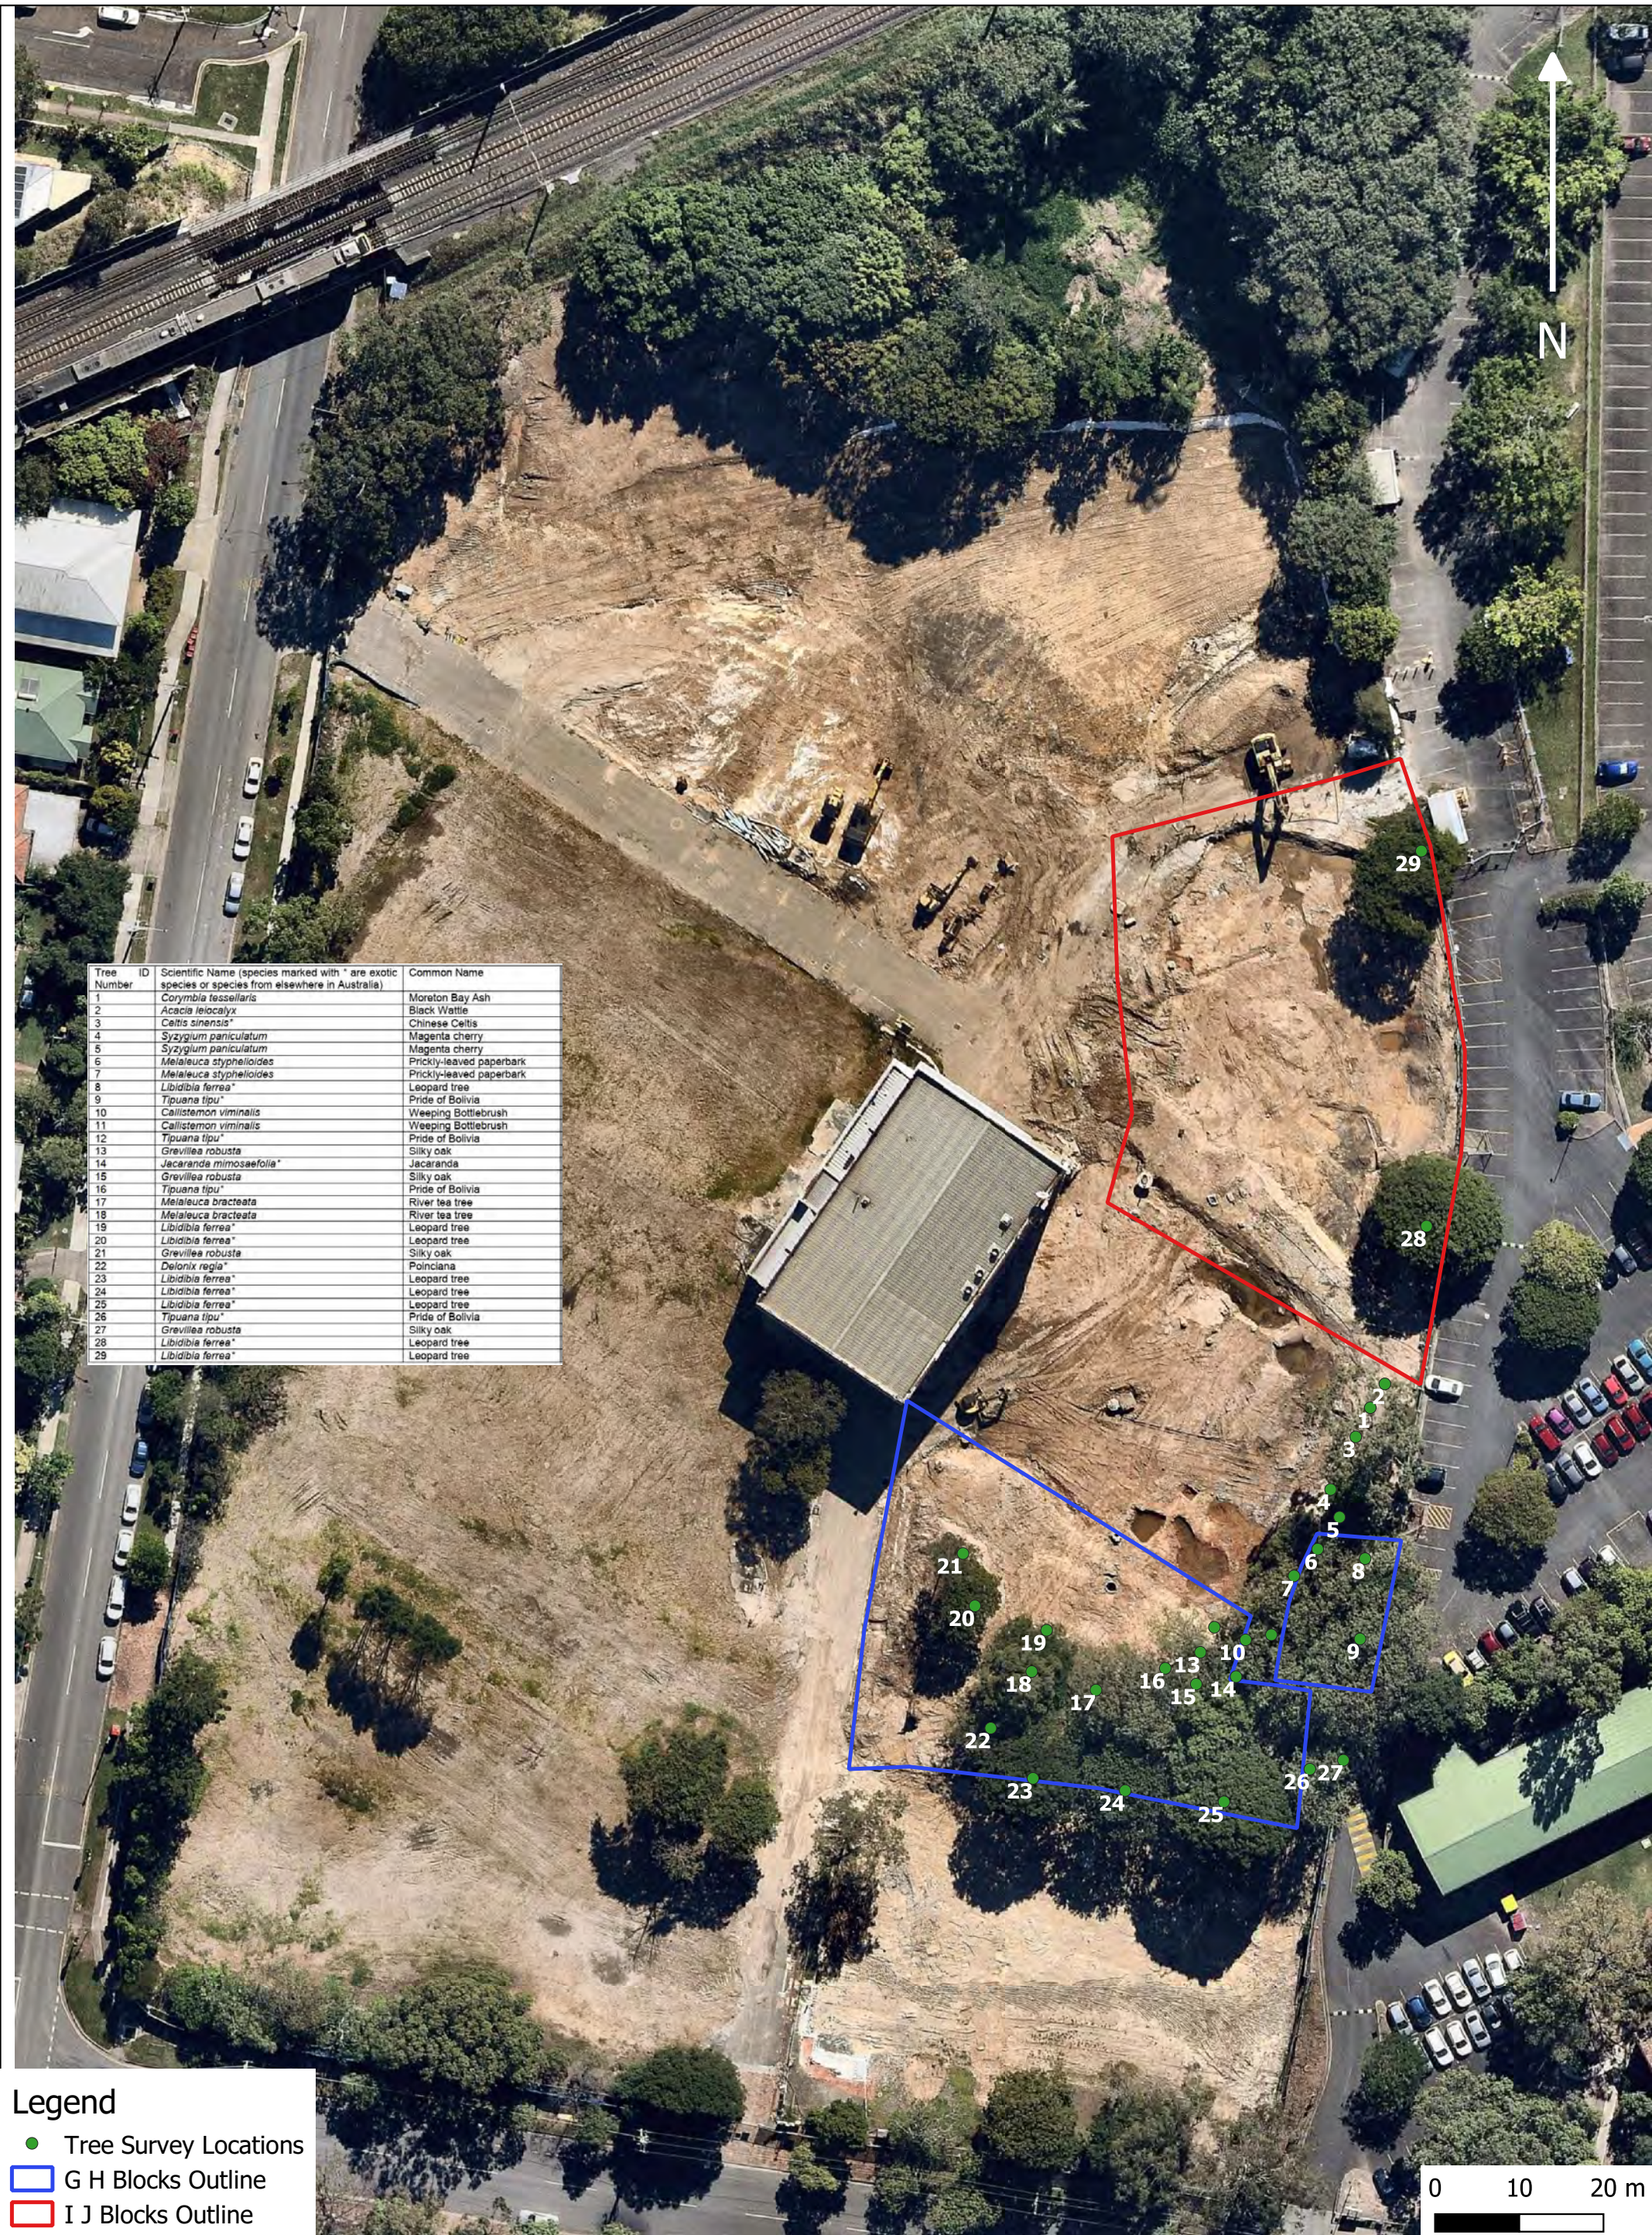
## **Figure 1 – Tree location**

To meet the current remediation objectives of the site it is understood all contaminated soil is required to be removed, including the soil under and around the trees within the remediation areas (Figure 1). It is also understood all trees within the remediation areas are growing within contaminated soil. To achieve the remediation objective it does not appear feasible to retain the trees as it is not feasible or practical to remove and replace
