22 November 2019  
Our File Ref: B19289EL001 Revised  
Contact: Joseph Toon

**RE: YERONGA TAFE VEGETATION SURVEY**

## ARBORIST REPORT

**Project Address:** Yeronga TAFE  
70 Park Road  
Yeronga, QLD, 4104

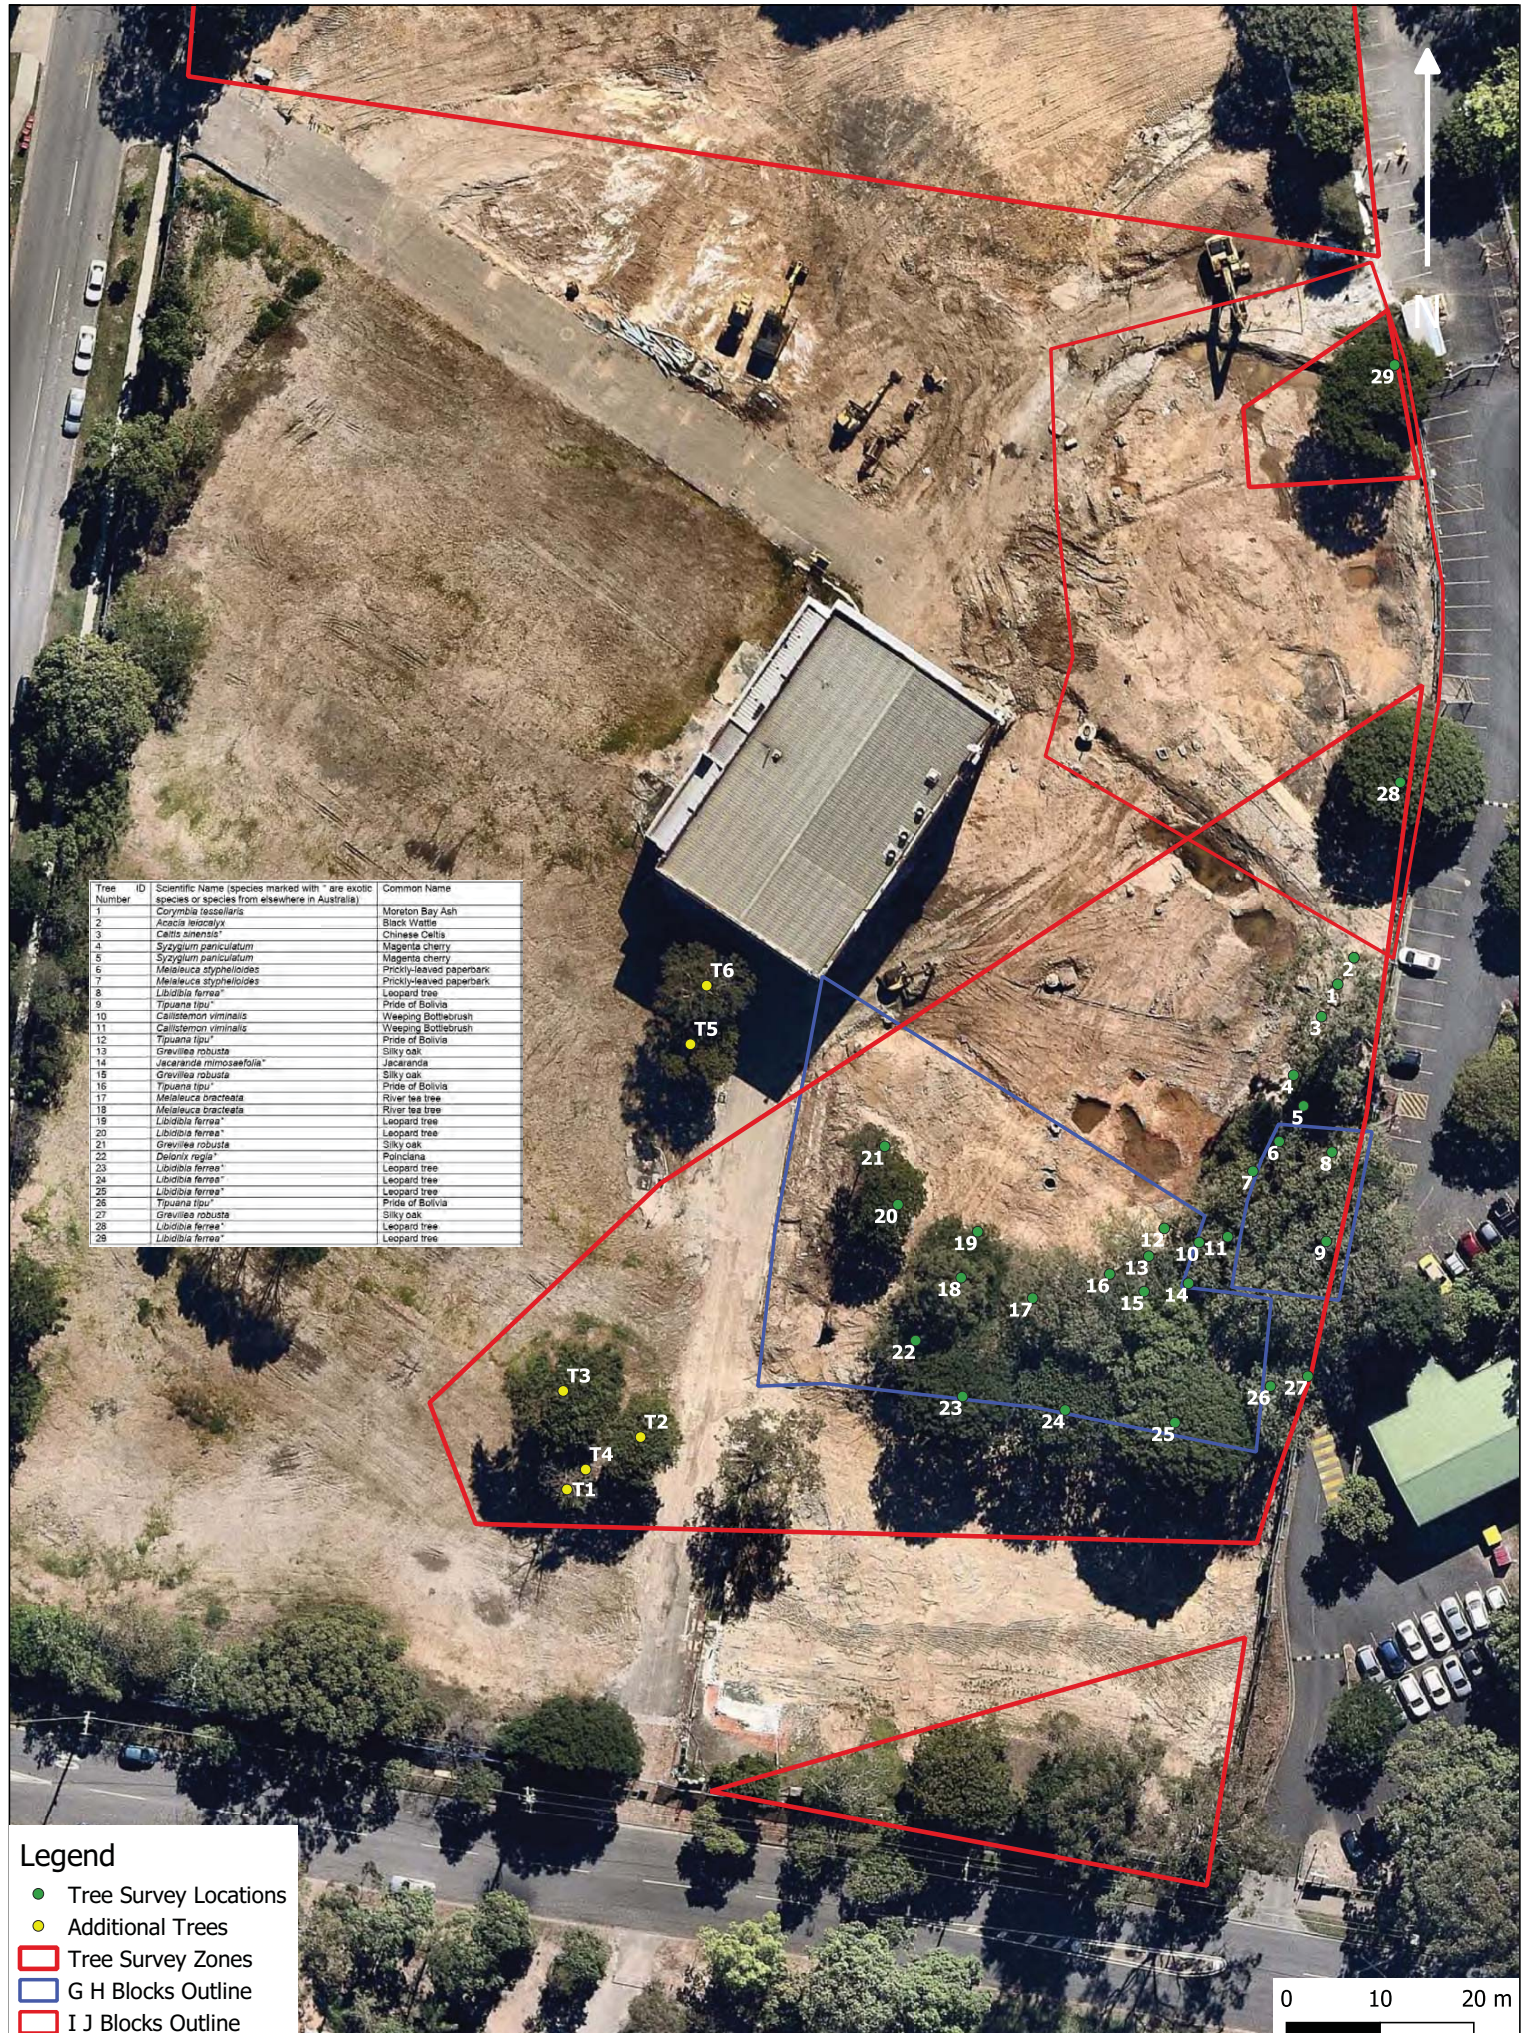
## **Figure 1 – Tree location**

A Level 5 AQF Qualified Arborist undertook the site investigation on 10 June 2019. Trees greater than 4 m in height and 10cm dbh were recorded. A total of 29 trees were identified within the remediation areas (Figure 1, Attachment A). Summarised in Table 1 and detailed in Attachment A, these trees include native and exotic species in fair to good health with some planted and some self-seeded. Of these 29 trees, one is listed as a Category 3 weed (Tree #3, *Celtis sinensis*, Chinese Elm).

Subsequent to the assessment undertaken in June, additional trees were identified for removal in November 2019 (T1-T6, Table 1) (Figure1). Although not assessed by an arborist, these generally appear to be in poor health or dead.

To meet the current remediation objectives of the site it is understood all contaminated soil is required to be removed, including the soil under and around the trees within the remediation areas (Figure 1). It is also understood all trees within the remediation areas are growing within contaminated soil. To achieve the remediation objective it does not appear feasible to retain the trees as it is not feasible or practical to remove and replace all soil from around the trees. (Please note the remediation area boundaries are indicative and have been drawn in from provided drawings.)
