## OAKS MEWS APARTMENTS BOWEN HILLS, QLD

### Stormwater Management Plan

**Oaks Mews Apartments**  
**141 Campbell Street**  
**Bowen Hills QLD 4006**

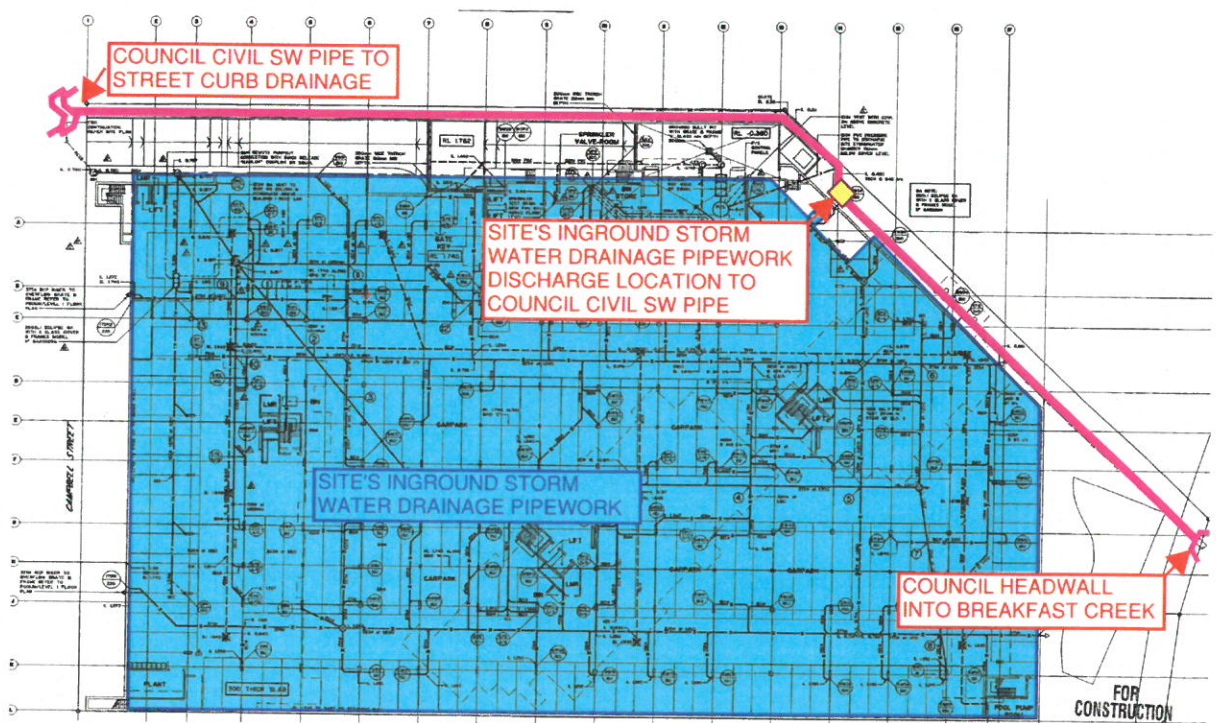
**Figure 1.0 – Site Drainage Discharge Plan**

As detailed in figure 1.0, the entire site's stormwater is conventionally drained via a network of inground pipework below the basement carpark and discharges into the Council's SW pit on the north-west side of the property. This pit is also fed by upstream curb side road drainage. There is a Ø900 Council SW outlet pipe that runs inground to a headwall within Breakfast Creek.

Syfon Systems investigation found that the existing Council headwall was 90-95% blocked with Mangroves which would have significantly contributed to the site inground pipework backing up and flooding the basement.

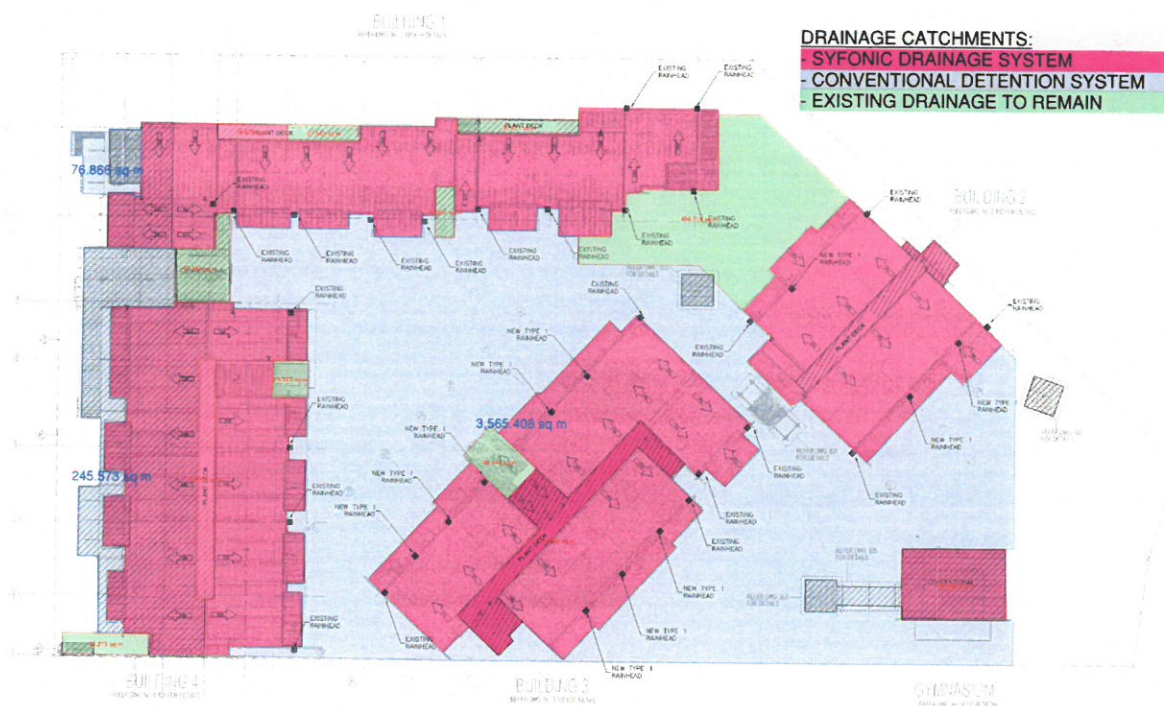
**Figure 2.0 – SITE PROPOSED DRAINAGE PLAN**

The new drainage solution consists of a network of new Syfonic Roof Drainage Systems that drains the upper roof's of the 5x Apartments as well as a Conventional Drainage Detention System that drains the Podium deck and low level roofs. Refer to figure 2.0.

Both the Syfonic and Conventional Detention Systems connect into a new Ø560 Stormwater Pit and Inground that discharges into the Breakfast Creek via a new headwall.

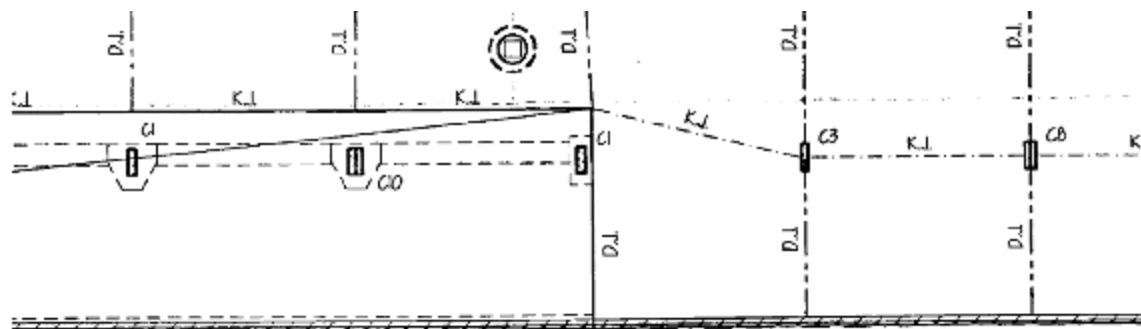
Figure 1 – Extract of the Basement Slab Plan showing the slab and subsurface design

The slab depth varied considerably between 75mm and 250mm thick with the average slab thickness being around 100mm. A review of the structural engineering documentation confirmed that the slab was designed to be 100mm thick, constructed on a waterproof membrane/geofabric/150mm drainage gravel layer/geofabric with 75mm diameter agi lines on an 8.0m grid. This profile has been adopted to manage sub-surface water ingress – this may or may not have been noted during the soils investigation. The profile adopted is used to manage water in tidal zones as a method of managing water ingress (flooding) above slab level. For this system to work the stormwater outfall must be free-draining or pumped away from the basement and the water ingress rate from the sub-surface soil profile must be less than the capacity of the pipe

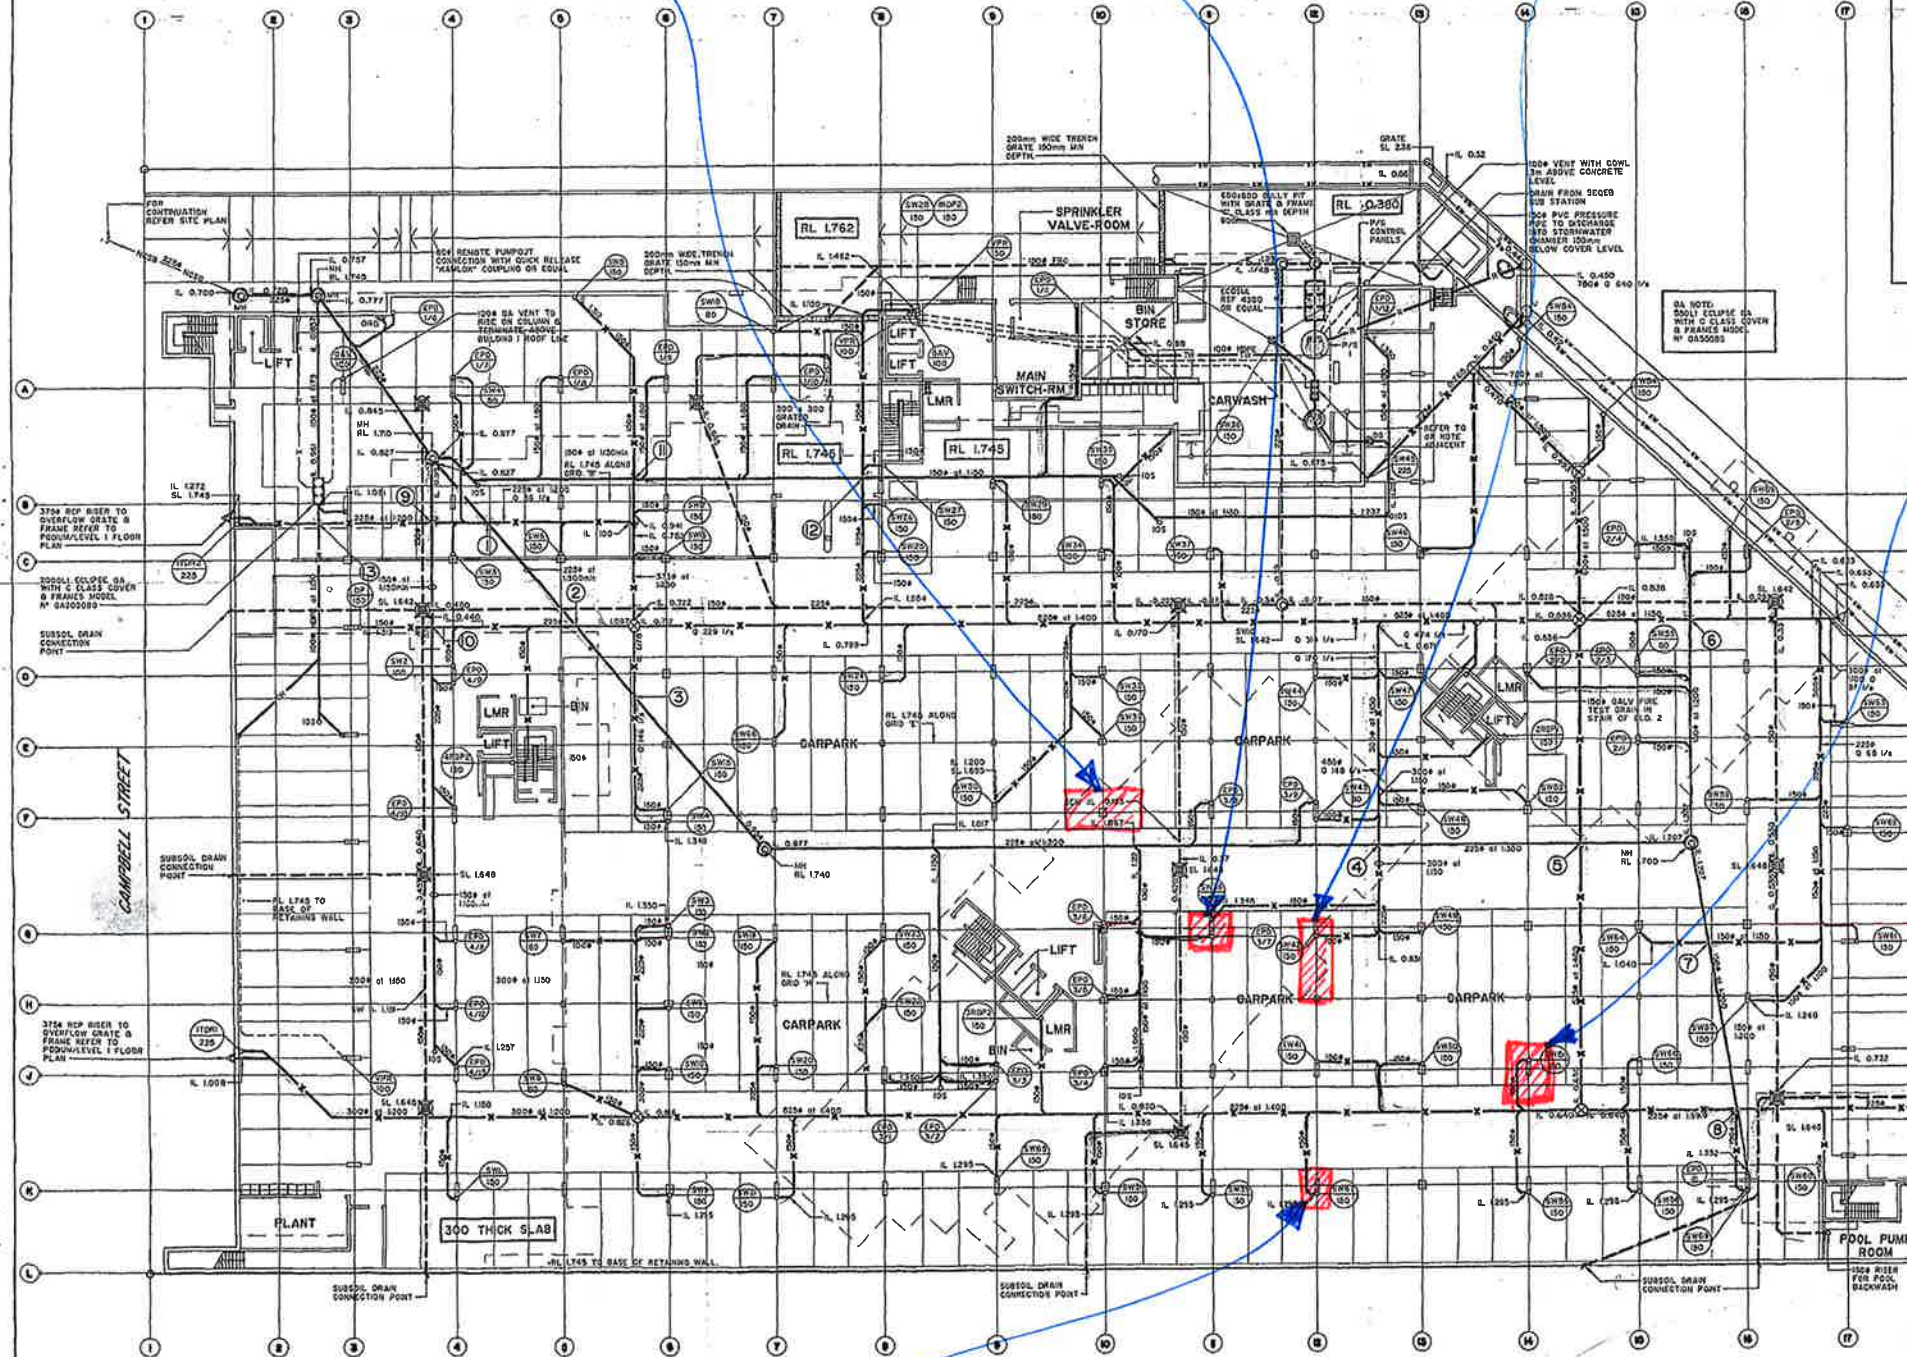
SLAB INVESTIGATION LOCATIONS

Based on reviews of the available documentation, observed defects and cost limitations and following a site inspection and meeting with the contractor, five (5) locations were selected for and invasive investigation. This work included saw-cutting and removal of the existing basement slab on ground and some subgrade material. The five (5) locations selected for the investigation are identified on the Slab Investigation Locations plan attached in Appendix A.

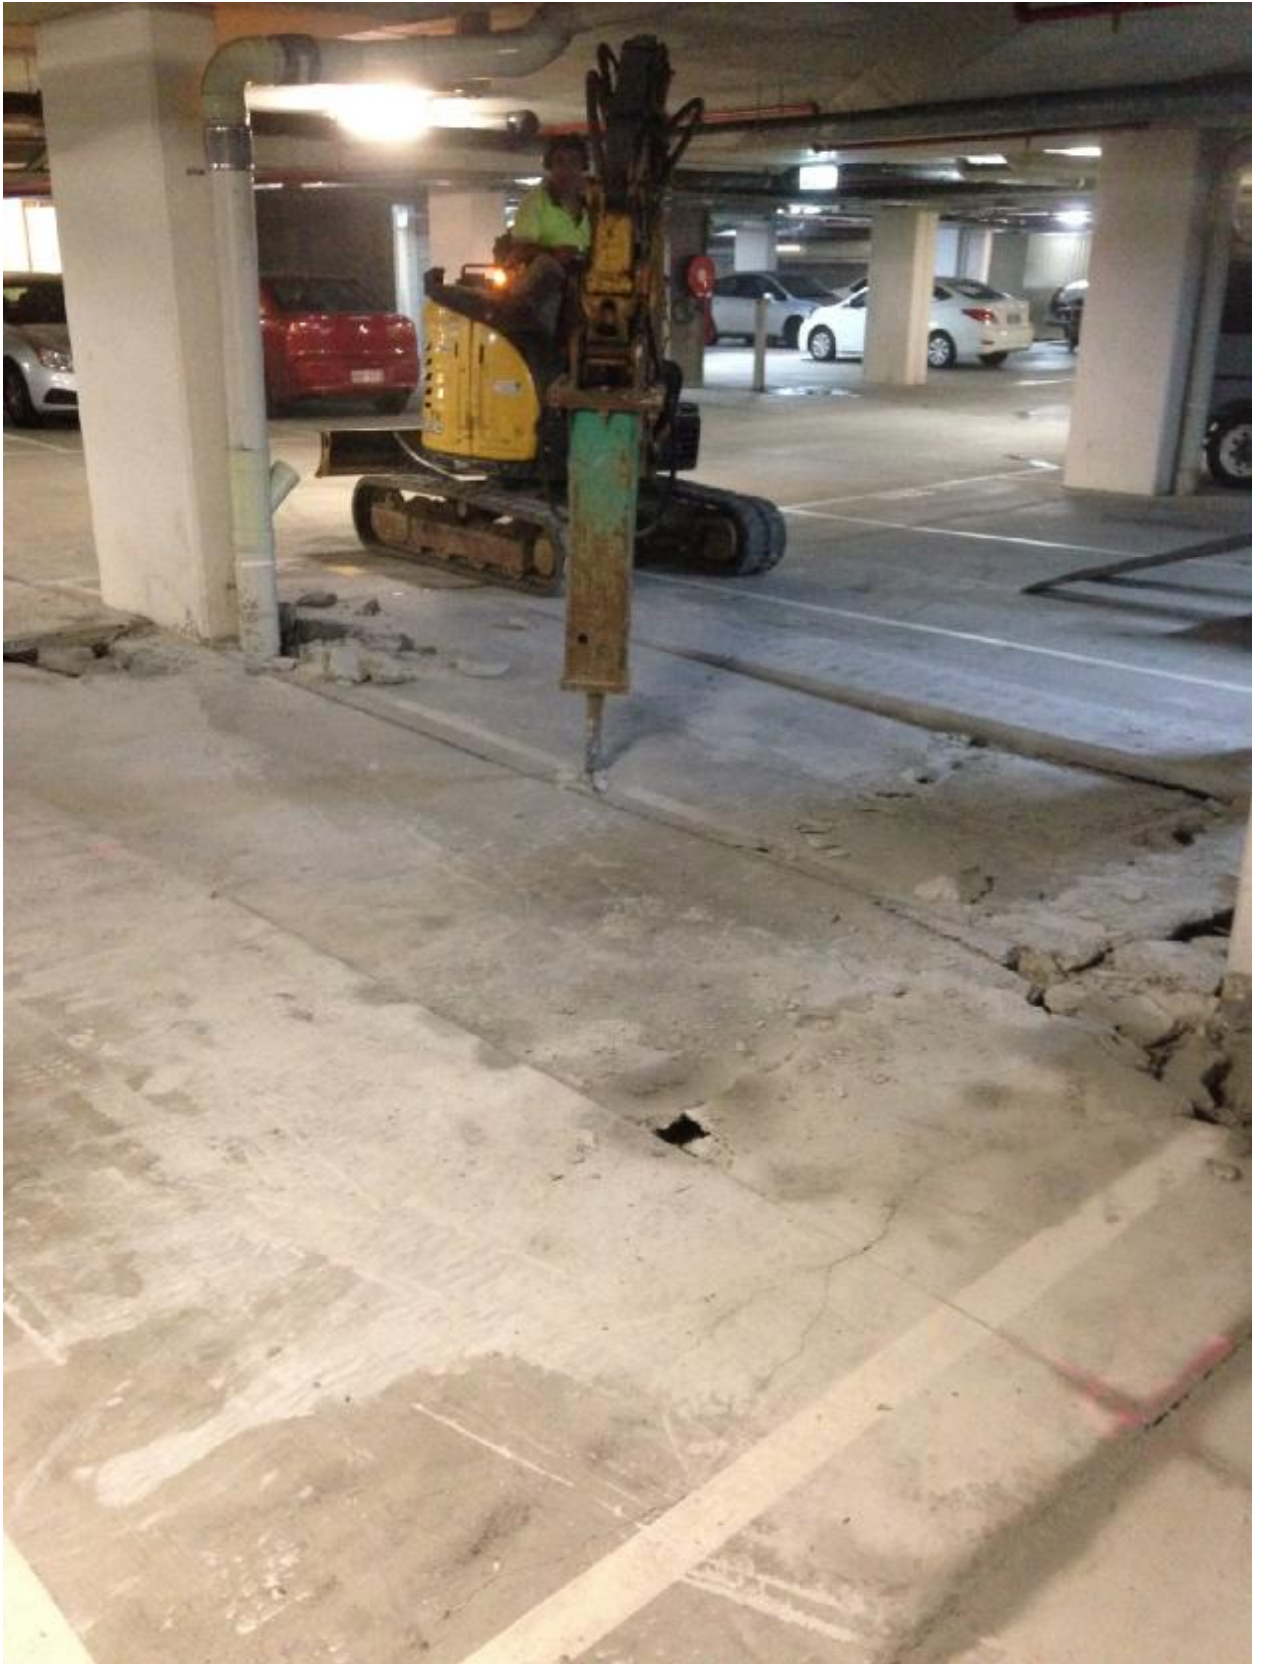
- There was a void under slab;
- The 150mm diameter roof-water pipe at this location was broken at a joint under the slab;
- We noted that the slab was cast on plastic on a sandy gravel layer with a geofabric layer underneath – we did not observe any geofabric layer under the slab as nominated in the design and the gravel was contaminated;
- The broken pipe was repaired prior to repouring the slab; and
- Once the slab was removed the surrounding slab dropped. Some further saw cutting and slab removal was required to allow the slab to drop around the column and minimise steps at existing slab joints.

Photo 6 – Existing slab being removed

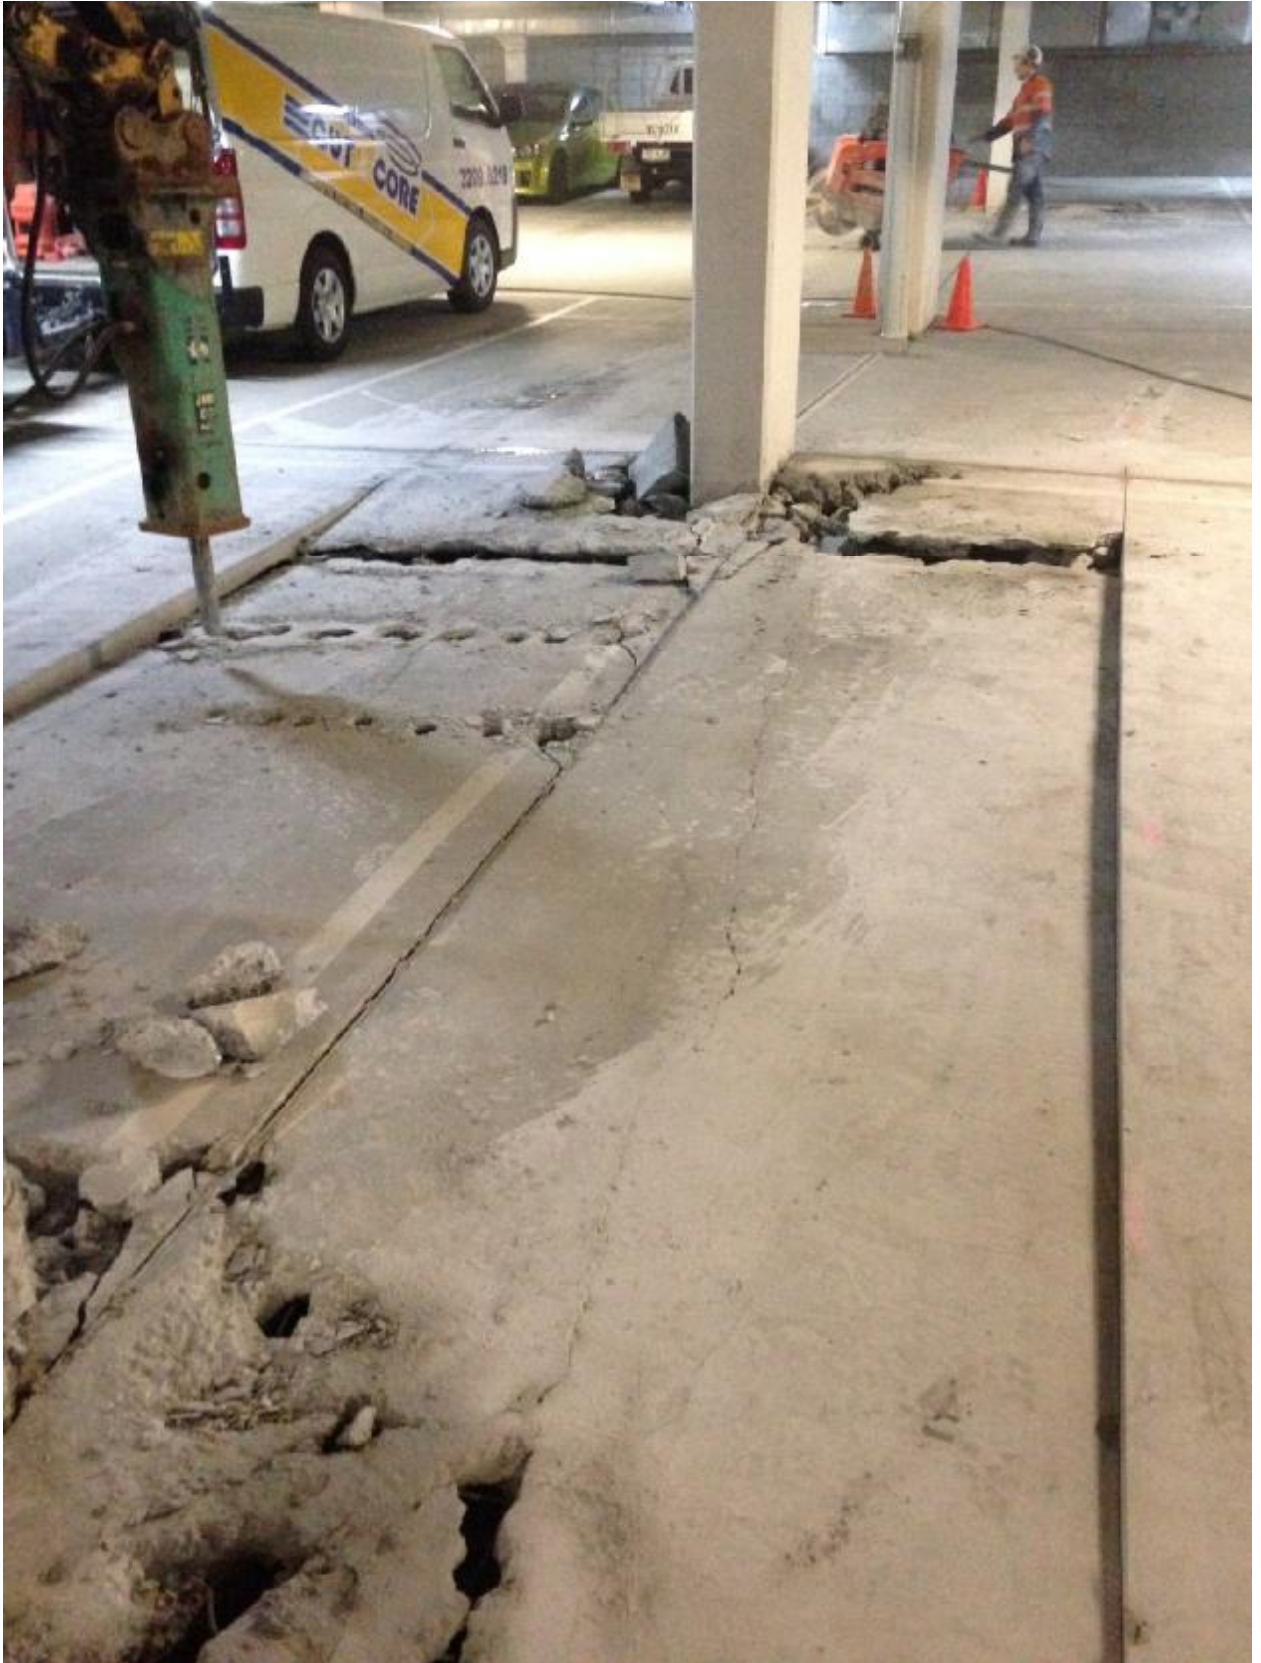
Photo 7 – Existing slab being removed

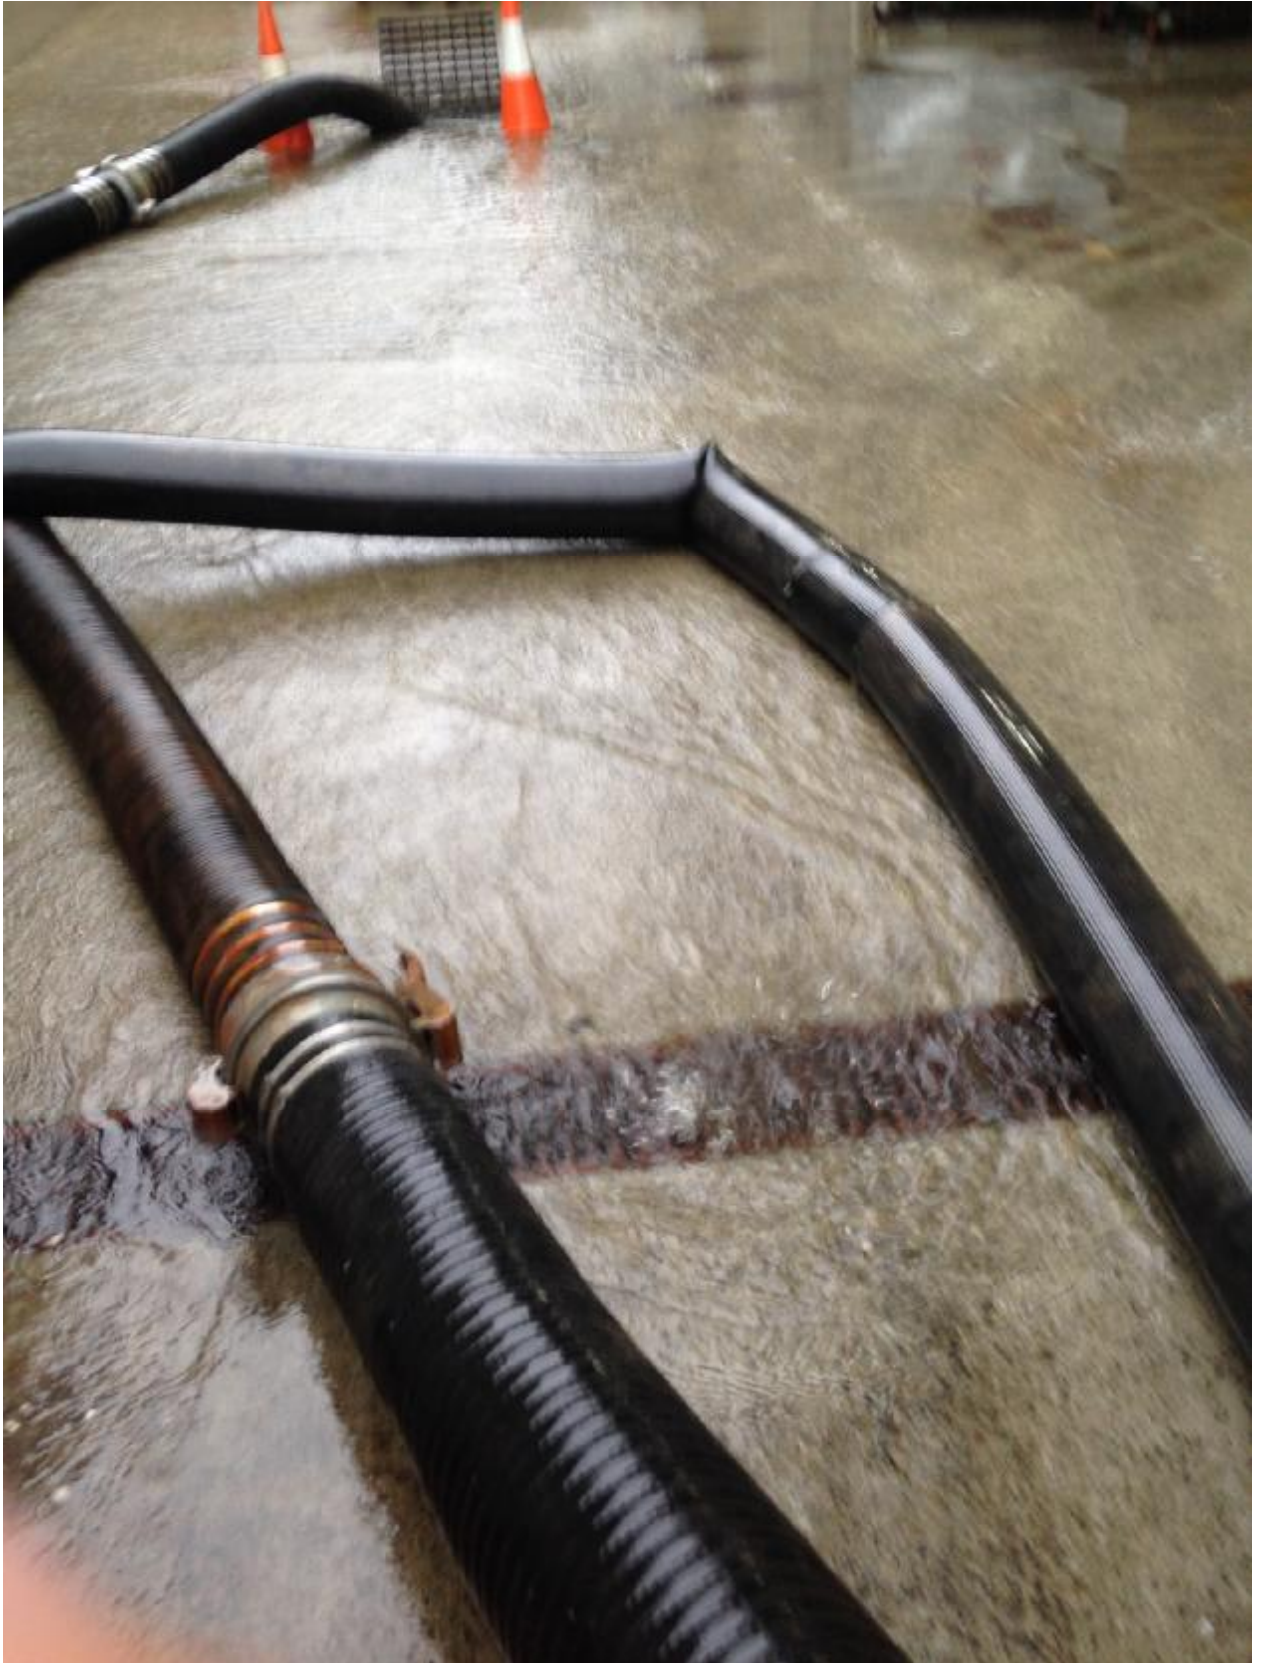
Photo 2 - Temporary pump located in loading dock during rain event
