Project No. 019-113A

17 February 2021

**RE: TREE CLEARANCE AND WASTE REMOVAL METHODOLOGY- NORTHERN PORTION  
FORMER YERONGA TAFE  
70 PARK ROAD, YERONGA**

**PLANS AND DOCUMENTS  
referred to in the PDA  
DEVELOPMENT APPROVAL**

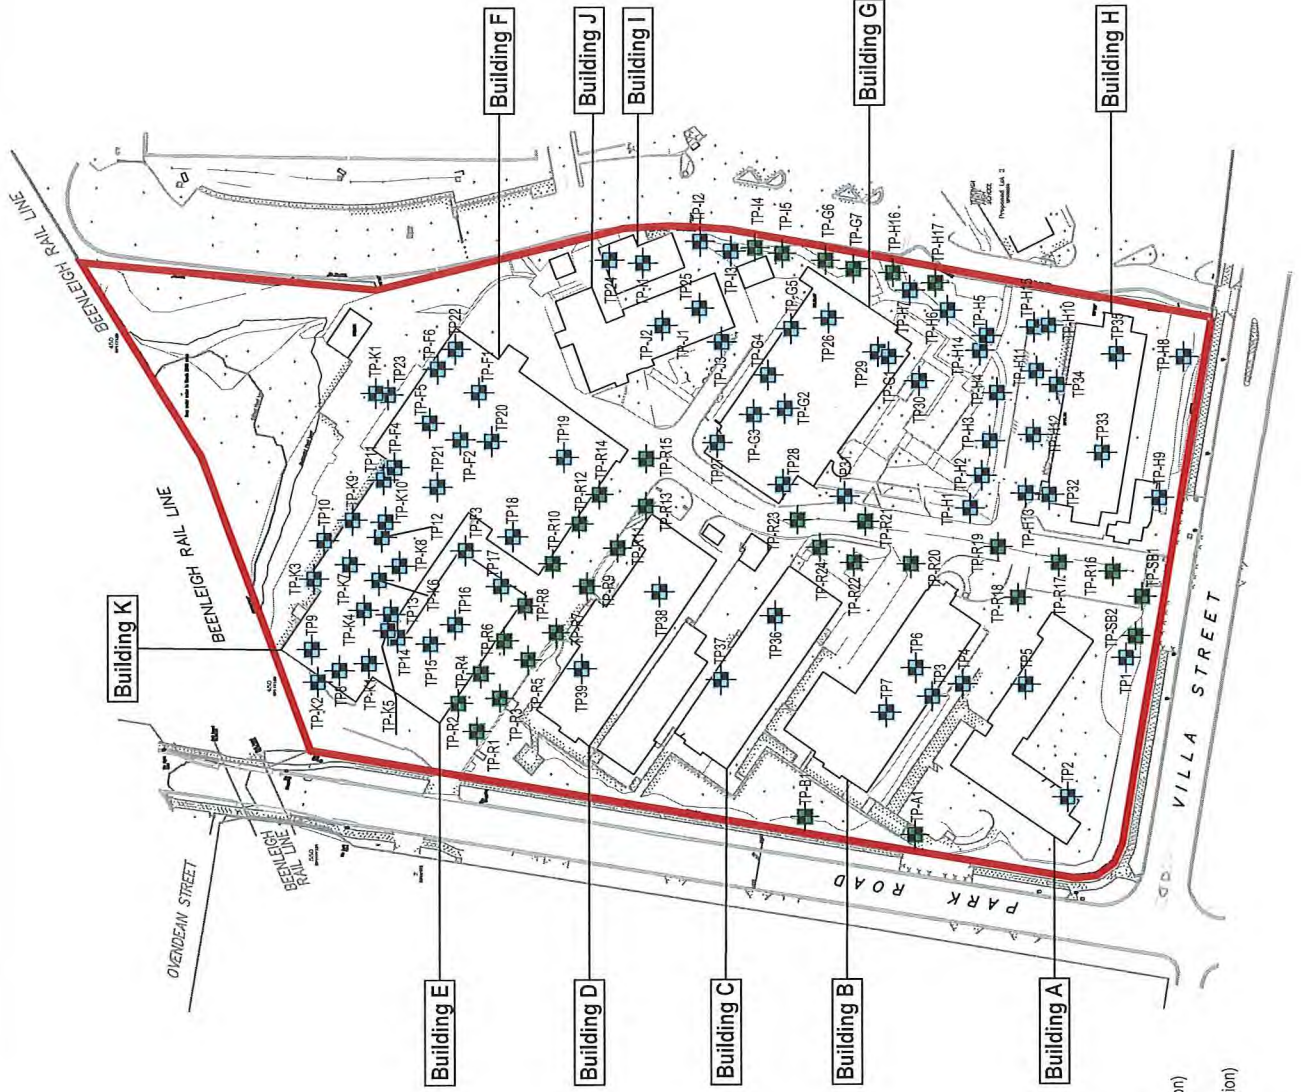
DATE: DECEMBER 2019  
DRAWN: LA  
APPROVED:  
PROJECT No: 019-113A  
DRAWING No: 2 REV: C

Butler Partners Pty Ltd (Butler Partners) initially undertook an investigation of the material beneath the slabs of the former buildings across the site in March 2019 by the excavation of thirty-nine test pits. The initial building slab investigation locations are presented in Drawing No. 2 Rev C. The investigation found that a number of the former building slab areas were underlain by construction and demolition (C&D) waste containing fibro fragments which laboratory analysis confirmed to be Asbestos Containing Materials (ACM). The locations where ACM fragments were initially identified within C&D waste are presented in Drawing No. 2 Rev C.
