Butler Partners
geotechnical • geo-environmental • groundwater

**Slope Stability Assessment
Oxley PDA - Stage 1A**
Seventeen Mile Rocks Road, Oxley

Prepared for
**Economic Development Queensland
Project No. 018-118D**

29 September 2020

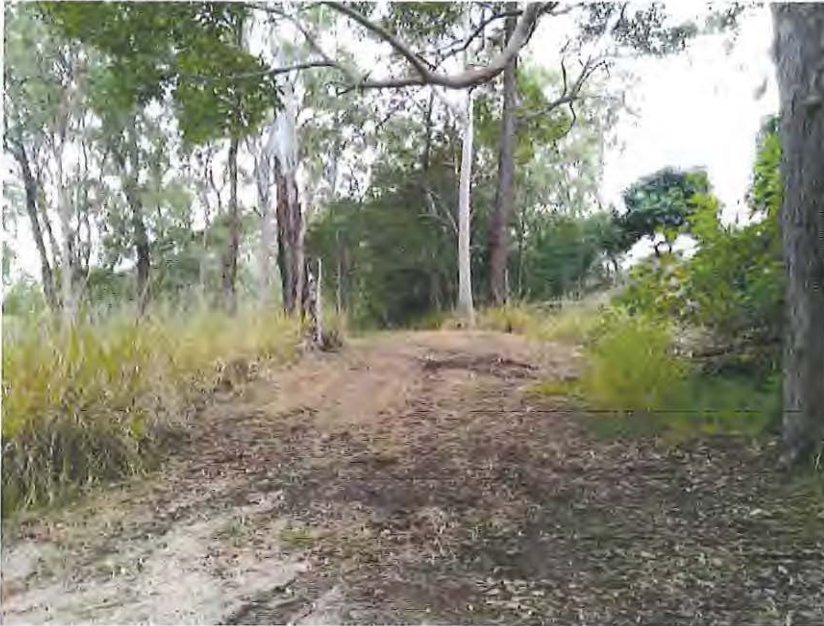
A detailed walk-over inspection of the Stage 1A site slopes by senior experienced geotechnical engineers and a (non-stereo) inspection of aerial photographs of the site did not reveal any indications of any significant instability over the area.

Photograph 3: View of the site looking north-east from Bore 100

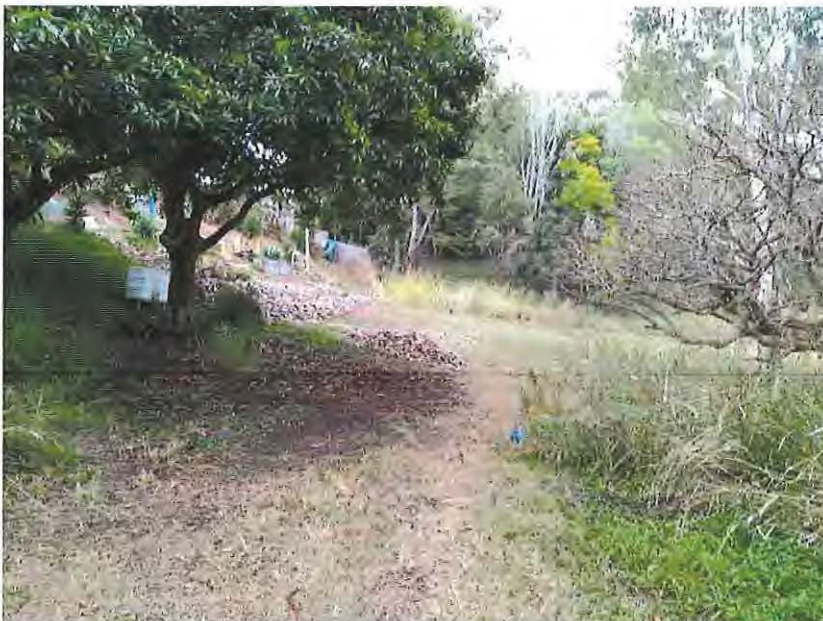
Photograph 4: View of the site looking south-west from Bore 102

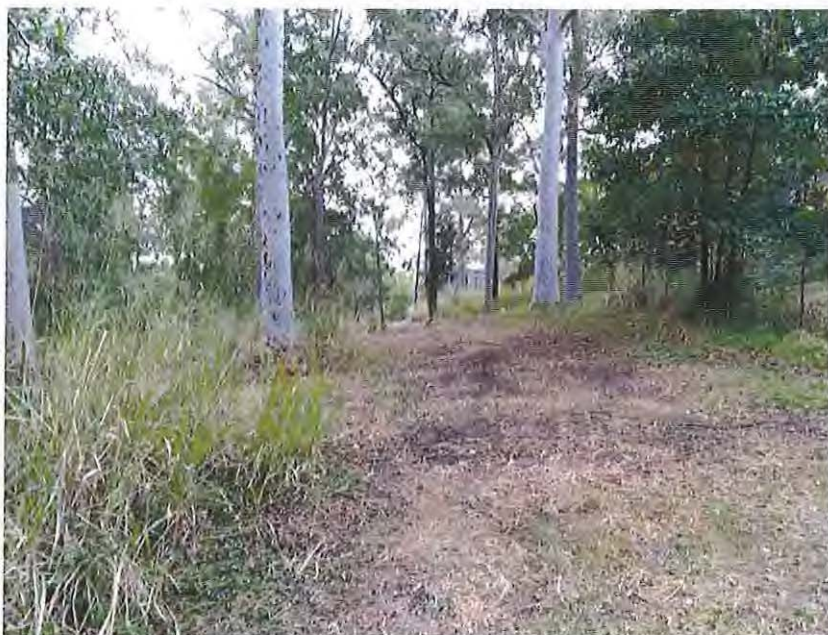
Photograph 5: View of the site looking north-east from Bore 102

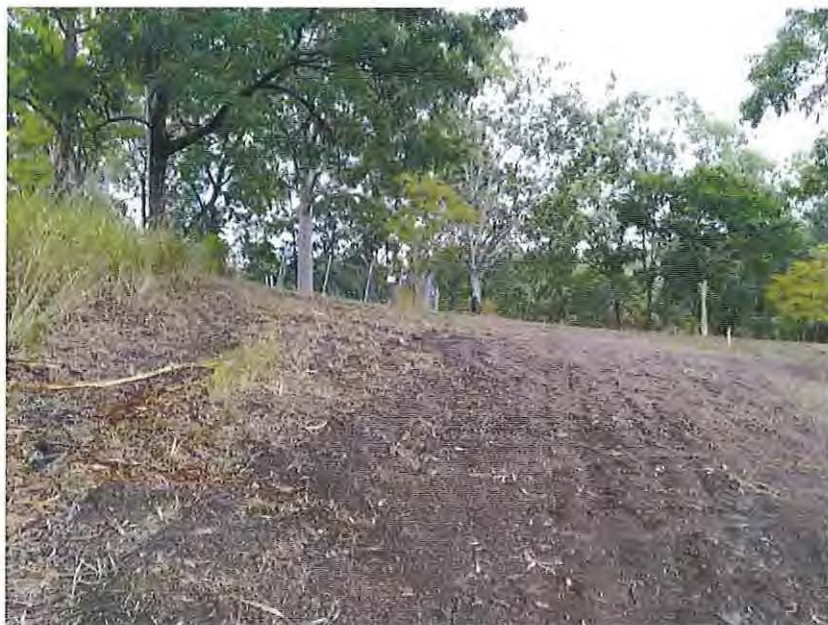
Photograph 6: View of the site looking east from Bore 105

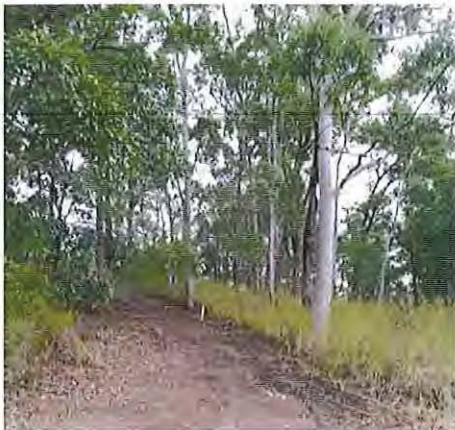
A walk over inspection of the sloping sections of the Stage 1A site did not reveal any indications of site slope creep (or any indications of general instability). No indication of slope creep could be observed in mature trees located on the sloping sections of the site; as indicate in selected Photograph 7 and Photograph 8, no indication of bent tree trunks (which is indicative of slope creep/failure), was observed.

Photograph 8: General view of mature trees

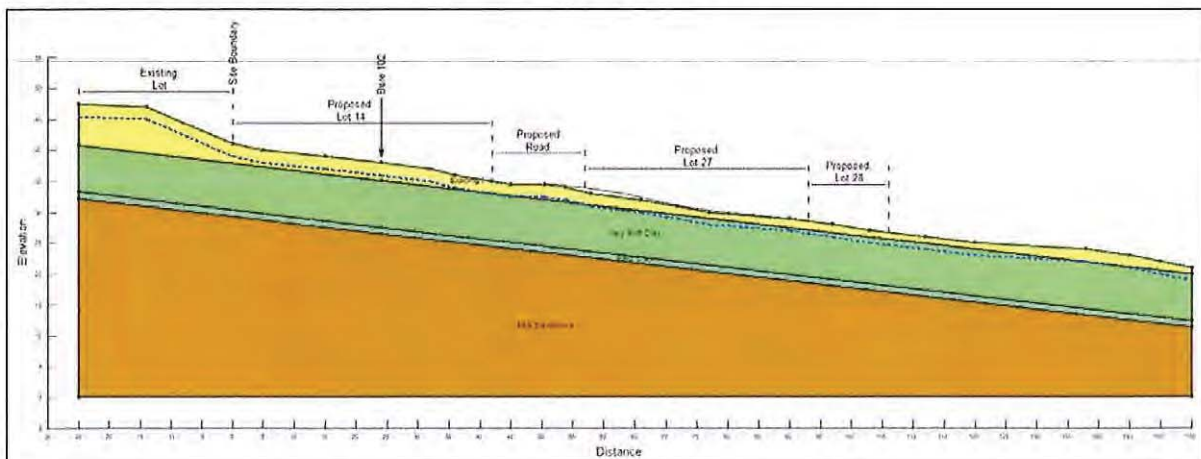
The slope profile and stratigraphy adopted for each of the six sections analysed are given in Figure 4 to Figure 9 and the location of each section analysed is indicated in Drawing No. 1. It should be carefully noted that at the location of Bore 102, the fill was assumed to be controlled for the purpose of the stability analysis; if the existing fill is uncontrolled, a lower FOS value would apply to this location.

Figure 6: Adopted slope profile and stratigraphy of section near Bore 102

To minimise the risk of potentially adverse future settlement occurring (or adverse effects on slope stability), it is recommended that all uncontrolled fill present be removed and replaced/recompacted with Level 1 controlled fill during the bulk earthworks program that will occur during the construction of the Stage 1A development. It is recommended that geotechnical inspection (and fill control), should be undertaken by Butler Partners during bulk earthworks to confirm the extent of existing fill to be removed and to control the replacement fill.
