Independent Arboricultural Services

Arboricultural Impact Assessment

11-23 Macarthur Avenue
Hamilton QLD 4007

IAS11653

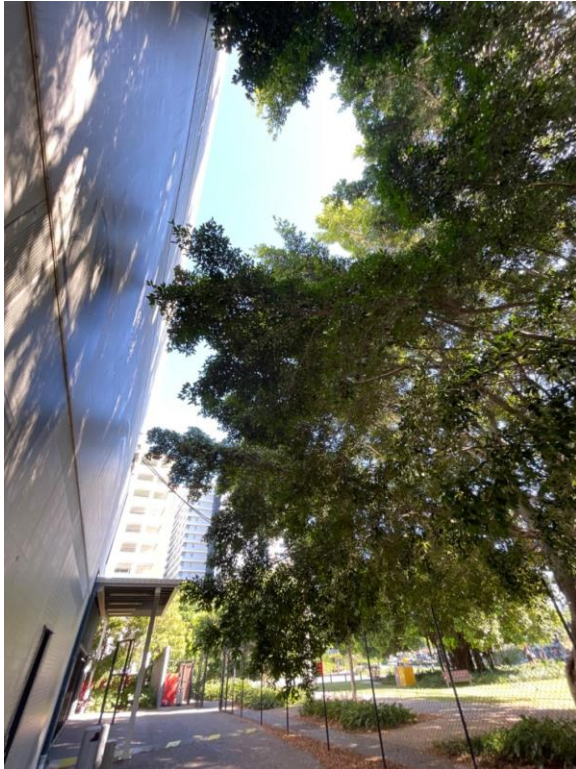
Tree 1 – Clearance to existing structure within the *Subject Site*.
