***BROADWAY HOTEL***  
**WOOLLOONGABBA**

CONSERVATION MANAGEMENT PLAN

Prepared by  
IVAN McDONALD ARCHITECTS  
for  
BROADWAY PROJECTS QLD PTY LTD

OCTOBER, 2022

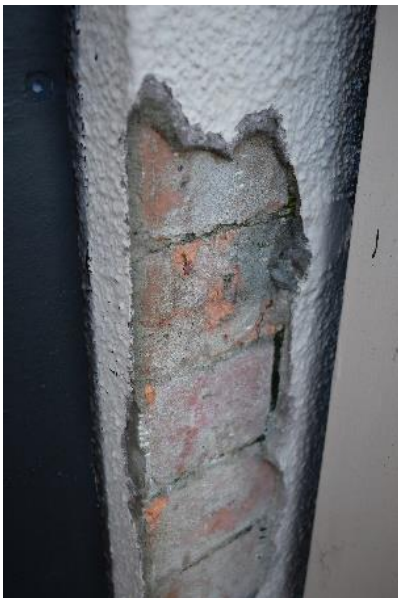
Figure 51

The external brickwork is now generally rendered and painted (**figure 51**) and the terracotta dressings are painted. Remnant sections of tuck-pointing survive to the walls of FV2, SV2 (which are painted over) & SV1 (which is substantially intact) (**figure 52**) and a remnant section of lime-pencilled face brickwork survives on the rear façade (**figure 53**).

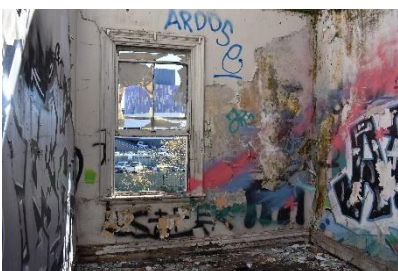
Figure 54

Most of the original external timber door and window joinery has been either totally or substantially destroyed by fire. This appears to have originally been a consistent system of cedar, double-hung, two-light window sashes (**figure 54**) and cedar framed-and-panelled doors. Most of the surviving doors and windows are from the 1958 alterations (or later) and are typically modern assemblies of silky oak construction. Sufficient documentary and physical evidence exists, however, on which to base an accurate reconstruction of the missing external door and window joinery.

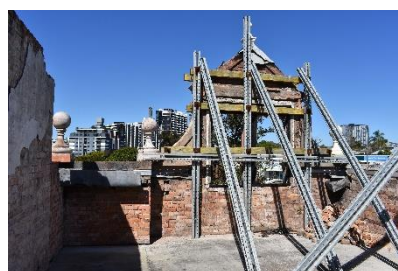
Figure 62

The 1958 renovations removed important verandah elements that articulated the principal façades and provided interstitial spaces between inside and outside. These are verandahs GV1 & FV1 on the Logan Road façade and verandah FV3 on the Balaclava Street façade where the original verandah external walls were removed and modern windows and doors were installed at the façade line. An original verandah space survives at SV1 (albeit now without mansard walls and external door joinery) (**figure 59**) and the original FV3 concrete floor slab is evident overhead in the Public Bar (**figure 60**). A modern timber deck and lightweight roof structure are attached to the Logan Road façade at ground floor level (**figure 61**). To provide temporary support to the second floor walls, steel braces have recently been installed (**figure 62**).

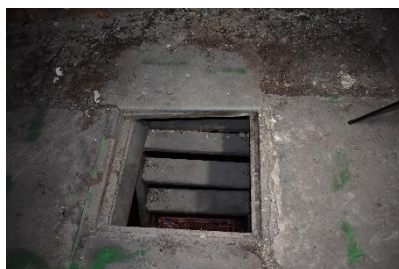
Figure 71

The basement is currently flooded and was not able to be inspected except cursorily via an access hatch and timber stairs in the Public Bar floor (**figure 71**). 2010 measured drawings show that the basement extends under the entirety of the Public Bar (B1) and the original part of the single-storey rear wing (B2). B1 and B2 are at different floor levels reflecting the different ground floor levels above. Basement B1 has cast iron columns supporting steel bearers and timber floor joists (**figure 72**) and two unsealed light wells to the Balaclava Street footpath (**figure 73**).

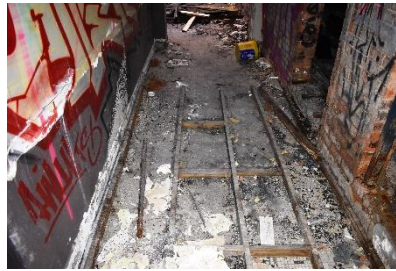
Figure 75

The ground floor of the main hotel building is considerably fire-damaged and vandalised and remaining debris makes analysis of the floor fabric difficult. Multiple minor changes to floor levels exist throughout the ground floor which relate to a variety of concrete and timber substrates and a variety of built-up overlaid floor finishes. For instance, the G3 Public Bar floor at the basement access hatch (**figure 74**) shows an original timber floor layer, a particleboard top layer and a possible intermediate concrete topping layer. This varies from both the G1 entry floor level (**figure 75**) and the G5 floor level (**figure 76**).

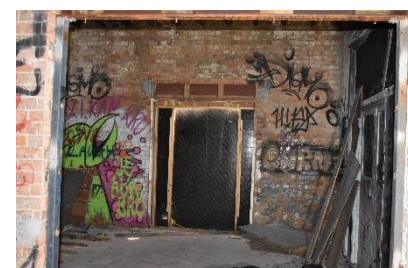
Figure 80

Throughout the ground floor, the original white-set, lime-plastered wall finishes remain to G2, G3 & G6 but have been removed to G1, G5 & GST. The original lath-and-plaster ceilings have generally been removed and only a remnant lath-and-plaster ceiling and (assumed) original moulded plaster cornice survives in G6 (**figure 77**). The removal of ceiling finishes does, however, reveal original first floor construction above which includes a number of original steel beams supported on sandstone blocks built into the brick walls (**figures 78 & 79**). The removal of plaster wall finishes also reveals the considerable number of wall penetration changes that have occurred over time (**figure 80**).

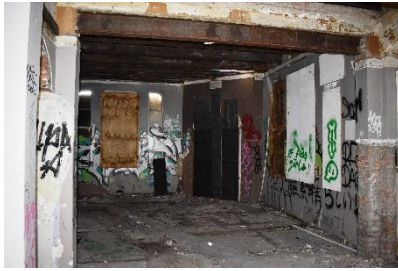
Figure 81

The most-recent public bar counter has been removed and the public bar (G3) is now a large open space (**figure 81**). The original internal timber staircase no longer survives (**figure 82**) except for some remnant landing fabric at the second floor level (**figure 83**). Substantial photographic evidence of the stairs, as well as some physical evidence of floor framing positions, does exist upon which to base an accurate reconstruction of the stairs.

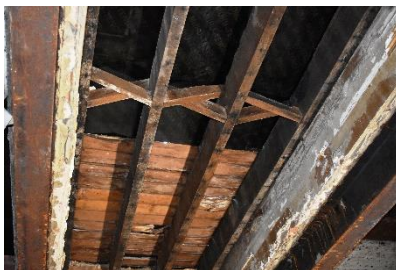
Figure 84

The first floor of the main hotel generally retains its original herringbone-strutted hardwood floor frame although the structural condition of the fire-damaged members requires further detailed investigation (**figure 84**). The original 6" (150mm) hoop pine flooring also exists in, at least, F7, F8 and part of F3. Elsewhere, the hoop pine flooring has been replaced by temporary plywood sheeting. All internal doors and most timber mouldings have been removed from the first floor except for F7 & F8 where remnant hoop pine flooring and remnant moulded cedar skirtings survive. A substantially intact cedar double-hung window set survives in F8 (**figures 85 & 86**). The brick walls were originally finished internally with white-set, lime plaster which survives in F2, F7, F8 & F9 and parts of F3, F4 & F6, however, the condition of this surviving plaster requires further detailed investigation. **Figure 87** shows F3. The FV2 first floor corner turret verandah retains its original concrete floor. Original tuck-pointing to the inside faces of the turret's brick walls is evident but has been painted over (**figure 88**).

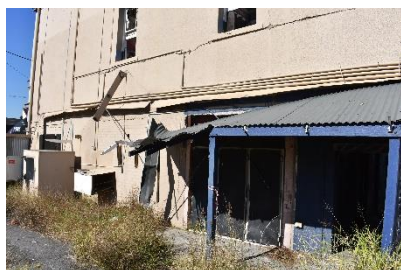
Figure 118 Side wall

The *Broadway Hotel* can only be described as being in extremely poor condition and remains under high threat of further deterioration. **Figures 116 – 125** show the general condition of the building which is also illustrated in **section 4**.

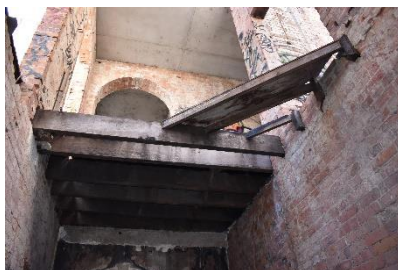
Figure 119 Stairwell GST

The original internal stairwell is now an open void with no roof, no windows, no staircase and only a remnant section of unsafe stair landing on the second floor.
