Waterway investigation within Lot 4 SP332712, Olsen Road New Beith

Date: 29 July 2024

From: Fishology Consulting Pty Ltd

Project: Waterway investigation within Lot 4 SP332712, New Beith.

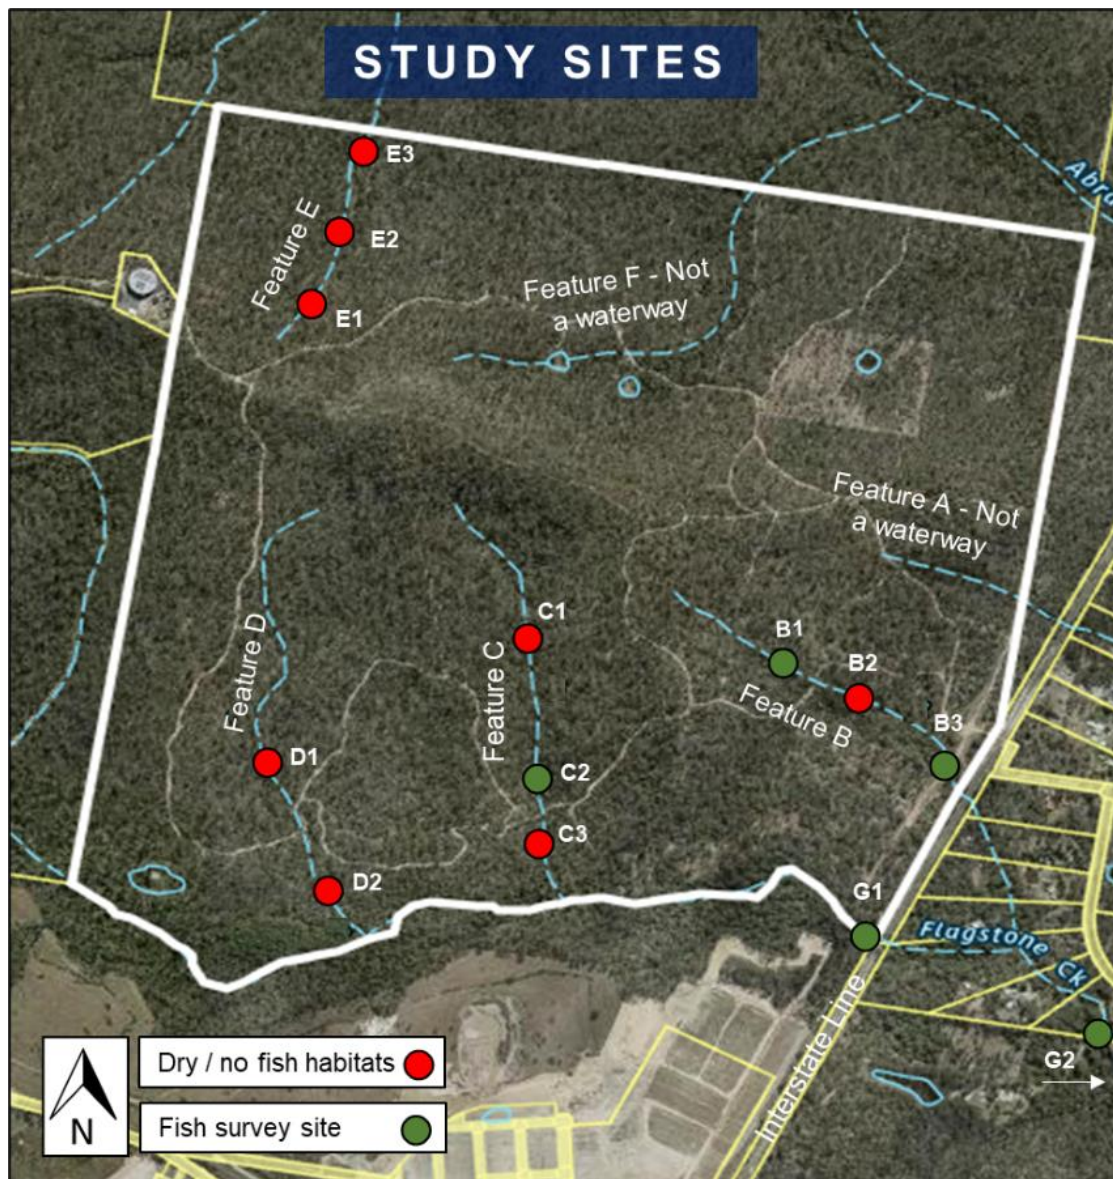
Figure 2. Overview of study area and survey sites revisited during the current assessment. Site G2 was located just above the Pebble Creek Way Road crossing.

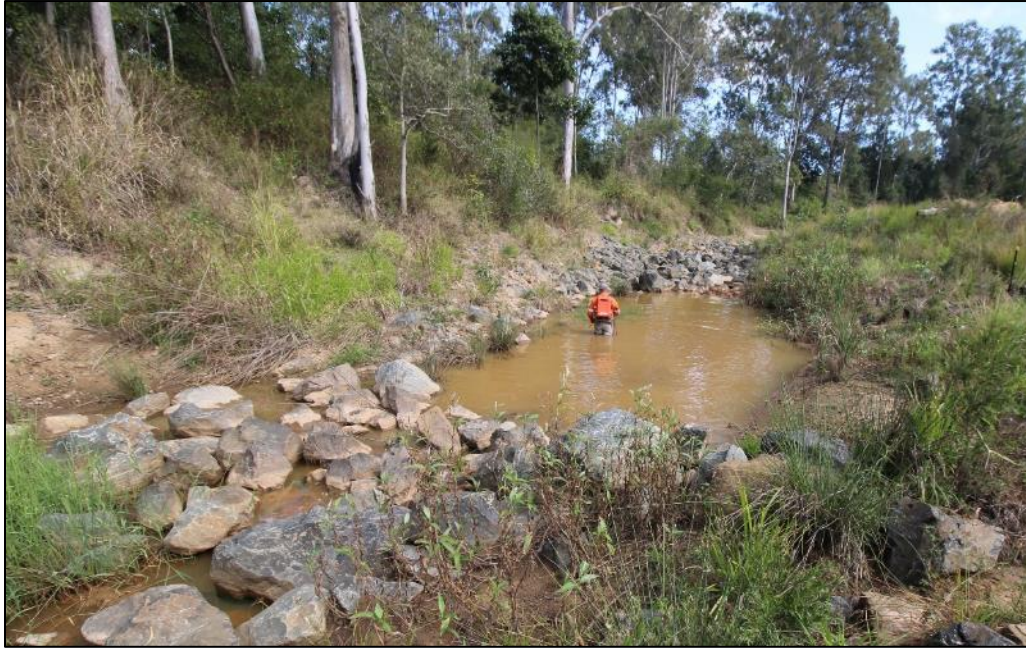
Site

Fish sampling in Flagstone Creek just above Pebble Creek Way. 1.2km below the study area.

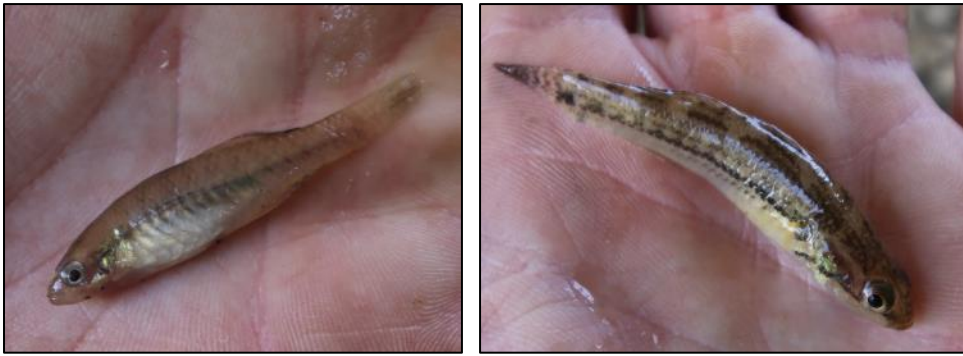
Empire gudgeon (left) and striped gudgeon (right) captured in lower Flagstone Creek (Site G2).

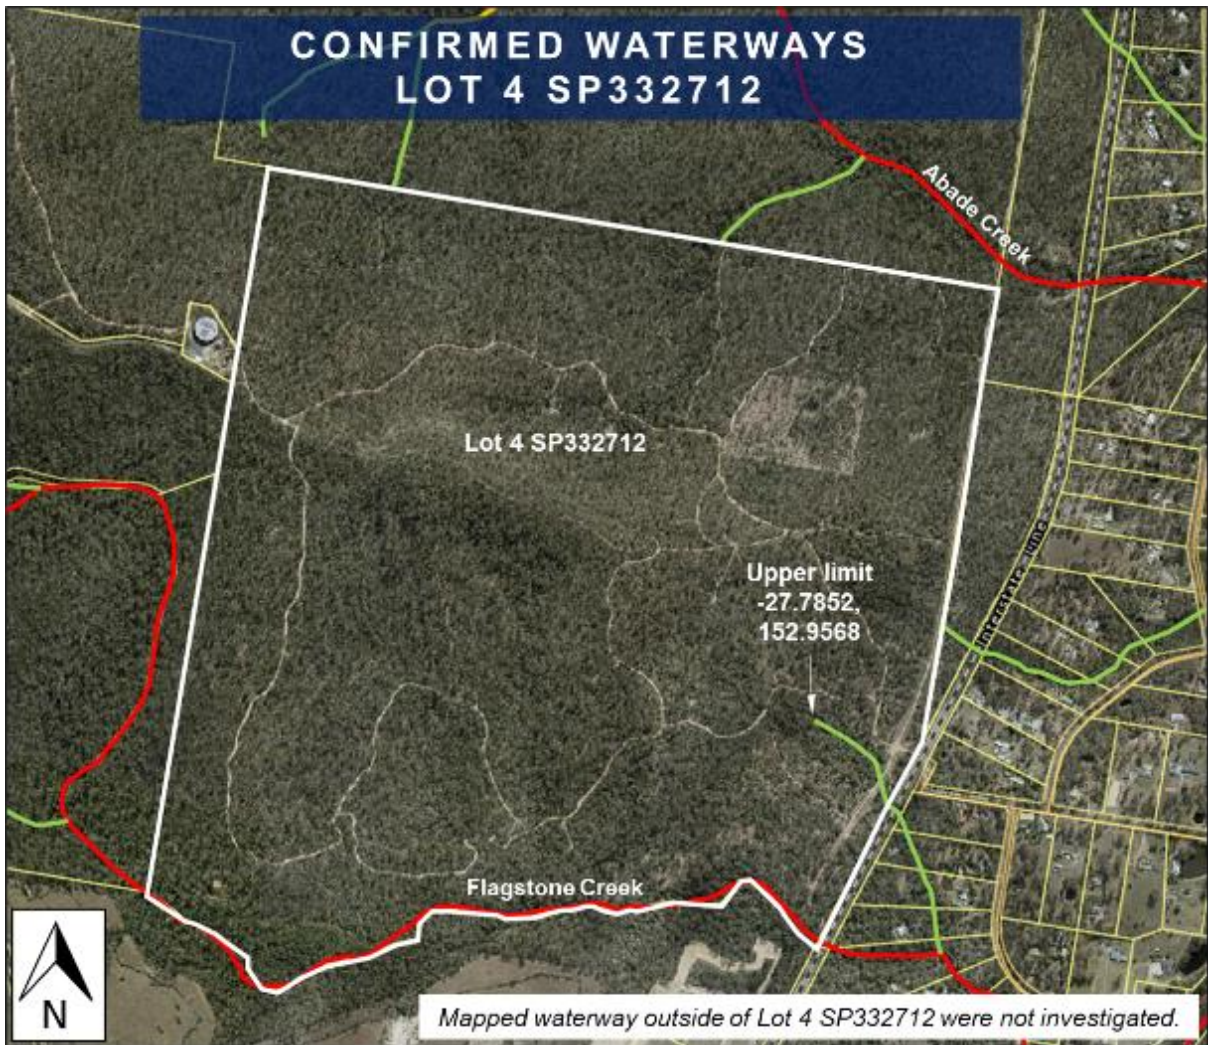
Appendix C – Alternative waterway mapping

Two site visits were undertaken of Lot 4 SP332712 during contrasting hydrological conditions to assess the status of mapped waterways. This second site visit did not provide any new information to change the results of the first site assessment undertaken and documented in Fishology Consulting (2024). Alternative mapping is provided in Appendix C of this report.

To ensure waterway barrier works are planned and designed appropriately, endorsement of alternative waterway mapping is recommended.
