BROADWAY HOTEL WOOLLOONGABBA

CONSERVATION MANAGEMENT PLAN

Prepared by
IVAN McDONALD ARCHITECTS
for
BROADWAY PROJECTS QLD PTY LTD

OCTOBER, 2022

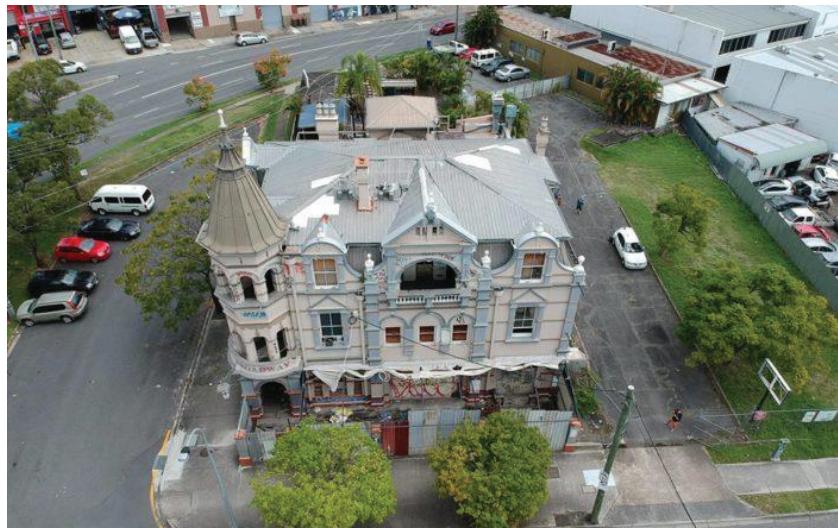
*Following the fire, all the remaining internal linings to the main hotel building which were not destroyed by the fire, or water from fighting the fire, were removed in order to render the site safe. This included all the wall and ceiling linings and door frames. Some of the internal linings were asbestos.²⁴ Prior to the 2010 fire, Inaspace Architects had prepared a comprehensive set of measured drawings of the *Broadway Hotel* which are shown at **figures 20-24** and reproduced in full at **appendix 1**. The only notable change from previous plans of the hotel was the installation of another new public bar counter. An aerial view of the hotel after the 2010 fire is shown at **figure 25**.*

Figure 25 *Aerial view of the Broadway Hotel after the 2010 fire*
Source: Cr Jonathan Sri for the Gabba Ward/Facebook

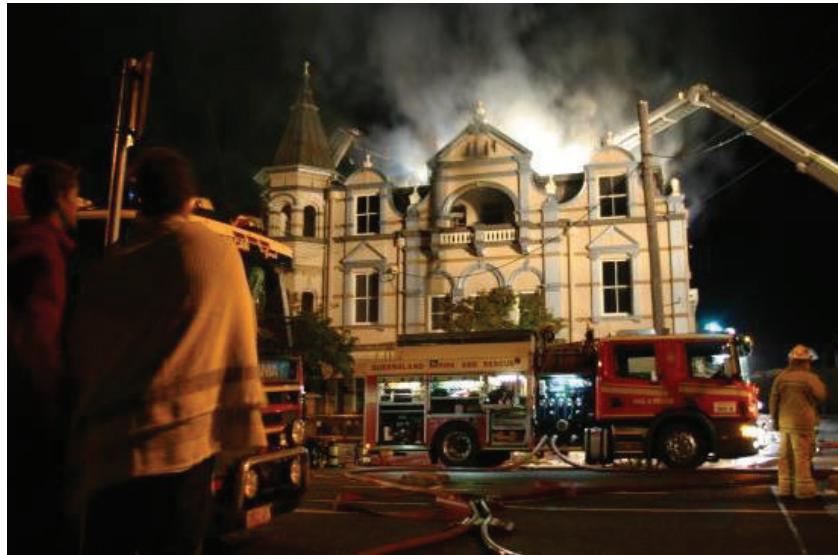
The fire collapsed the entire main building roof structure including the corner turret's spire and seriously damaged the remaining timber floor structures and internal finishes. The rear two-storey wing and the 1980s beer garden structures were also extensively damaged. An aerial view of the hotel after the 2018 fire is shown at **figure 27**.

Figure 26 *The Broadway Hotel on fire again in 2018*
Source: Google Images

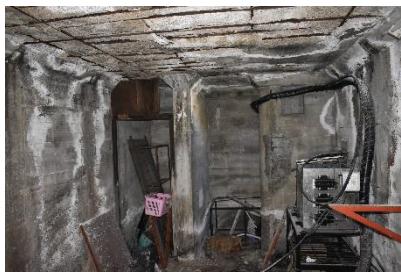
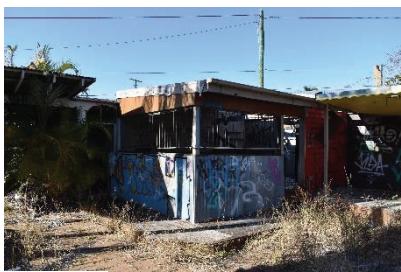
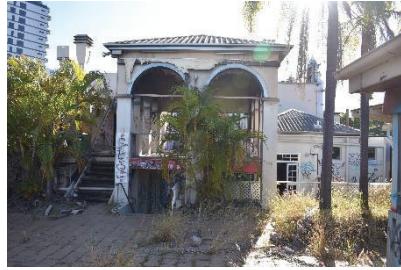
Figure 40

The *Broadway Hotel* is a three-storey loadbearing brick structure with suspended timber and concrete floors and, currently, no roof structure. A part basement floor (B1 & B2) exists under the public bar and the original part of the rear single-storey wing. The rear single-storey wing (G7-G10) is of loadbearing brick construction with a suspended timber floor over the basement and a timber-framed roof sheeted in Klip-lok (or similar) metal deck roofing. The original side verandah of the single-storey wing was removed in 1958 and replaced with the current enclosed space and parapeted flat roof when the rear of the wing was extended at that time. An early, but not original, rear two-storey wing is of loadbearing brick construction with concrete slabs on ground, a suspended timber first floor and 1958-1960 timber-framed skillion roofs with brick parapets. Various outbuildings are located in the rear courtyard and at the rear of the site including a 1942 air raid shelter and a 1980 two-storey open pavilion which are all currently approved for demolition due to their dangerous structural condition (**figures 40-42**).

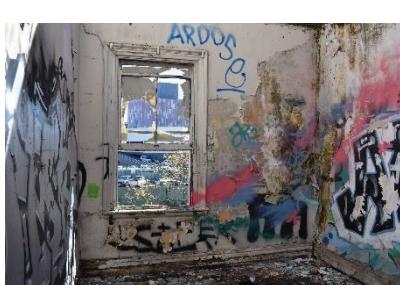
Figure 54

Most of the original external timber door and window joinery has been either totally or substantially destroyed by fire. This appears to have originally been a consistent system of cedar, double-hung, two-light window sashes (figure 54) and cedar framed-and-panelled doors. Most of the surviving doors and windows are from the 1958 alterations (or later) and are typically modern assemblies of silky oak construction. Sufficient documentary and physical evidence exists, however, on which to base an accurate reconstruction of the missing external door and window joinery.

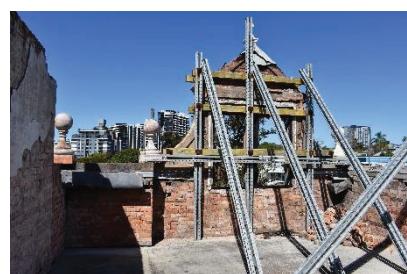
Figure 62

The 1958 renovations removed important verandah elements that articulated the principal facades and provided interstitial spaces between inside and outside. These are verandahs GV1 & FV1 on the Logan Road façade and verandah FV3 on the Balaclava Street façade where the original verandah external walls were removed and modern windows and doors were installed at the façade line. An original verandah space survives at SV1 (albeit now without mansard walls and external door joinery) (**figure 59**) and the original FV3 concrete floor slab is evident overhead in the Public Bar (**figure 60**). A modern timber deck and lightweight roof structure are attached to the Logan Road façade at ground floor level (**figure 61**). To provide temporary support to the second floor walls, steel braces have recently been installed (**figure 62**).

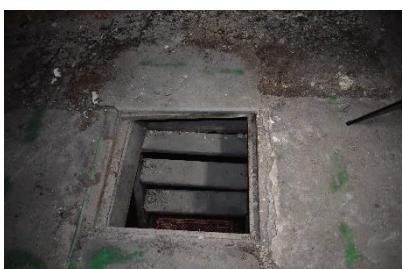
Figure 71

The basement is currently flooded and was not able to be inspected except cursorily via an access hatch and timber stairs in the Public Bar floor (**figure 71**). 2010 measured drawings show that the basement extends under the entirety of the Public Bar (B1) and the original part of the single-storey rear wing (B2). B1 and B2 are at different floor levels reflecting the different ground floor levels above. Basement B1 has cast iron columns supporting steel bearers and timber floor joists (**figure 72**) and two unsealed light wells to the Balaclava Street footpath (**figure 73**).

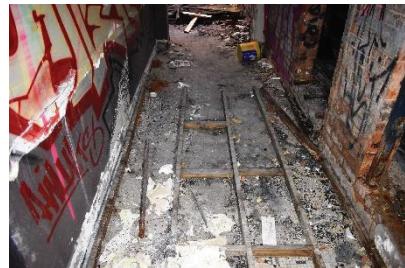
Figure 75

The ground floor of the main hotel building is considerably fire-damaged and vandalised and remaining debris makes analysis of the floor fabric difficult. Multiple minor changes to floor levels exist throughout the ground floor which relate to a variety of concrete and timber substrates and a variety of built-up overlaid floor finishes. For instance, the G3 Public Bar floor at the basement access hatch (figure 74) shows an original timber floor layer, a particleboard top layer and a possible intermediate concrete topping layer. This varies from both the G1 entry floor level (figure 75) and the G5 floor level (figure 76).

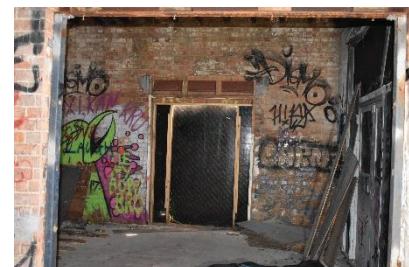
Figure 80

Throughout the ground floor, the original white-set, lime-plastered wall finishes remain to G2, G3 & G6 but have been removed to G1, G5 & GST. The original lath-and-plaster ceilings have generally been removed and only a remnant lath-and-plaster ceiling and (assumed) original moulded plaster cornice survives in G6 (figure 77). The removal of ceiling finishes does, however, reveal original first floor construction above which includes a number of original steel beams supported on sandstone blocks built into the brick walls (figures 78 & 79). The removal of plaster wall finishes also reveals the considerable number of wall penetration changes that have occurred over time (figure 80).

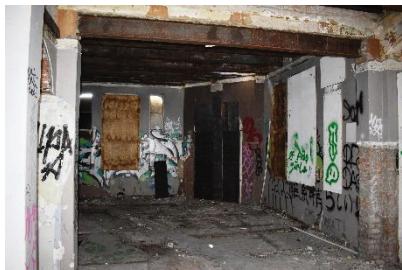
Figure 81

The most-recent public bar counter has been removed and the public bar (G3) is now a large open space (figure 81). The original internal timber staircase no longer survives (figure 82) except for some remnant landing fabric at the second floor level (figure 83). Substantial photographic evidence of the stairs, as well as some physical evidence of floor framing positions, does exist upon which to base an accurate reconstruction of the stairs.

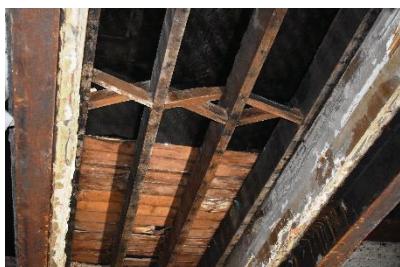
Figure 84

The first floor of the main hotel generally retains its original herringbone-strutted hardwood floor frame although the structural condition of the fire-damaged members requires further detailed investigation (figure 84). The original 6" (150mm) hoop pine flooring also exists in, at least, F7, F8 and part of F3. Elsewhere, the hoop pine flooring has been replaced by temporary plywood sheeting. All internal doors and most timber mouldings have been removed from the first floor except for F7 & F8 where remnant hoop pine flooring and remnant moulded cedar skirtings survive. A substantially intact cedar double-hung window set survives in F8 (figures 85 & 86). The brick walls were originally finished internally with white-set, lime plaster which survives in F2, F7, F8 & F9 and parts of F3, F4 & F6, however, the condition of this surviving plaster requires further detailed investigation. Figure 87 shows F3. The FV2 first floor corner turret verandah retains its original concrete floor. Original tuck-pointing to the inside faces of the turret's brick walls is evident but has been painted over (figure 88).

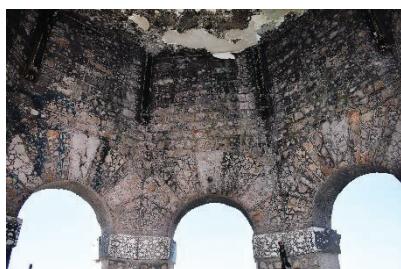
Figure 93

The second floor of the main hotel building contains the least amount of original/early fabric of all floor levels due to the complete fire loss of its floor and roof. Importantly, the original SV1 verandah space fronting Logan Road survives relatively intact including its original concrete floor and tuck-pointed brick walls. This fabric can provide sufficient evidence to reconstruct the missing GV1, FV1 & FV3 verandahs. A new suspended concrete floor slab was installed after the 2018 fire to stabilise the overall building structure. This slab extends to S1, S2, S3, S4, S6 & S9. The S5, S7, S8 & SST floor areas are void (**figures 89 & 90**). All internal doors and mouldings have been removed from the second floor. The original white-set, lime plaster wall finishes have generally been removed except for parts of S2, S3 & S9 (**figures 91 & 92**). The SV2 second floor corner turret verandah retains its original concrete floor and rendered (possibly concrete) soffit. Similarly to the first floor, original tuck-pointing to the external brick walls of the turret is evident but has been painted over (**figure 93**).

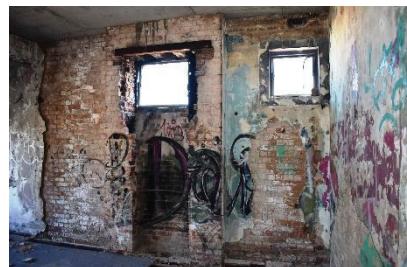
Figure 96

The main hotel building originally had six fireplaces throughout the building served by a three-flue chimney on the back wall, a single-flue chimney on the side wall and a two-flue chimney within the core of the building. No mantle pieces, fireboxes or hearths survive but original fireplace openings remain evident in G5, F3, F4 & S3 (**figures 94 – 97** respectively). The F4 chimney breast (**figure 96**) was penetrated by a new window opening in 1958.

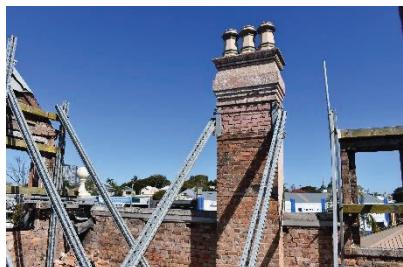
Figure 98

Original terracotta chimney pots (now painted) survive only to the rear wall chimney (**figure 98**). It appears that two of the three flues to the rear wall chimney originally serviced two fireplaces on the ground floor which no longer survive.

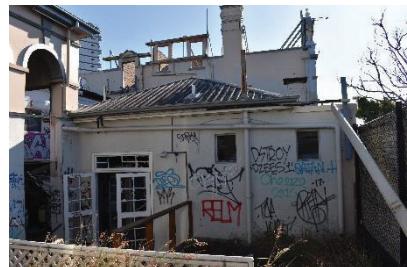
Figure 99

The original single-storey rear wing (G8 and part of G7) was extensively altered in 1958 by a rear extension and the replacement of the original Balaclava Street open verandah with an enclosed and parapeted extension for toilets (G9 & G10) (figure 99). This wing is likely to have been the original kitchen and a large fireplace opening is still evident in G7 (figure 100). The external brick walls (which appear to have originally been face brick) have been rendered and painted. The Ogee-profile guttering, beaded timber fascia and timber-boarded soffit (figure 70) are likely to be original details and, together with the surviving corner turret soffit (figure 63), can provide evidence to reconstruct the missing main roof eaves detail. Otherwise, this wing generally has a low level of intactness.

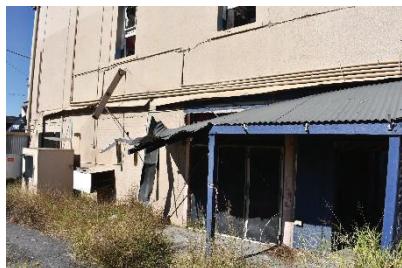
The *Broadway Hotel* can only be described as being in extremely poor condition and remains under high threat of further deterioration. **Figures 116 – 125** show the general condition of the building which is also illustrated in **section 4**.

Figure 118 Side wall

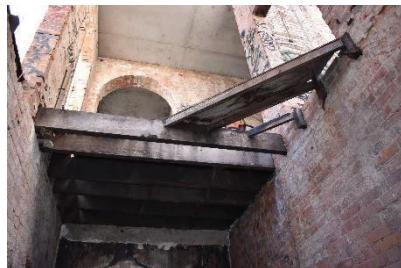
The original internal stairwell is now an open void with no roof, no windows, no staircase and only a remnant section of unsafe stair landing on the second floor.

Figure 119 Stairwell GST

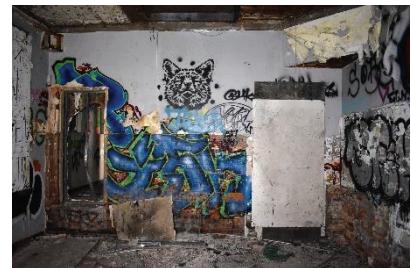
Figure 120 Public Bar G3

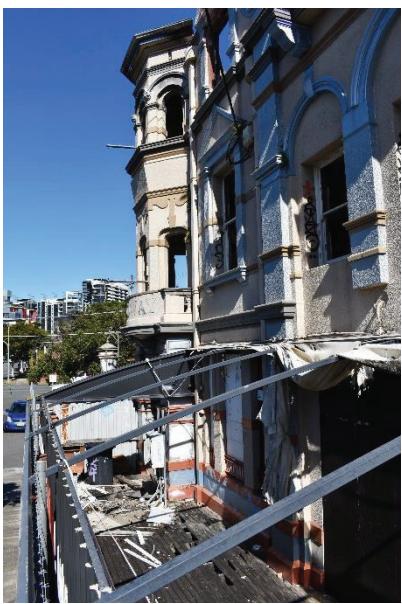
Figure 121 Logan Road deck

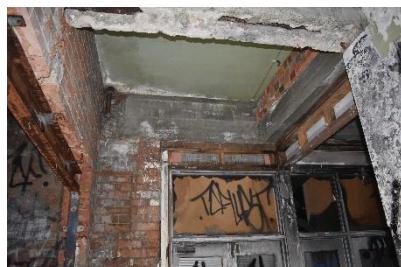
Figure 122 Ground floor GV1

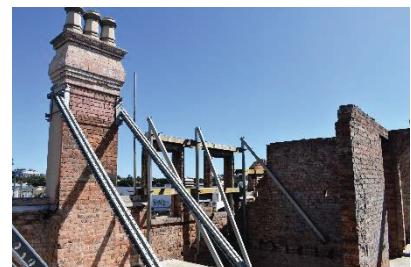
Figure 123 Second floor S4

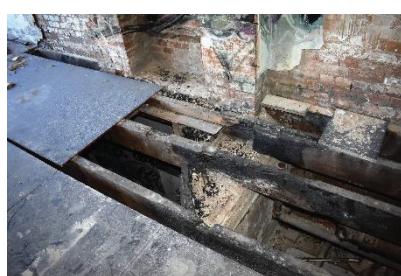
Figure 124 First floor F4

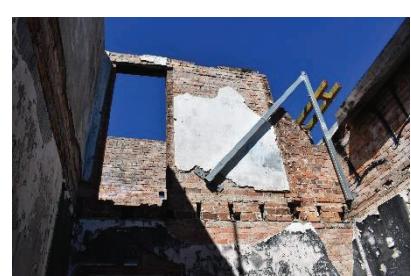
Figure 125 Second floor S7
