To: Phillip Usher Constructions
Attention: Ryan MacLellan <rmaclellan@thereforgroup.com.au>
Date: Tuesday, 28 April 2026
Ref: G250158 – M001 (v.3)
Re: Technical Memorandum – Structural conditions assessment
38 Mark Lane, Kangaroo Point

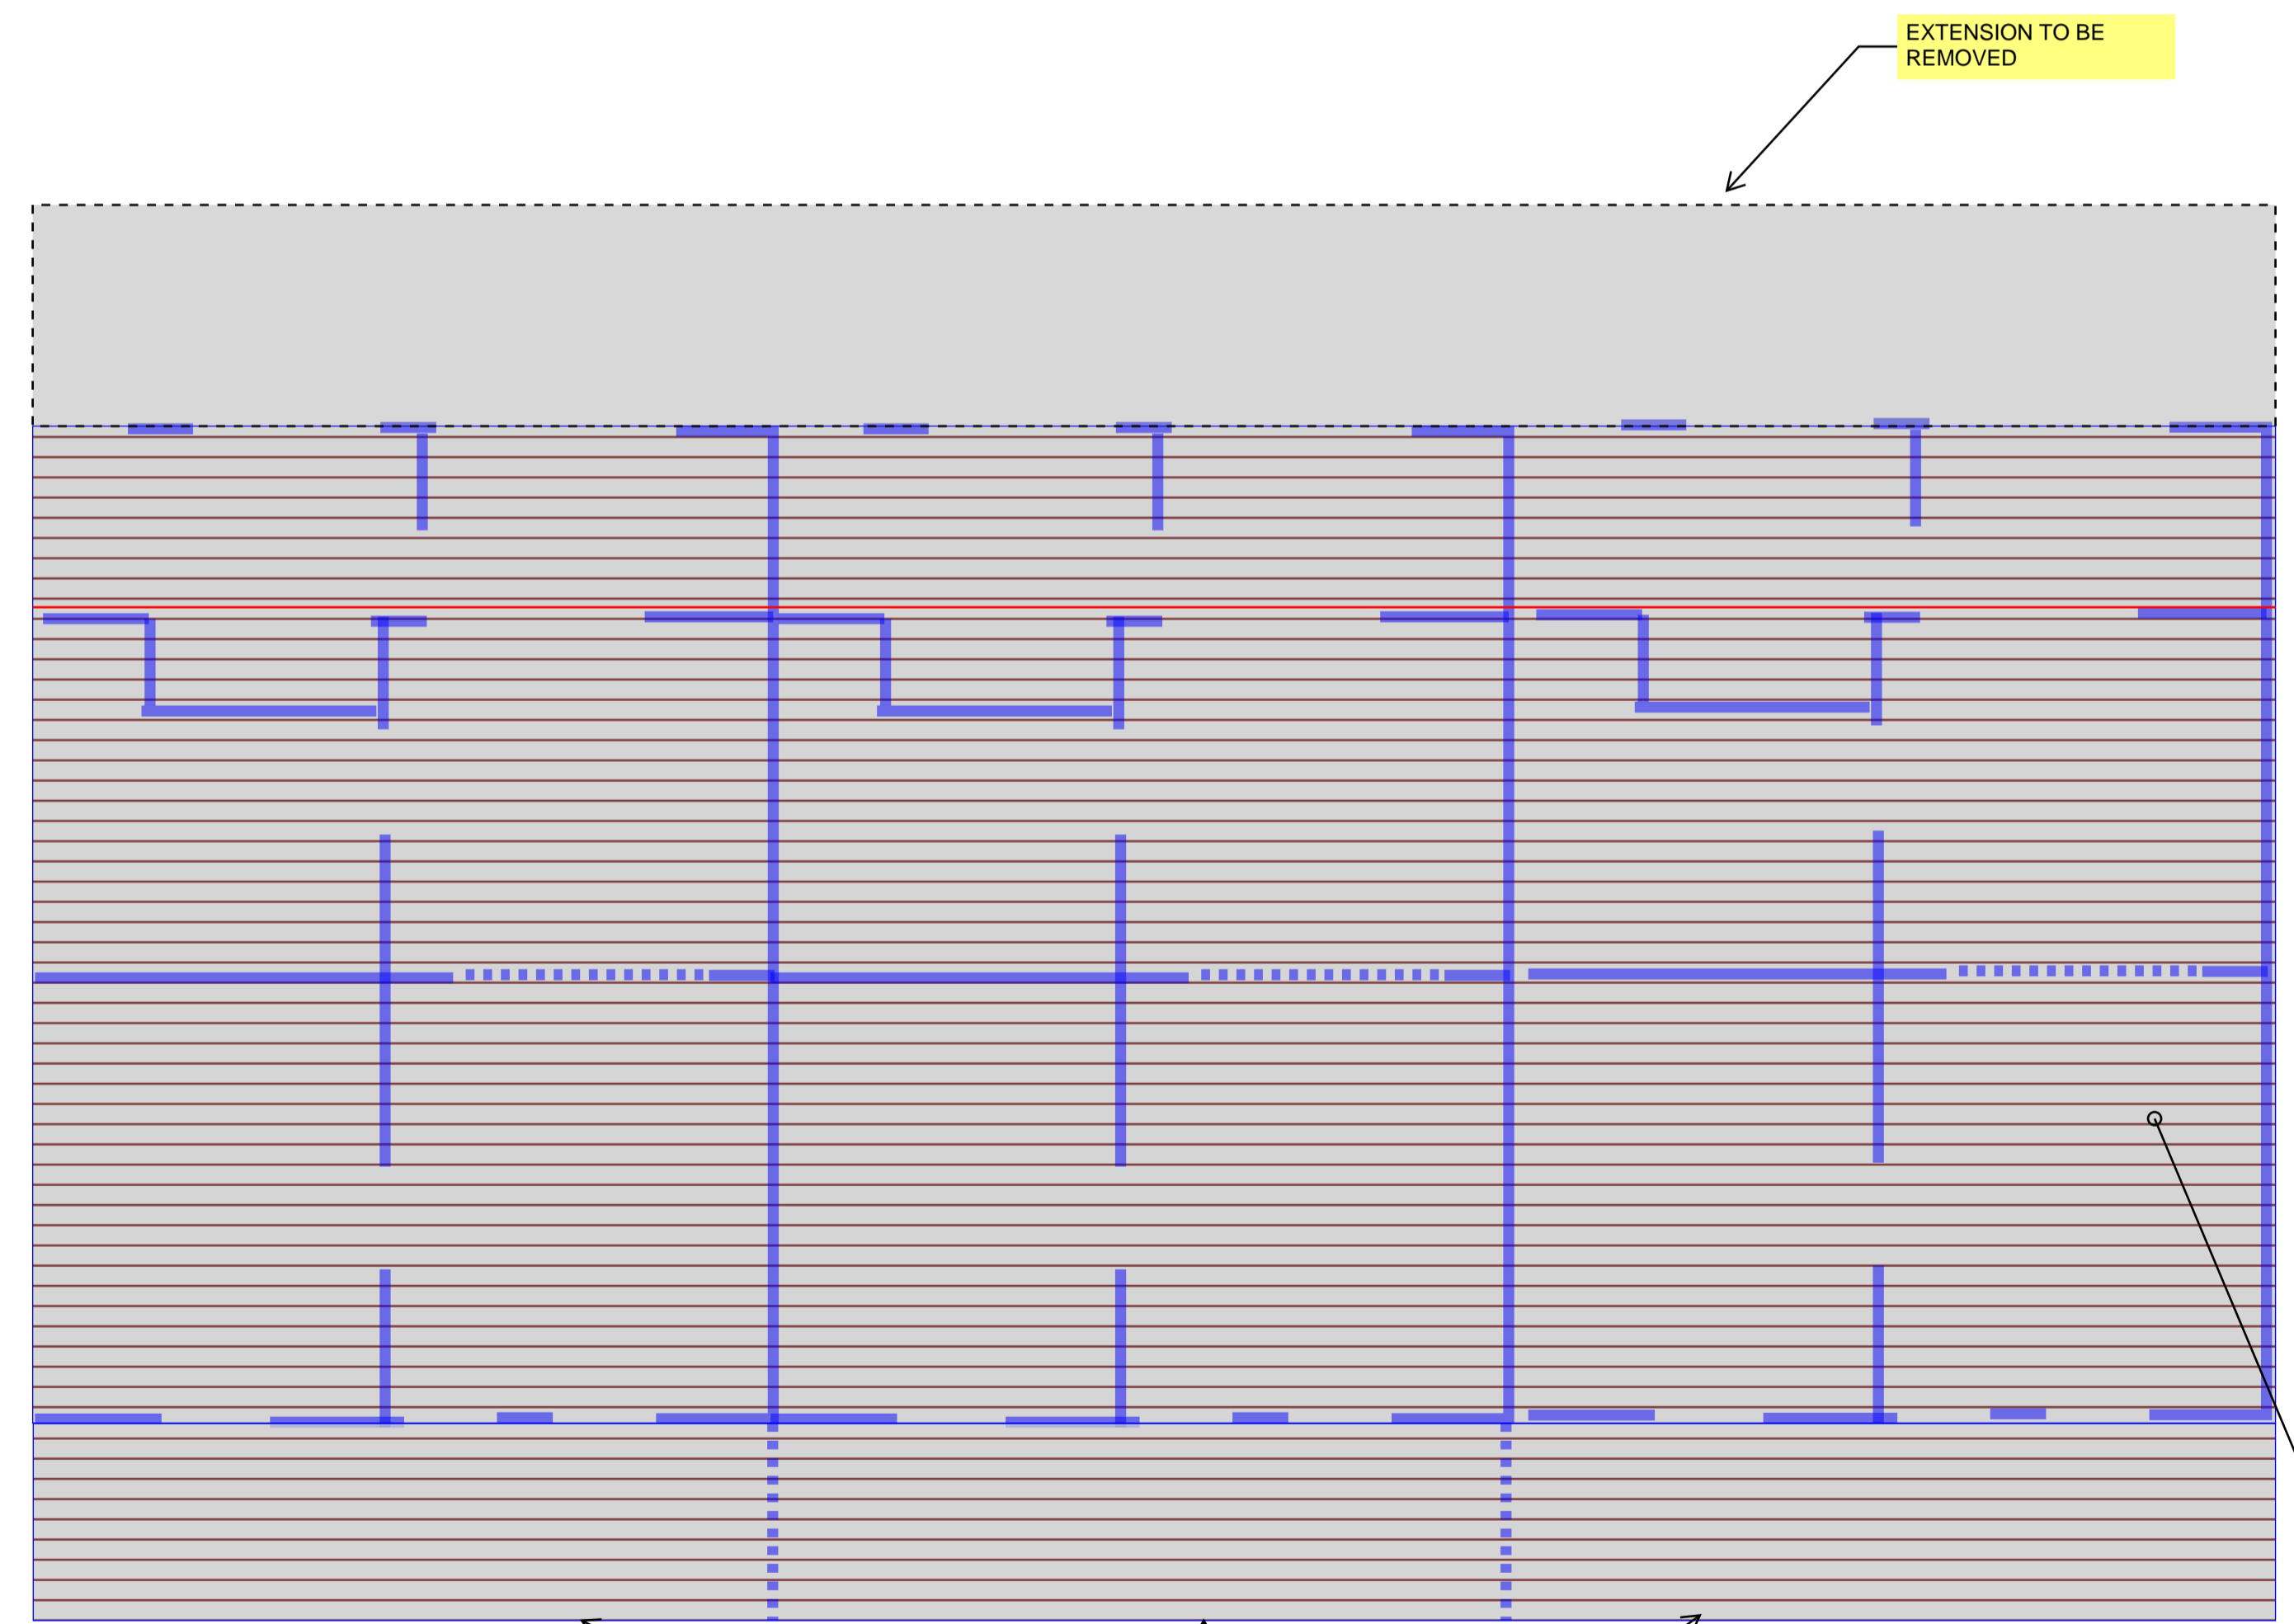
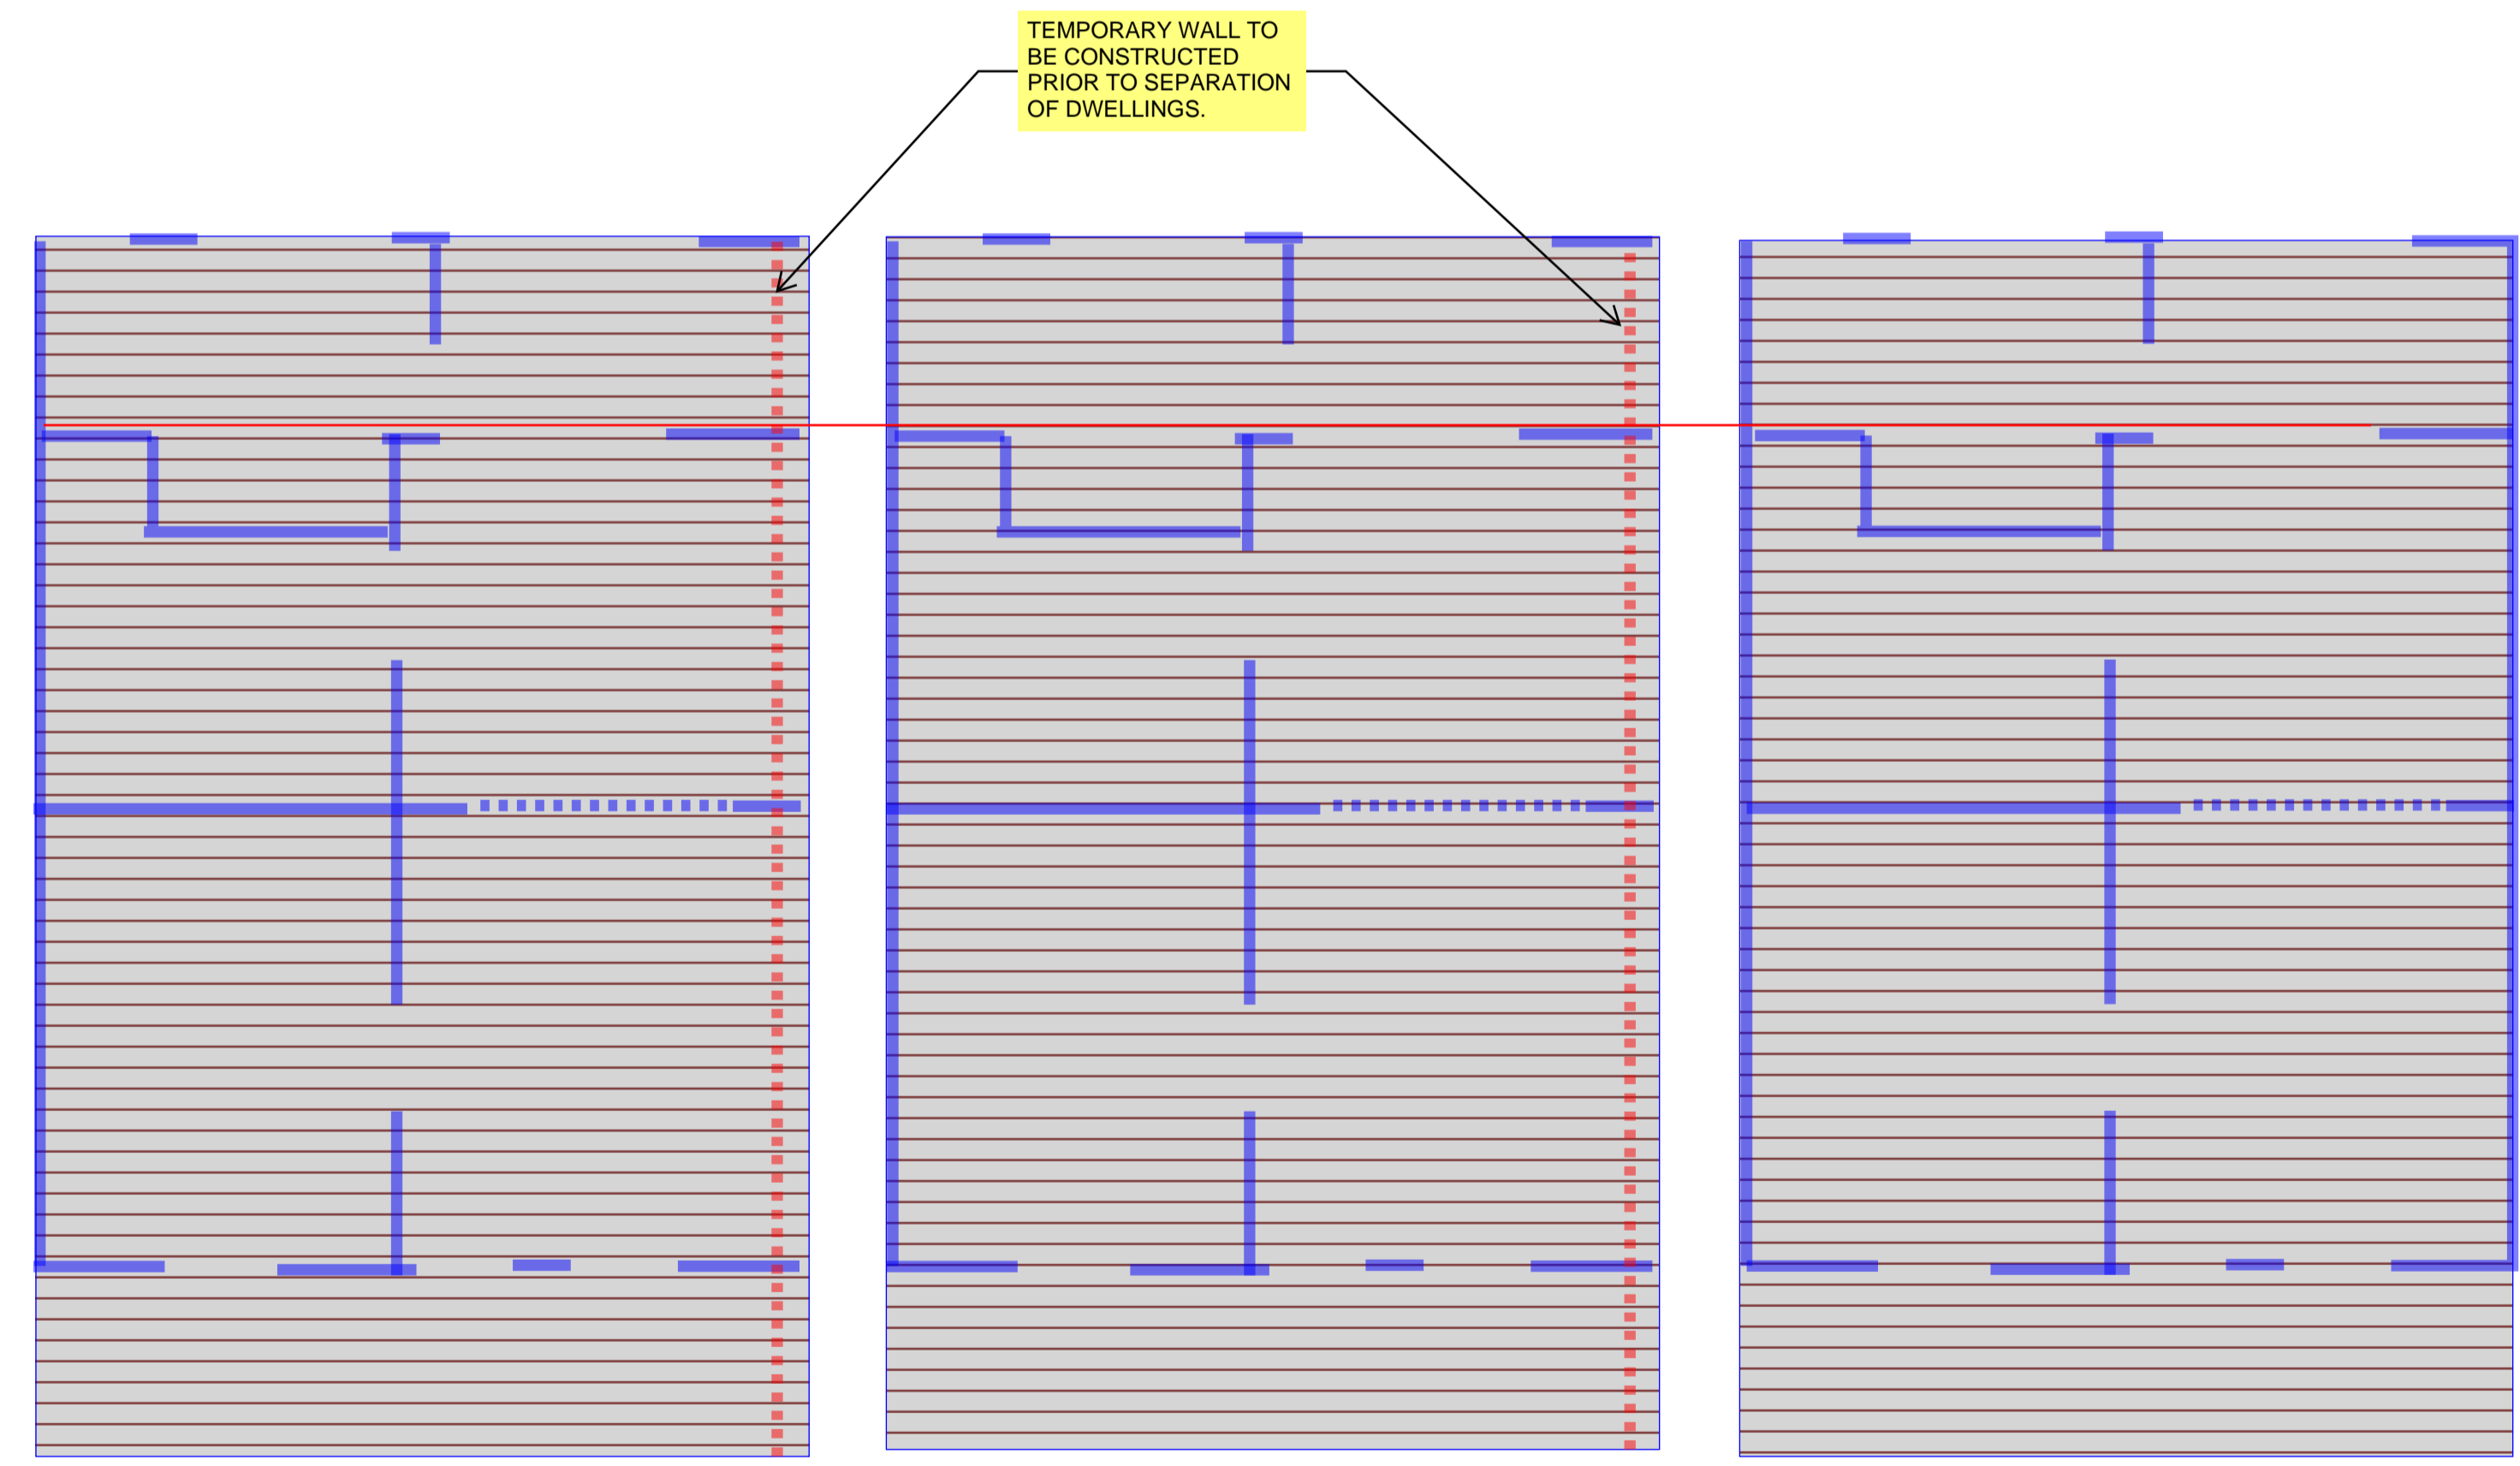
PLAN VIEW - CURRENT

FLOOR STRUCTURE IS IN VERY GOOD CONDITION AND APPEARS TO BE HAVE BEEN REPLACED
JOIST AND BEARER SPAN IS LARGER THAN THAT OF A BUILDING OF THIS AGE. STUMPS ARE NEW STEEL POSTS
