# PARADISE WATERS, DEEBING HEIGHTS PRECINCT A

## PRELIMINARY WATERWAY STABILITY ASSESSMENT

DesignFlow  
Prepared for Stockland  
December 2010

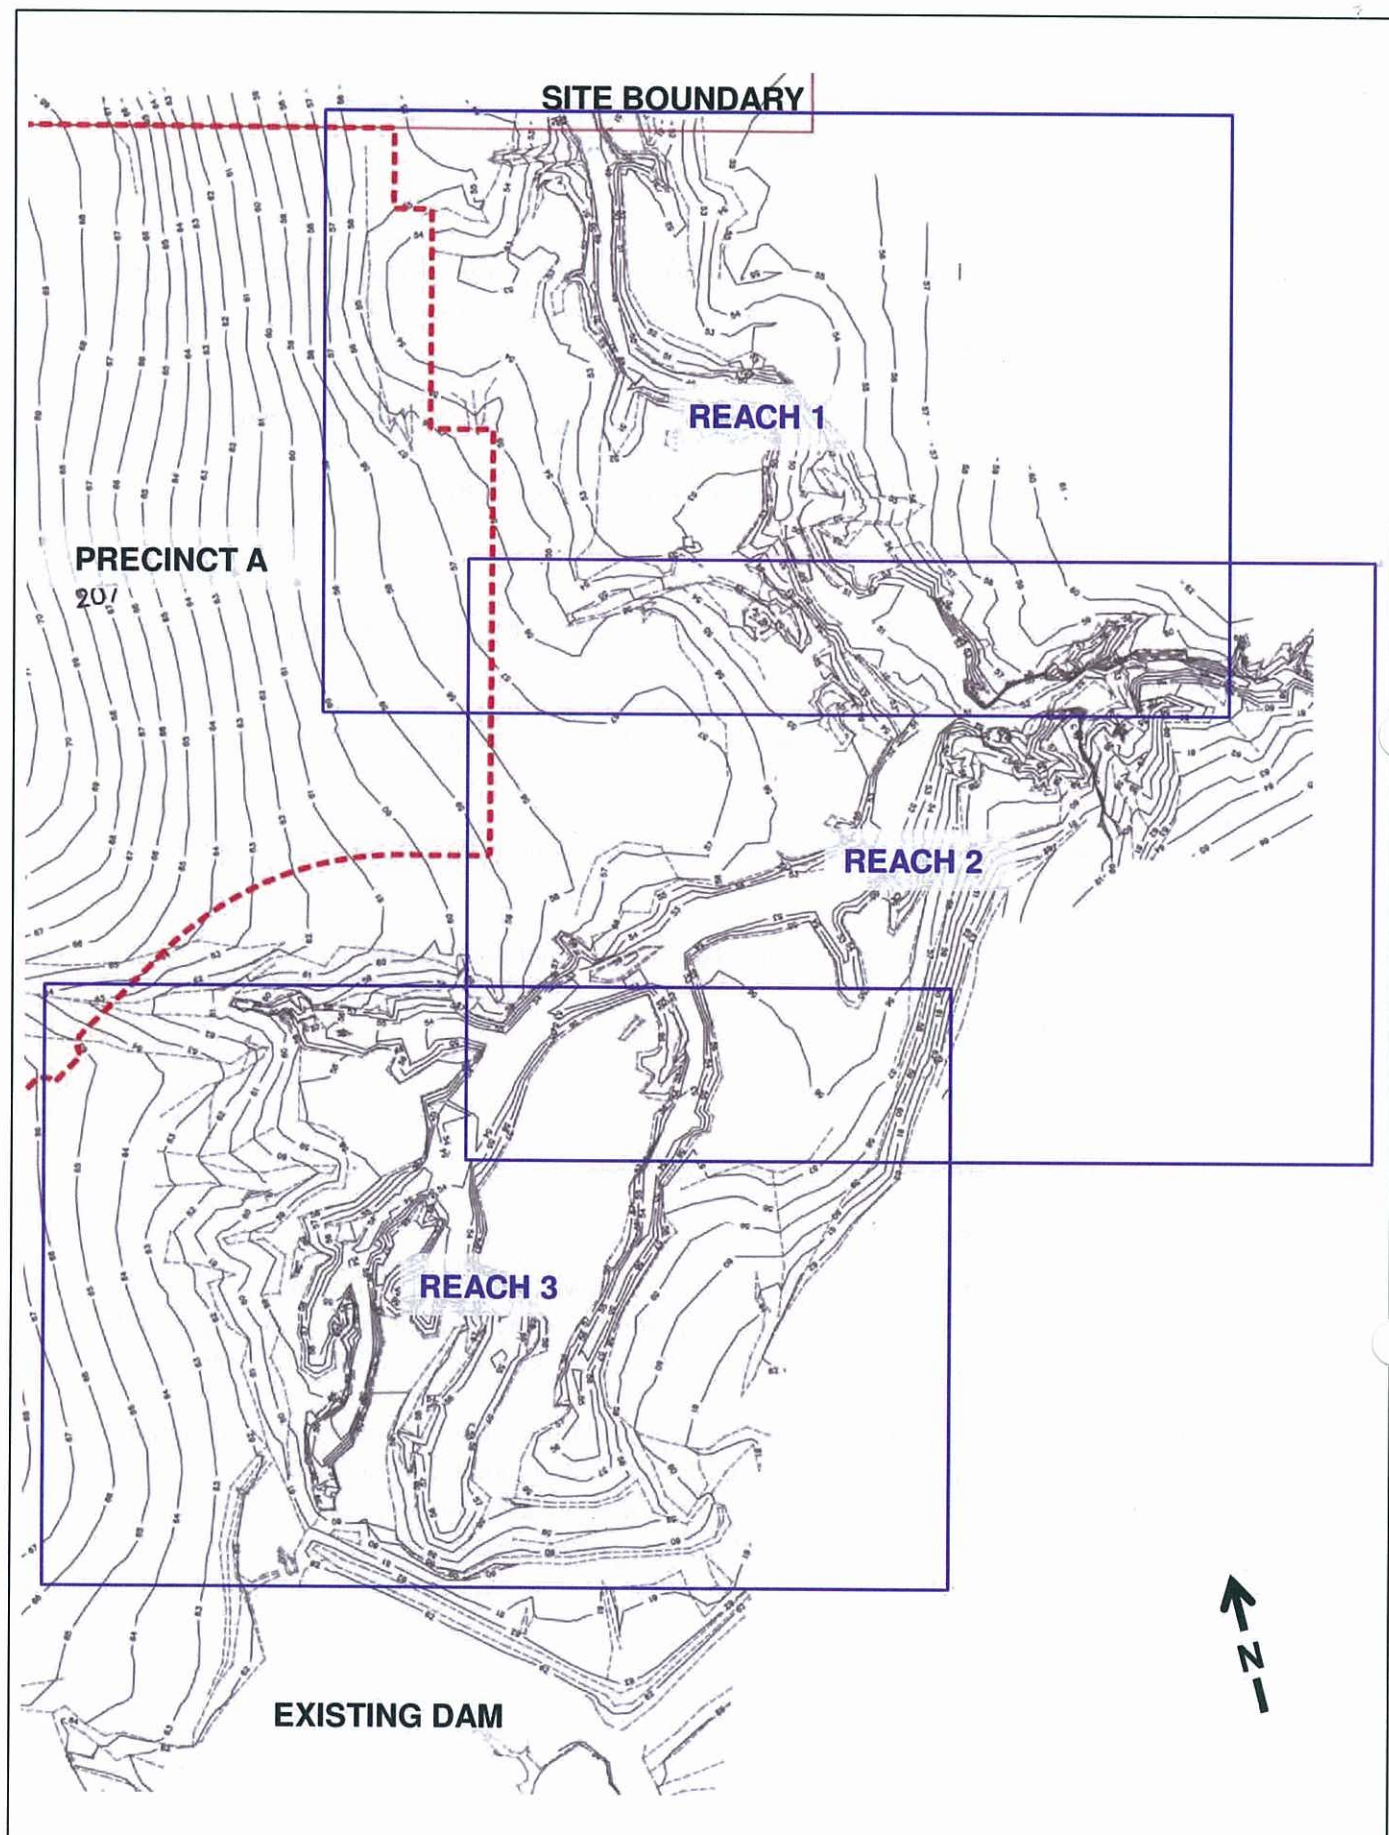
Sketch No.:  
FIGURE 6

For the purpose of this assessment, the waterway adjacent to Precinct A has been divided into three reaches based on the predominant waterway form, bank vegetation condition and general appearance. Figure 6 illustrates the extent of these reaches.

PARADISE WATERS PRECINCT A  
WATERWAY STABILITY ASSESSMENT  
WATERWAY REACH LAYOUT

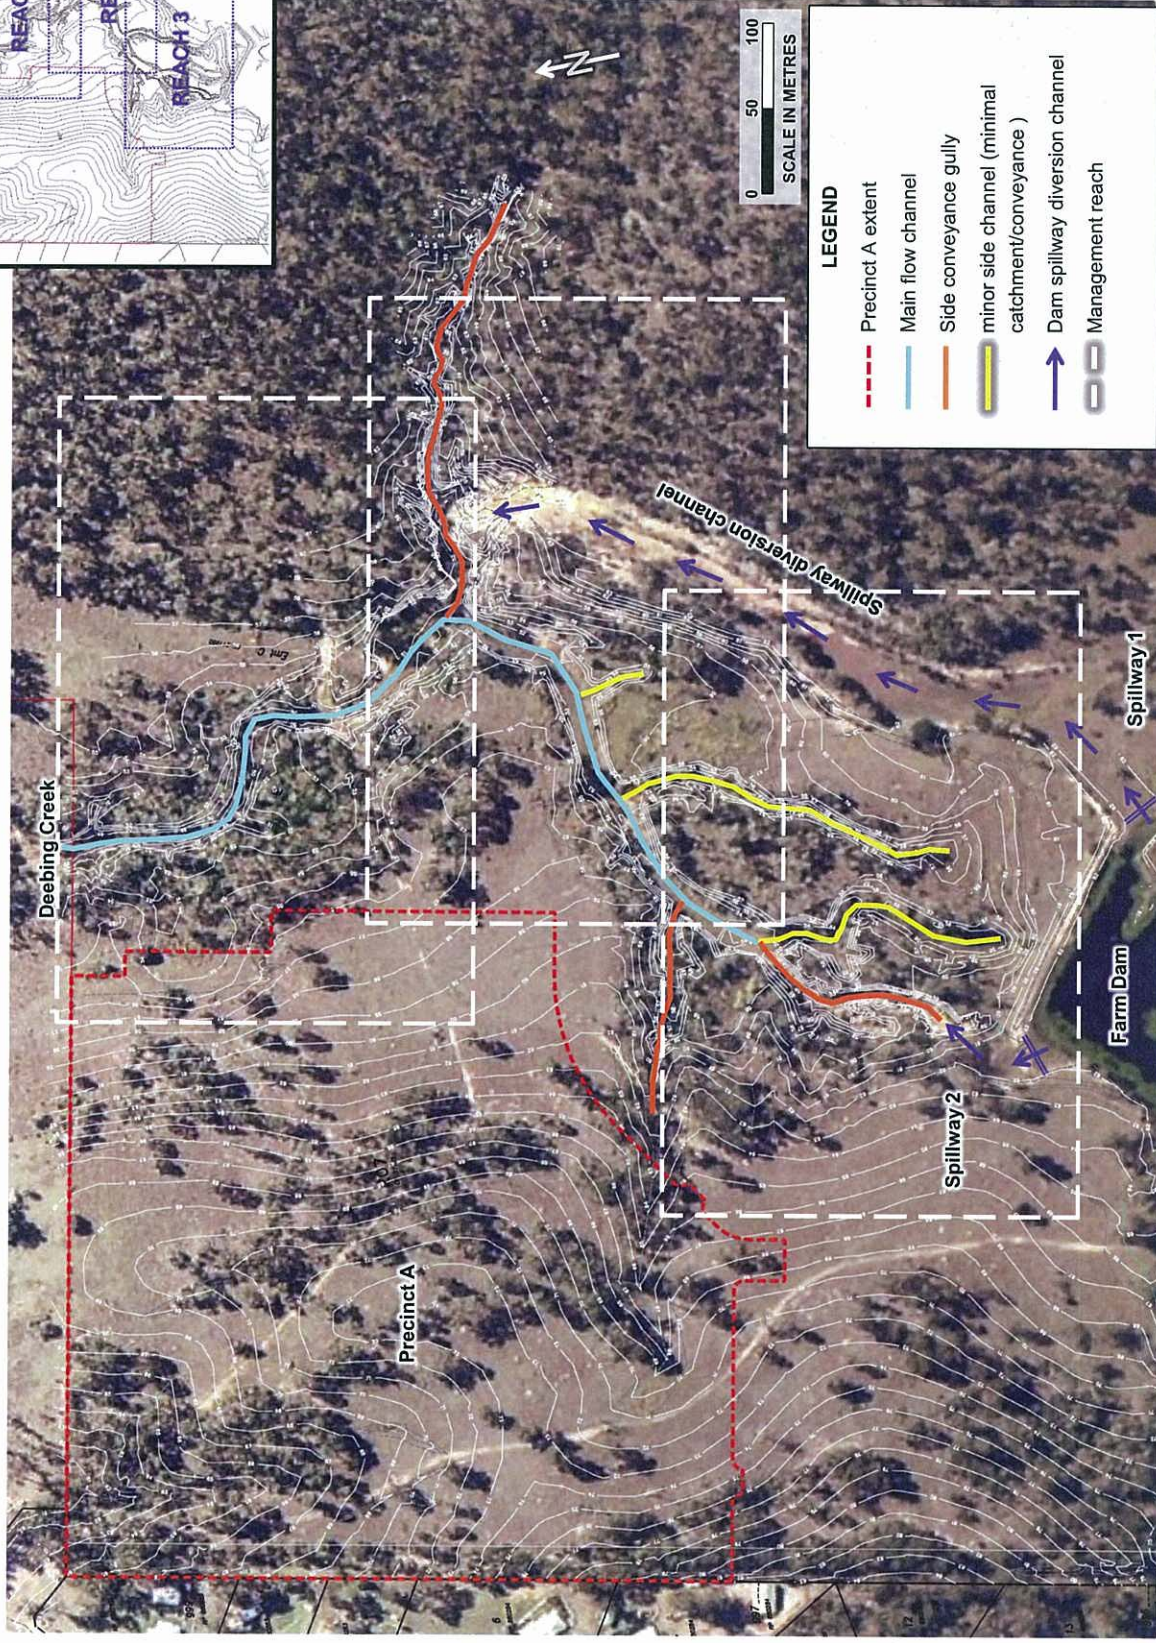
Sketch No.:  
Date: 10/12/10  
Scale: NTS  
FIGURE 7

- Single main channel with flat grade
- Downstream characterised by moderately steep banks with dense vegetation and mature trees extending behind banks (photo 1)
- Upstream widens to broad channel with reestablished banks, partially battered back with full grass/strub vegetation (photo 2)
- Previous bank erosion/scour evident in mid to upper reach but not visually active - established vegetation of upper and lower banks.
- Minor advancing head cut erosion face in channel (photo 2 & 3)
- High sediment load in stream bed from upstream erosion/sediment transport.
- Some gully erosion where vehicle/livestock crossings have occurred (photo 4)

This reach appears to be in a reasonably good state of recovery with low stream bed gradient and dense vegetation on lower and upper banks. Localised areas of bank (toe) scour and minor head cut indicate potential for further damage where stream hydrology is altered.
