Job No. DE21/113  
Ref No: 28651-Rev1  
Author: Simon Wynne

**RE: GEOTECHNICAL DESKTOP REVIEW FOR PRECINCT 6 YARRABILBA**

This report presents the results of a geotechnical desktop review carried out for the proposed residential development at Yarrabilba – Precinct 6 (herein referred to as the ‘site’). The work was requested by Cameron McClure representing Golding Contractors (Golding).

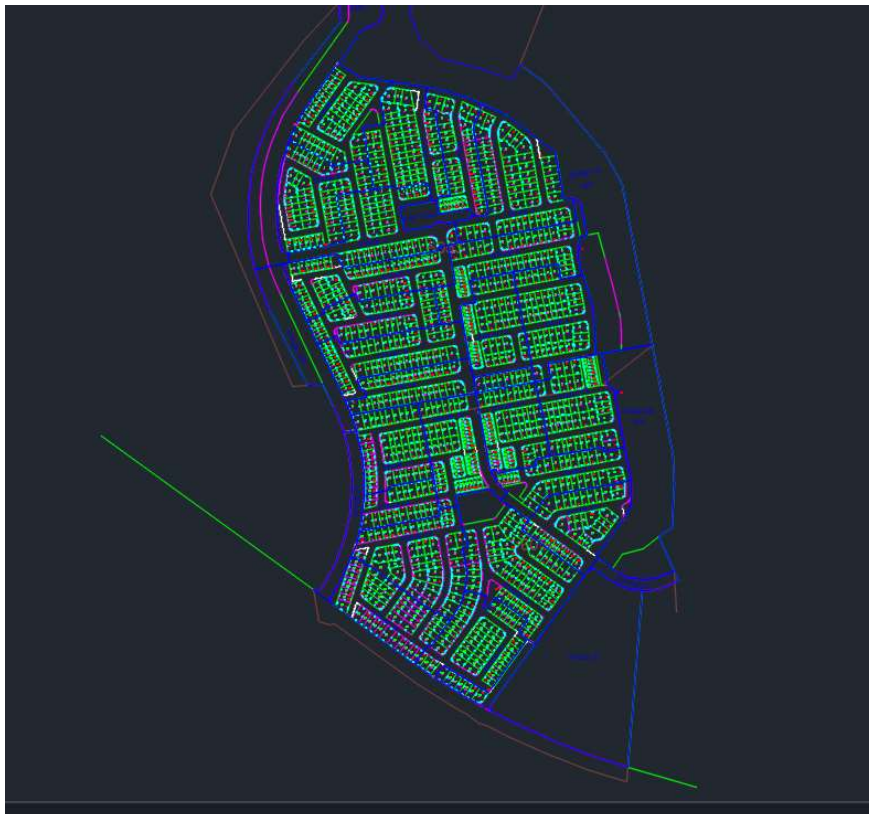
**Figure 2 – Indicative Precinct 6 Layout Plan**

An aerial image of the site which shows the broad site conditions is given in Figure 1. A copy of the Precinct 6 layout plan provided by Golding is given in Figure 2.
