## GEOTECHNICAL INVESTIGATION

Proposed Vertical Retirement Village  
Lot 8002, Baringa Drive, Baringa

Report for: Plantation Baringa Pty Ltd  
23387-001-Rev0  
15 January 2023

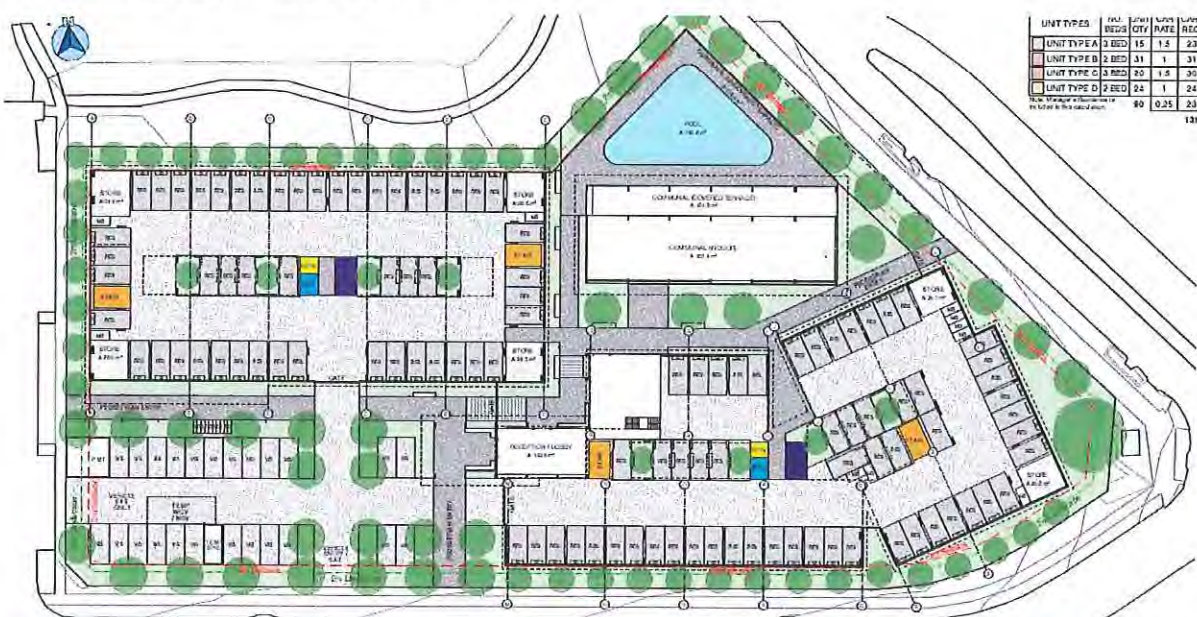
Text Figure 1: Extract from ground floor plan for the proposed development (courtesy of O.G.E, 2023)

Preliminary design drawings prepared by O.G.E Group Architects were supplied to us (Ref. Project No. 23040, Rev P3, dated 06 October 2023) and indicate that the proposed development will comprise retirement units in two 5-storey buildings, with a separate single storey communal indoor area, swimming pool and at-grade carparking (including under the multi-level buildings). We are advised by the project structural engineers (Empire Engineering) that the maximum column loads for the 5-storey buildings are expected to be in the order of 3500 kN to 4000 kN (working). Localised excavations will be required for underground services, footings and pool construction, however, are not expected to extend beyond about 1 m to 2 m below ground level (BGL).

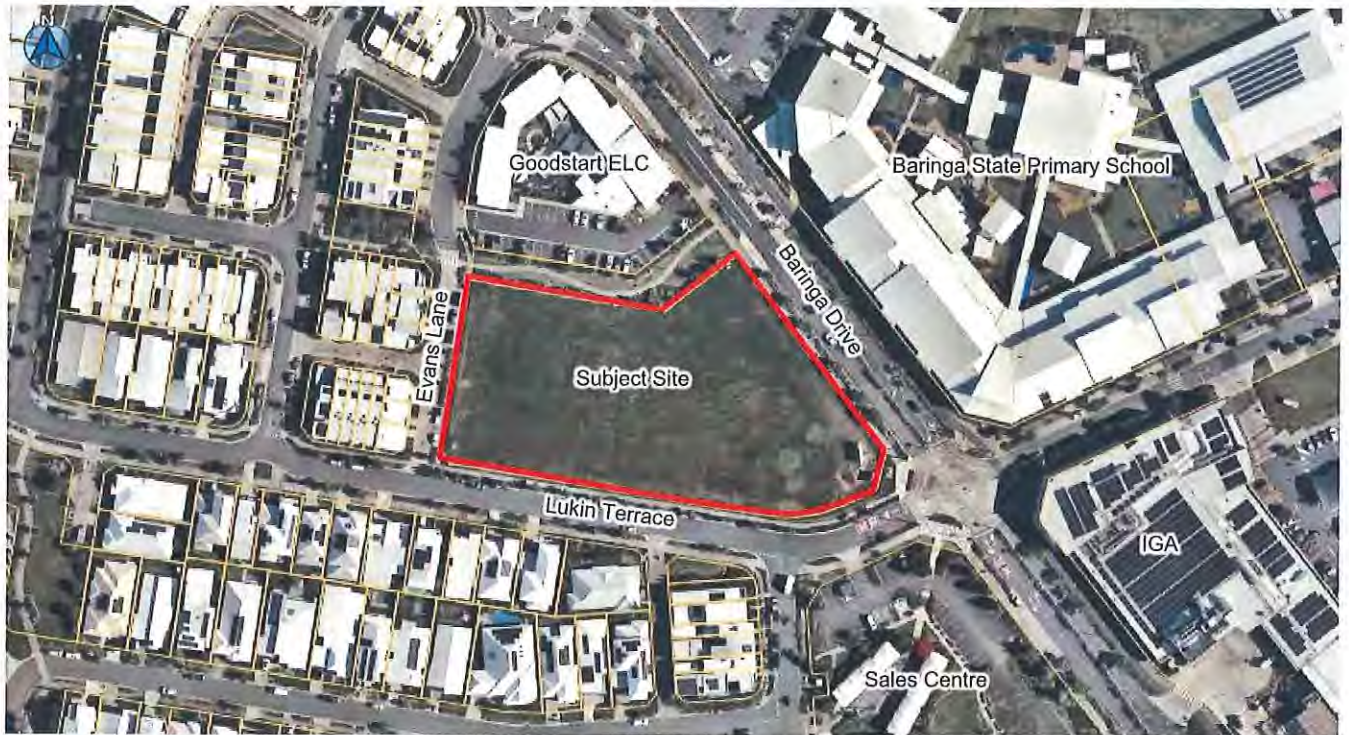
*Text Figure 3: November 2023 aerial image of the site and surrounds (courtesy of Nearmap)*

The site is situated centrally within the suburb of Baringa with frontages to Baringa Drive to the east, Lukin Terrace to the south and Evans Lane to the west. The site was vacant, grassed and approximately level at the time of the investigation. Existing underground services were located to the fringes of the subject site, in the road reserves. Surrounding properties featured residential blocks along with a Goodstart Early Learning Centre (ELC) to the north, Baringa State Primary School and Baringa IGA to east and the Stockland Aura Display Village and Sales Centre to the south-east.

Text Figure 3 overleaf presents an aerial image of the site and the immediate surrounds, with the above noted features annotated.

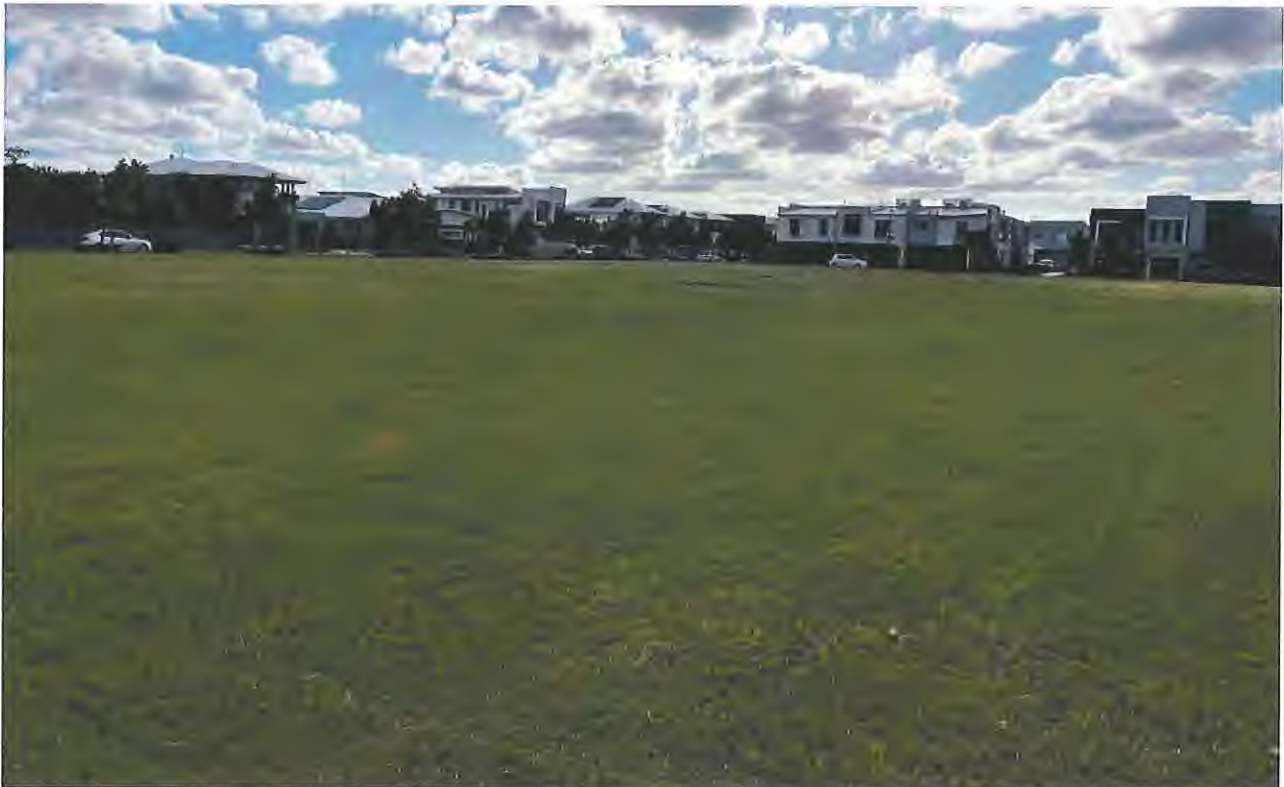
*Text Figure 4: View over site looking west*

Text Figures 4 and 5 below and overleaf illustrate site conditions at the time of the investigation.

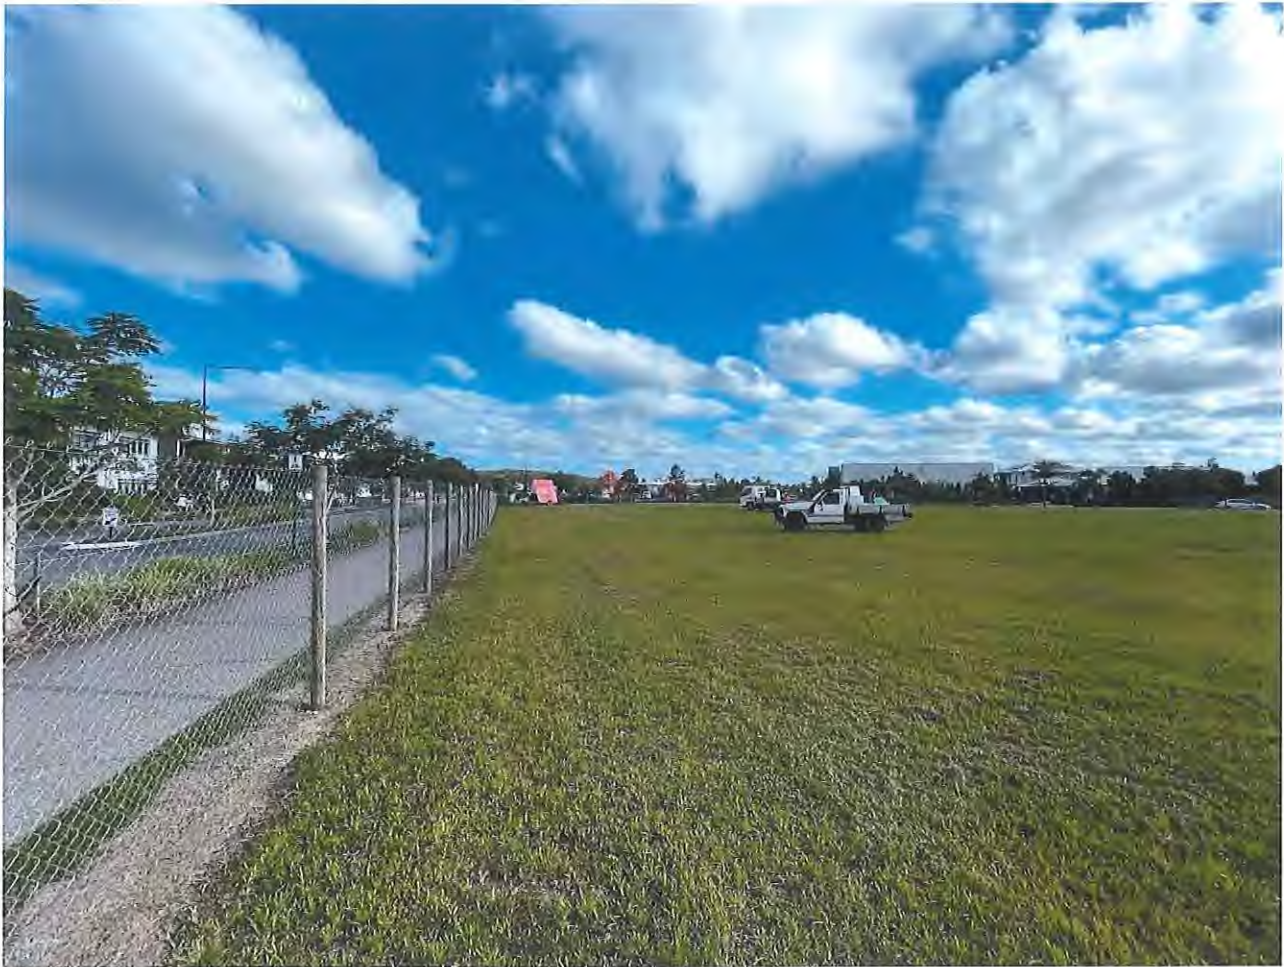
Text Figure 5: View of site looking south-east

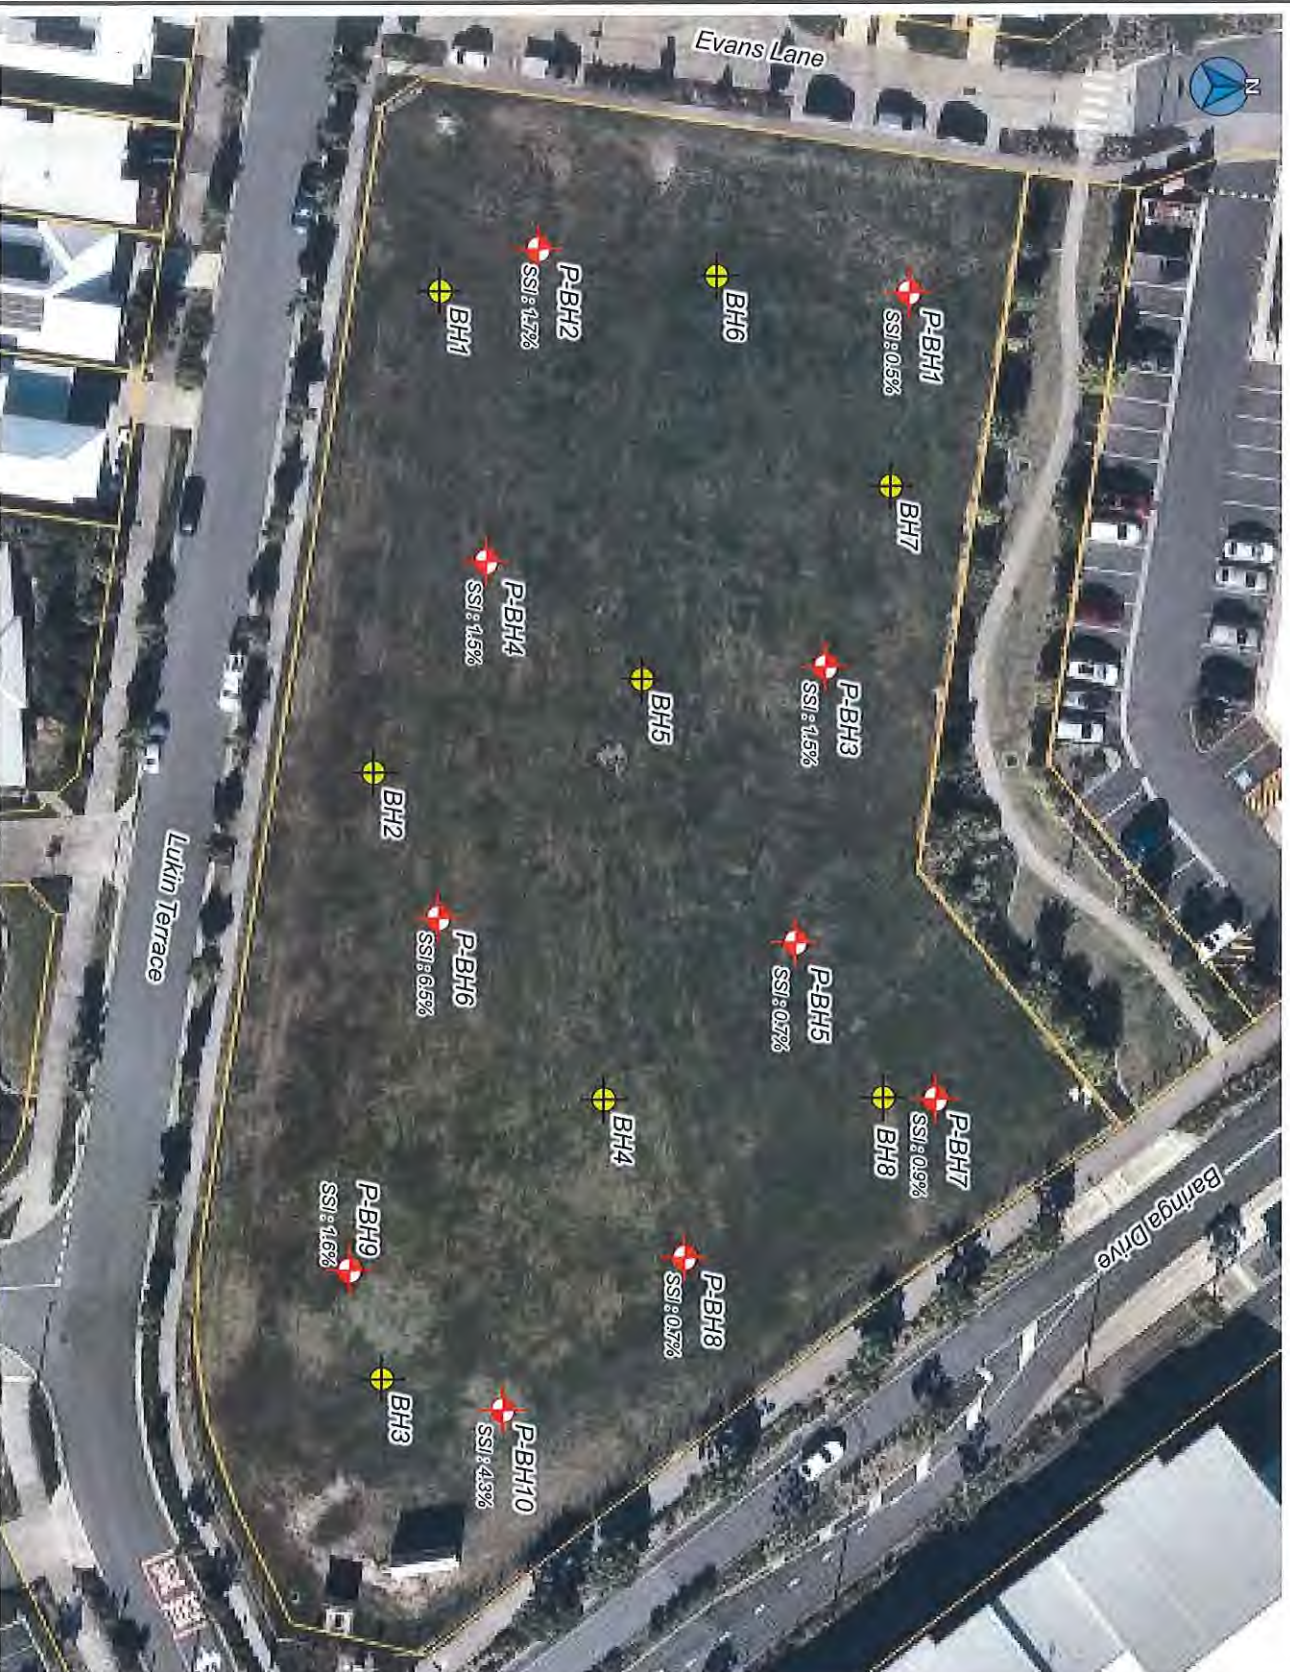
Figure 1: Site Plan

Notes:  
Aerial Imagery courtesy of NearMap (30 November 2023)

Reports of those boreholes and the laboratory results are presented in Appendix C. The previous borehole locations are shown in Figure 1 at the end of this report.

Reports of the current investigation boreholes, along with explanatory notes, are presented in Appendix A. Borehole locations are shown in Figure 1 at the end of this report.

We note that soil samples tested as part of the 2021 investigation returned SSI values ranging from 0.5% to 6.5%, which indicated up to a high potential for soil reactivity. SSI values for the corresponding boreholes are indicated in Figure 1.
