Engineering and Stormwater Report

Retire Australia - Parkside Yeronga
70 Park Road, Yeronga

Stantec Australia Pty Ltd

Project/File:
301051102

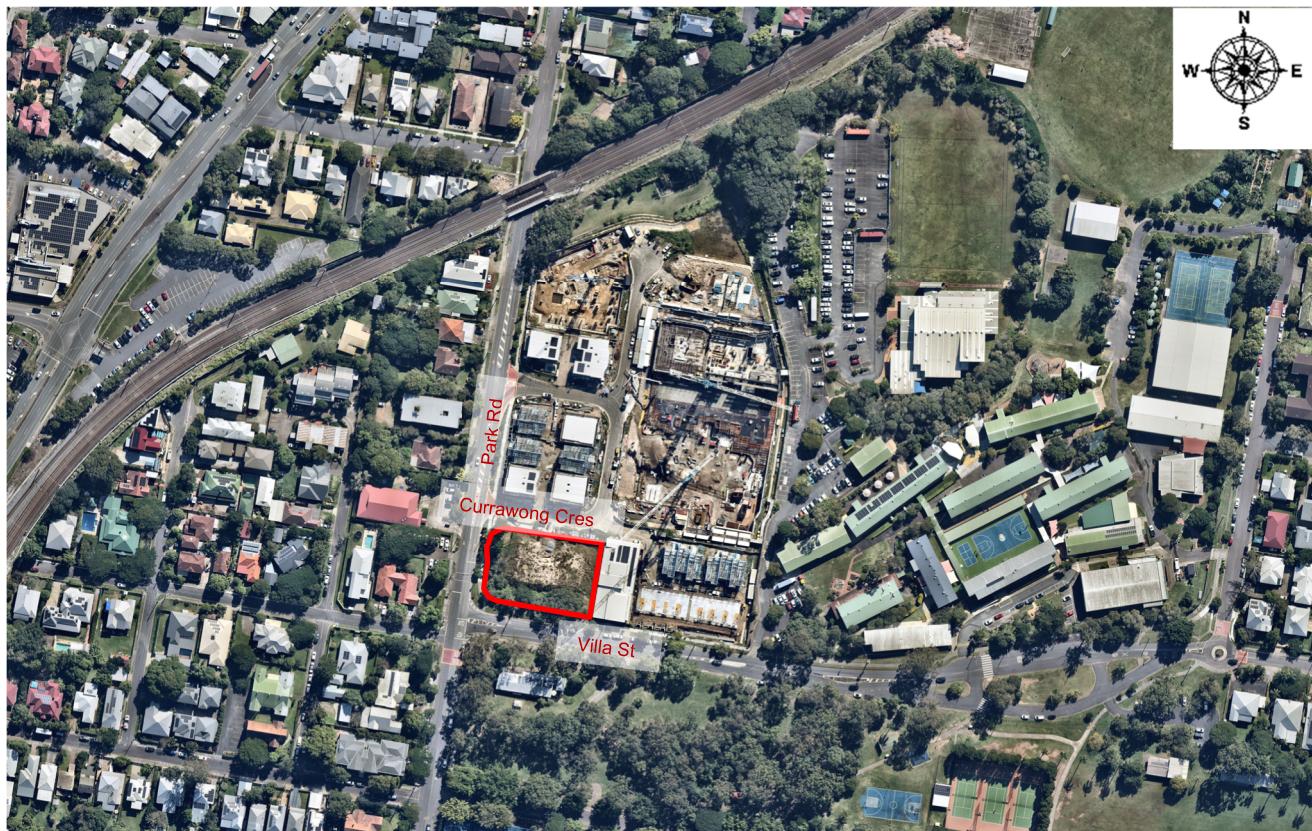
As seen in Figure 1 below, the proposed development site is bound by Currawong Crescent to the North, the Yeronga Community Centre on Lot 11 SP328496 to the East, Villa Street to the South, and Park Road to the West.

The development site is currently vacant with trees to the Southern and Western boundaries, and grass cover spreading over the site. There is a temporary stockpile of material located on the lot, which was sourced from other lots within the wider Yeronga PDA subdivision. At the time of writing this report, the stockpile was being removed from the site.

Figure 1 - Site Location Aerial (Source: Nearmap, Dated 8 May 2025)

Figure 1 - Site Location Aerial (Source: Nearmap, Dated 8 May 2025)

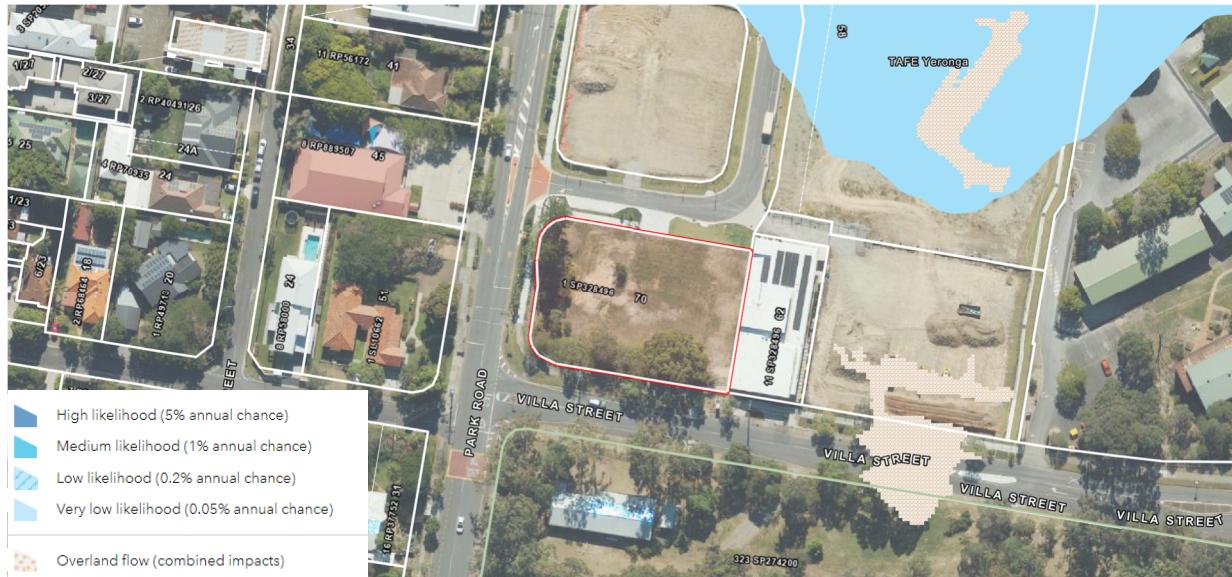
BCC Interactive Mapping, Flood Awareness Interactive Mapping and the Floodwise Property Reports identify that the site is not impacted by Brisbane River flooding, creek/waterway flooding and overland flow overlays.

Figure 3 - Flood Mapping (Source: Brisbane City Council Flood Awareness Mapping)

Figure 3 - Flood Mapping (Source: Brisbane City Council Flood Awareness Mapping)

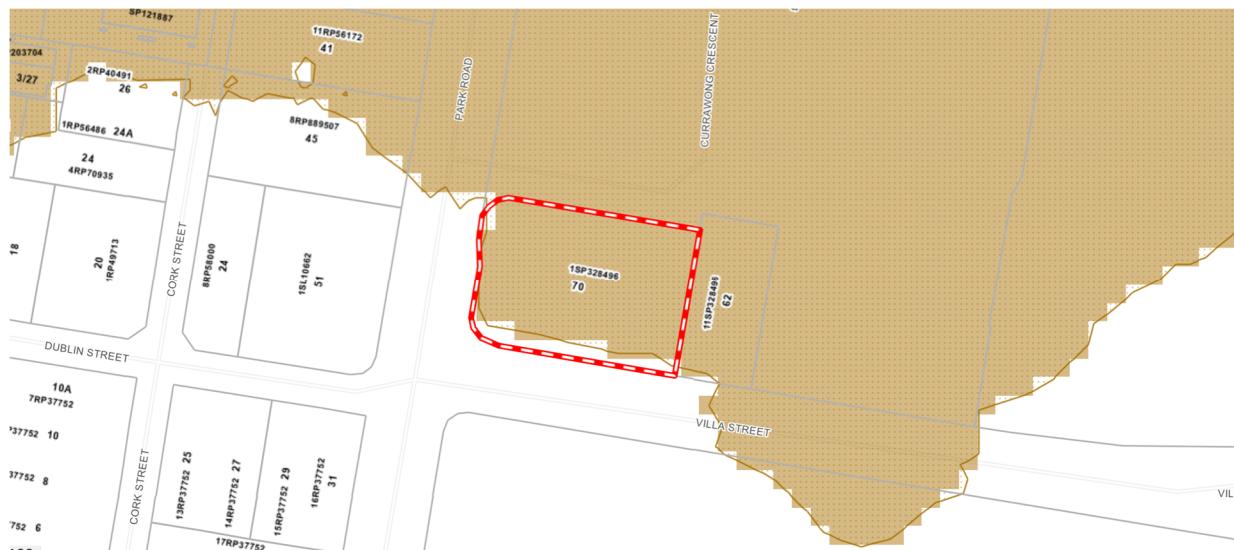
Acid sulfate soils are typically encountered in Holocene sediment and below 5mAHD. The lowest existing surface level of the site is approximately RL18mAHD at the Northern site boundary, with proposed excavations for the basement extending down to circa RL12.25mAHD. The site is subject to the Brisbane City Council acid sulfate soil overlay for land above 5mAHD to 20mAHD for potential acid sulfate soils (PASS) and actual acid sulfate soils (AASS). No bulk earthworks or pipe trenching works are expected to be undertaken below the 5mAHD contour.

Figure 4 - ASS Mapping (Source: Brisbane City Council Interactive Mapping)

Figure 4 - ASS Mapping (Source: Brisbane City Council Interactive Mapping)

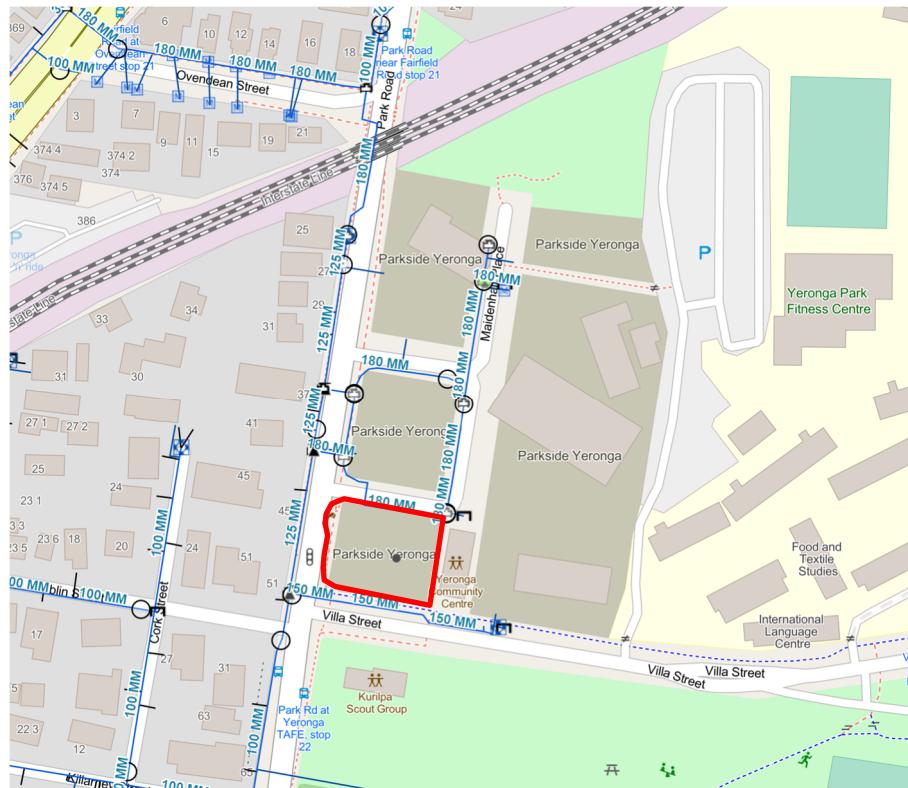
The size of the proposed water property connection for the domestic and fire servicing is to be confirmed by the Hydraulic Consultant in future detailed design phases.

Refer to the Proposed Development Plans in Appendix D for the proposed water network and connection location.

Figure 5 – Water Infrastructure Mapping (Source: Urban Utilities infrastructure interactive GIS mapping)

Figure 5 – Water Infrastructure Mapping (Source: Urban Utilities infrastructure interactive GIS mapping)

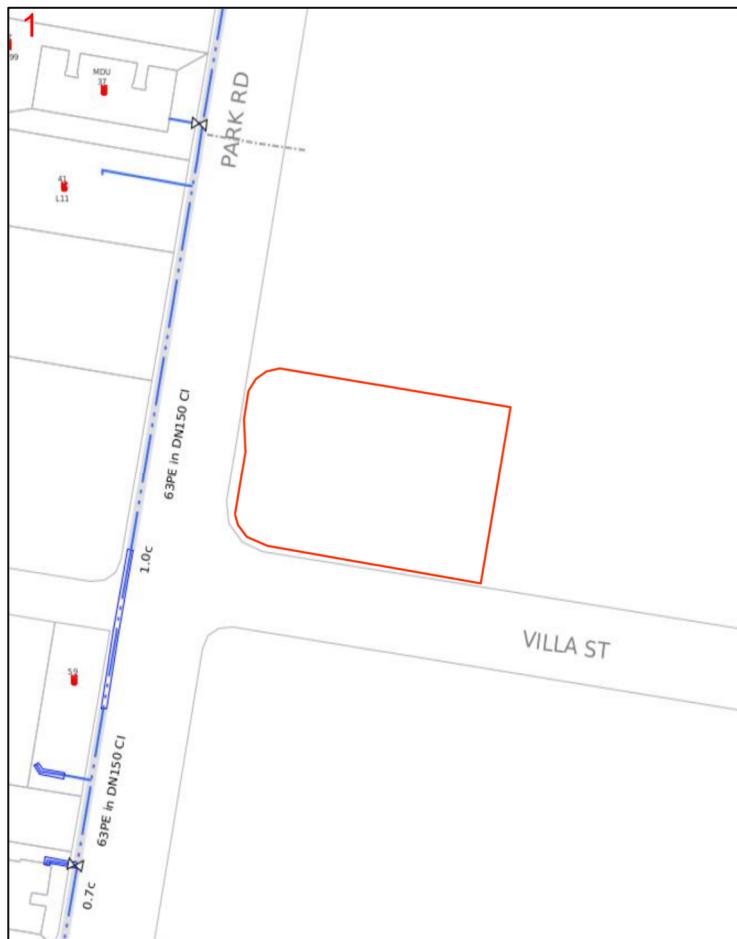
There is a DN63 PE existing gas main along the western verge of Park Road next to the development site.

No gas reticulation was required to be installed within the wider Yeronga PDA subdivision development, nor is it perceived that Retire Australia require a gas connection to support the proposed development.

Figure 8 - Existing Gas Infrastructure (BYDA)

Figure 8 - Existing Gas Infrastructure (BYDA)

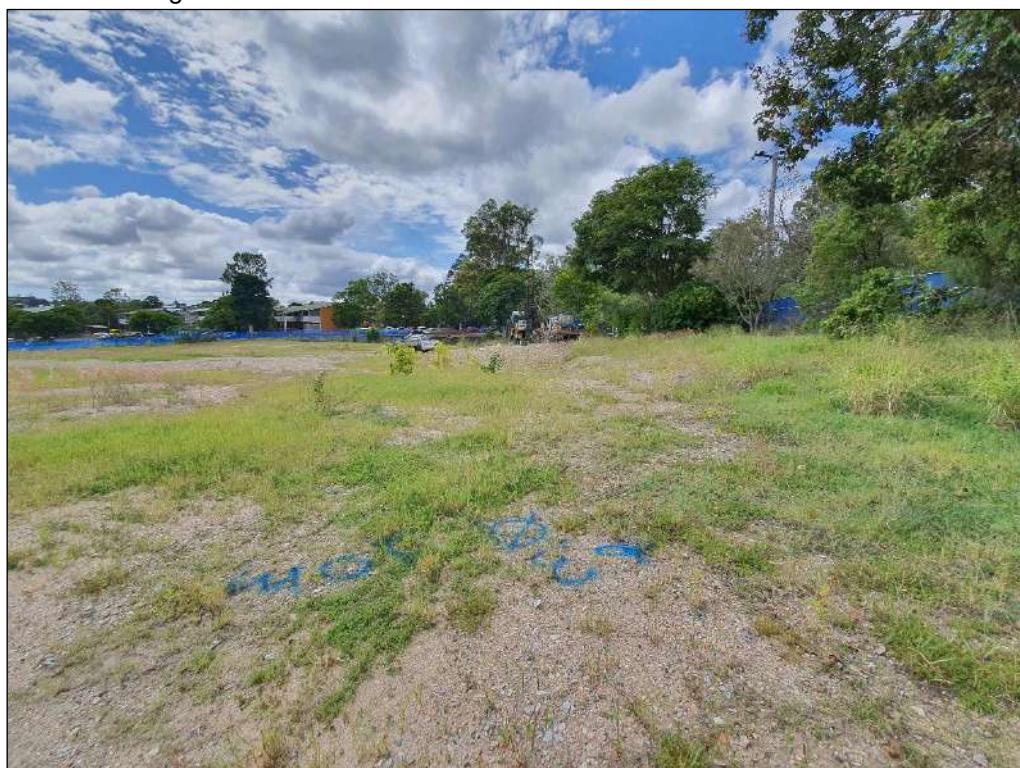
Figure 1: Looking east towards the rig set up on Bore 2.

The ground surface at the site was sparsely covered by poorly-maintained grass with the remaining areas exposed fill subgrade and small to large sized trees were observed scattered along the northern, western and eastern boundaries. Furthermore, localised rock outcrops were also observed in various areas of the site. The topography within the majority of the site was relatively flat, however, generally sloped gently down from the southern and south-western boundary towards the north, north-eastern boundary. With reference to recorded bore levels and Brisbane City Council Interactive Mapping, the site levels are approximately RL 20 mAHD near the southern boundary, and approximately between RL10 mAHD and RL7 mAHD near the northern boundary of the site. Photographs of the site are indicated in Figures 1 to 3.

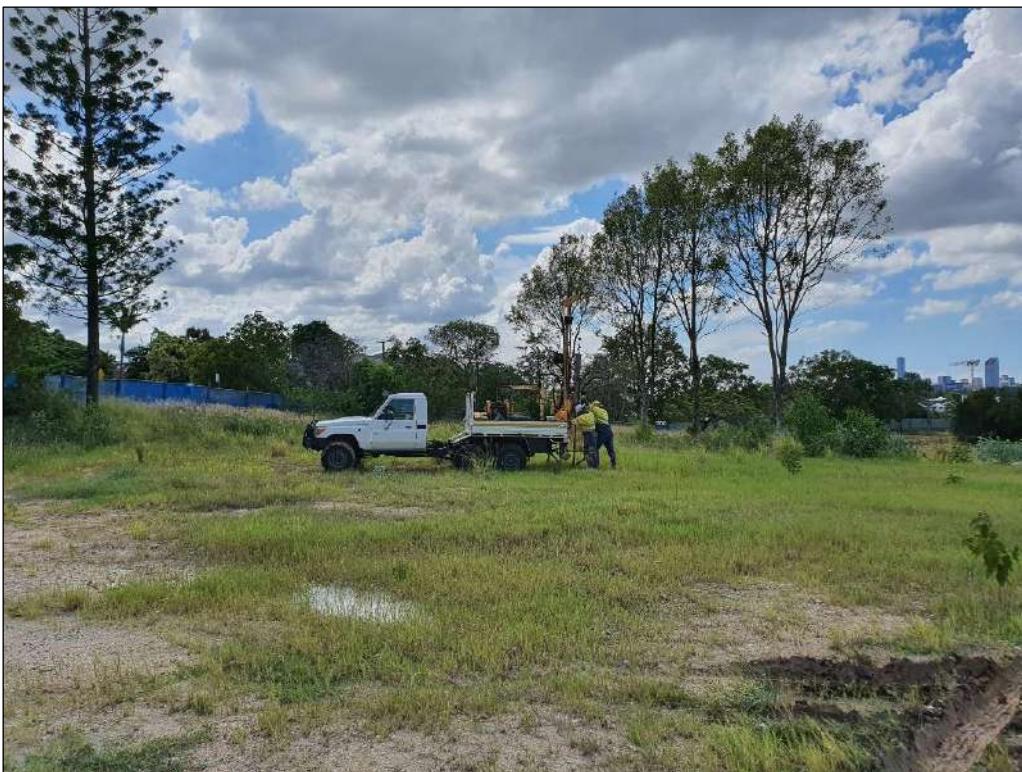
Figure 2: Looking north-west towards the rig set up on Bore 2.

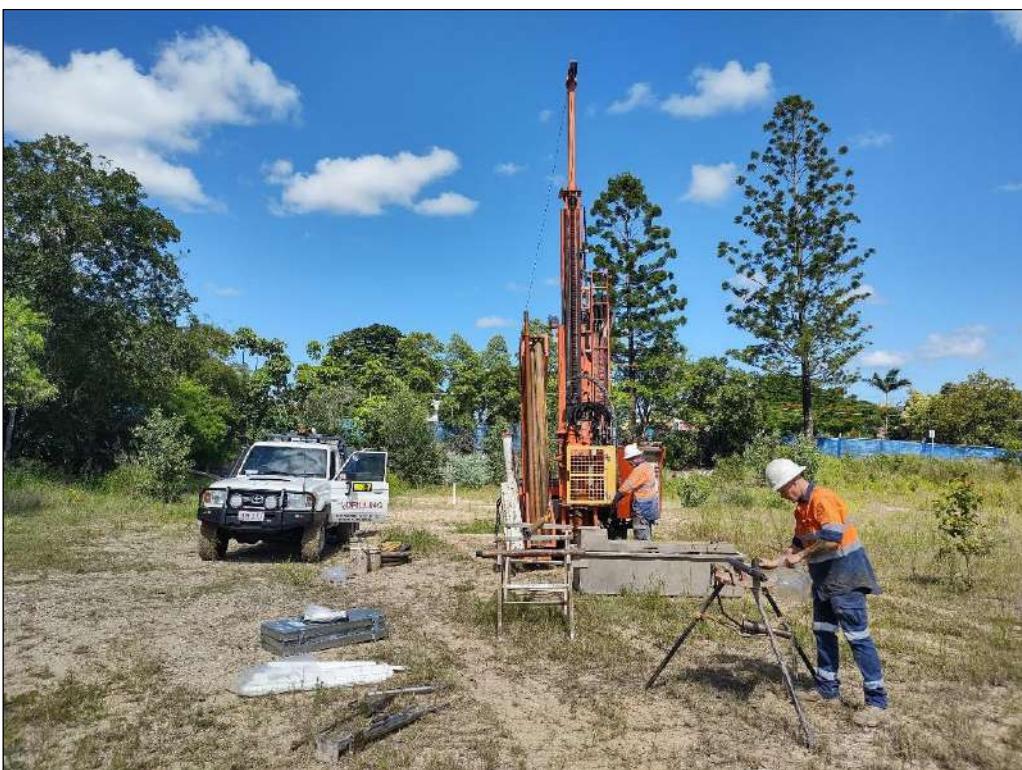
Figure 3: Looking west towards the rig set up on Bore 24.

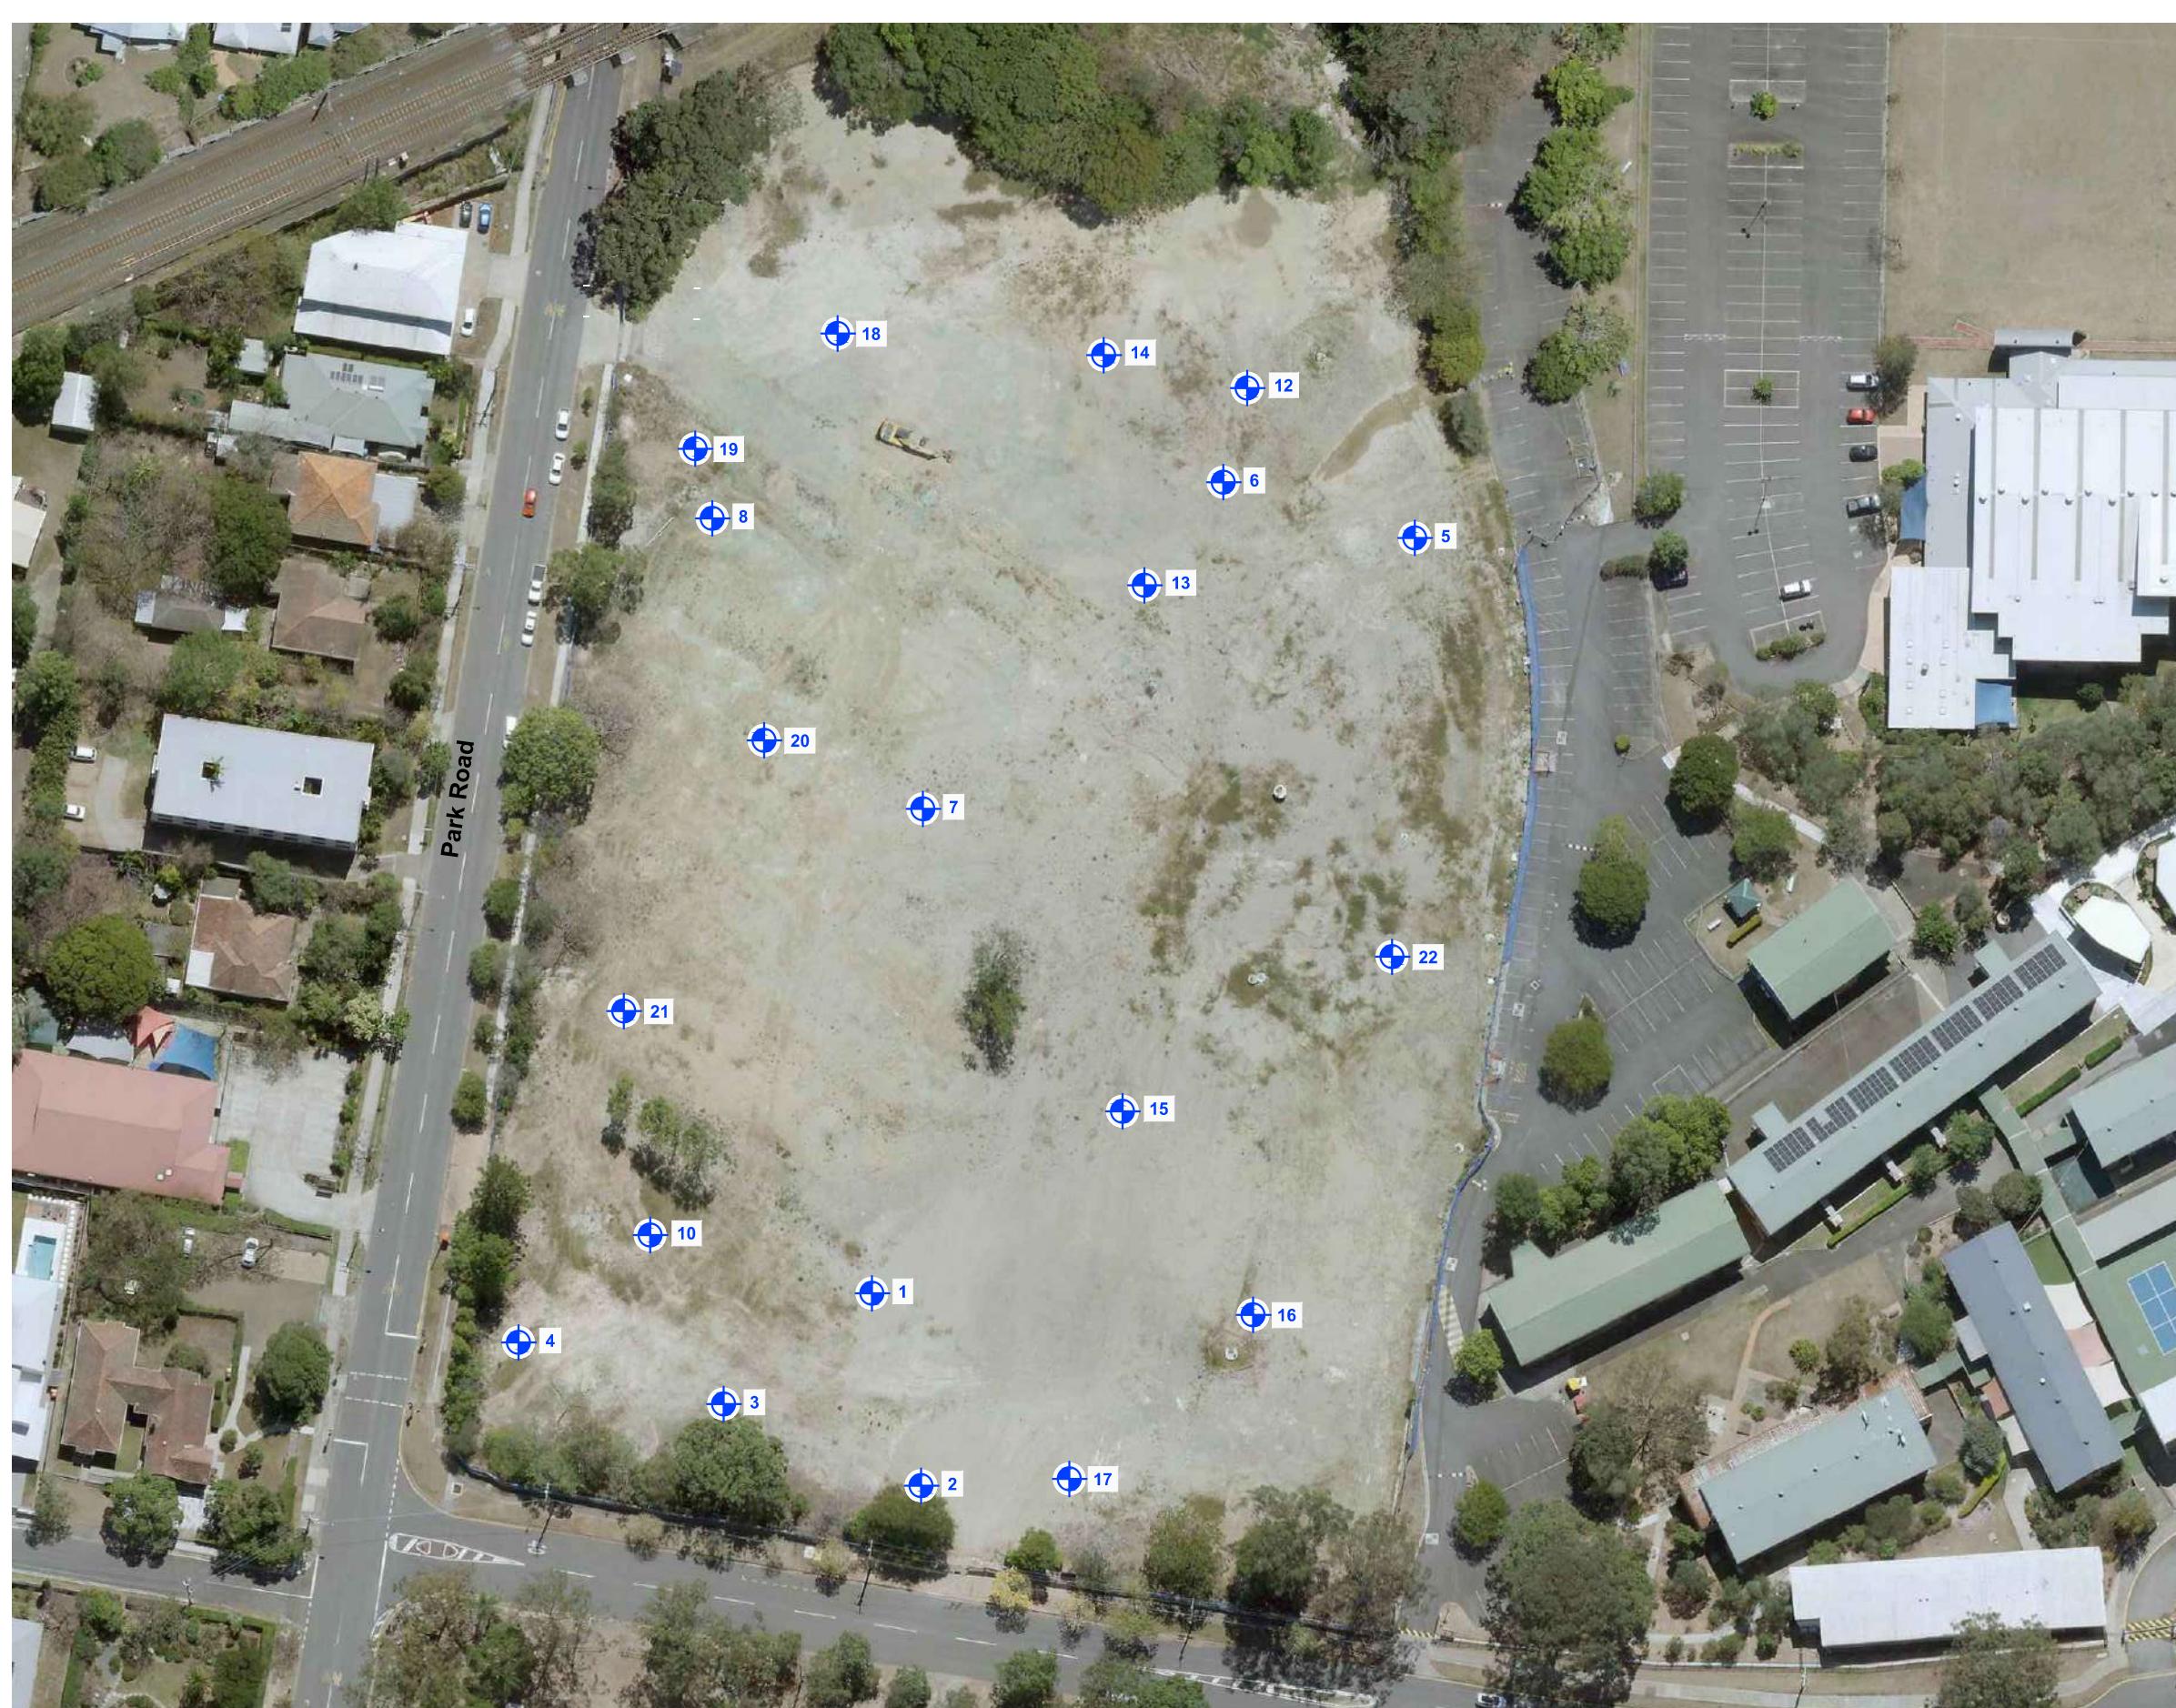
Drawing 1 - Site and Test Location Plan

1. Test locations are approximate only and are shown with reference to existing site features.
2. Image obtained from Metromap. Date of imagery 27-09-2020.

The site is located on the eastern side of Park Road, Yeronga (refer to Drawing 1 in Appendix B), and is bounded by Park Road to the west, Villa Street to the south, the Ferny Grove and Beenleigh railway lines to the north and Yeronga State High School to the east. At the time of the investigation, the site was vacant with all previous buildings/developments having been demolished.

The test locations were set out by a geotechnical engineer and the UTM coordinates and ground surface levels at the test locations were recorded using a differential GPS accurate to approximately up to 5 m and are presented on Drawing 1 in Appendix B. Bores 1 to 6 were completed by an experienced engineer who logged the bores, collected samples for laboratory testing. The remaining bores were then completed by a geotechnician who prepared field logs of the subsurface conditions, collected samples for visual and tactile assessment, and laboratory testing. Upon receipt of the samples at DP's laboratory, the samples and field logs were checked by a geotechnical engineer.
