***BROADWAY HOTEL***  
**WOOLLOONGABBA**

HERITAGE IMPACT STATEMENT  
2023

Prepared by  
IVAN McDONALD ARCHITECTS  
for  
BROADWAY PROJECTS QLD PTY LTD

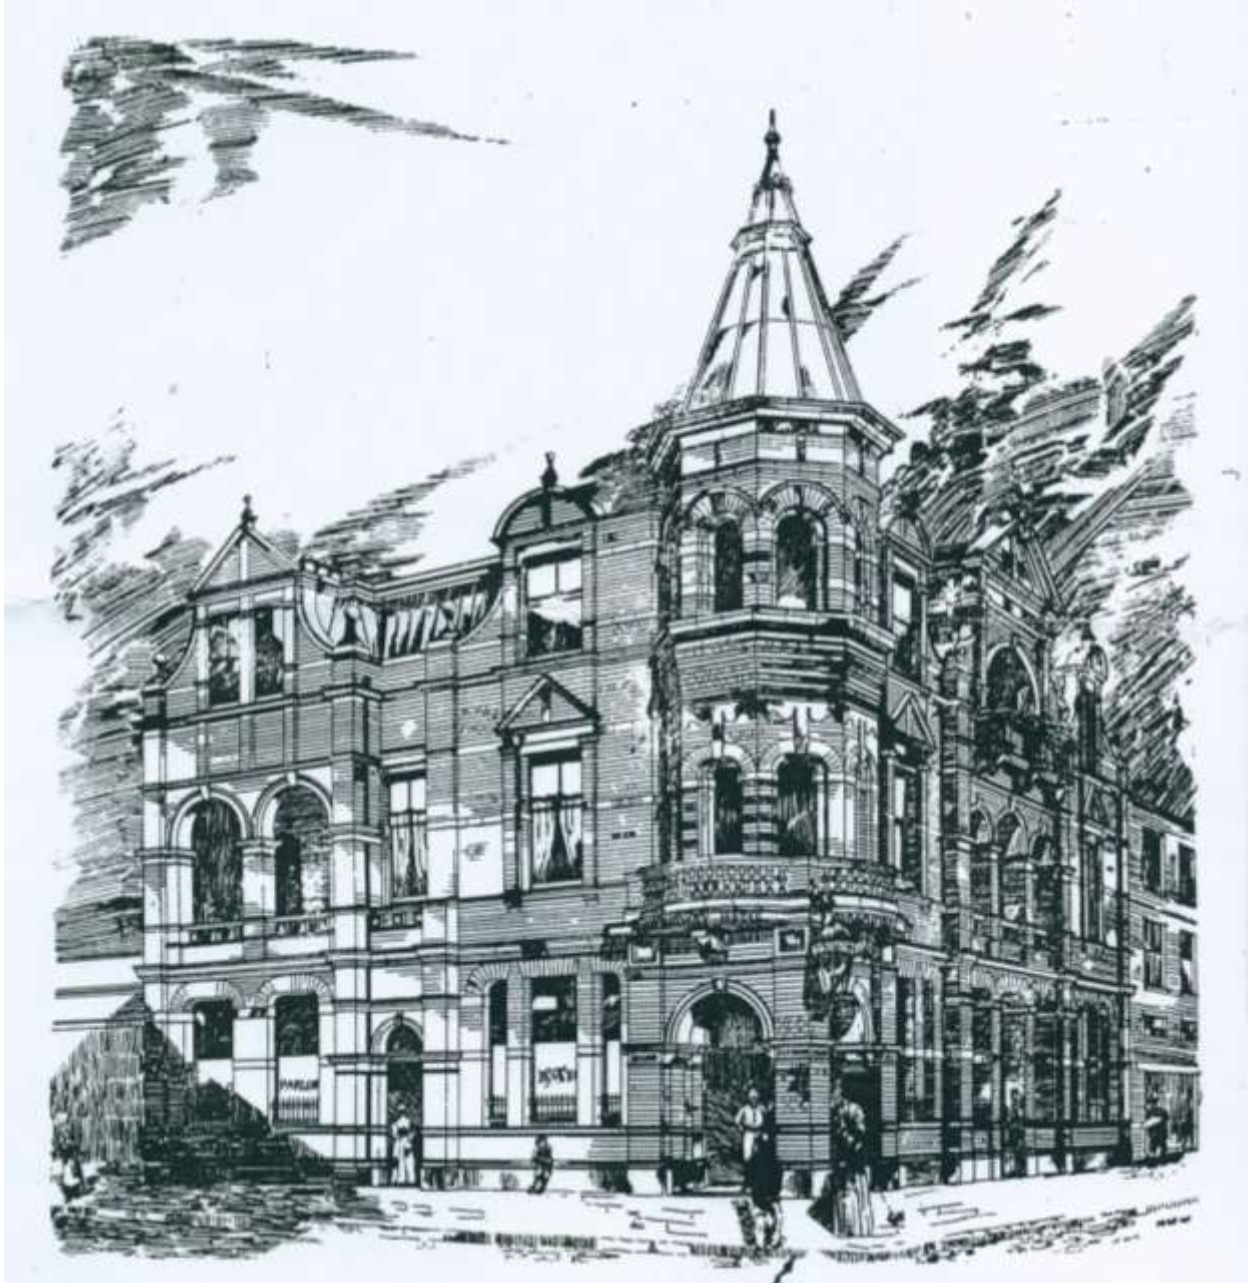
**Figure 2** *John Hall & Son's impression of the Broadway Hotel published in 1892*  
Source: The Building and Engineering Journal

Historical conditions are broadly shown at **figures 2 – 4** and a full history is set out in section 3 of the **cmp**.

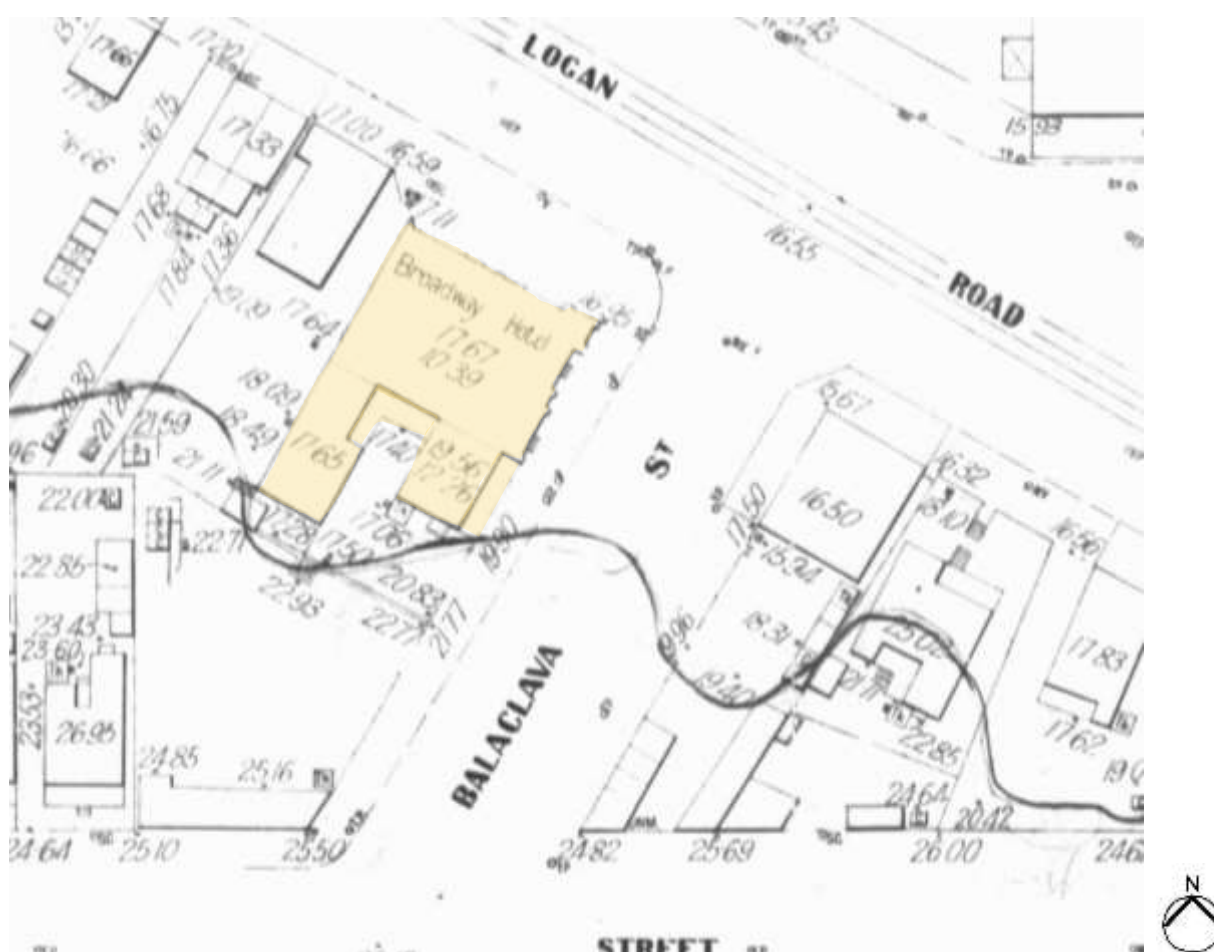
**Figure 3** Extract from BCC Detail Plan No. 367 published in 1922 showing the footprint of buildings on the site at that time. Note that Short Street is referred to as part of Balaclava Street. Source: BCC Archives

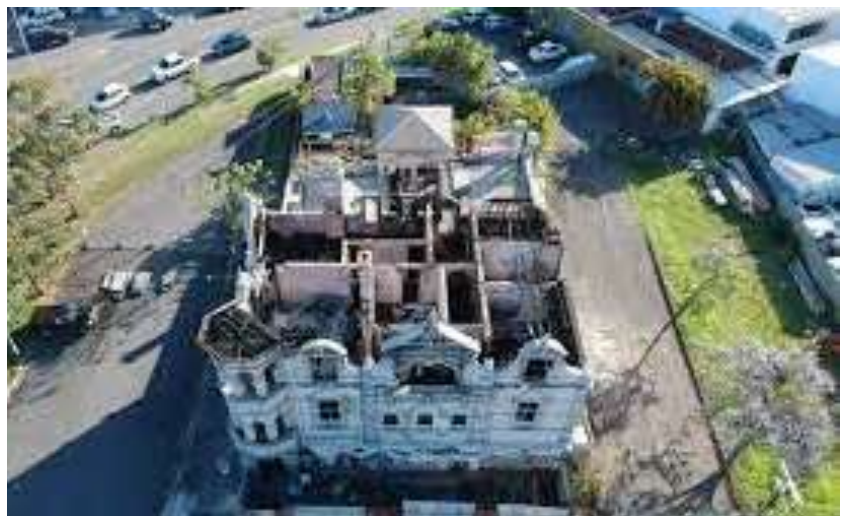
**Figure 8** Aerial view of the Broadway Hotel after the 2018 fire  
Source: Brisbane Times (Jesse Harrison)

Existing conditions are broadly shown at **figures 5 – 9** and in **appendix 2** and a more-extensive report on the condition of the *Broadway Hotel* is set out in section 4 of the **cmp**.

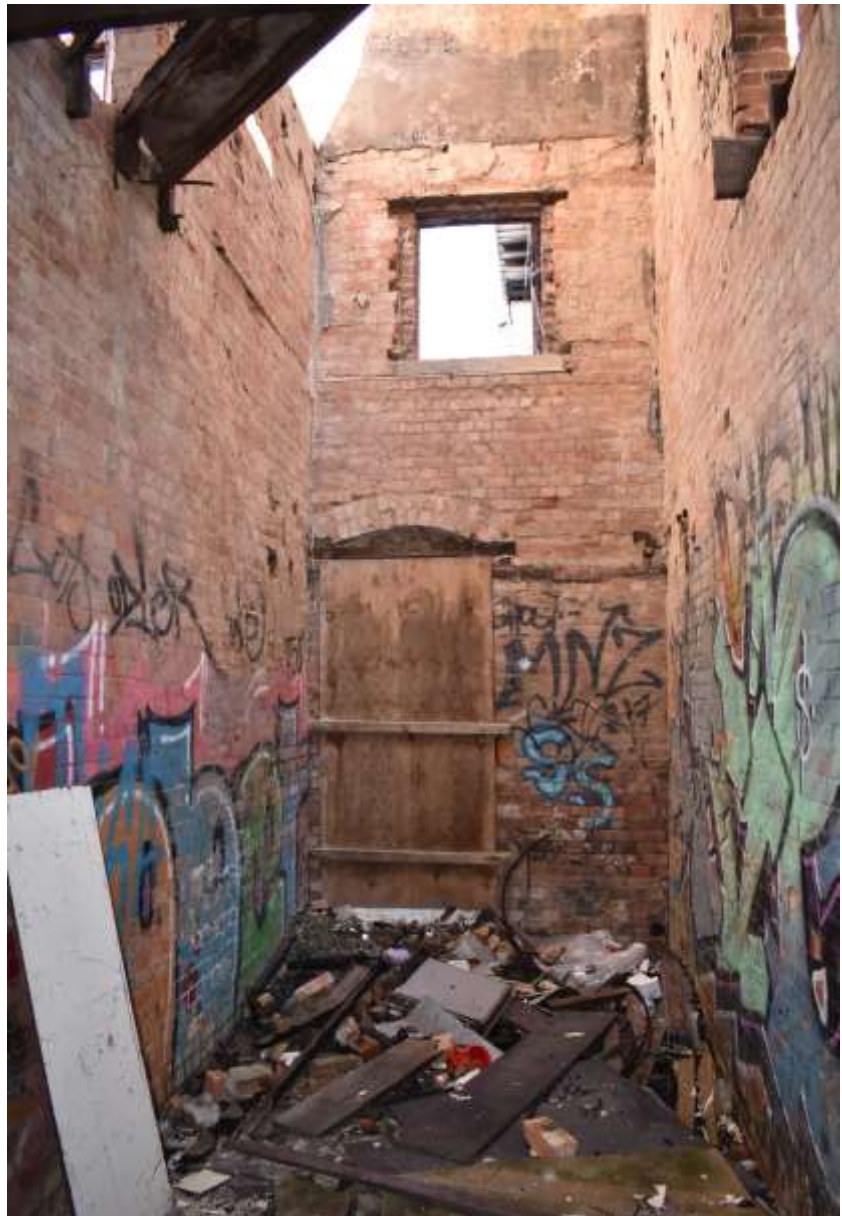
Figure 9 Ground floor stairwell in 2022

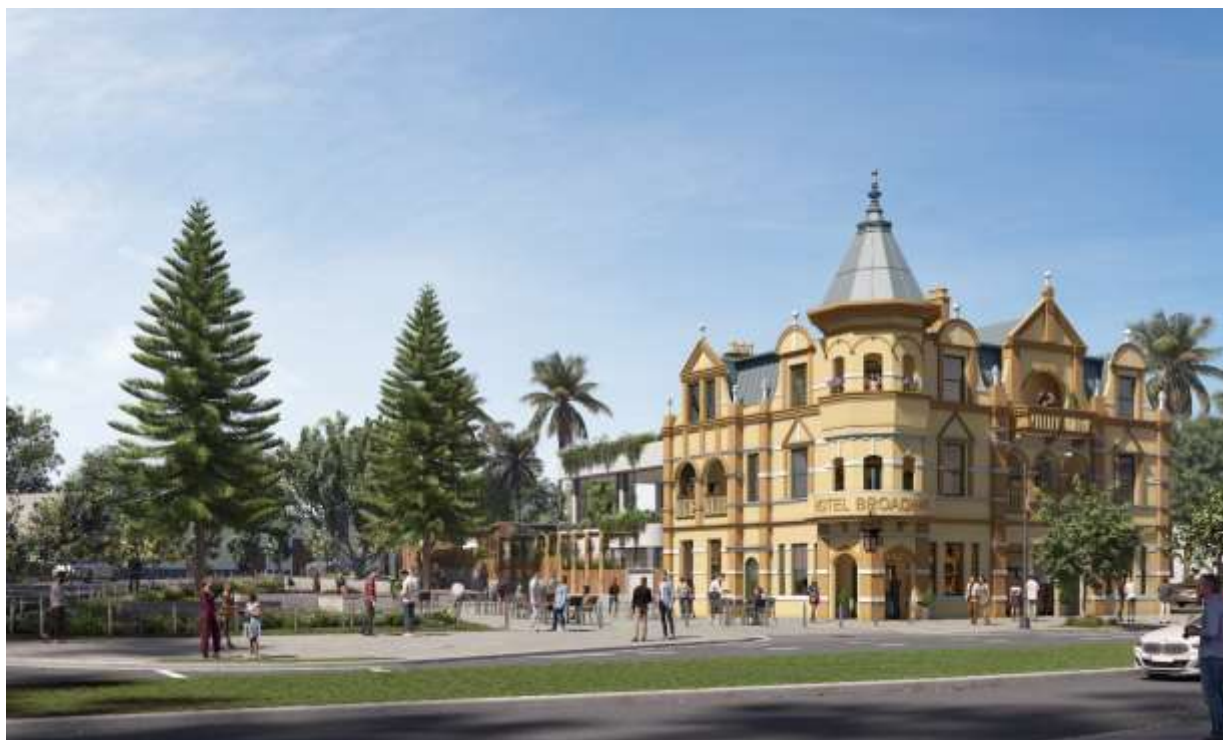
**Figure 18** 3D render of reconstructed hotel showing Phase 1 rear addition  
Source: Red Door Architecture

As set out generally in the proposal and particularly on **proposal drawings DA-115 to DA-1-118 & DA-1-200 to DA-1-202**, it is proposed to reconstruct important missing external elements in order to return the *Broadway Hotel* to a fit and usable state and in accordance with the cmp’s conservation policy. This will have an overwhelmingly positive heritage impact as shown at **figure 18**. These reconstructed elements include:

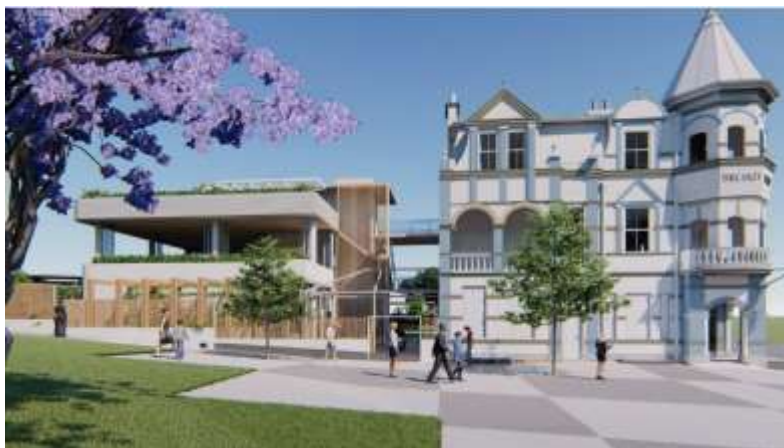
In Phase 1, it is proposed to construct an interim 3-storey building behind the existing hotel and which is detached from the existing hotel except for a narrow link at each of the two upper floor levels utilising existing doorways in the hotel's rear wall. In Phase 2, it is proposed to construct an ultimate 5-storey, visually neutral podium behind the existing hotel and which is detached from the existing hotel except for a narrow link at each of the upper floor levels utilising existing doorways in the hotel's rear wall. The Phase 2 podium will be surmounted by a high-rise tower set back from the podium perimeter. In both phases of development, disabled access to all levels of the existing hotel will be via a lift in the new rear buildings.

**Figure 20** Phase 1 3D view from Balaclava Street  
Source: Red Door Architecture

Whilst the proposed new rear buildings (and particularly the proposed high-rise tower) will be readily apparent behind and beside the existing hotel, important viewlines to the existing hotel's principal facades from Logan Road and Balaclava Street will not be restricted and the existing hotel's corner turret will retain its visual prominence as shown at **figures 20 & 21**. Overall, the proposal conforms to the cmp's setting and site development policy and will not upset the identified streetscape and townscape qualities of the *Broadway Hotel* to any unreasonable or unacceptable degree.

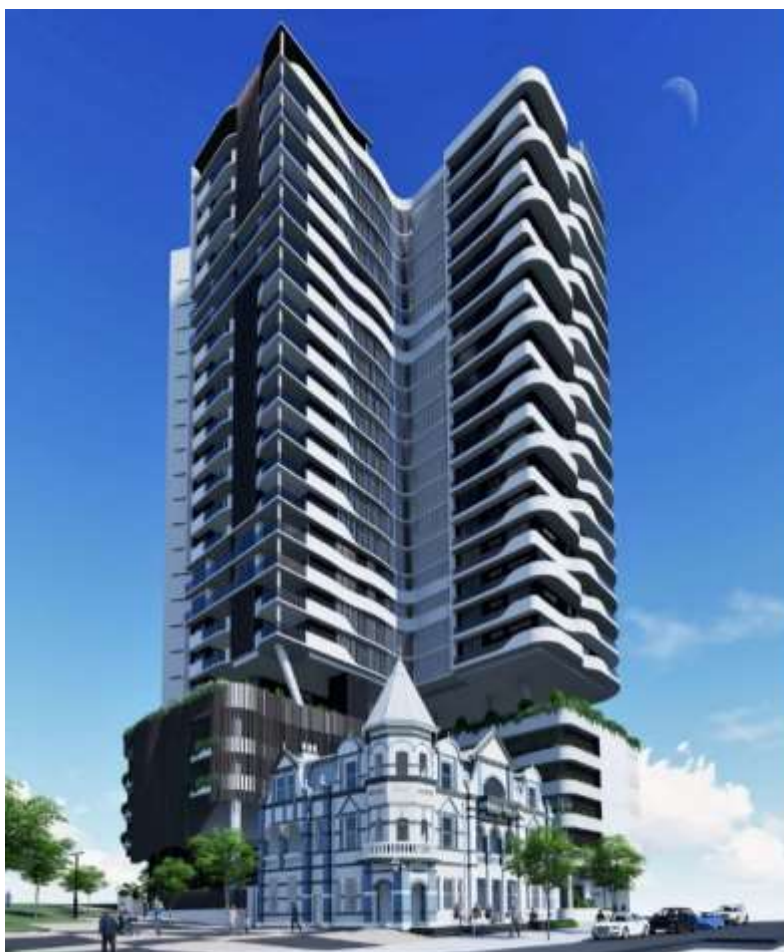
**Figure 21** Phase 2 3D view from corner of Logan Road & Balaclava Street  
Source: Red Door Architecture

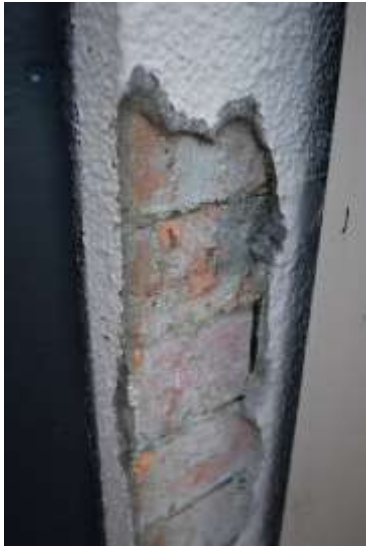
Figure A2.7 *Rendered brickwork*

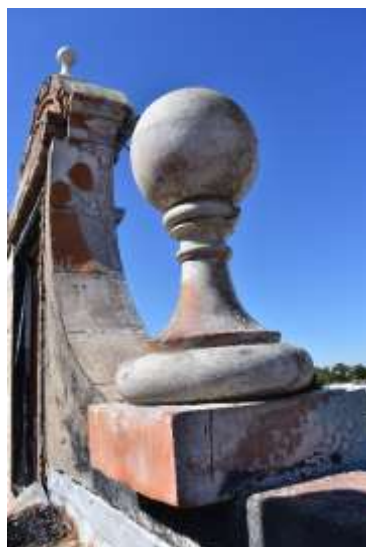
Figure A2.14 *Terracotta parapet detail*
