Preliminary Geotechnical Assessment

Precinct 1

Southern Thornlands (Confidential)

62 – 124 Springacre Road, Thornlands

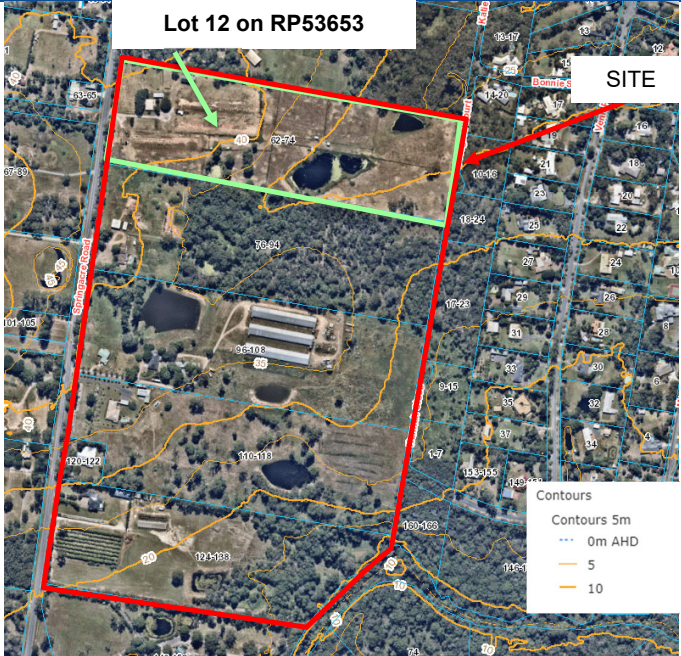
<p>Source: RCC City Plan Interactive Mapping (Not to Scale).</p>
Drainage	<p>Stormwater runoff across the level hard stand areas of the allotment would flow towards storm pits around the residential dwellings towards the roadways. All other runoff outside of the hard stand areas would infiltrate through the soil and follow the topography of the site towards the central portion flowing towards the southeast.</p>
Nearest Surface Water Receptor	<p>The nearest water body is Eprapah Creek located approximately 600 m to the southeast of the allotment. A waterway off Eprapah Creek is located across the allotment which flows towards the dams within the southern Lots.</p>
Lot 13 on RP53653	
Site Use	<p>Rural residential dwellings.</p>
Site Features, Buildings and Structures	<p>The allotment (Lot 13 on RP53653) consisted of one residential dwellings, two sheds, concrete pads and a number of compacted fill stockpiles for motor cross use. The larger portion of the allotment consists of dense vegetation with dirt tracks.</p> <p>One dam is situated along the central southern boundary.</p>

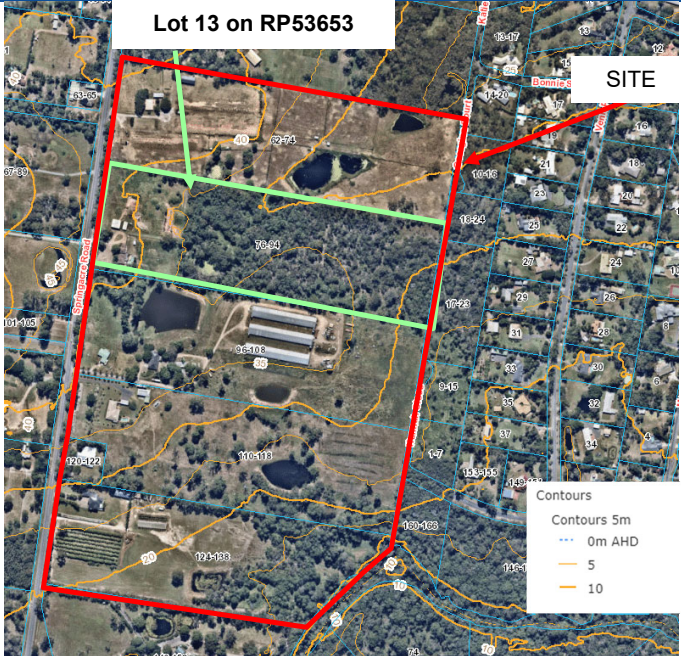
Topography	<p>The elevation of Lot 13 on RP53653 ranges between 40 m Australian Height Datum (AHD) and 30 m AHD (RCC City Plan, 2013). The site has a gradient slope of approximately 10 m toward the central southern boundary.</p>

<p>Source: RCC City Plan Interactive Mapping (Not to Scale).</p>
Drainage	<p>Stormwater runoff across the level hard stand areas of the allotment located within the western portion would flow towards storm pits along Springacre Road. All other runoff outside of the hard stand areas would infiltrate through the soil and follow the topography of the site towards the southern central portion flowing towards the south.</p>
Nearest Surface Water Receptor	<p>The nearest water body is Erapah Creek located approximately 500 m to the southeast of the Lot 13 on RP53653. A waterway off Erapah Creek is located towards the north on Lot 12 on RP53653 that appears to flow in a north east to south western direction towards the dam located on Lot 13 on RP53653.</p>
Lot 14 on RP53653	
Site Use	<p>Rural residential dwellings and previous Poultry Farm.</p>
Site Features, Buildings and Structures	<p>Lot 14 on RP53653 consisted of two residential dwellings, three sheds, three large poultry sheds, shipping containers, above ground water tanks, a gravel compacted road way, and several areas containing waste materials.</p> <p>Two dams are evident on this lot (Lot 14 on RP53653), one is situated along the central southern boundary and the other within the eastern portion.</p>

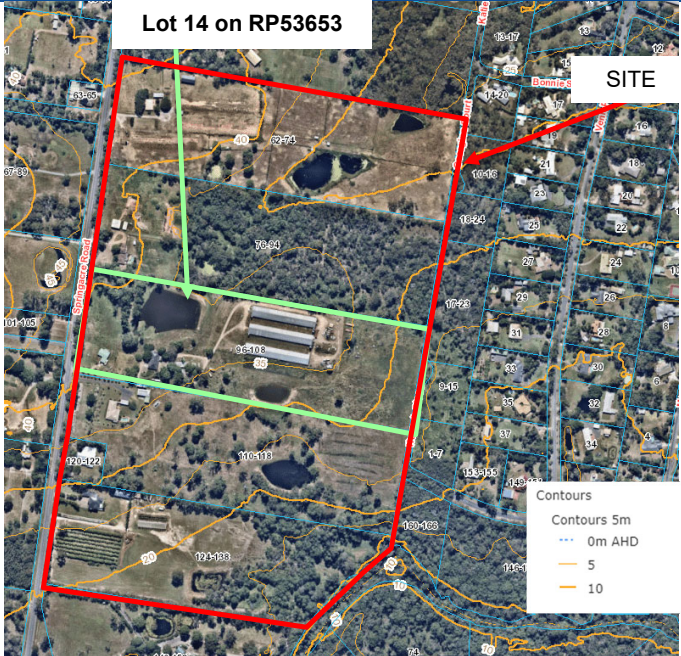
Topography	<p>The elevation of Lot 14 on RP53653 ranges between 40 m Australian Height Datum (AHD) and 30 m AHD (RCC City Plan, 2013). The site has a gradient slope of approximately 10 m toward the southeastern boundary.</p>

<p>Source: RCC City Plan Interactive Mapping (Not to Scale).</p>
Drainage	<p>Stormwater runoff across the western portion appears to run towards the dam within the northwest. The area towards the east appears to have a drainage line that runs along the southern most poultry shed and flow towards the dam located along the southern boundary.</p> <p>This southern most dam appeared to catch all runoff surrounding the poultry sheds.</p>
Nearest Surface Water Receptor	<p>The nearest water body is Erapah Creek located approximately 400 m to the southeast of the allotment. The northwestern dam appears to be connected to a waterway or tributary off Erapah Creek.</p>
Lot 1 on RP128089	
Site Use	Residential dwellings including sheds and pool.
Site Features, Buildings and Structures	<p>The allotment consisted of residential dwelling, five sheds and one inground pool.</p> <p>Allotment is fenced and appears to be in good condition.</p> <p>Further detailed information is provided in section 4.0.</p> <p>Site features are shown in Figure 4, attached.</p>

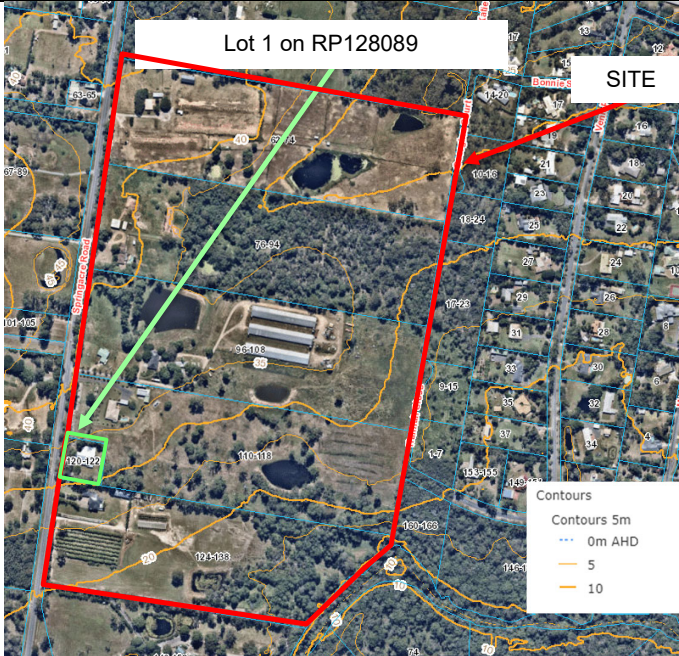
Topography	<p>The elevation of the allotment ranges between 36 m Australian Height Datum (AHD) and 30 m AHD (RCC City Plan, 2013). The site has a gradient slope of approx. 6 m toward the southeastern boundary.</p>

<p>Source: RCC City Plan Interactive Mapping (Not to Scale).</p>
Drainage	Stormwater runoff across the allotment appears to run towards the neighbouring allotment in the east. Overland flow generally runs towards the east and flows towards the dam located south east of the allotment.
Nearest Surface Water Receptor	The nearest water body is Erapah Creek located approx. 400 m to the south east of the allotment. The northwestern dam appears to be connected to a waterway or tributary off Erapah Creek.
Lot 2 on RP128089	
Site Use	Rural residential dwellings.
Site Features, Buildings and Structures	<p>The allotment consisted of one residential dwelling, inground pool, one shed, a shipping container, and sealed drive way.</p> <p>One dam is evident on this allotment situated along the central southern boundary.</p>
Topography	The elevation of the allotment ranges between 40 m Australian Height Datum (AHD) and 20 m AHD (RCC City Plan, 2013). The site has a gradient slope of approximately 20 m toward the southeastern boundary.

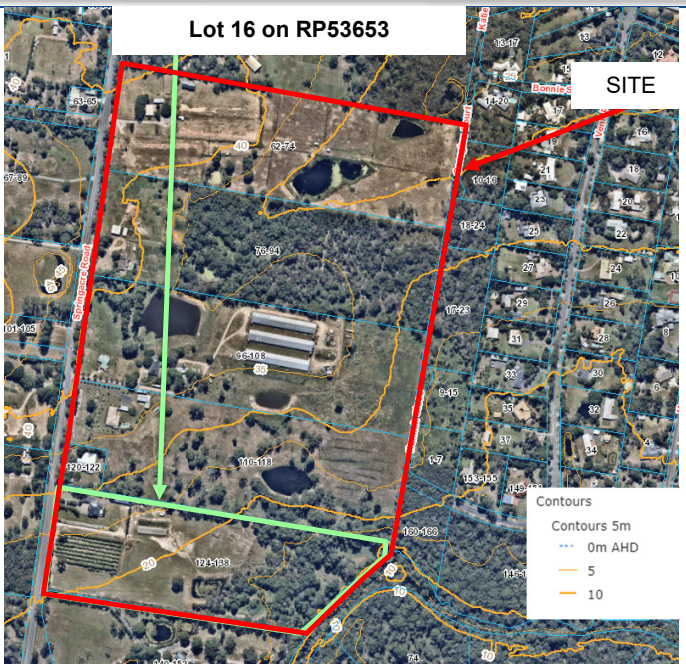
Topography	<p>The elevation of the allotment ranges between 30 m Australian Height Datum (AHD) and 10 m AHD (RCC City Plan, 2013). The site has a gradient slope of approximately 20 m toward the southeastern boundary.</p>

<p>Source: RCC City Plan Interactive Mapping (Not to Scale).</p>
Drainage	<p>Stormwater runoff across the allotment appears to run towards the southeast. The tributaries evident across the allotment run in a northwest to southeast direction flowing towards Erapah Creek which is located along the southeastern boundary.</p>
Nearest Surface Water Receptor	<p>The nearest water body is Erapah Creek located along the southeastern boundary. Erapah Creek flows towards Redland Bay in a northeasterly direction.</p>

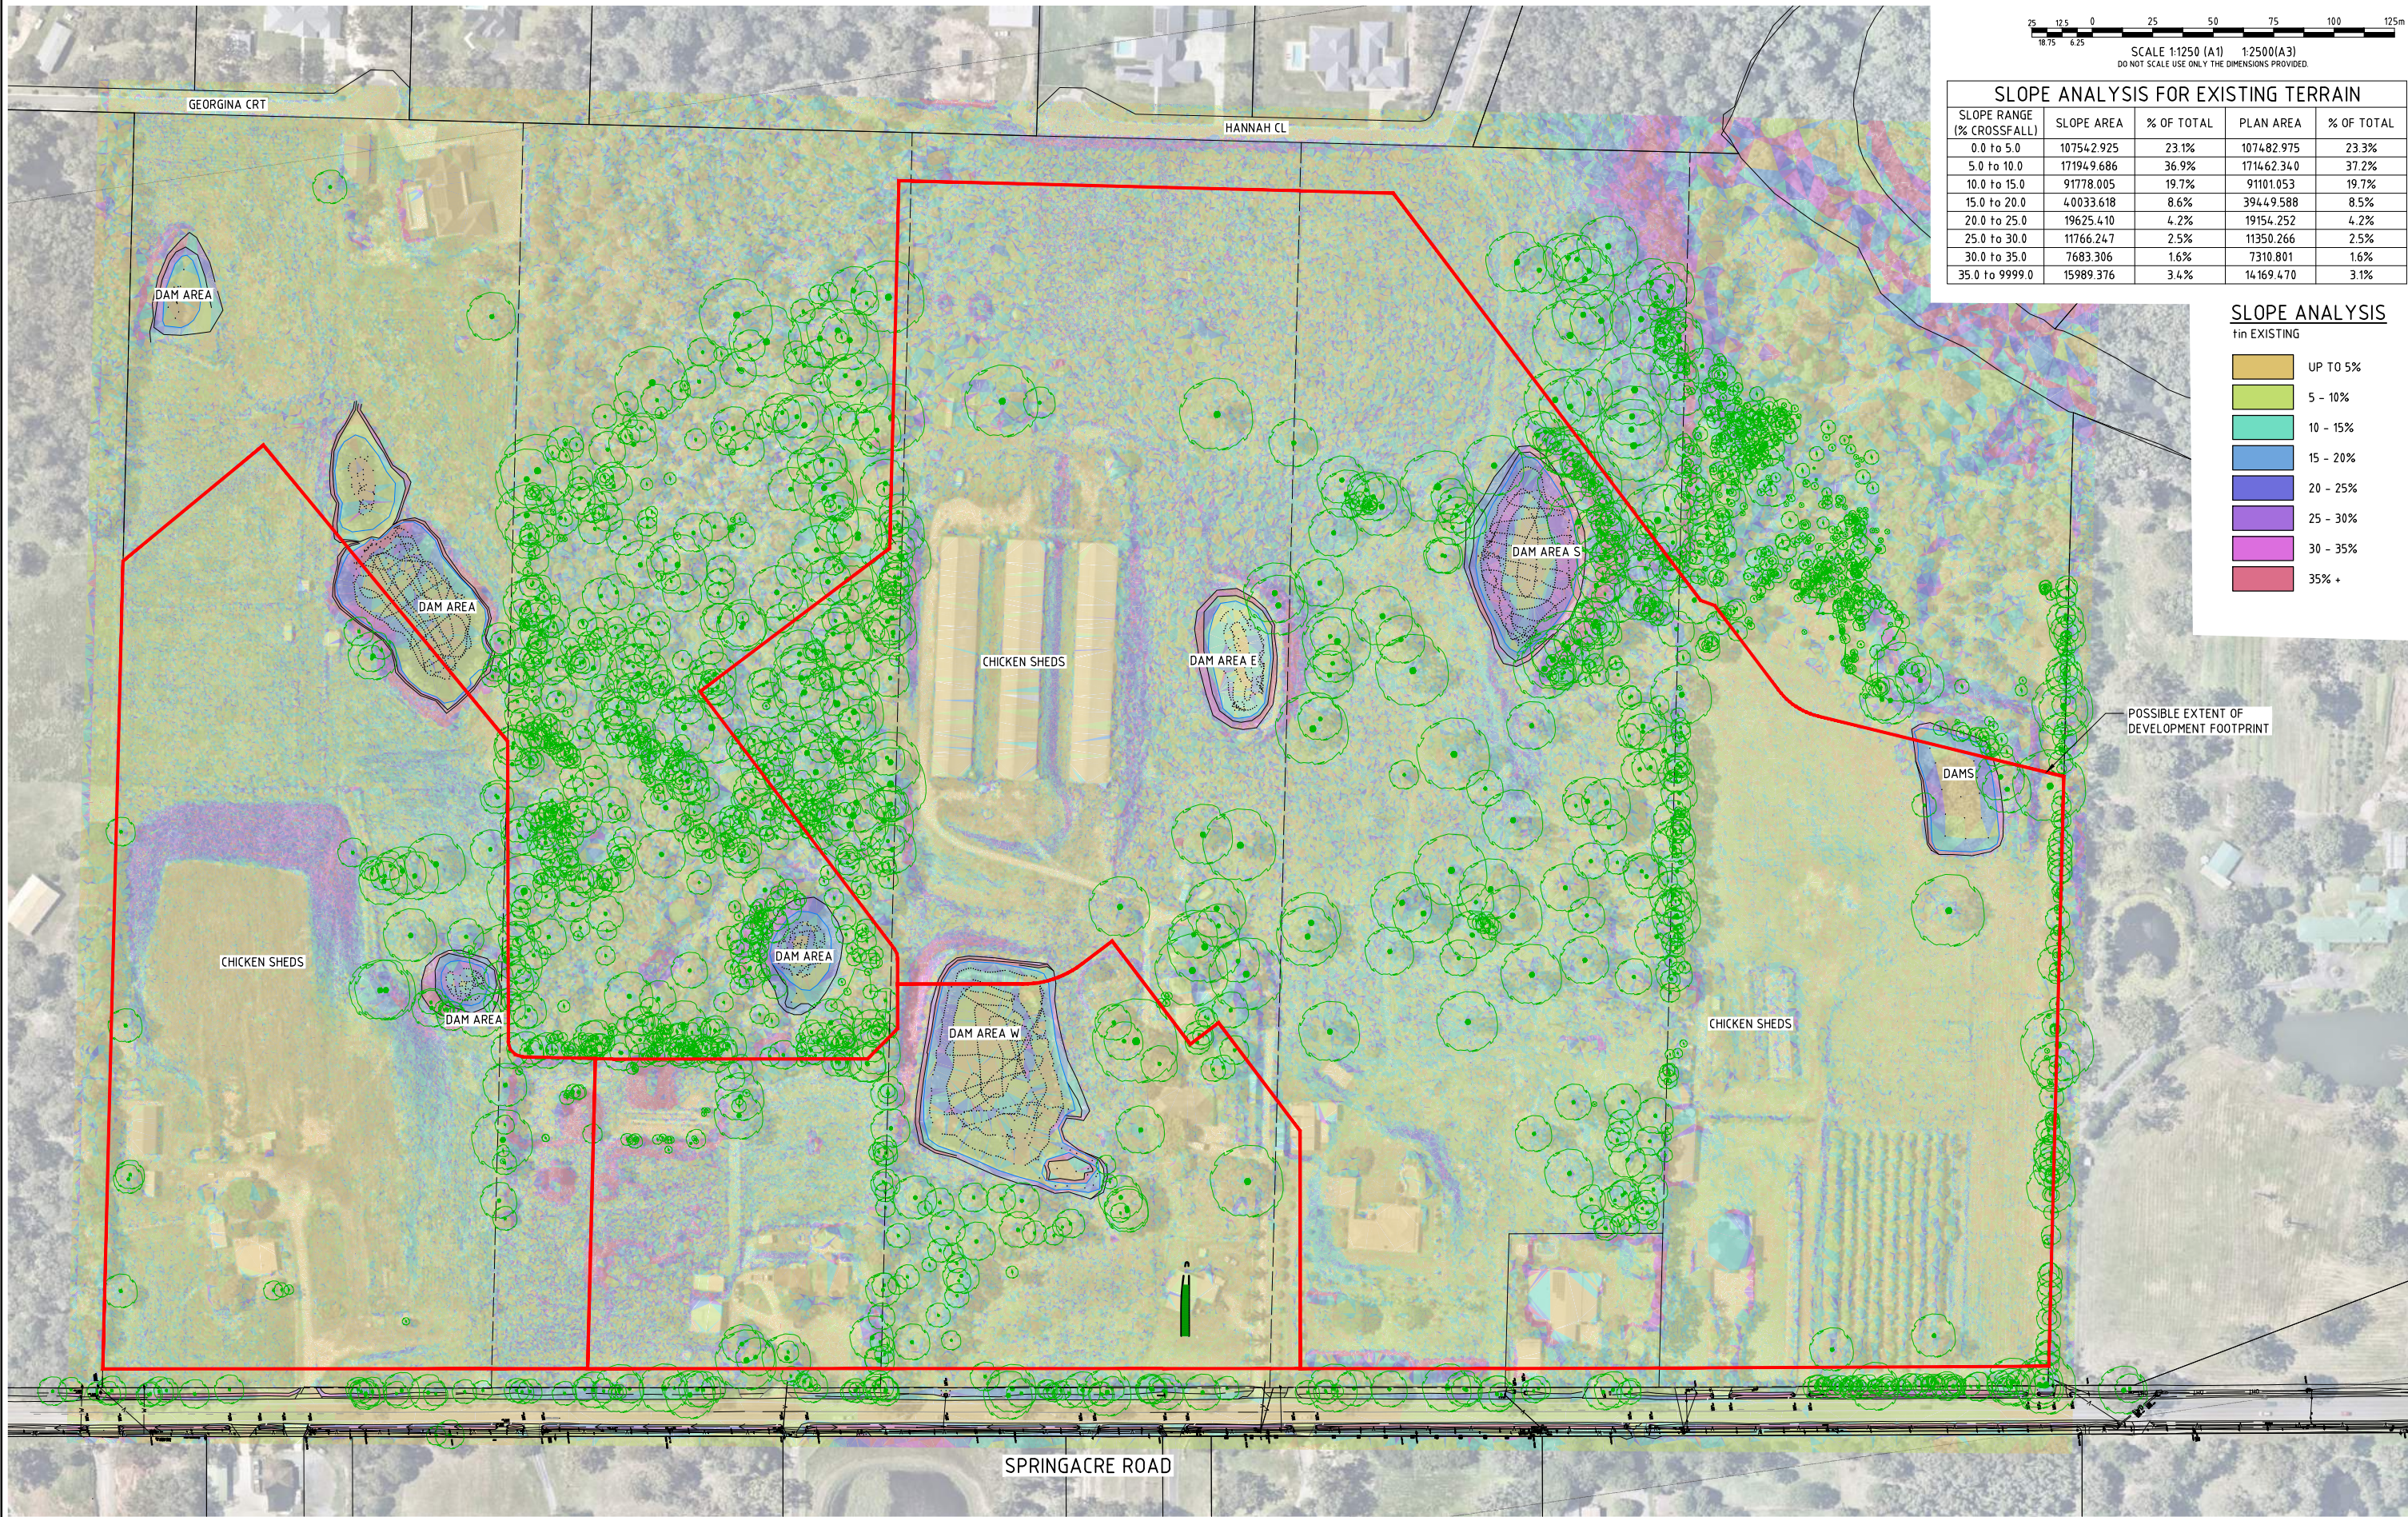
Slope Analysis

SLOPE ANALYSIS FOR EXISTING TERRAIN				
SLOPE RANGE (% CROSSFALL)	SLOPE AREA	% OF TOTAL	PLAN AREA	% OF TOTAL
0.0 to 5.0	10754.2925	23.1%	107482.975	23.3%
5.0 to 10.0	17194.9686	36.9%	171462.340	37.2%
10.0 to 15.0	91778.005	19.7%	91101.053	19.7%
15.0 to 20.0	40033.618	8.6%	39449.588	8.5%
20.0 to 25.0	19625.410	4.2%	19154.252	4.2%
25.0 to 30.0	11766.247	2.5%	11350.266	2.5%
30.0 to 35.0	7683.306	1.6%	7310.801	1.6%
35.0 to 9999.0	15989.376	3.4%	14169.470	3.1%
