BROADWAY HOTEL WOOLLOONGABBA

HERITAGE IMPACT STATEMENT 2023

Prepared by
IVAN McDONALD ARCHITECTS
for
BROADWAY PROJECTS QLD PTY LTD

JUNE, 2023

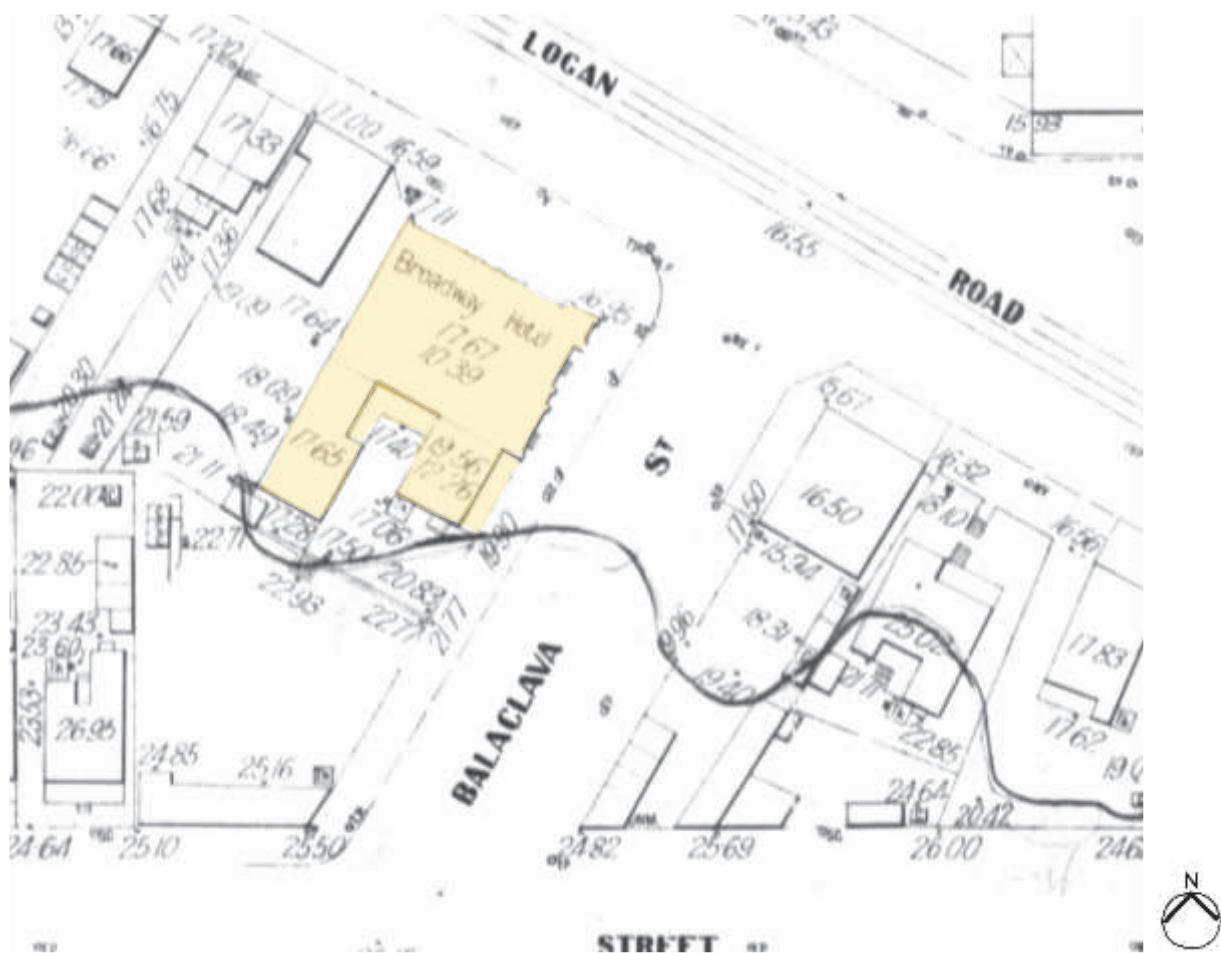
Figure 3 Extract from BCC Detail Plan No. 367 published in 1922 showing the footprint of buildings on the site at that time. Note that Short Street is referred to as part of Balaclava Street.
Source: BCC Archives

Historical conditions are broadly shown at **figures 2 – 4** and a full history is set out in section 3 of the **cmp**.

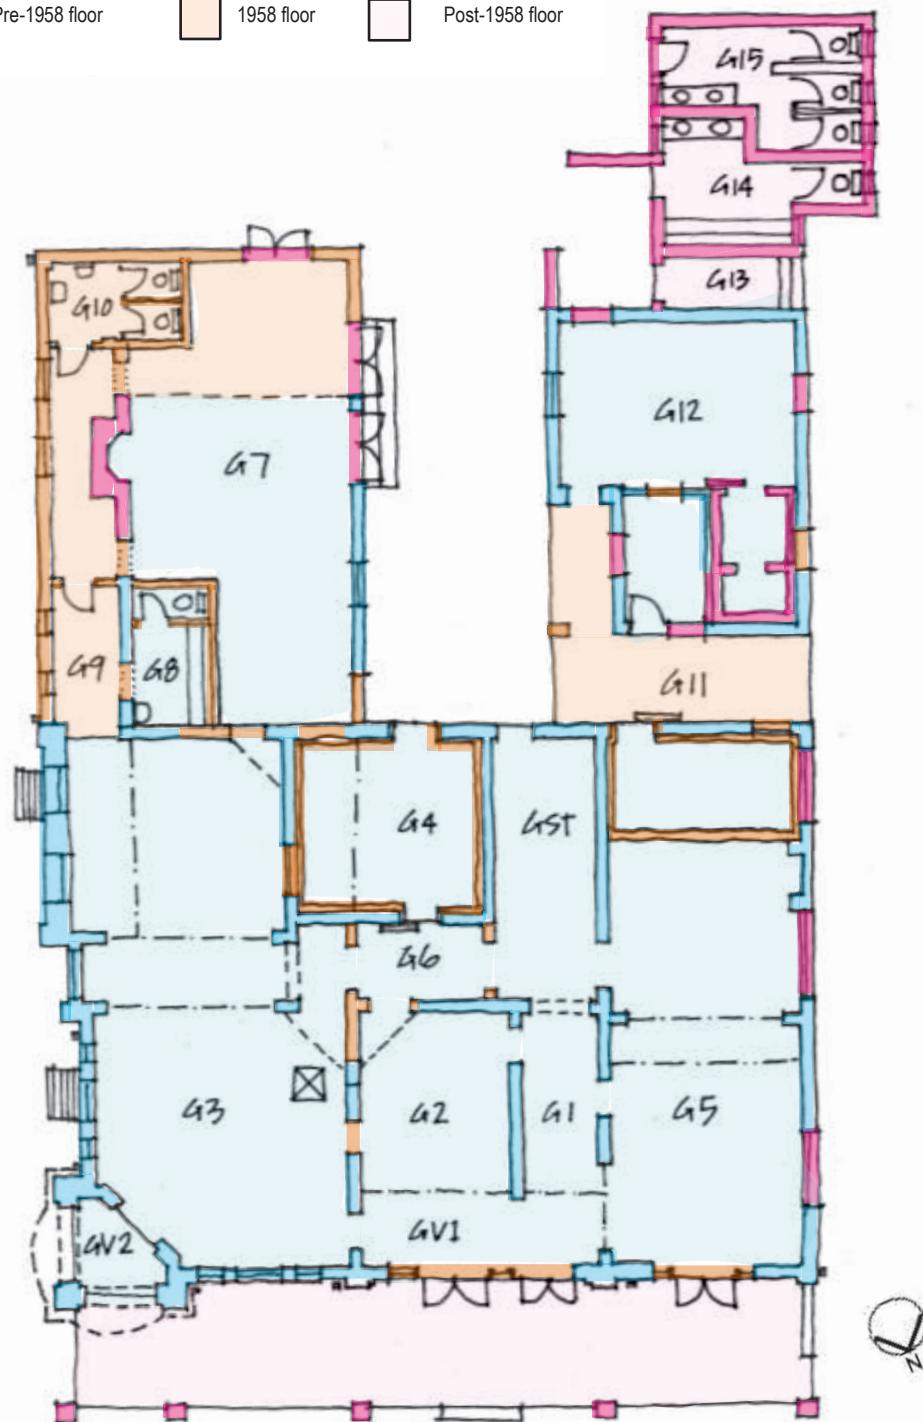
Pre-1958 wall 1958 wall Post-1958 wall
Pre-1958 floor 1958 floor Post-1958 floor

Figure 10 Diagrammatic ground floor plan showing existing fabric from different eras

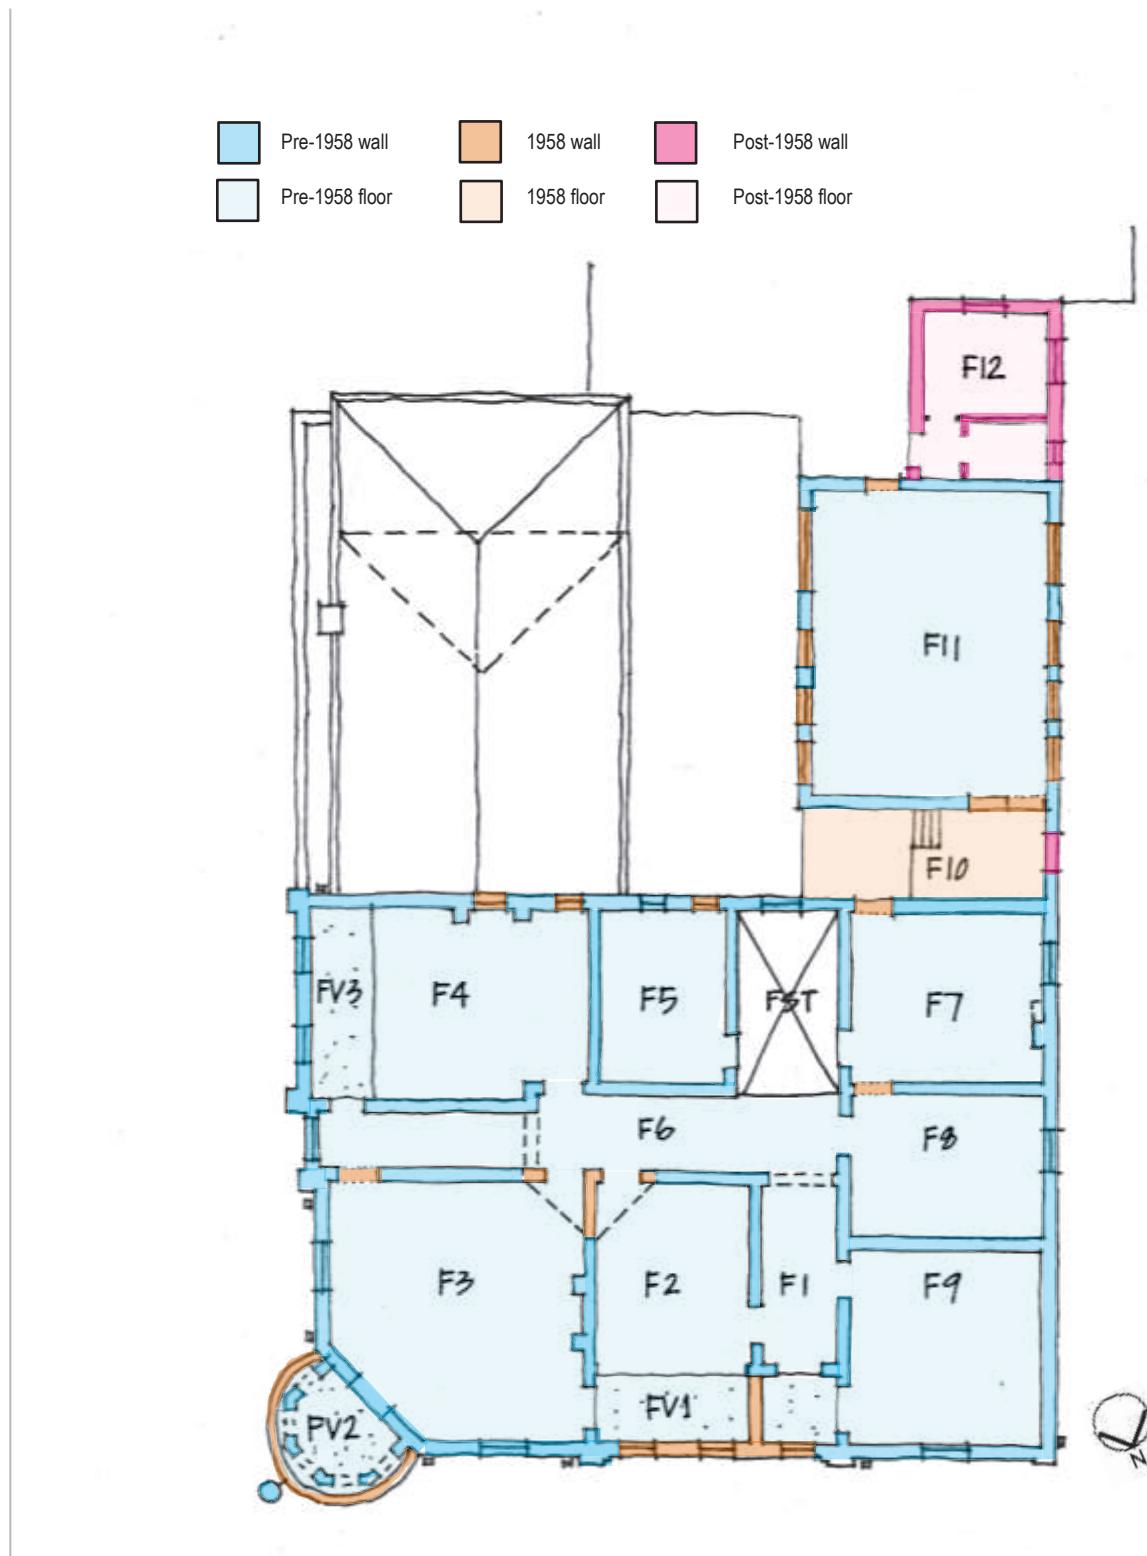
Figure 11 Diagrammatic first floor plan showing existing fabric from different eras

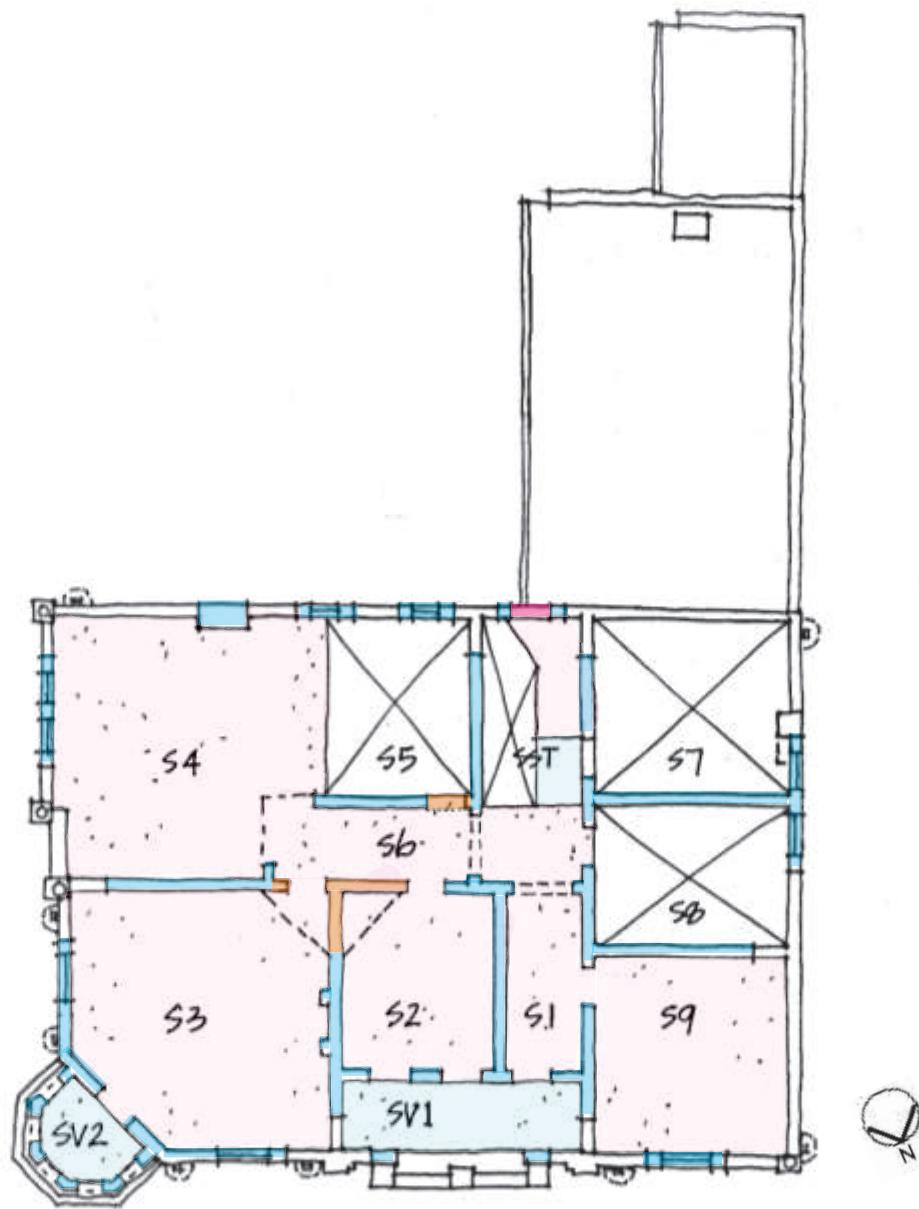
Figure 12 Diagrammatic second floor plan showing existing fabric from different eras

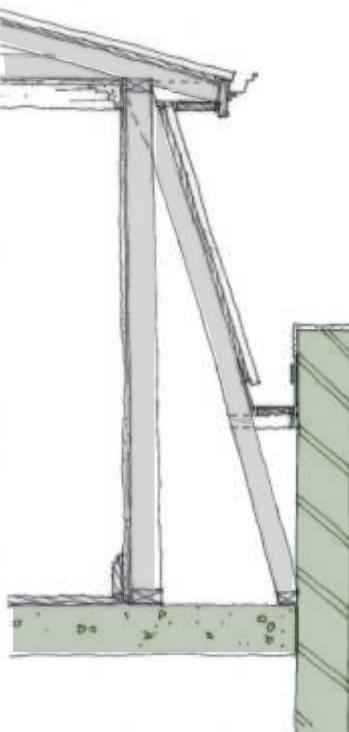
Figure 14 Mansard roof

- The original main roof was a mansard form sheeted in "pan-and-rib"-profile galvanised sheeting and draining via a series of Ogee-profile eaves gutters and concealed box gutters behind existing parapet walls. The box gutters discharge into 20th century semi-circular rainwater heads and rectangular downpipes with decorative wall straps. Apart from some remnant box guttering and a few embedded wall flashings, none of the mansard roof system survives. The original roofing and rainwater goods were made of galvanised sheet metal. For authenticity,

consistency and compatibility, all future roof sheeting and rainwater goods should be made of galvanised sheet metal (not Zincalume). Soldered joints are preferred but riveted and sealed joints are acceptable. Under no circumstances should PVC rainwater goods be used. Roofing screws are acceptable. For longevity and authenticity, the best quality 0.6mm Z600 galvanised sheeting should be used. Where concealed from view, a modern roof framing system may be used eg, nail-plated roof trusses.

Policy 70: The original 0.6mm Z600 unpainted galvanised steel "pan-and-rib"-profile mansard roof should be reconstructed.

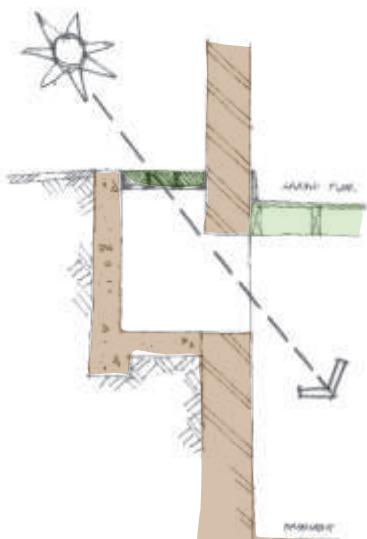
Figure 17 Basement "floor lights"

- The original basement is flooded and its condition is currently unknown. When accessible, the basement fabric should be inspected. Two original basement lights in B1 currently have non-weatherproof steel grilles at the Balaclava Street footpath level. These openings should be made weatherproof and could introduce basement "floor lights" to continue to admit light to the space. If required for an adaptive re-use, the basement floor level could be lowered to provide suitable head height, provided that existing masonry walls and cast iron columns are not undermined. Future basement access may be provided in accordance with policy 56.

Additionally, two translucent glass basement "floor lights" are proposed to be installed on the Balaclava Street footpath in order to weatherproof the existing basement. This will have no adverse heritage impact and conforms to cmp policy 82.

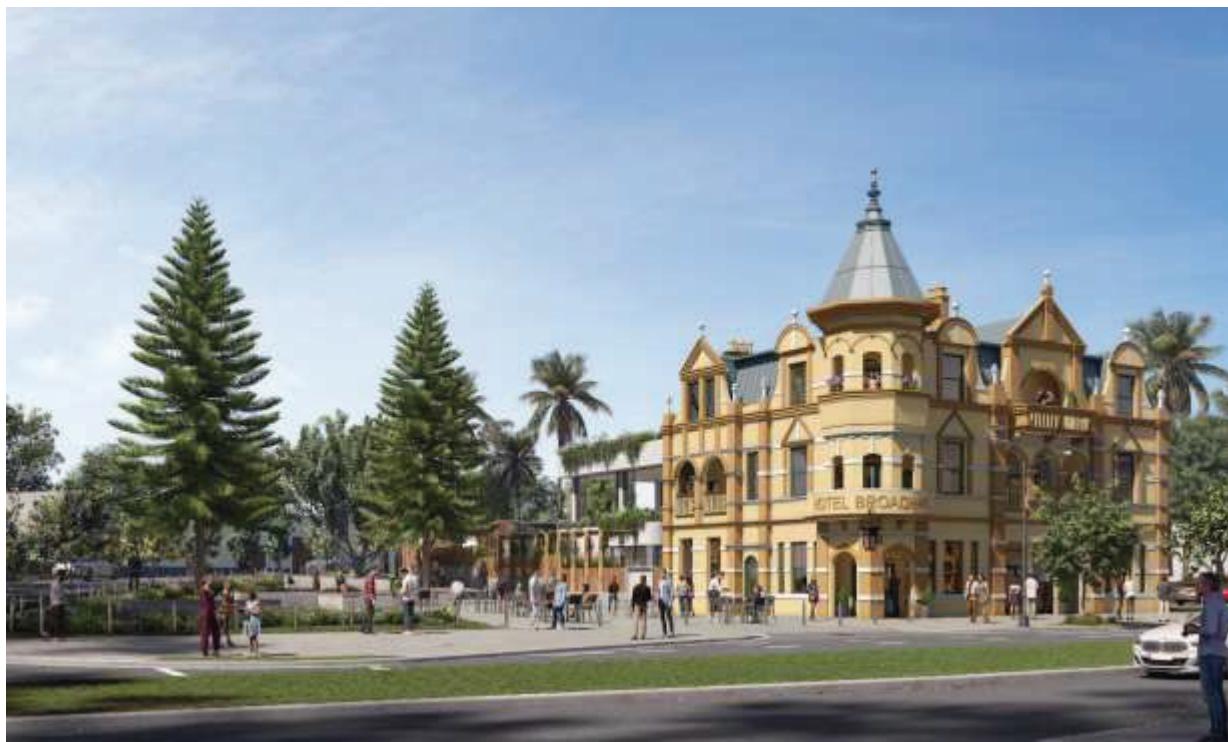
Figure 18 3D render of reconstructed hotel showing Phase 1 rear addition
Source: Red Door Architecture

As set out generally in the proposal and particularly on **proposal drawings DA-115 to DA-1-118 & DA-1-200 to DA-1-202**, it is proposed to reconstruct important missing external elements in order to return the *Broadway Hotel* to a fit and usable state and in accordance with the cmp's conservation policy. This will have an overwhelmingly positive heritage impact as shown at **figure 18**. These reconstructed elements include:

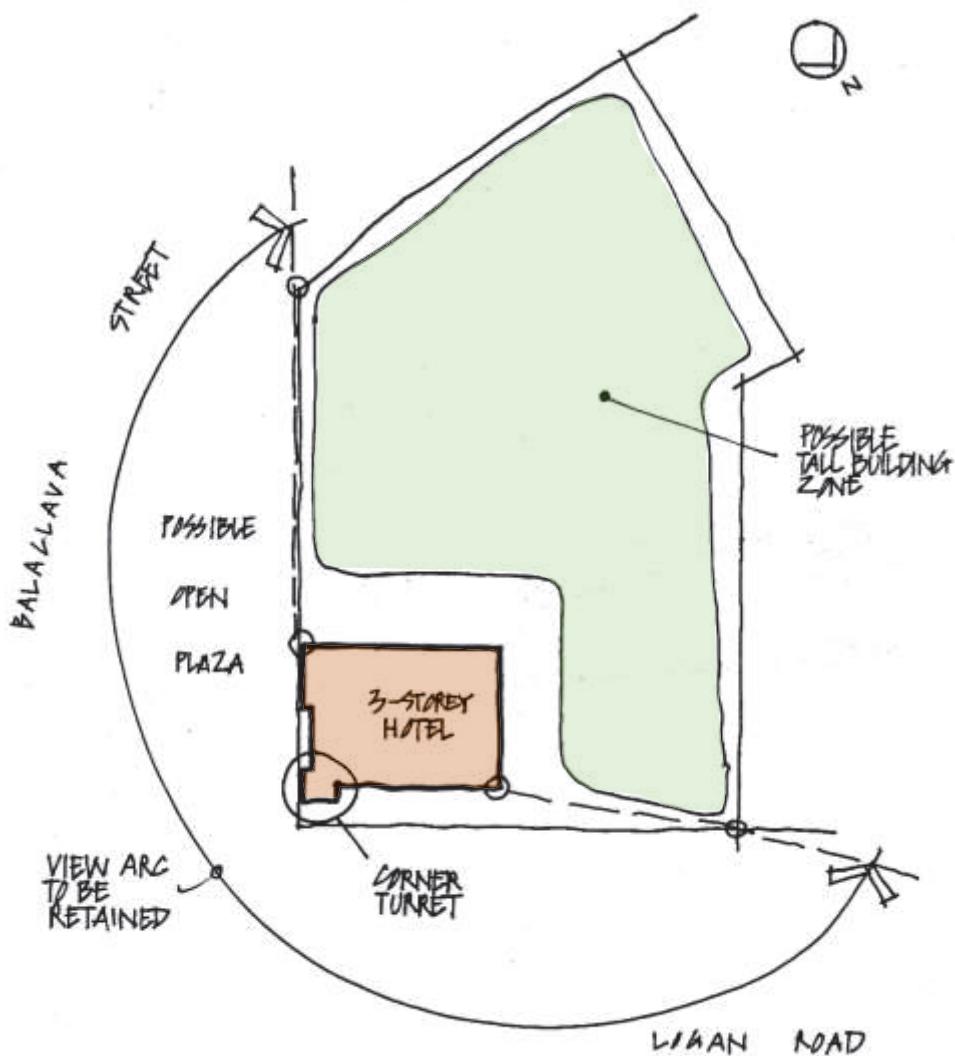
Figure 19 Setting diagram in relation to cmp policies 100-104
Source: 2023 cmp

The cmp includes a setting diagram consistent with the above policies which is shown at **figure 19**.

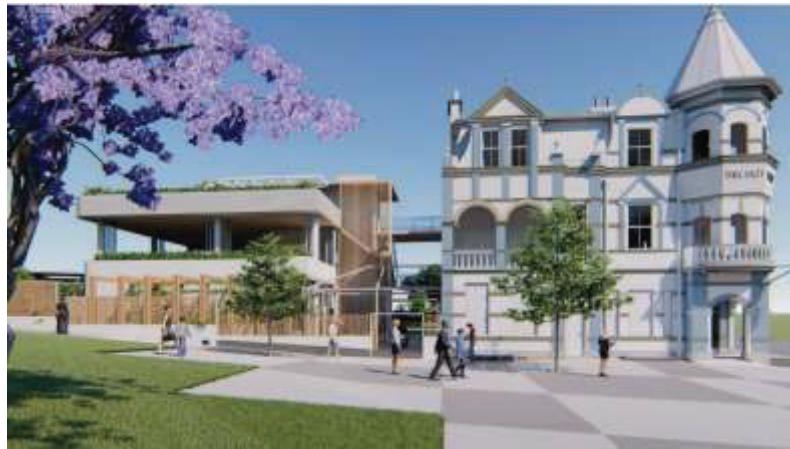
Figure 20 Phase 1 3D view from Balaclava Street
Source: Red Door Architecture

In Phase 1, it is proposed to construct an interim 3-storey building behind the existing hotel and which is detached from the existing hotel except for a narrow link at each of the two upper floor levels utilising existing doorways in the hotel's rear wall. In Phase 2, it is proposed to construct an ultimate 5-storey, visually neutral podium behind the existing hotel and which is detached from the existing hotel except for a narrow link at each of the upper floor levels utilising existing doorways in the hotel's rear wall. The Phase 2 podium will be surmounted by a high-rise tower set back from the podium perimeter. In both phases of development, disabled access to all levels of the existing hotel will be via a lift in the new rear buildings.

Whilst the proposed new rear buildings (and particularly the proposed high-rise tower) will be readily apparent behind and beside the existing hotel, important viewlines to the existing hotel's principal facades from Logan Road and Balaclava Street will not be restricted and the existing hotel's corner turret will retain its visual prominence as shown at **figures 20 & 21**. Overall, the proposal conforms to the cmp's setting and site development policy and will not upset the identified streetscape and townscape qualities of the *Broadway Hotel* to any unreasonable or unacceptable degree.

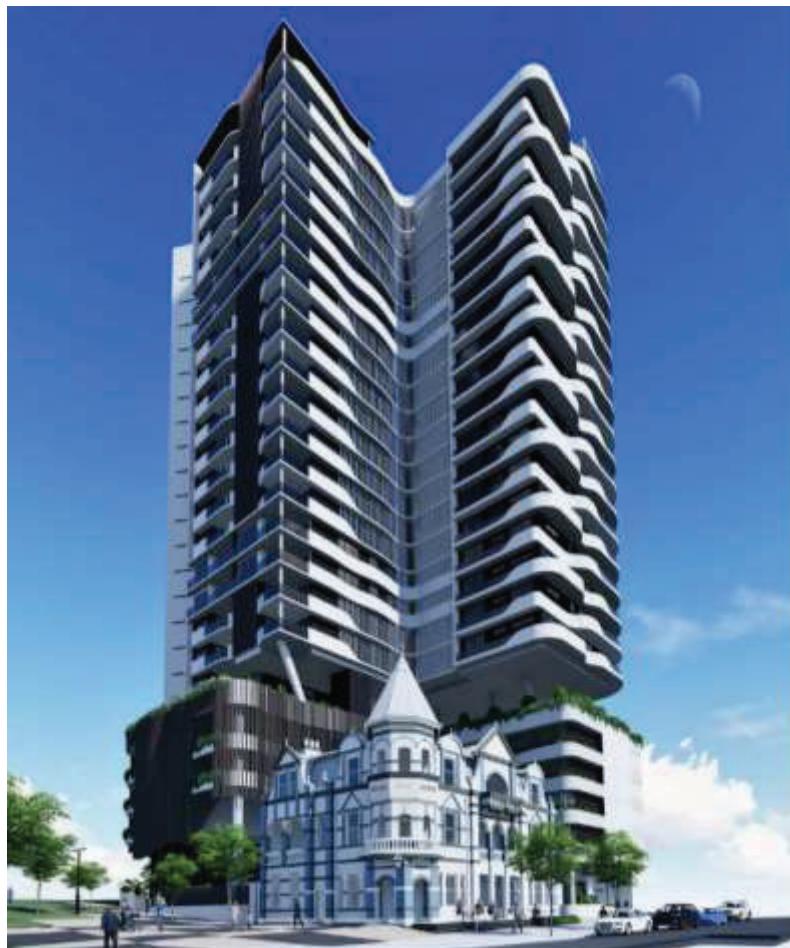
Figure 21 Phase 2 3D view from corner of Logan Road & Balaclava Street
Source: Red Door Architecture

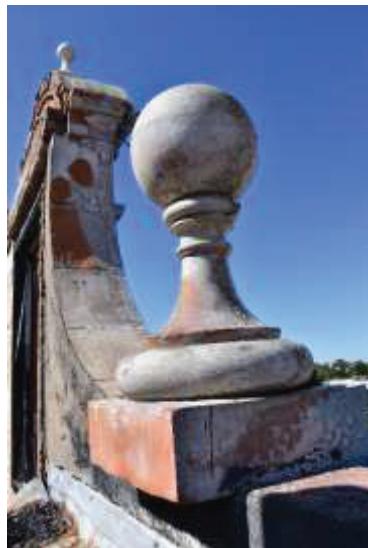
Figure A2.14 *Terracotta parapet detail*

- The original building featured high-quality face brick walls which were tuck-pointed on the principal street facades and lime-pencilled on the rear wall and (likely assumed) side wall. Added to this was a complex system of moulded terracotta decorative trim on the principal street facades. The face brick walls are now generally rendered and painted and the terracotta trim is now painted and broken in places. Remnant tuck-pointing exists to FV2 & SV2 (but is painted over) and to SV1 (where it is substantially intact). Whilst it is relatively easy to remove the paint from the terracotta trim, removing the render from the original face brickwork may not be feasible due to likely damage to the brick face. If the render cannot successfully be removed to reveal the original face brickwork, the existing system of render and paint will have to remain and be made good, albeit with an appropriate colour scheme in accordance with policy 26.

Policy 68: The existing paint should be removed from the original terracotta trim to the principal facades by a non-damaging paint removal technique and any broken or missing terracotta reconstructed to match the original detail. Sandblasting is not permitted.

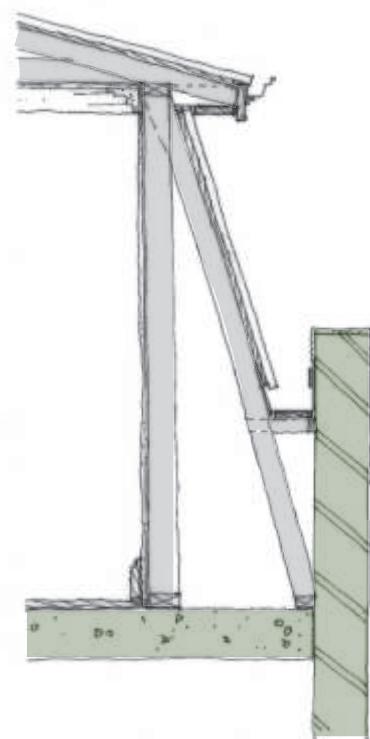
Figure 128 Mansard roof

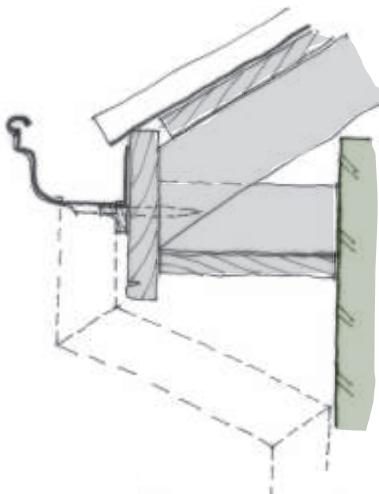
Figure 129 Eaves detail

Policy 72: *The original 0.6mm Z600 mansard roof galvanised steel box guttering should be reconstructed behind existing parapets and drain via existing 20th century rainwater heads and rectangular downpipes.*

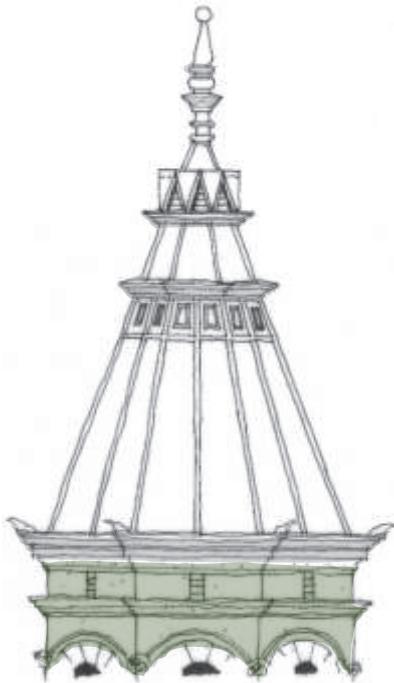
Figure 130 Turret spire (not to scale)

- The original corner turret spire was a steeply pitched octastyle roof with tapered and bellcast “pan-and-rib”-profile galvanised sheeting embellished by sheet metal decorative bands and finial. Although the spire was destroyed by fire down to the eaves lines, sufficient documentary evidence exists on which to base an accurate reconstruction.

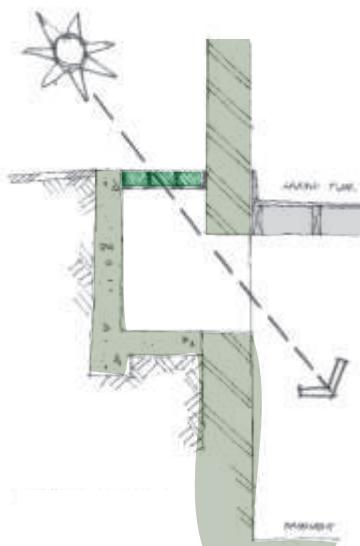
Figure 131 Basement "floor lights"

Policy 82: New basement "floor lights" may be installed to weatherproof the existing B1 openings.

Policy 83: A lower basement floor may be installed to allow usable head height.

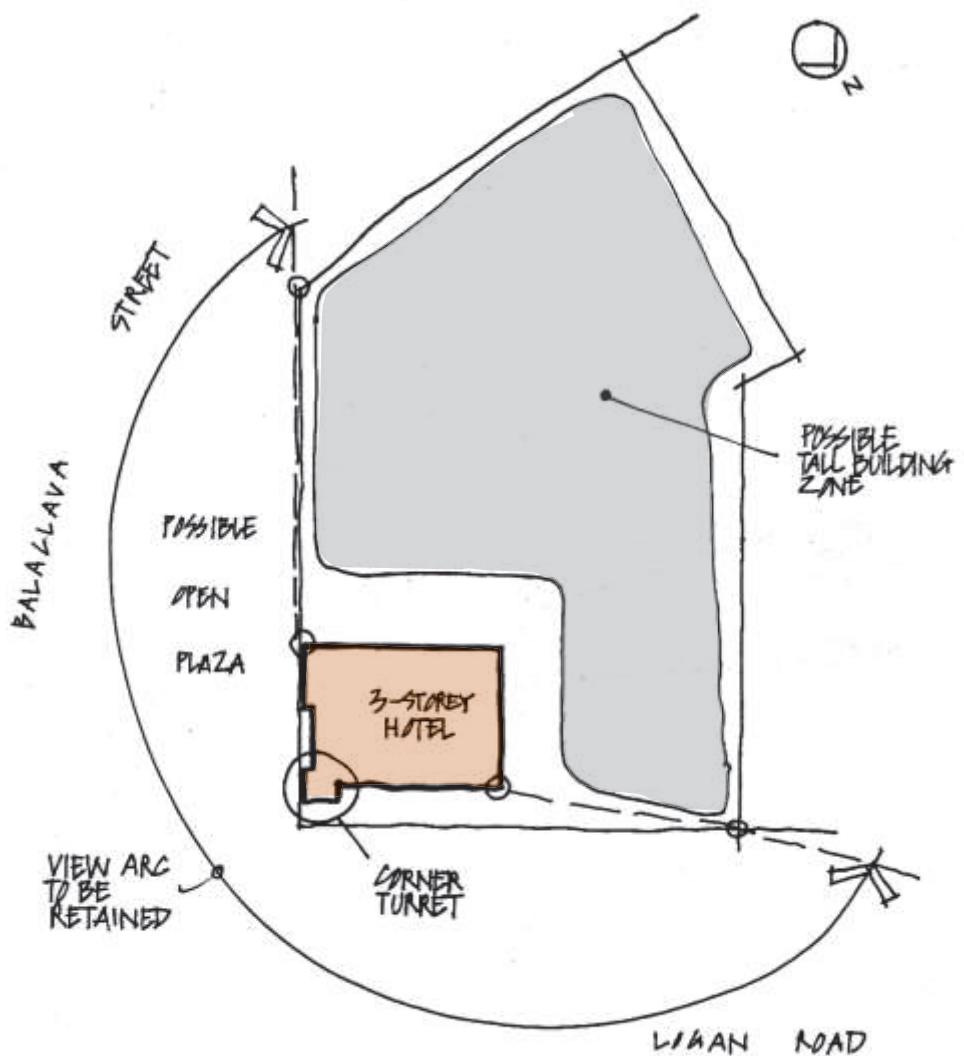
Figure 132 Setting diagram

Policy 110: *The current Queensland Heritage Register boundary is considered to provide an appropriate curtilage for conserving the Broadway Hotel's setting.*

A setting diagram consistent with the above policies is shown at figure 132.
