Job No. DE21/113 Ref No: 28651-Rev1 Author: Simon Wynne

RE: GEOTECHNICAL DESKTOP REVIEW FOR PRECINCT 6 YARRABILBA

This report presents the results of a geotechnical desktop review carried out for the proposed residential development at Yarrabilba – Precinct 6 (herein referred to as the 'site'). The work was requested by Cameron McClure representing Golding Contractors (Golding).

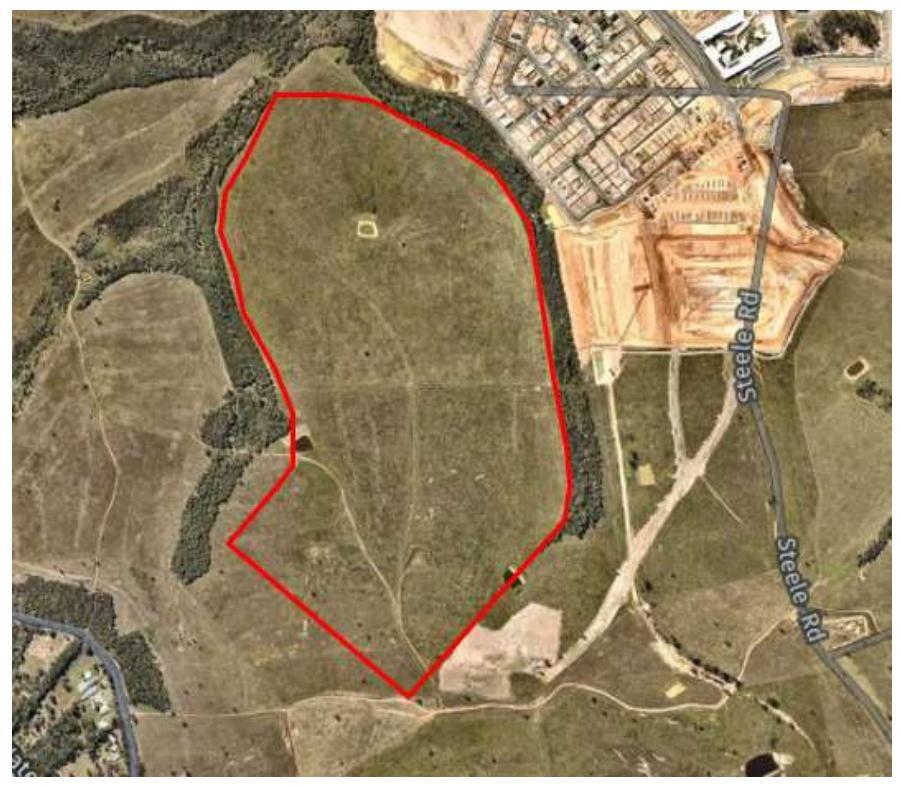
Figure 1 – Aerial Image of the Site (in red) (Image © Nearmap – showing April 2023)

The site occupies Lot 6000 on SP338330 and part of Lot 3102 on SP338990 for the access leg and is located to the west and southwest of the existing Yarrabilba Precincts 4 and 4E. The area appears to currently comprise undeveloped rural land / farmland.

The ground surface in the area slopes downwards at approximately 3° to the north, east and west from a minor north-south aligned ridge in the southern part of the site.

An aerial image of the site which shows the broad site conditions is given in Figure 1. A copy of the Precinct 6 layout plan provided by Golding is given in Figure 2.

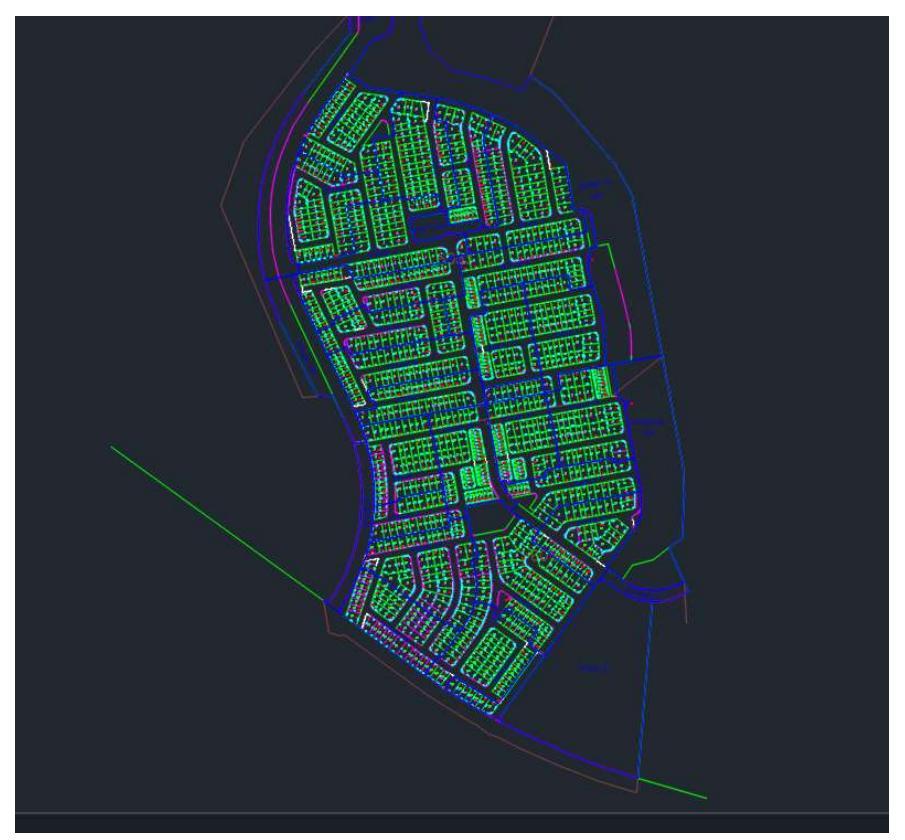
Figure 2 – Indicative Precinct 6 Layout Plan
