Geotechnical & Acid Sulfate Soils Investigation Report Proposed Multi-Storey Residential Development 280 MacArthur Avenue, Hamilton

Report Number: J002388-002-R-Rev0

7 June 2024

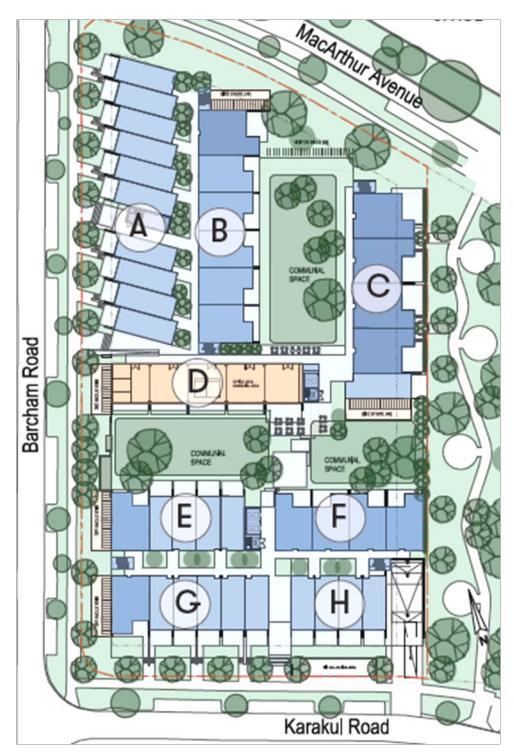
Image 1: Extract from proposed development plan at ground level.

The proposed development includes a number of four and five-level unit buildings over a single-level partly inground basement, as shown in Images 1 and 2 below. Bulk excavation to about RL 3.4 m (about 2 m below finished ground level and up to about 1 to 1.5 m below existing ground level) is anticipated.

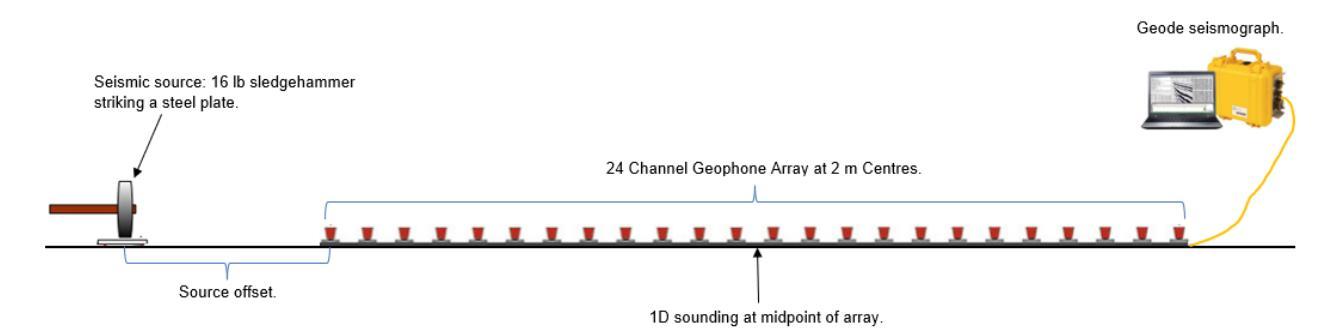
Image 4: Example MASW acquisition schematic.

The quality of the produced MASW dispersion curves for each sounding was typically good, with high signalto-noise (S/N) ratios for the fundamental-mode dispersion energy, for a frequency range between about 4 Hz and 20 Hz.

The geophysical survey line locations are shown on Figure 1 in Appendix A, and the survey results are shown in Figure 2 in Appendix A.

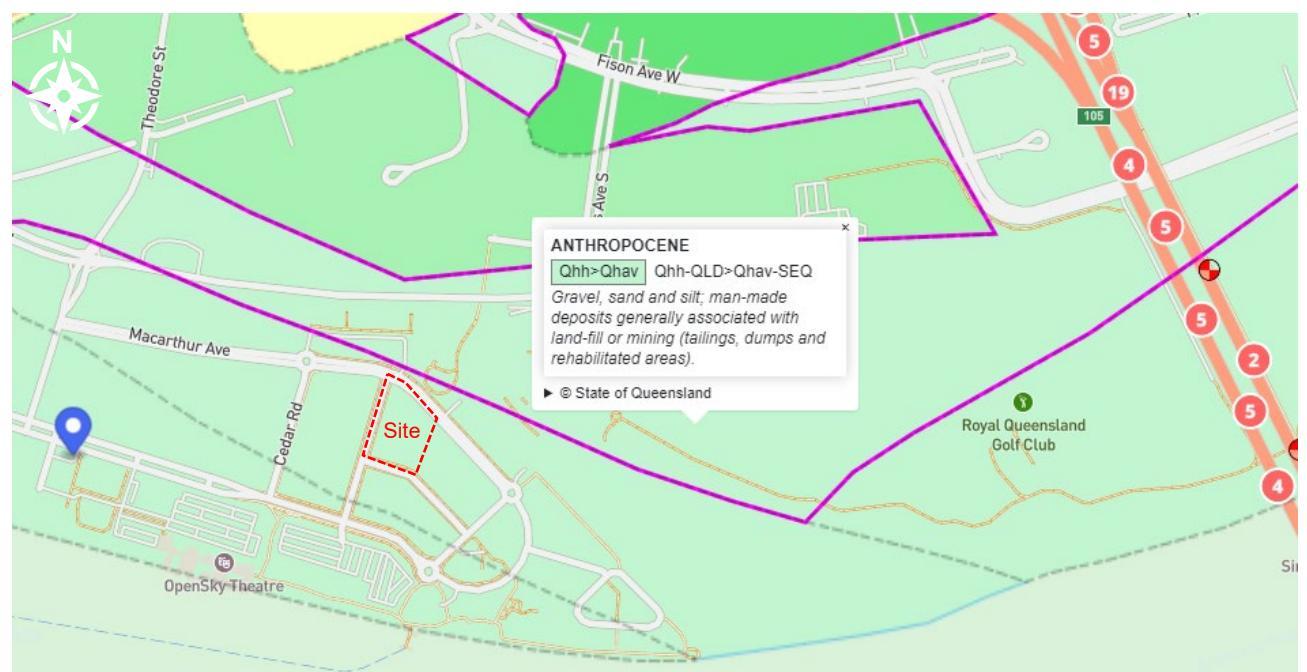
Image 5: Extract from QGD map showing regional geology (not to scale).

The Queensland Geotechnical Database (QGD) indicates that the site is located in an area of Quaternary age Anthropocene comprising :*Gravel, sand and silt; man-made deposits generally associated with land-fill or mining (tailings, dumps and rehabilitated areas)*". An extract of the relevant geological map is shown in Image 5 below.

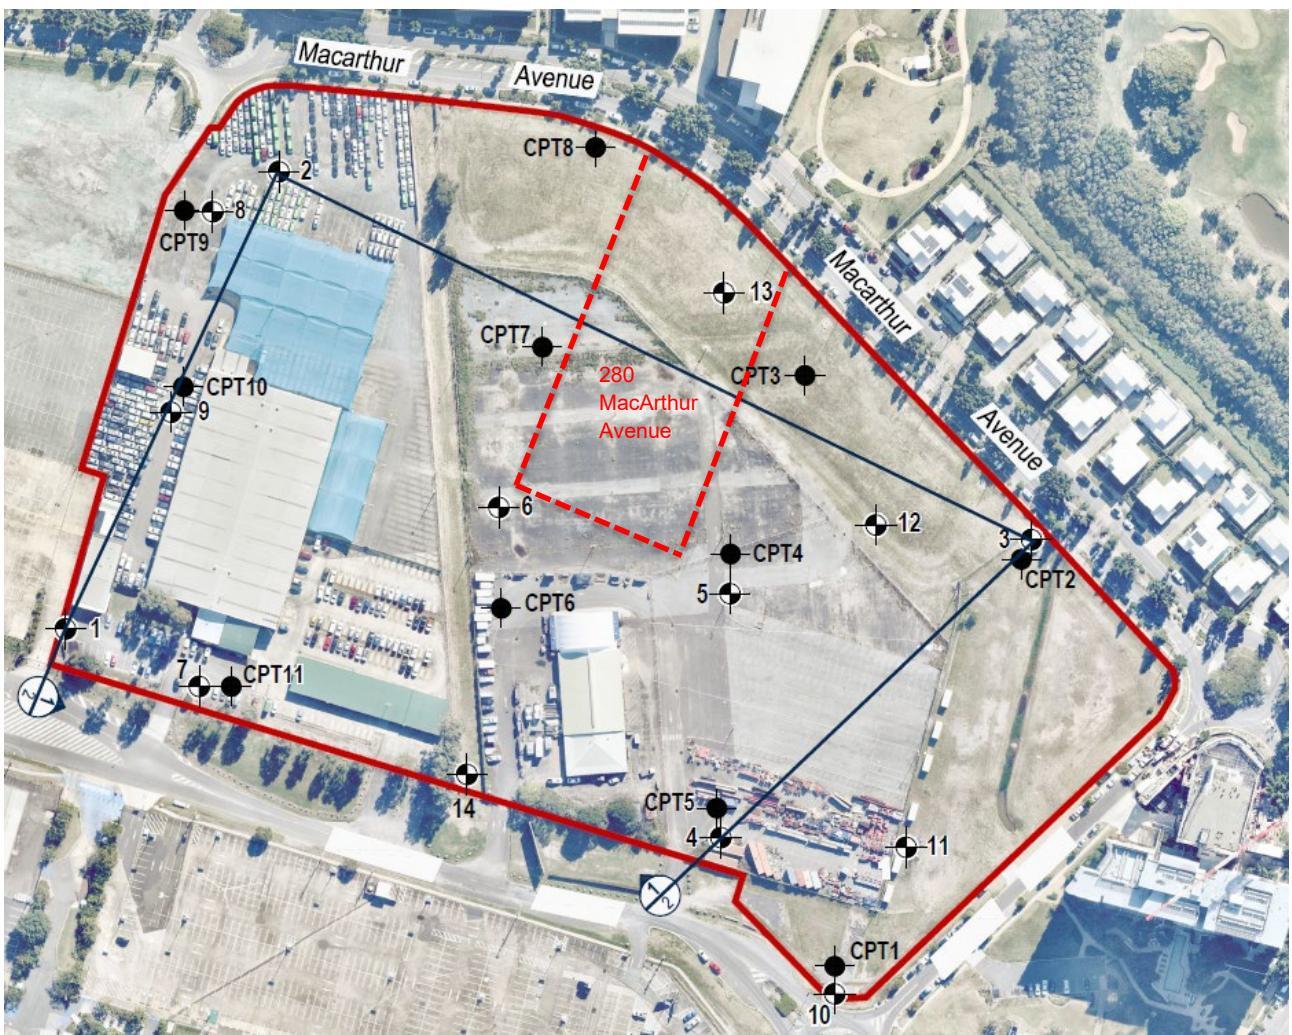
Image 7: Previous investigation locations (extract from Butler Partners report 018-150J dated October 2020, with site location by Core).

- Fill to 1.1 to 1.2 m BGL comprising clayey sands; dynamic cone penetration (DCP) tests indicate this fill was mostly relatively dense apart from a loose band around 0.4 m BGL at borehole 13. No records to confirm the fill was placed in a controlled manner were seen (nor would be usually available for dredge spoil placement) and the fill would be considered uncontrolled

- 'Upper alluvium' (possibly including some dredge spoil?) comprising very soft to firm clay to about 6.5 to 7.5 m BGL, then very loose to loose clayey sand (with a firm clay band in places) to about 16 to 17 m BGL

- Lower alluvium comprising loose to medium dense clayey sand (with stiff clay bands in places) then medium dense with dense material encountered below about 30 m to 31 m BGL where the CPTs met refusal

The previous ASS laboratory testing indicated that the sand and clay have potential acidity but also contained high levels of acid neutralising capacity (ANC) which appeared to be due to shells. Shells cannot not be relied upon for neutralising acidity and are not included in the assessment of neutralized. The liming rates for the sand fill (in one sample only tested) were found to be 4 kg/t and for the underlying clays varying from 5kg/t to 6 kg/t (e.g. boreholes 1, 2, 7, 12 and 13 but 23 kg/t to 33 kg/t in others, e.g. boreholes 4, 5, 6, 7 and 10).

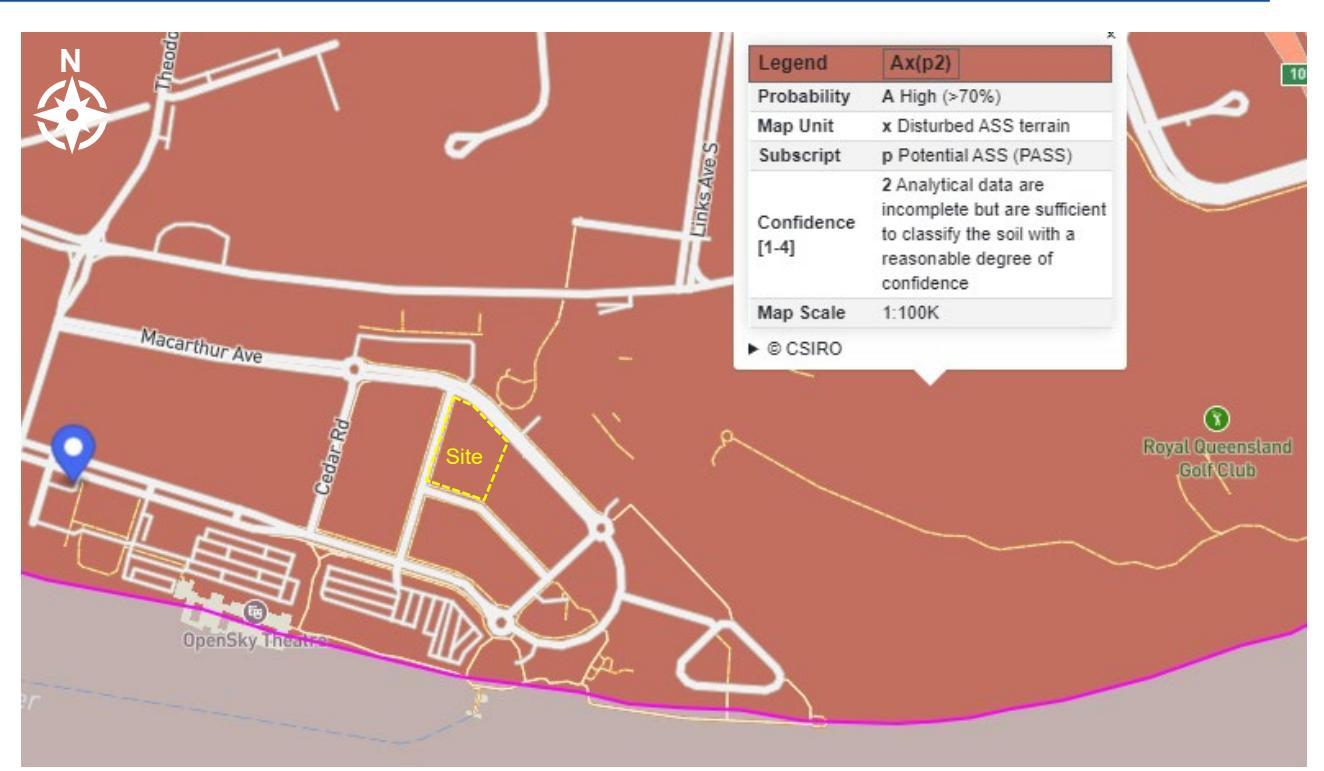
Image 8: Extract from QGD map showing ASS classification (not to scale).

This site is mapped as a high probability (>70%) for the presence of ASS, likely due to the elevation of the site and proximity to the Brisbane River. An extract of the relevant ASS map is shown in Image 8.

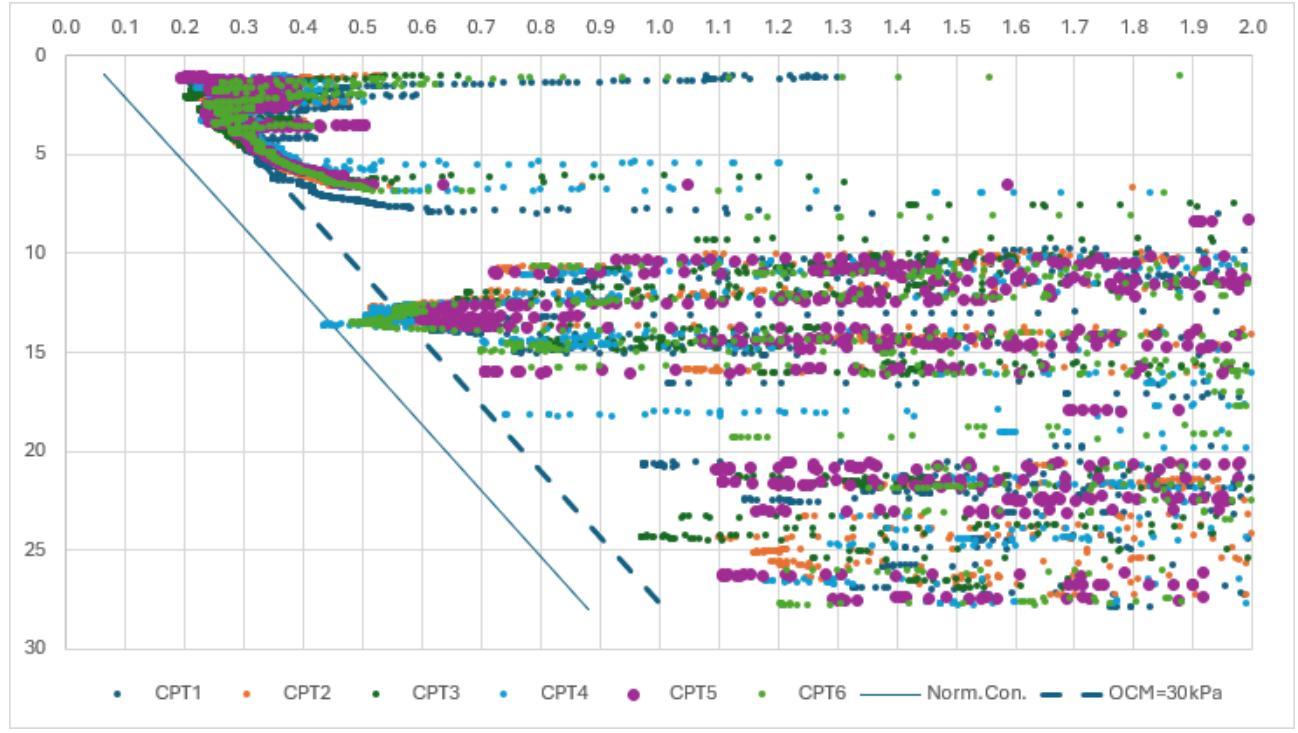
Image 9: Analysis of CPT tip resistance results.

In order to assess the settlement characteristics of the weaker clay layers encountered in the CPTs, the tip resistance was compared to those expected for normally consolidated clays as well as those for lightly overconsolidated clays at differing overconsolidation margins (OCM). From this analysis, an OCM of 30 kPa was found to best represent the nature of the clays (refer Image 9). The analysis therefore indicates that the upper alluvial clay is lightly over-consolidated. Consolidation settlement should therefore be anticipated under new loads (e.g. from structure or pavements supported on ground and not piles, or fill).

Estimated primary consolidation settlement at the CPT locations range between about 70 mm and 75 mm, for assumed new development loads not exceeding 20 kPa. If larger loads are proposed then higher primary settlements can be expected as well as additional secondary settlements; further advice should be obtained if such higher loads are to be considered.

Differential settlement will be likely due to variation in clay thickness/extent as well as due to varying structural loads and supports (e.g. between piled and non-piled elements). This will need to be considered in the development design, e.g. detailing of gravity services and other entry points as well as other parts of the development, noting they will be remaining settlements in the existing roads and filled areas due to that fill.

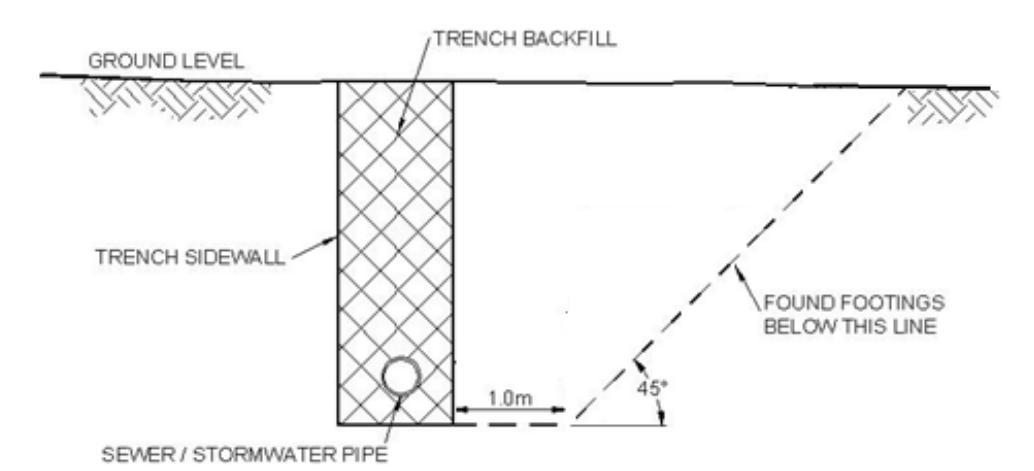
Diagram 1: Exclusion zone for base of footings.

All footings should found such that they are not adversely affected by any adjacent excavations batter slopes, trenches, or retaining walls that are not designed to support building loads. To minimise the potential for any adverse interaction effects, footings should found at least below a plane extending 1 m horizontally from the base of trenches/batter slopes/excavations/retaining walls, then rising up at 1V:1H. This requirement is illustrated in Diagram 1.

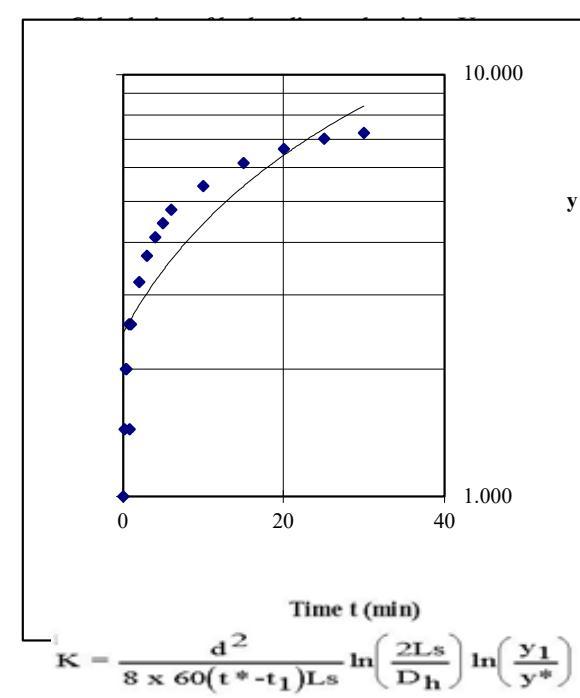
Depth of borehole (H)	4.00 m	(measured from ground surface)
Depth to bottom of seal (Hb)	4.00 m	(measured from ground surface)
Test section length (L)	3.0 m	
Diameter of pipe (D _p)	0.05 m	Note **:
Diameter of test section (D _h)	0.10 m	1. $d = D_p$ or D_h if no gravel pack
Dia. of water surface (d)**	0.069 m	
Static depth to gw (h _s) (tos)	4.00 m	
Depth of water in screen (Ls)	3.00 m	if water surface is within gravel
Bore inclination	0 °	pack
Stickup of pipe (s)	0.40 m

where $t^*, y^*, t_1 = 0, y_1 = 1$ define slope of a straight line fitted to the observations

$t_1(min) =$	15.00	t*(min) =	30.00	
$y_1(m) =$	6.17	y*(m) =	7.278	
K = 1.5E-07 m/sec
