# YARRABILBA PRECINCT 5 STORMWATER MANAGEMENT PLAN

VERSION 2

DesignFlow  
Prepared for Lendlease  
September 2017

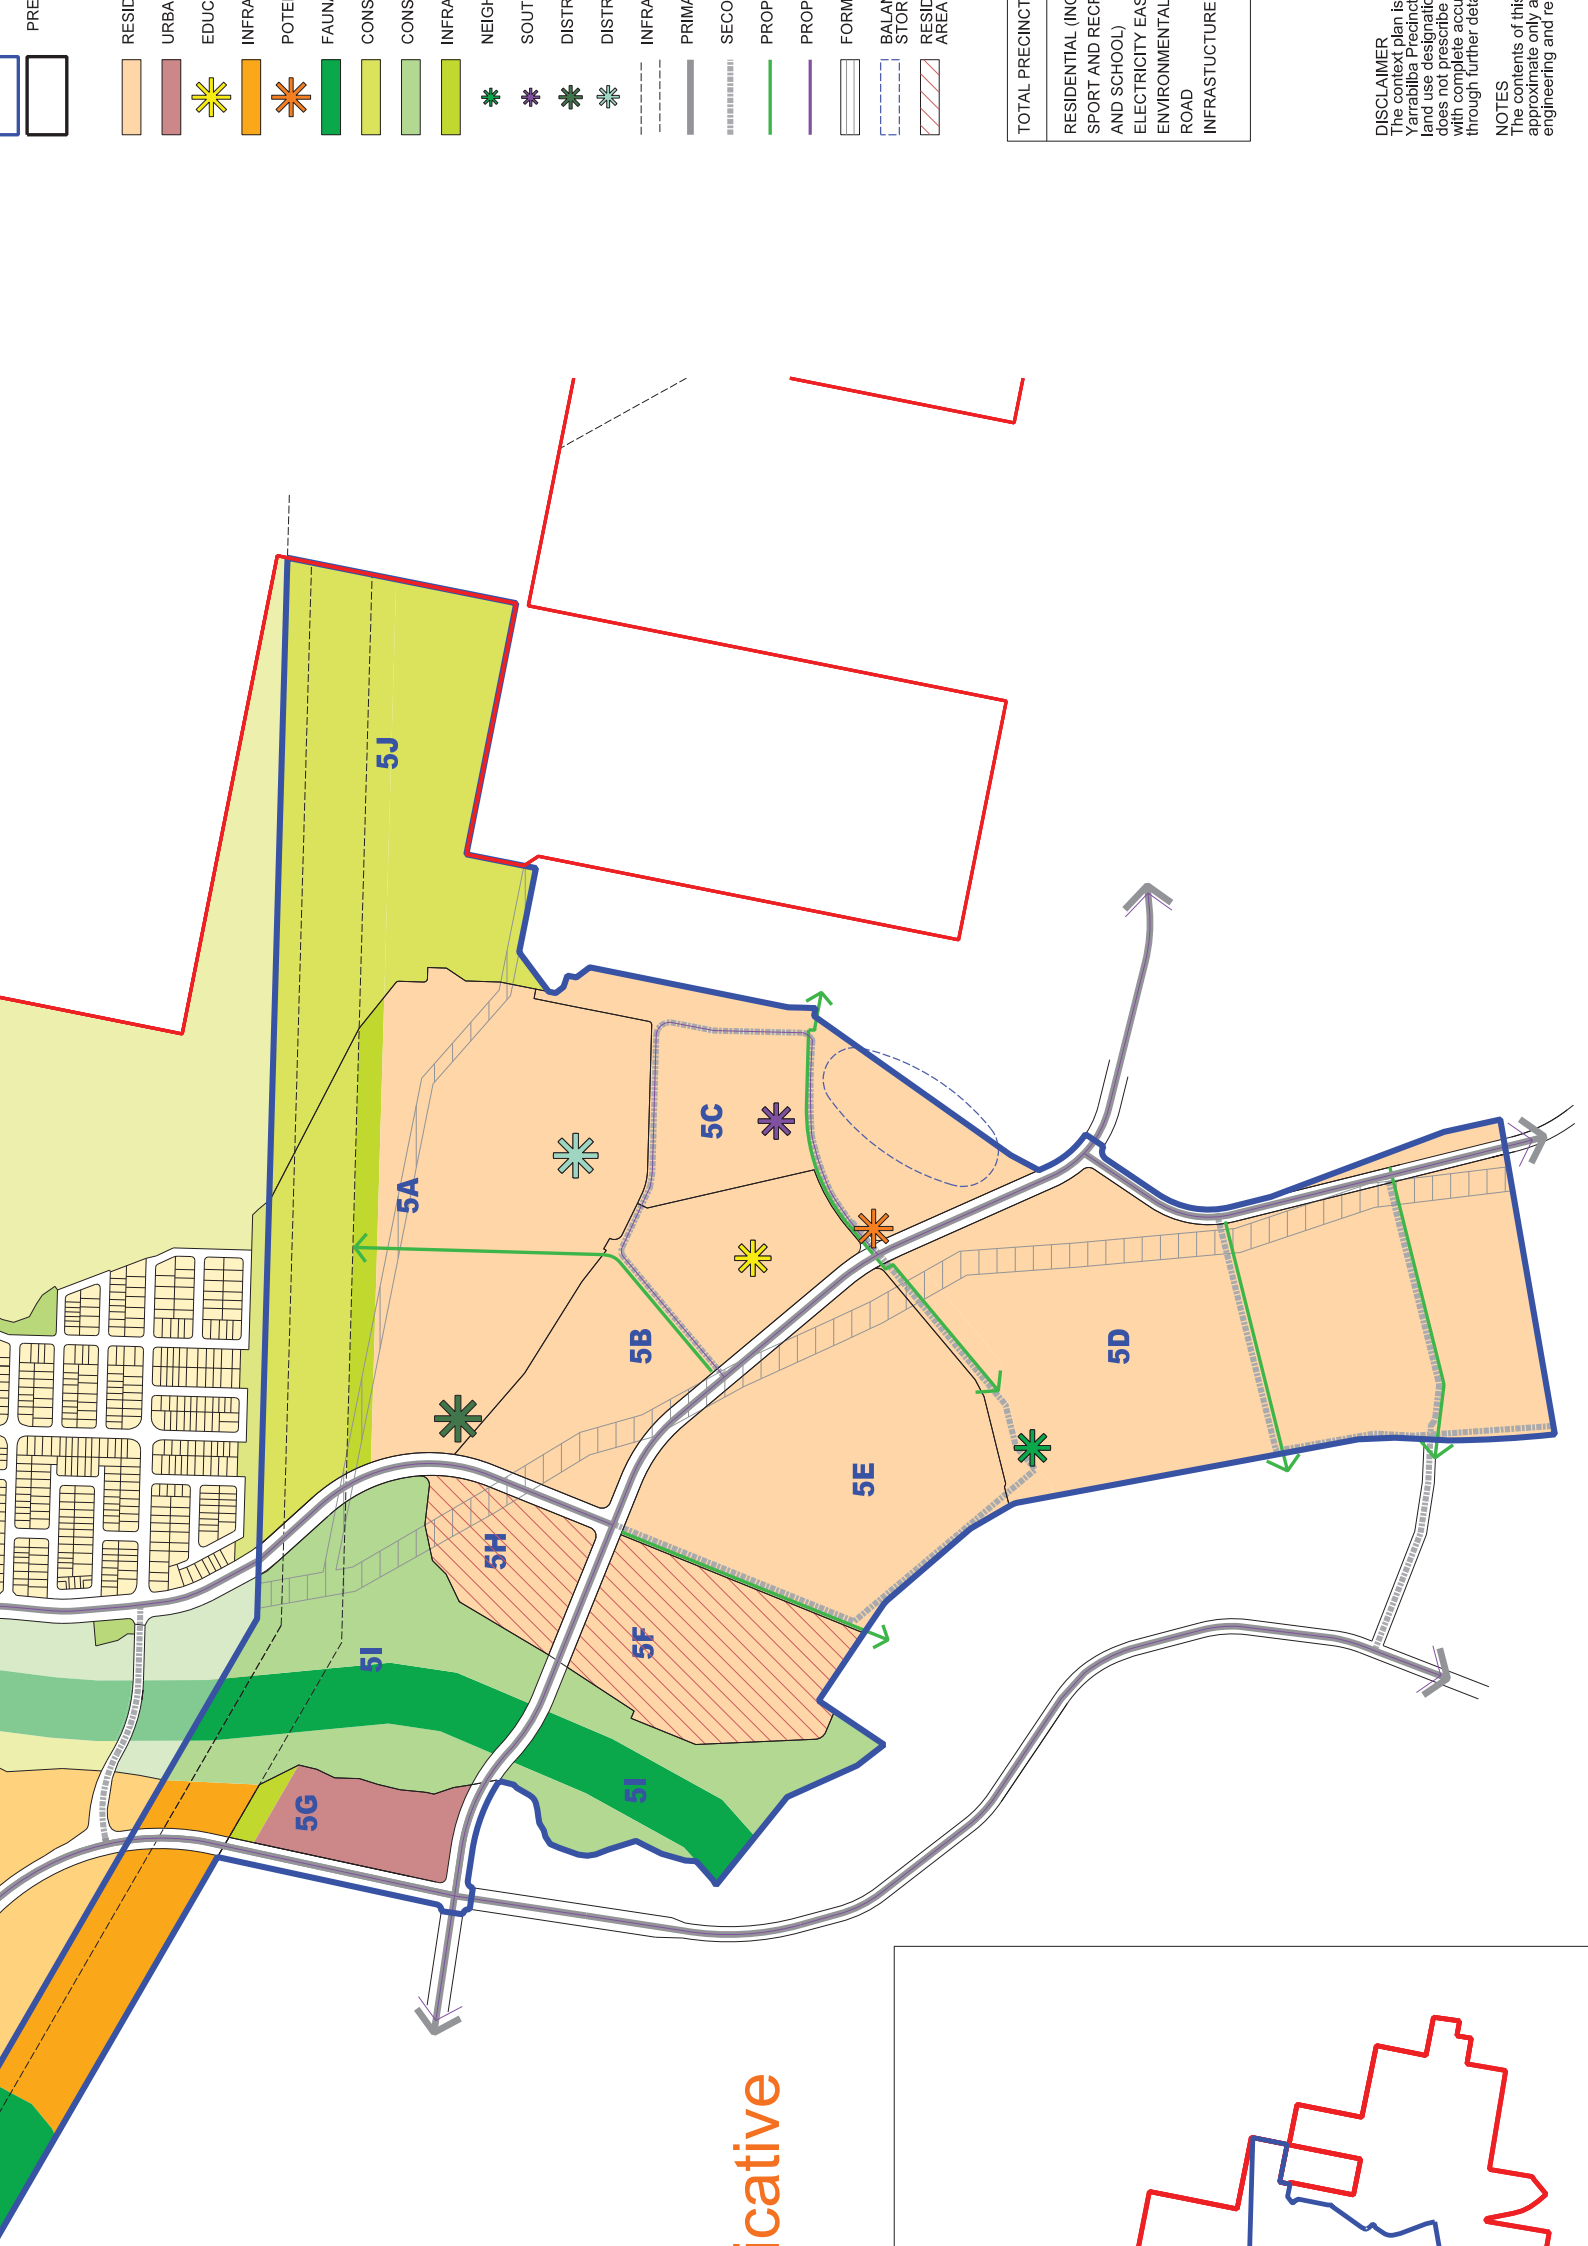
The total area of Precinct 5 development boundary is approximately 247 ha with a significant portion of Precinct 5 associated with fauna, waterway and conservation corridors as well as major infrastructure easements as illustrated in Figure 4.

While much of the southern tributary lies just outside the precinct boundary, it is included in its entirety for this assessment as it receives and conveys stormwater runoff from the majority of Precinct 5D and 5E (sub-precinct numbering as per Figure 4). The Upper Quinzeh Creek reach forms a minor part of the main waterway through the site which becomes a declared watercourse (under the Water Act 2000) at the northern boundary of the powerline easement.

The strategy is broadly divided into three areas defined by the strategy approach adopted and discharge location (note: precinct sub-stage numbering in accordance with endorsed Context Plan in Figure 4 previously):

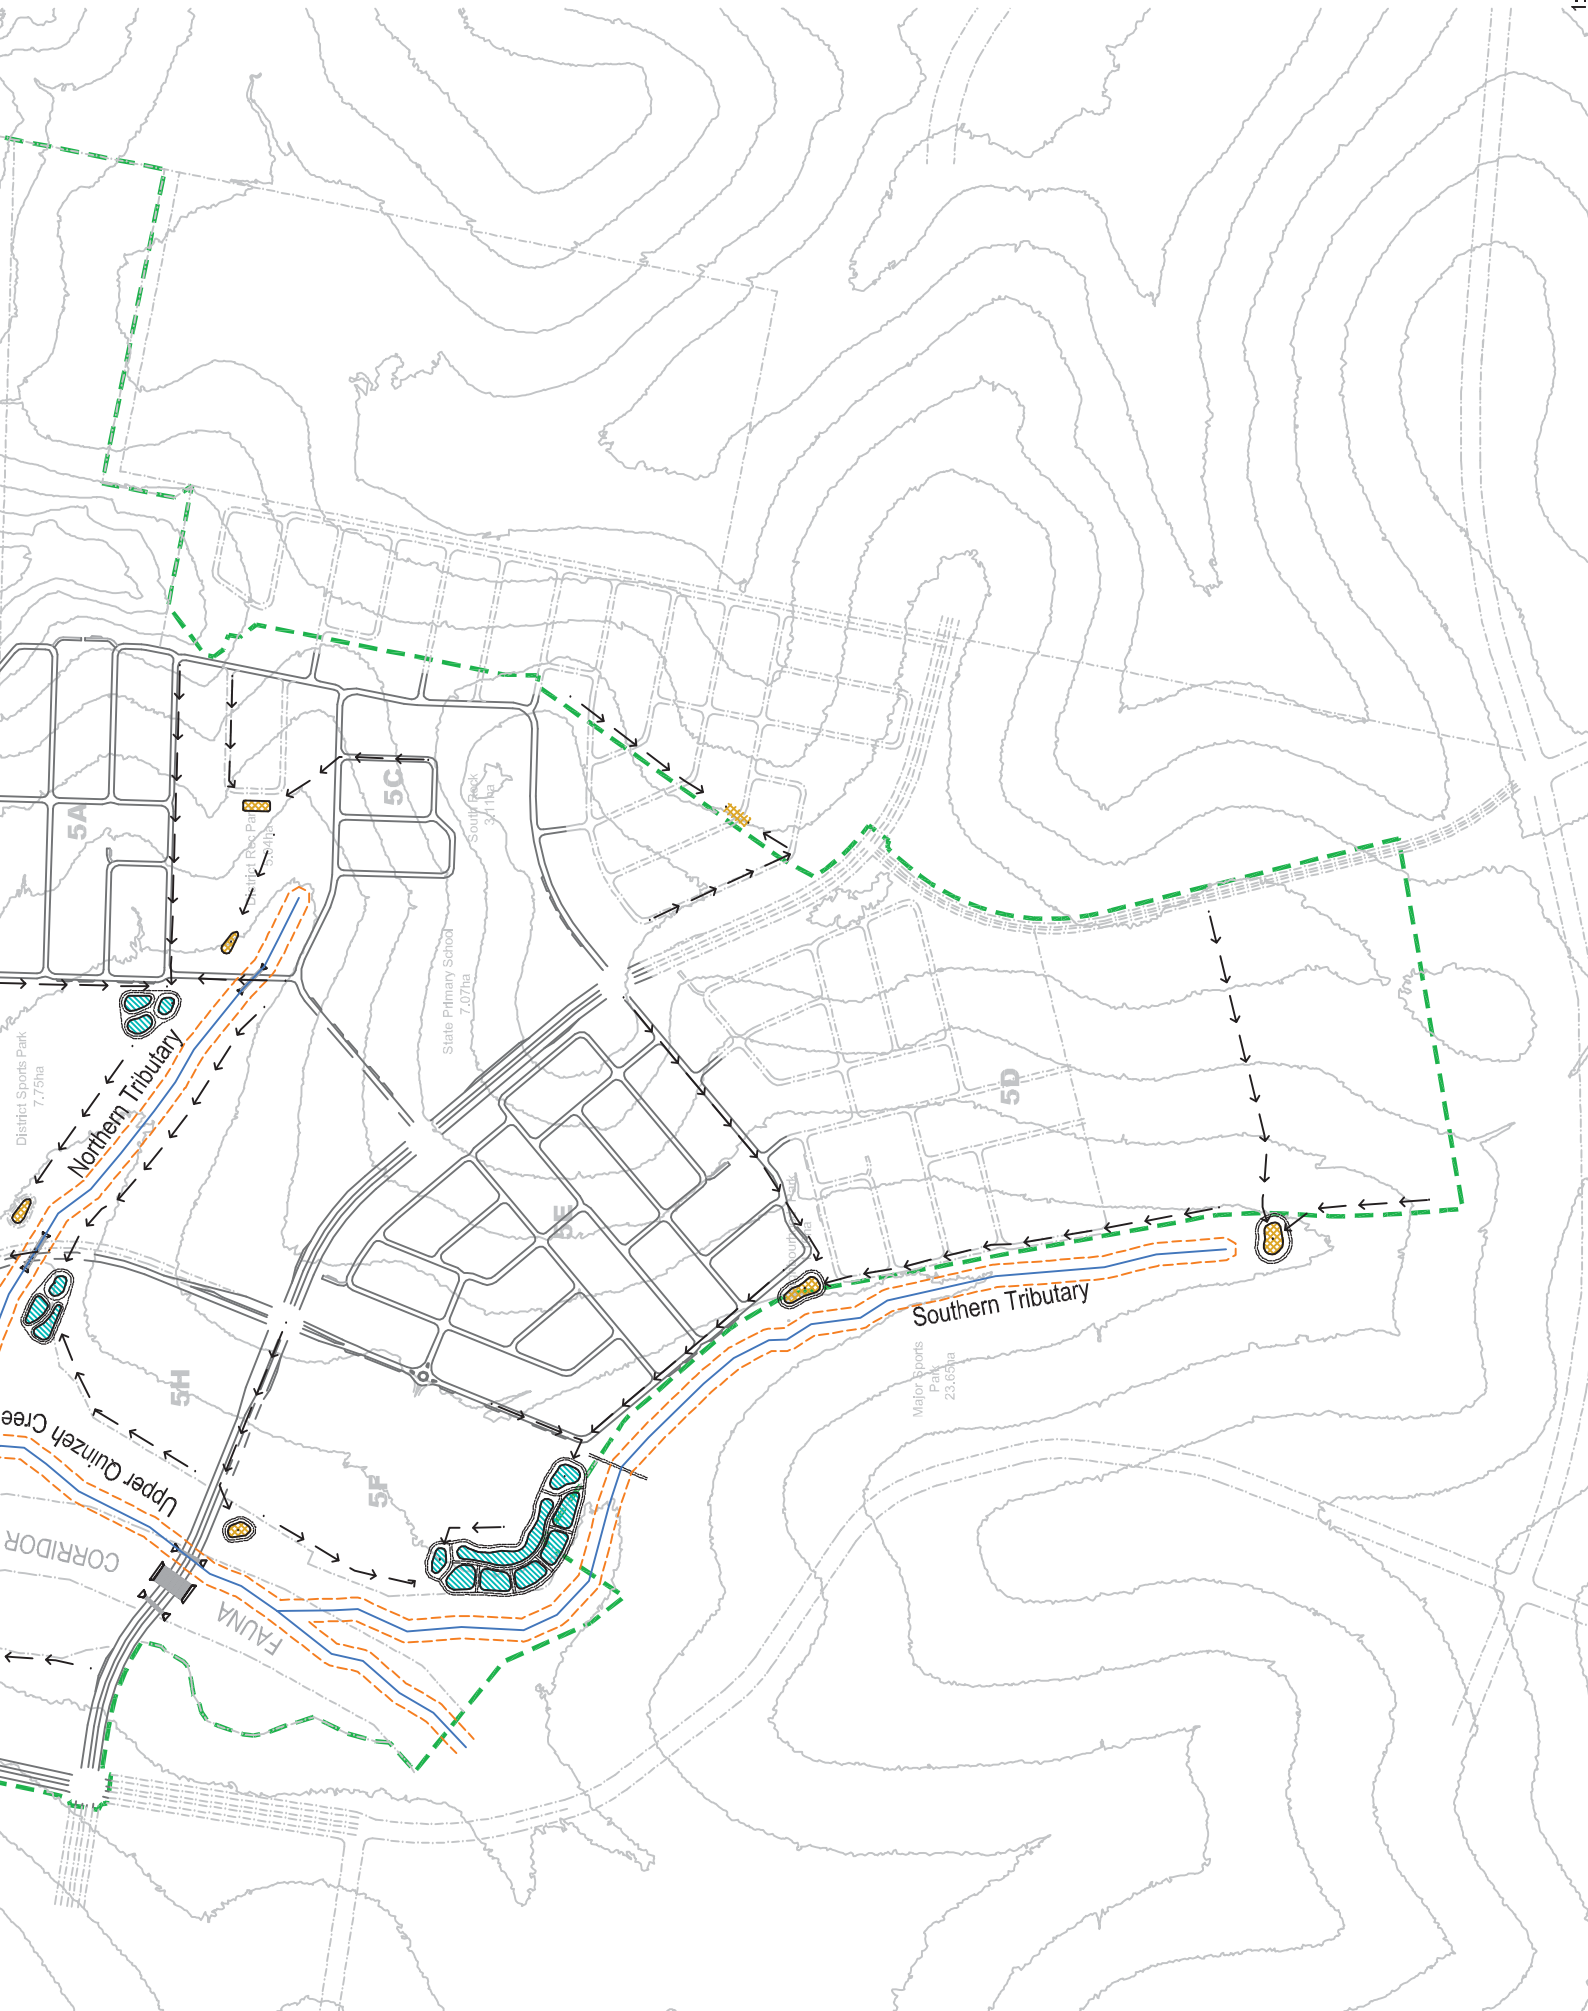
- 5m Contour
- Waterway
- High Efficiency
- Batch Sedimentation
- Diversion

1. Construction phases identify opportunities for permanent stormwater locations. However, the ESC requirements.
2. Additional sediment required within the sediment control proposed construction.
3. Basin sizing must be in accordance with IECA Guidelines.

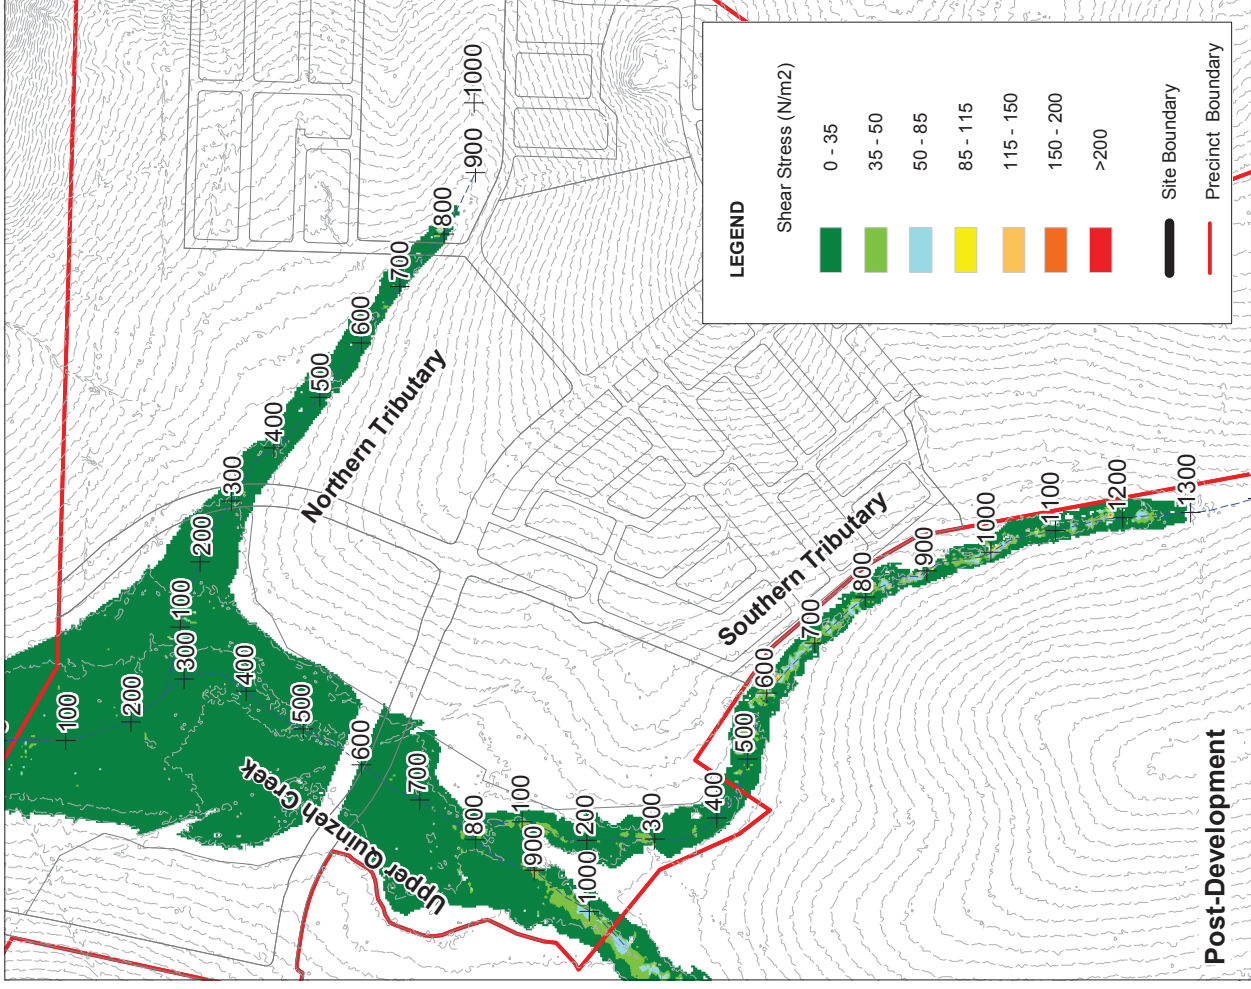
Additional review of the minor (2 year ARI) and major (50 year ARI) bed shear stress results from the detailed hydraulic modelling undertaken as part of the *Yarrabilba (Quinzeh Creek) Flood Study – Version 1* (DesignFlow, 2017) was also undertaken to broadly identify any potential erosion locations for ongoing monitoring within Precinct 5. The results indicates that bed shear is very low to low across the majority of the Precinct 5 waterways for both the 2 and 50 year ARI. Under post development conditions, localised increases in the southern tributary are evident however these are still low (generally <85 N/m<sup>2</sup>). In a number of these locations, targeted management of existing issues identified in Section 5.3 (such as scour pools and poor vegetation) will greatly enhance the capacity of the existing waterway to cope with minor increases in bed shear associated with increased flows.

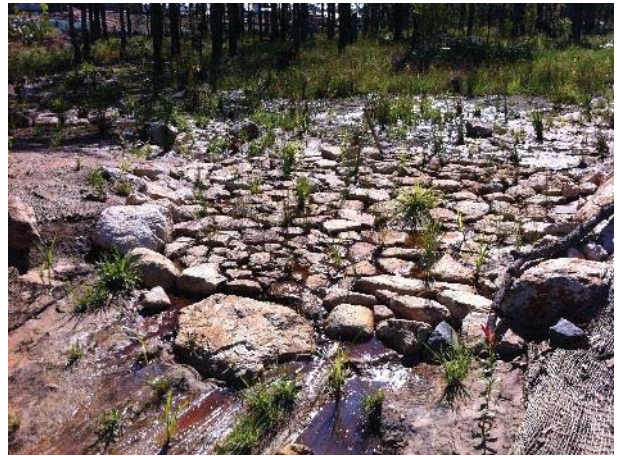
Scoured areas and incised channels are to be reshaped to flatten vertical edges and placement of rock or rock mattress over geofabric to armour underlying soil. Integrate planting within rock voids where practical. Rock protection must be formed with depressed centre to ensure flows are directed into and through the area and set down slightly below the natural ground level to avoid flow redirection around the edges (creating new scour).

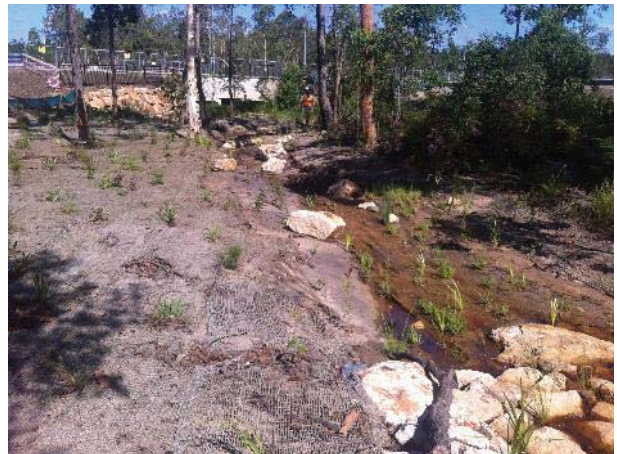
Areas with little or no vegetation cover should be replanted with a mix of locally established species to create both a soil anchor (via roots) as well as flexible grasses that can lay flat during flow (as a surface armouring) to create a stable flow path. This is most appropriate to broad low gradient flow paths (where rock channel linings are not required). The use of pinned down jute or coir mat (not net) prior to planting is required to create a short term soil stabiliser until vegetation is established. Revegetation should also form part of any rock protection works.

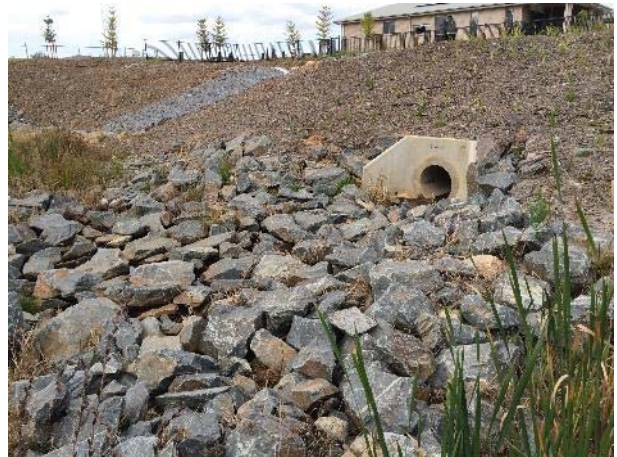
All stormwater headwalls to be provided with rock aprons configured appropriately (in accordance with QUDM) to the size and number of pipes. Where natural channel just downstream of apron is susceptible to further instability, aprons should be enlarged or lengthened beyond unstable area. Further, if instream stabilisation has been identified, the rock apron should be linked to this zone to avoid potential scour between two areas.

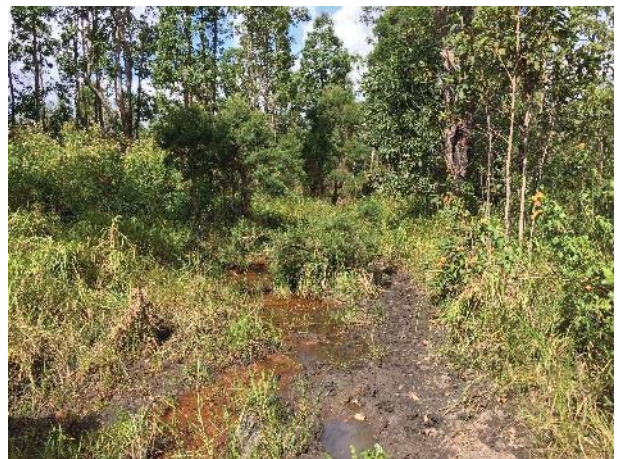
Where no (or very minor) erosion exists or potential future scour areas may occur based on high bed shear values (refer to Figure 7 previously) consideration should be given to minimising intervention in these areas where surrounded by very stable and/or well vegetated waterways zones. The potential impact of accessing these zones to undertake remedial activities (i.e. with earthmoving machinery) would likely create greater disturbance than benefit. Therefore, in the first instance, these areas will be monitored over the course of Precinct 5 development as well as into the adjoining precinct(s) development to review if these areas are degrading further. Reactive remediation can therefore be undertaken as required.

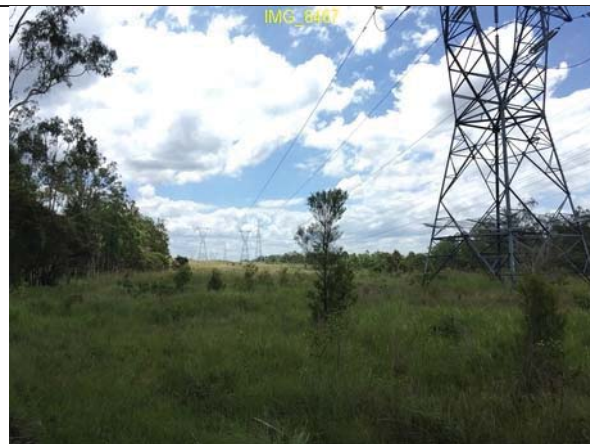
CH0-200 Powerline easement is fully cleared (grasses and some immature regrowth remain), broad flat scattered boggy zones.

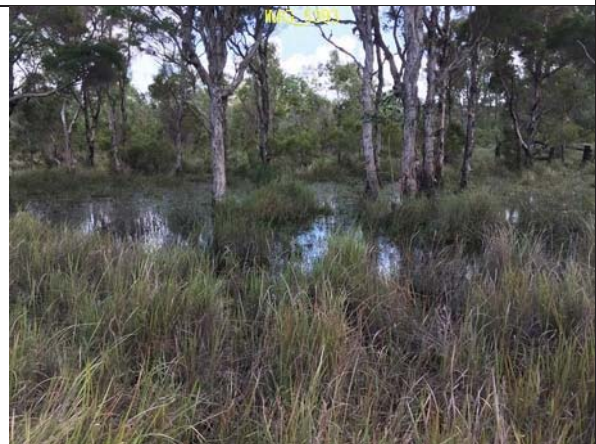
CH200-400 mapped wetland - upstream extent with standing water, lower extent damp only. Excellent vegetation coverage.

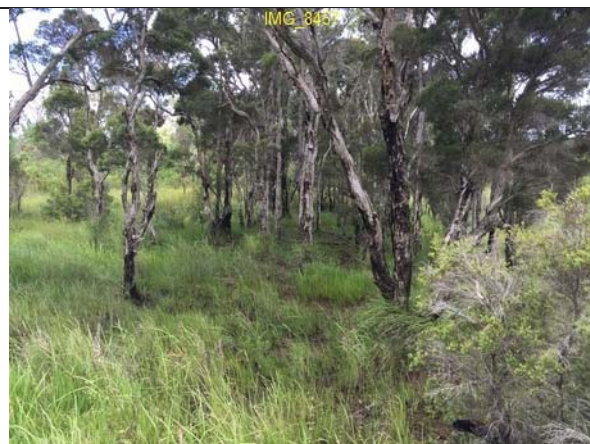
CH400-600 Dense wetland understorey, moderate canopy, broad, flat, profile, no defined channel. Standing water throughout, no instability.

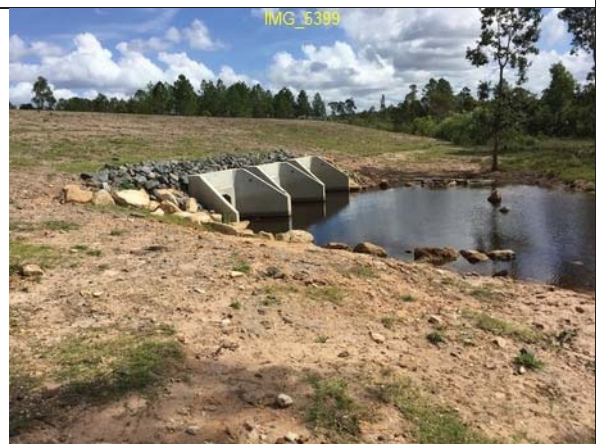
CH600 Interim flood bund 16-INT (downstream side). Post-civil works so minimal established vegetation evident.

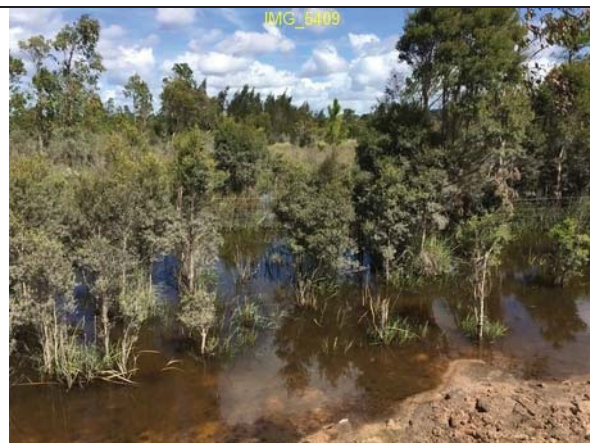
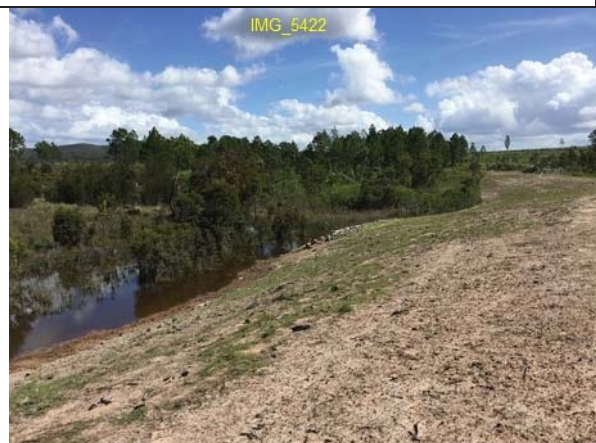
CH600-800 broad flat wetland zone, moderate/dense vegetation within standing water. Vegetation (u/s of flood bund 16-INT).

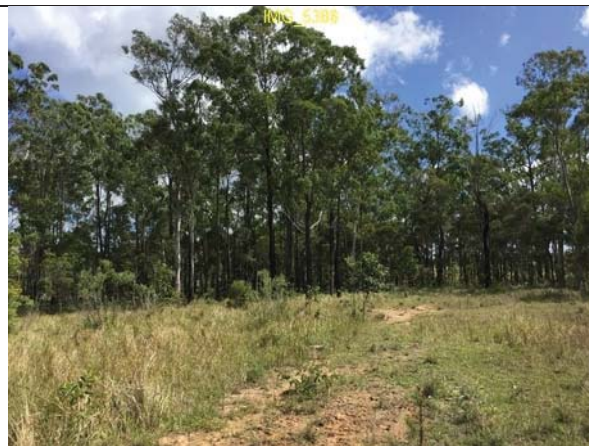
CH0-100 mapped wetland zone (background).

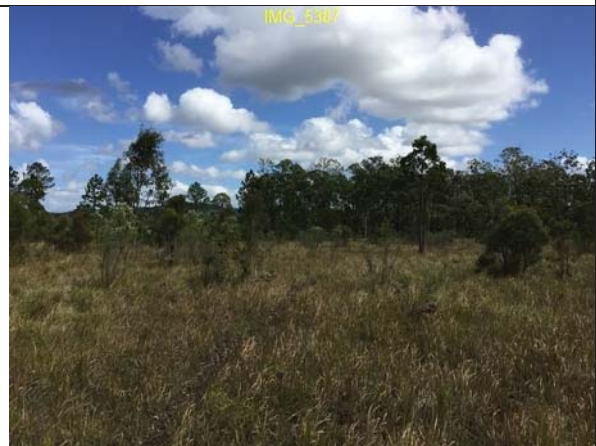
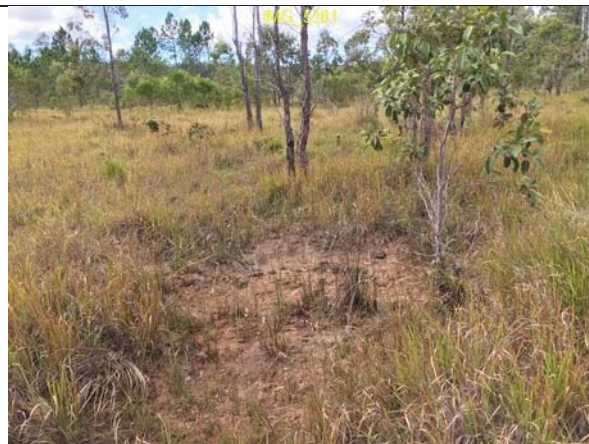
CH100-500 very broad, flat gradient, open grassland, minimal trees, no channel definition.

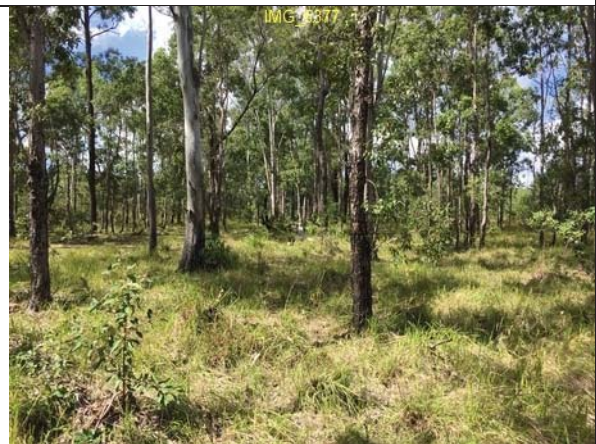
CH500-800 open woodland with generally good grass cover, no flow channel present, minor livestock damage, very low gradient.

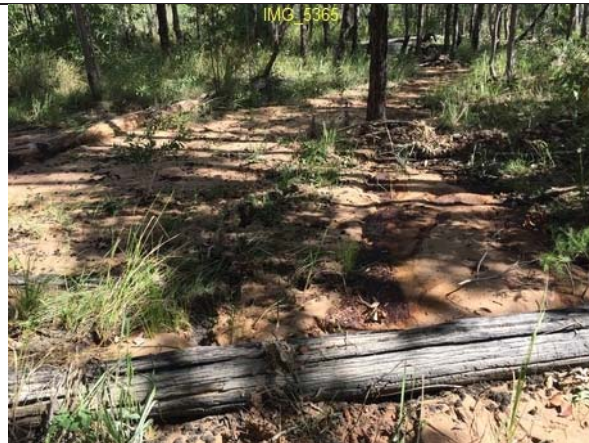
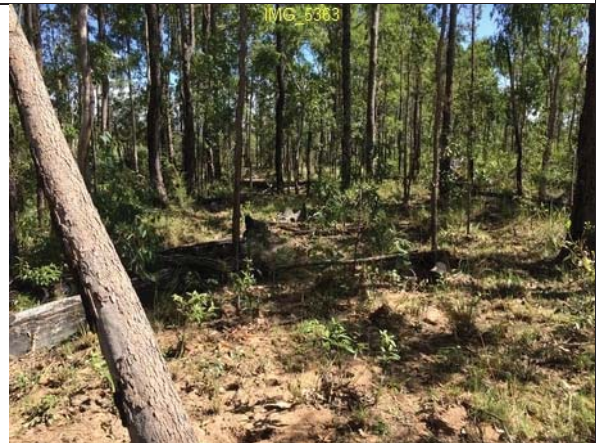
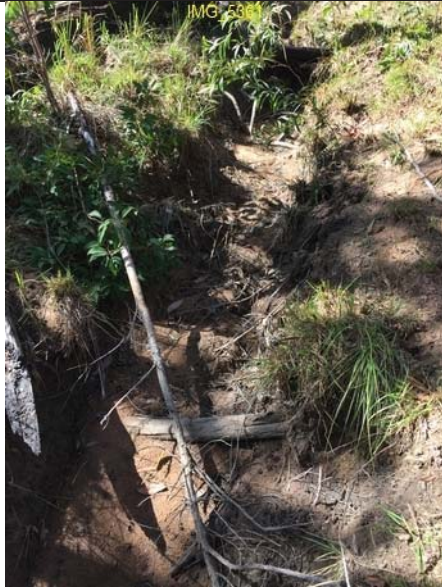
CH800-900 reduced grass undergrowth, localised low flow channel (incised 20-50cm) with sediment deposition downstream of low flow channel formation, slight gradient.

CH800-900 reduced grass undergrowth, localised low flow channel (incised 20-50cm) with sediment deposition downstream of low flow channel formation, slight gradient

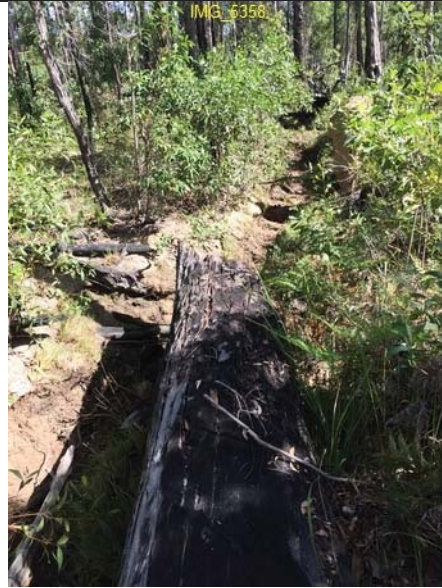
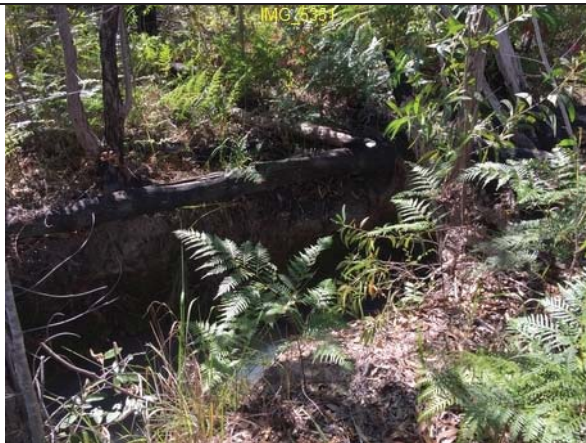
CH900-1000 narrow incised low flow channel (1m wide to 0.75m deep) alternating with grassed broad sheet flow area, small pockets of scour pool, generally goof vegetation cover outside low flow channel.

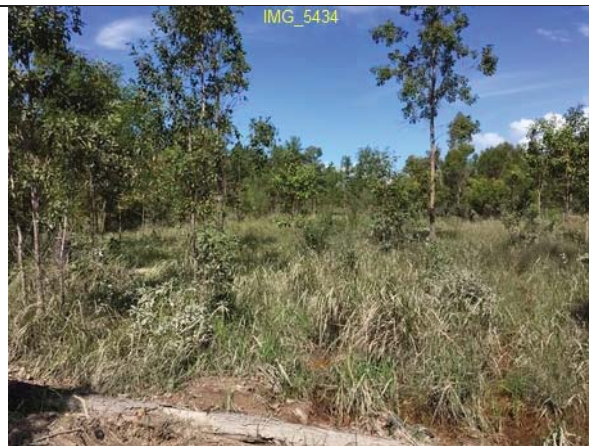
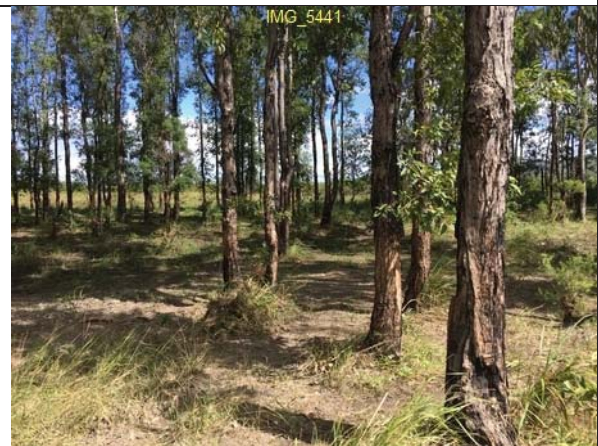
CH0-500 open vegetation downstream transitioning into localised wooded zones, undefined low flow path within very broad flat waterway, scattered wet depressions throughout.

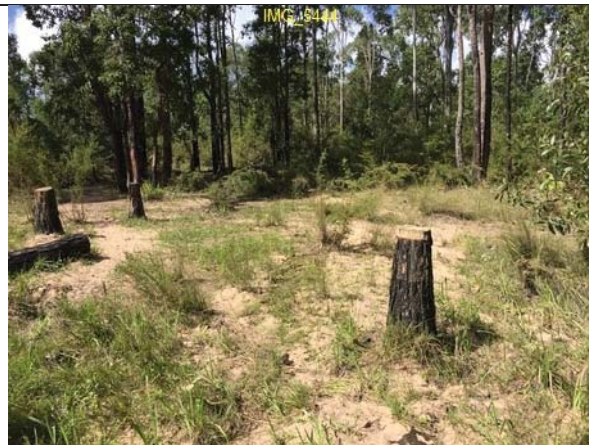
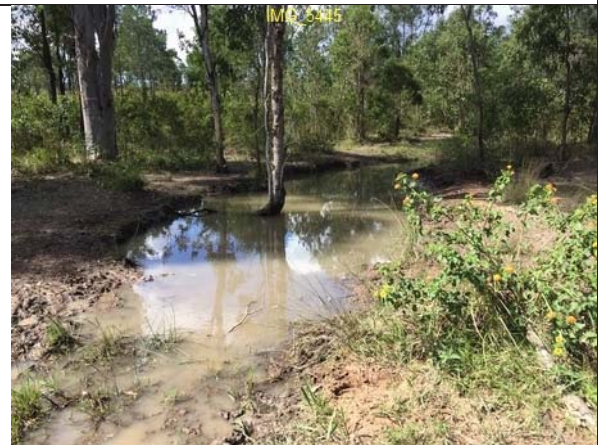
CH500-600 moderate groundcover, clumps of trees, localised shallow pool and downstream sediment deposition area. Some livestock damage near pool.

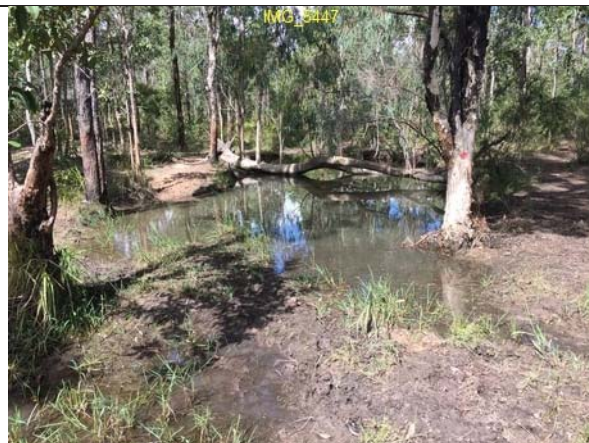
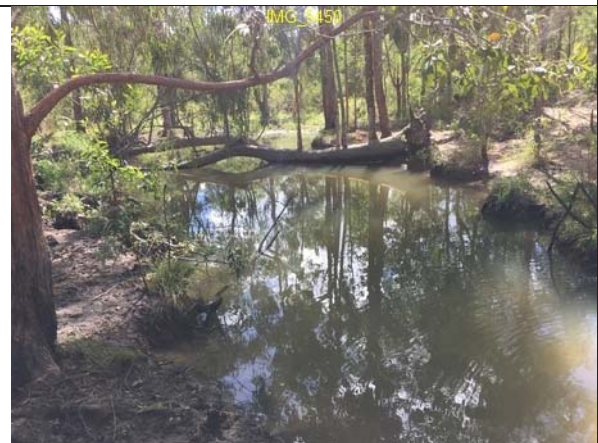
CH600 stable pond, bare banks surrounded by mature and regrowth trees, some livestock damage to fringe.

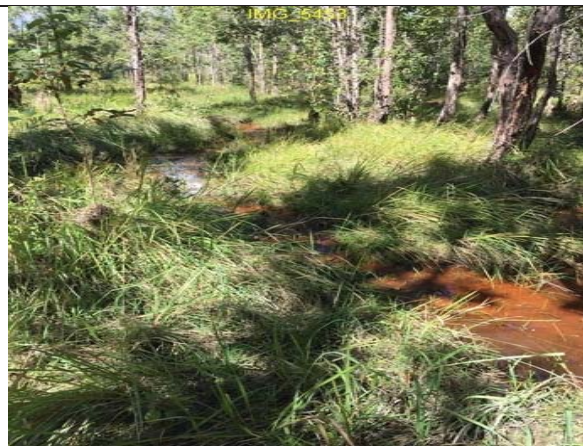
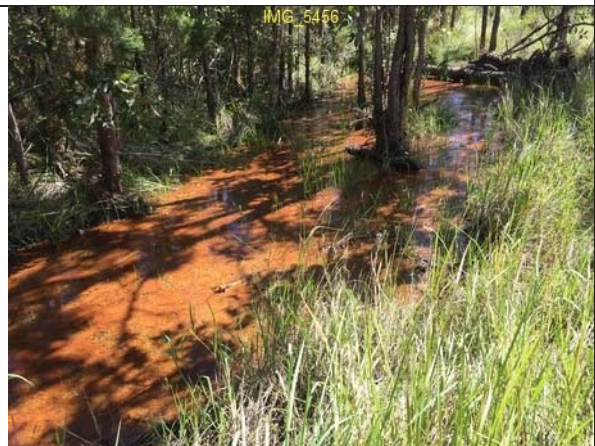
CH600-800 iron bacteria coloured low flow shallow channel surrounded by dense groundcover and moderate tree canopy. No significant instability within low flow.

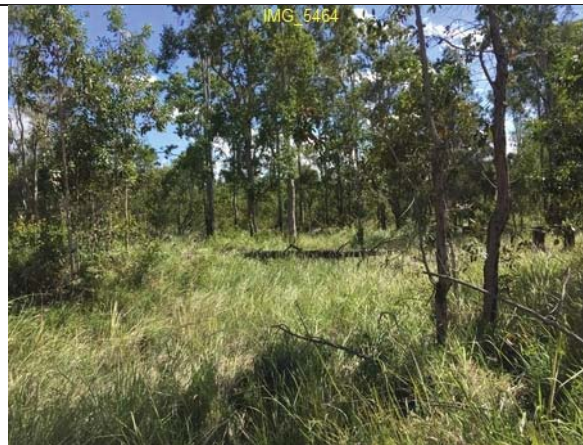
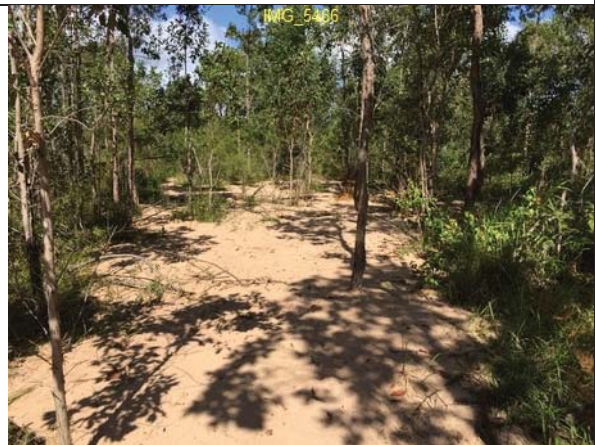
CH800-850 well grassed broad flow path with localised sediment slug interspersed (material from upstream chain of ponds/scour pool)

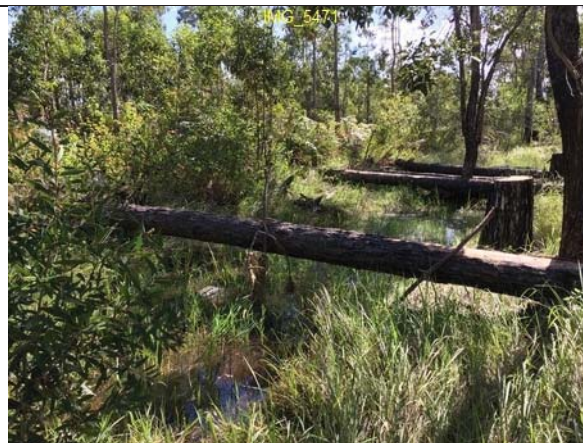
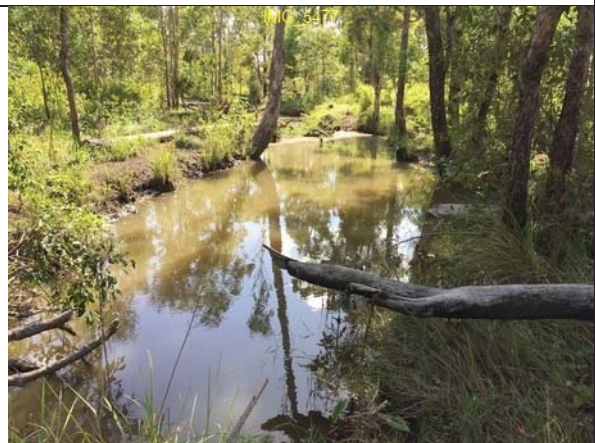
CH850-950 Chain of ponds surrounded by dense vegetation. Local areas of instability and/or livestock damage.

| SOUTHERN TRIBUTARY | | |
|---|---|---|
| <b>S8</b> | 880-930 | Chain of ponds (scour pools) with establish trees – review habitat and undertake targeted works to stabilise banks, remove/relocated vegetation, energy flow, revegetate livestock damaged banks, and monitor development. |

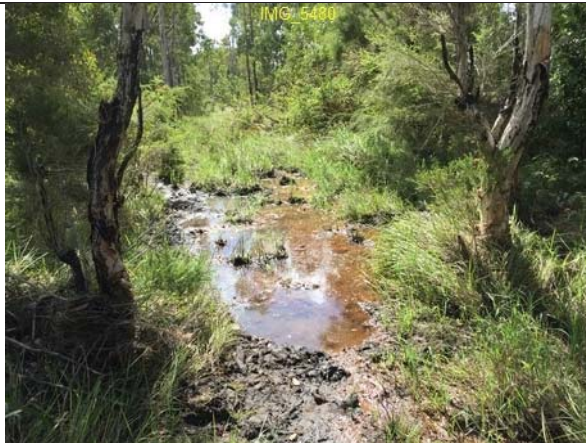
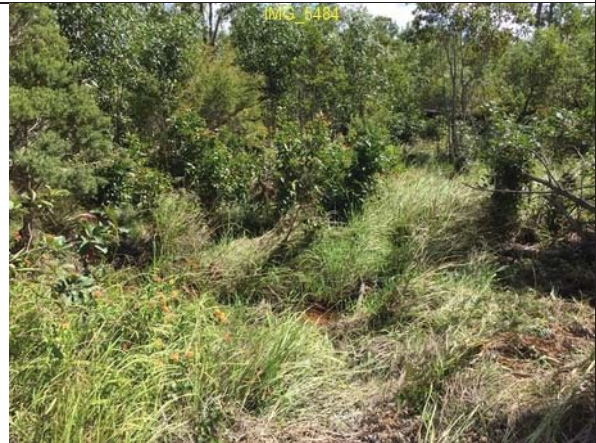
CH950-1200 livestock disturbance, iron rich seepage within undefined low flow channel surrounded by dense ground and tree cover.

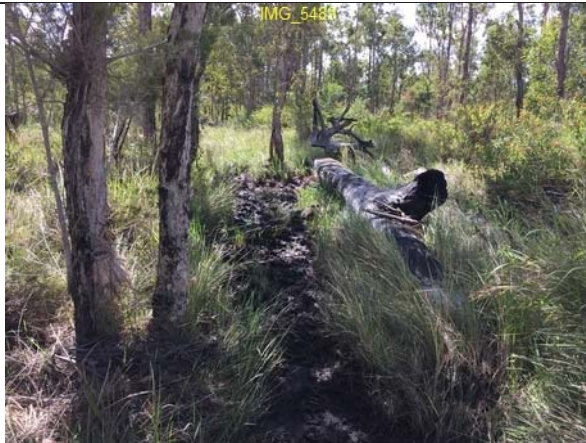
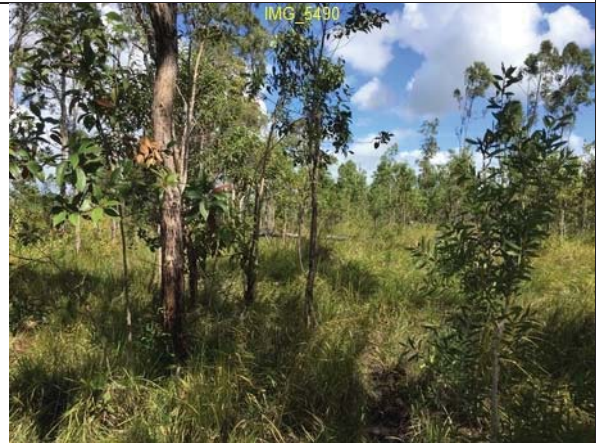
CH1200-1300 dense grass surrounding iron rich low flow channel with pockets of livestock disturbance. Minimal instability issues.

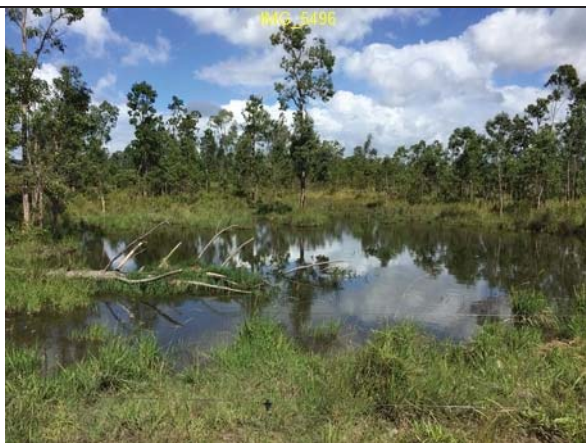
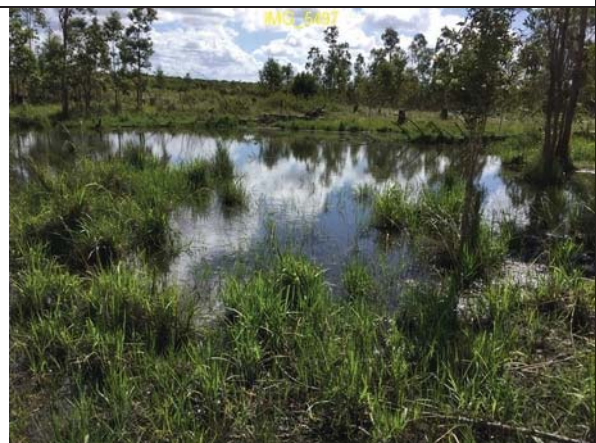
CH1300-1350 moderate size pond ~30m x 50m (upstream of track crossing)

| SOUTHERN TRIBUTARY | | |
|---|---|---|
| <b>S11</b> | 1300-1350 | Ephemeral wetland/pond - review habitat value with ecologist and undertake targeted works to stabilise banks, decommission or stabilise track crossing at downstream, revegetate livestock damaged banks and monitor following upstream development. |

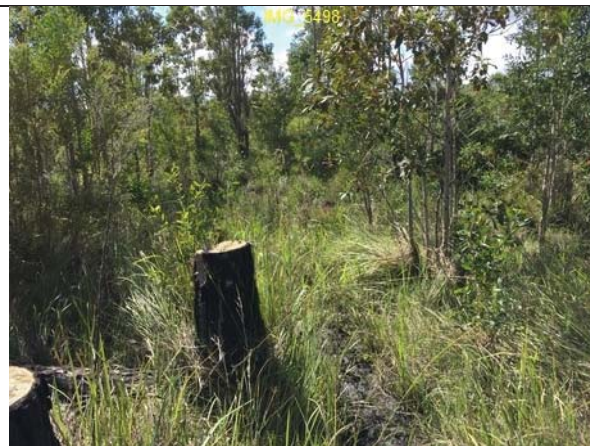
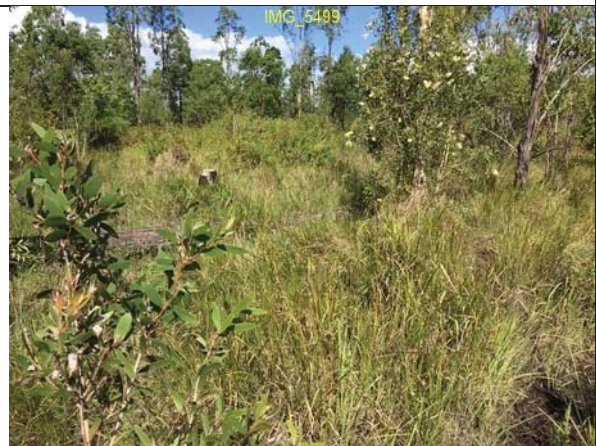
CH1350-1500 dense grass, regrowth and very low seepage evident in localised pockets (no defined channel)
