# Appendix K

## Fauna Flora Management Plan

**RE: FAUNA FLORA MANAGEMENT PLAN FOR STAGE 4a OF CARSELDINE VILLAGE RENEWAL MASTERPLAN**

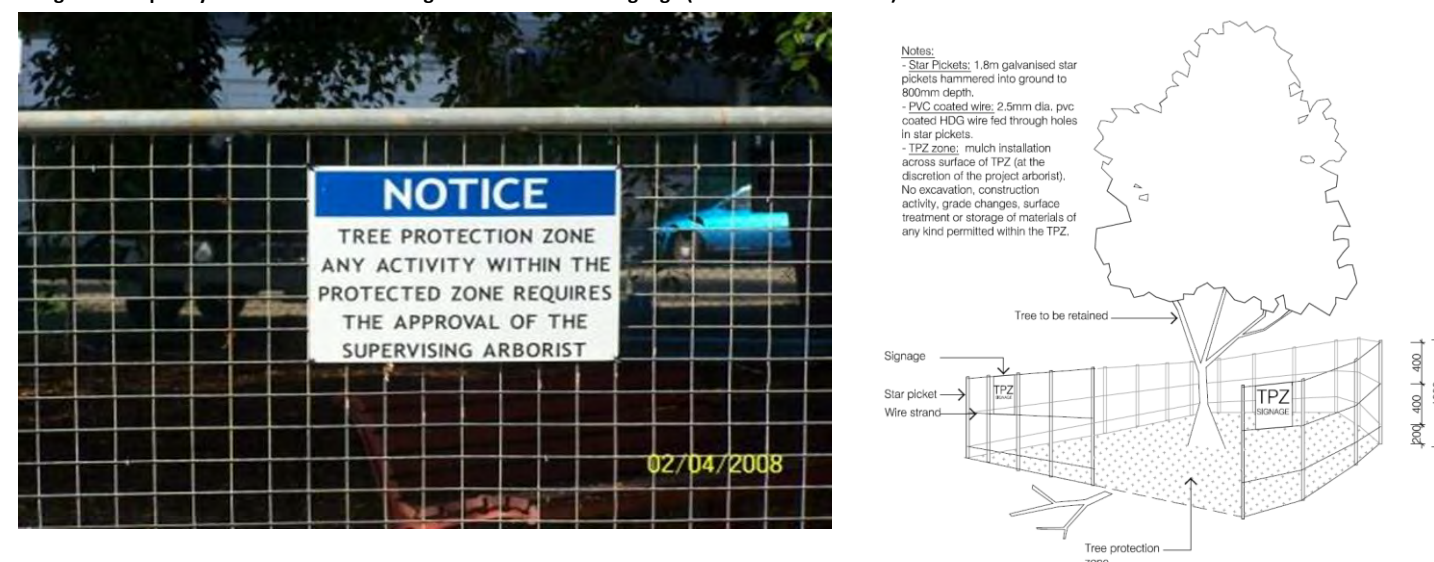
Image 3 – Temporary Metal Exclusions Fencing and Exclusion Zone Signage (Source Arbor Australis)

The Project Manager will be ultimately responsible to the establishment of or engage a contractor to establish the necessary Tree Protection Fencing in accordance with the recommendations by Project Arborist. Tree Protection Fencing must be erected under the direction of the Project Arborist and remain erected prior to and during all phases of the clearing and construction. Fencing may only be removed once construction works have been fully completed. Tree Protection Fencing requirements are outlined below:

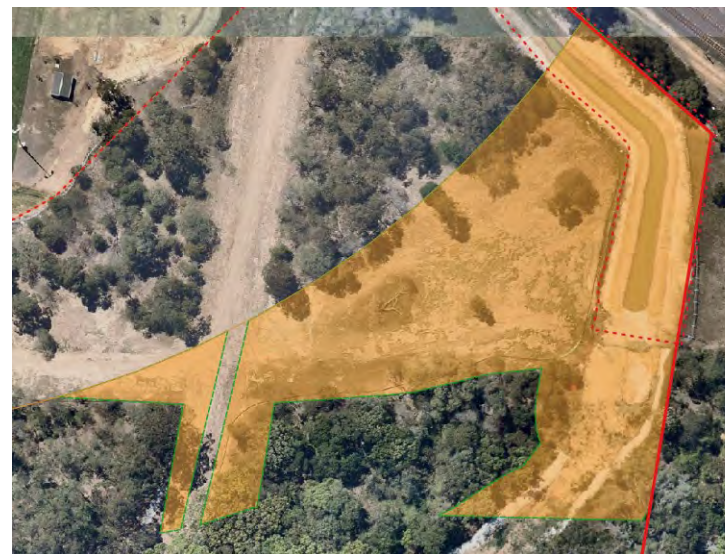
**Inset 3 – MU1B Open grassy expanses on the upper alluvial terraces (Preclear RE12.3.11b)**

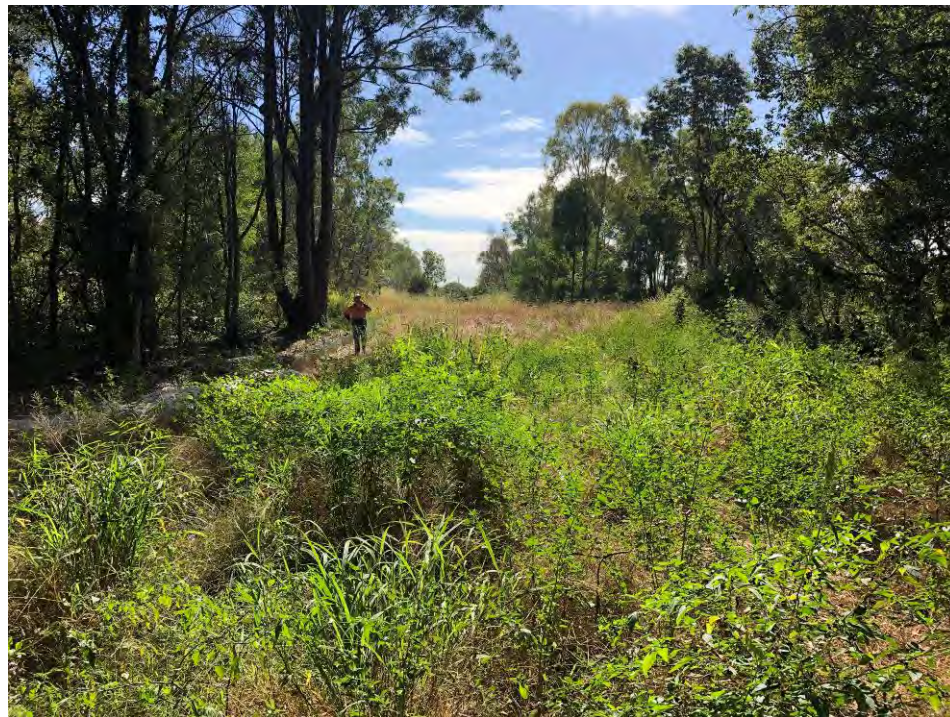
**Inset 1 – View of MU1A - area subject to recent clearing for stormwater management for Stage S.**

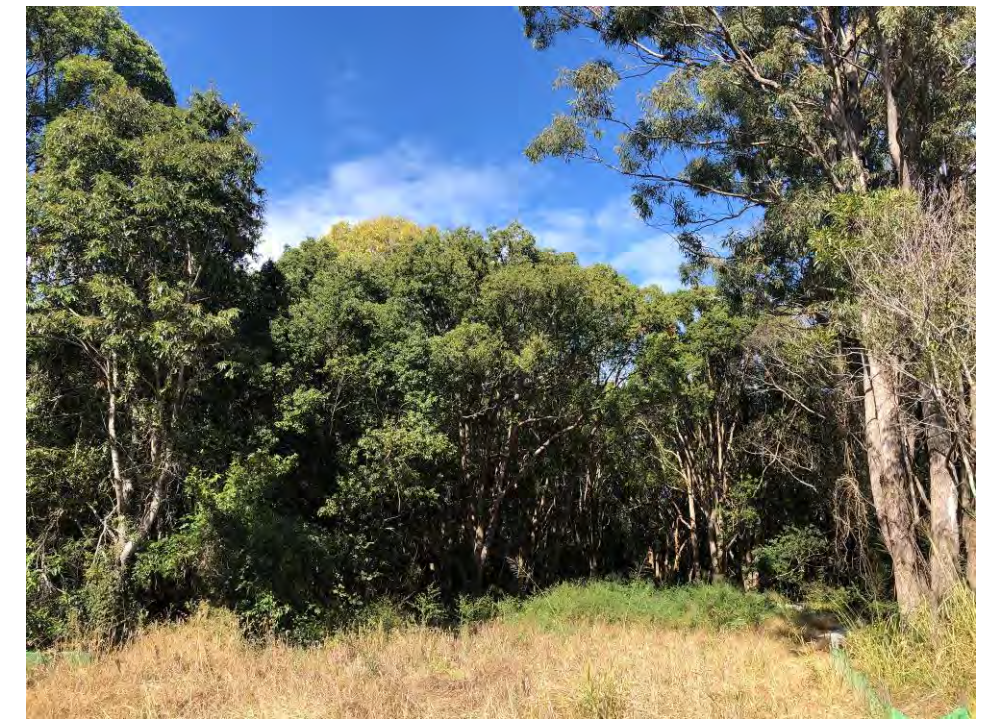
**Inset 5 – View of MU2 and the significant areas dominated by camphor laurel**

MU 2 is located within the far south eastern extent of the CV boundary and encompasses an existing patch of highly degraded vegetation. The existing vegetation is dominated by *Cinnamomum camphora*\* (camphor laurel), a highly invasive woody weed species with some highly scattered juvenile native canopy trees. This MU is considered to be non-remnant vegetation for the purposes of satisfying the compensation requirements under the FBMP and is a total of 0.59 hectares

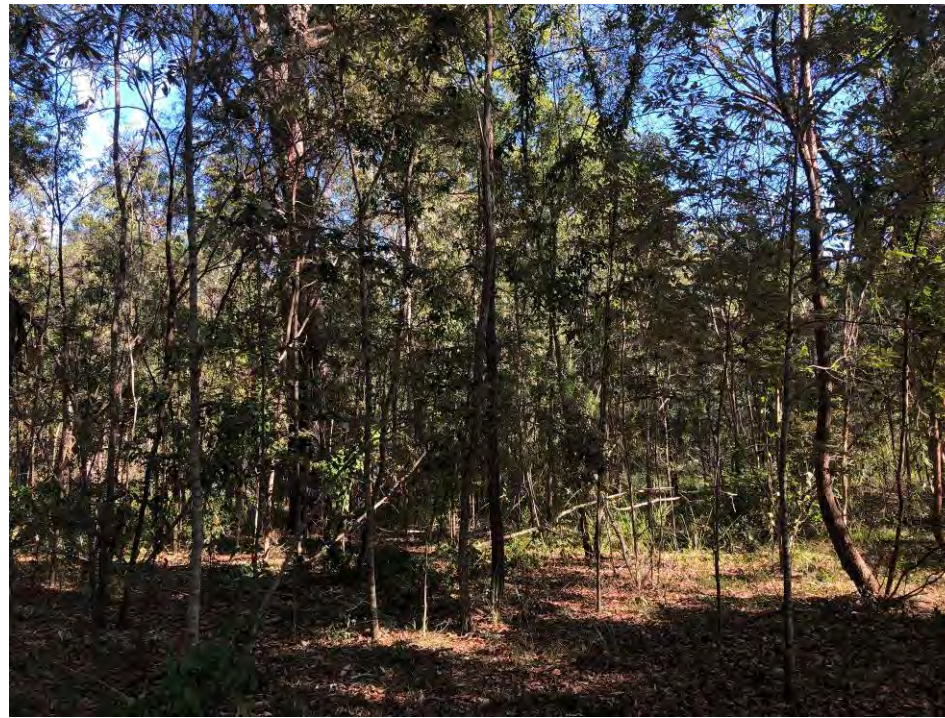
**Inset 7 – View of regrowth forest (MU3) and the dense stands of Acacia**

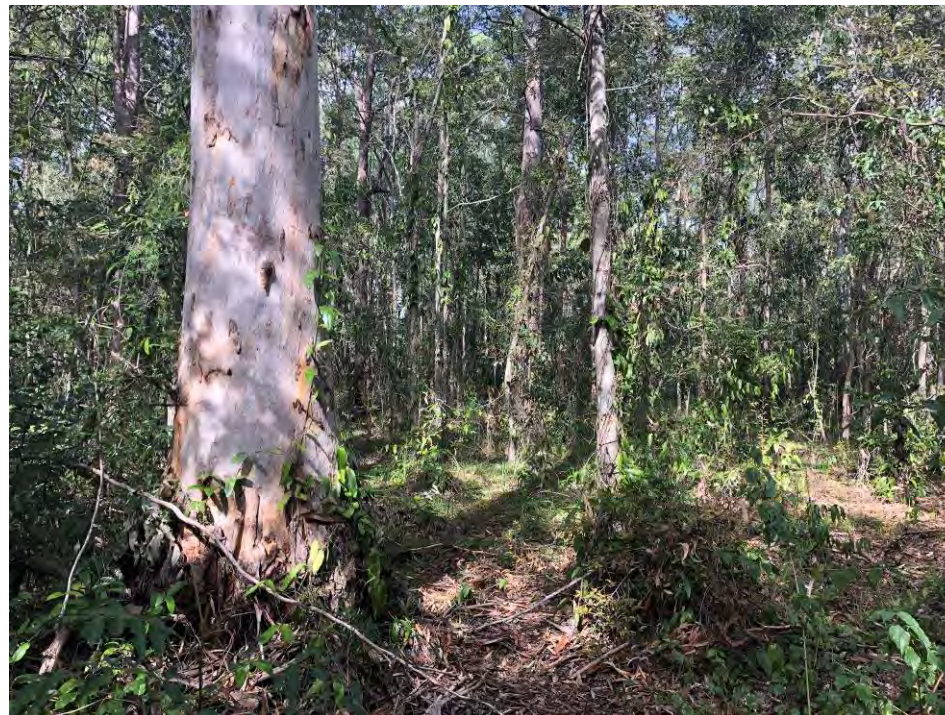
**Inset 8 – View of remnant open forest community (MU 4)**

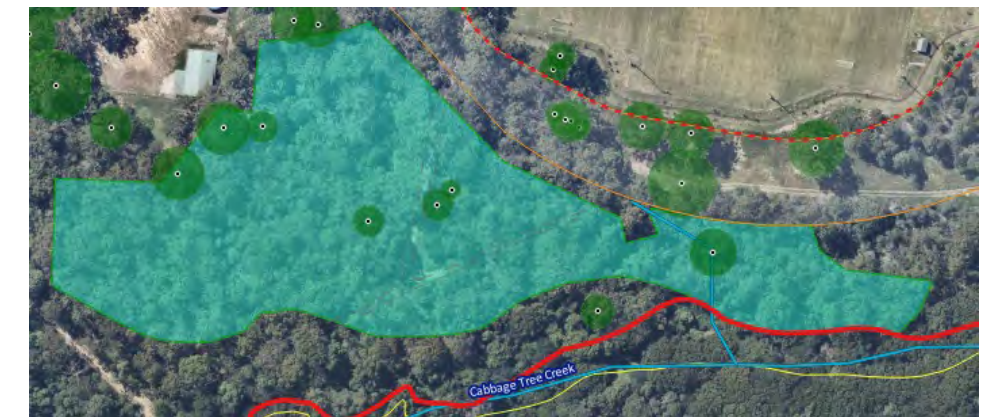
**Inset 9 – View of MU4 and the extent of remnant vegetation to be subject to ANR**

This community has a strong natural resilience and will benefit from weed management measures. The intent for this MU is to retain and enhance the open forest communities through natural regeneration methods. The main focus within this MU is to control, treat and remove the pest plant species, most notably the exotic understory. There are numerous exotic species present that will require attention the majority of which are listed in **Table 8**.
