Marine Plant Monitoring  
Program

Redland Bay Islands Vehicle  
Ferry Terminal Upgrade

Client: Sealink

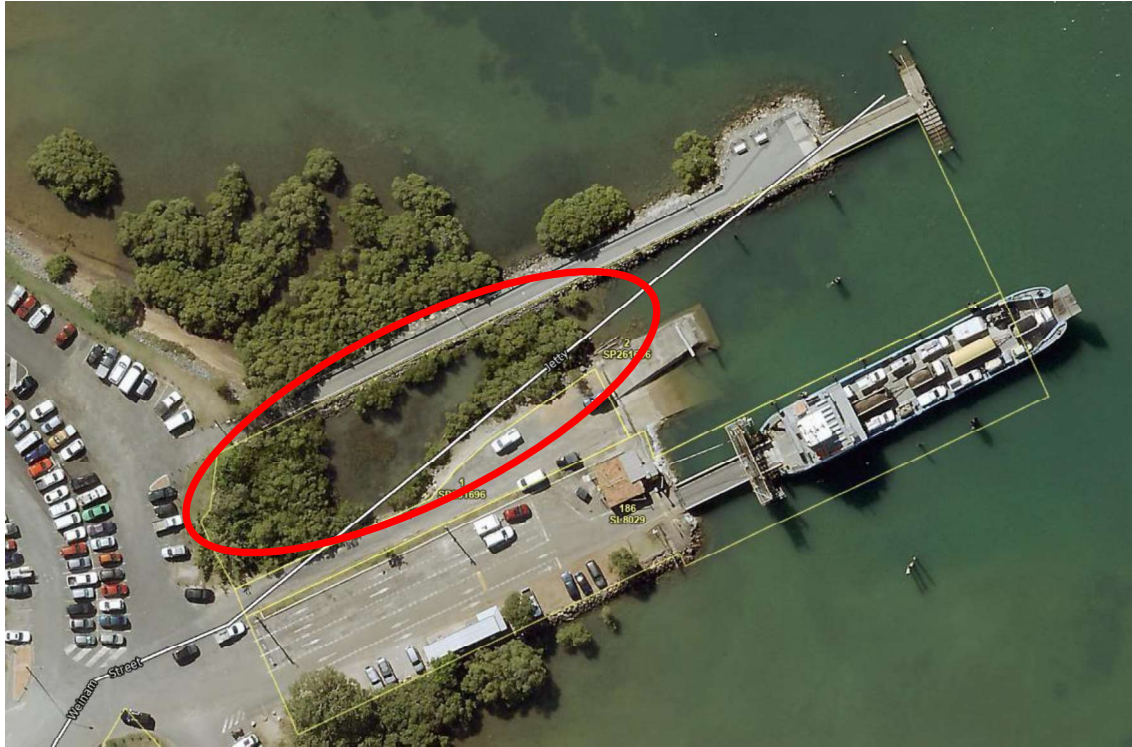
Figure 1. Marine plant impact site

The existing ferry terminal has capacity to cater for two ferries and includes an area for vehicle queuing, a site office and other facilities. The vehicle ferry terminal is used by workers and tourists to access the southern Moreton Bay islands of Macleay, Russel, Lamb and Karragarra as well as North Stradbroke Island. Mangroves are present immediately to the north of the facility within a small enclave formed by the ferry terminal and the public jetty (see **Figure 1**). This area of marine plants is proposed to form the focus of the investigation.

The marine plants present comprise a narrow band of grey mangrove (*Avicennia marina*), with several other species such as orange mangrove (*Rhizophora stylosa*) and river mangrove (*Aegiceras corniculatum*) also present. Some salt marsh species are also present in proximity to the existing revetment wall.
