**Appendix J**  
**Civil Engineering Report and Functional Layout Plans**

# CARSELDINE VILLAGE STAGE 4B

## ENGINEERING SERVICES REPORT

KN GROUP  
MARCH 2022

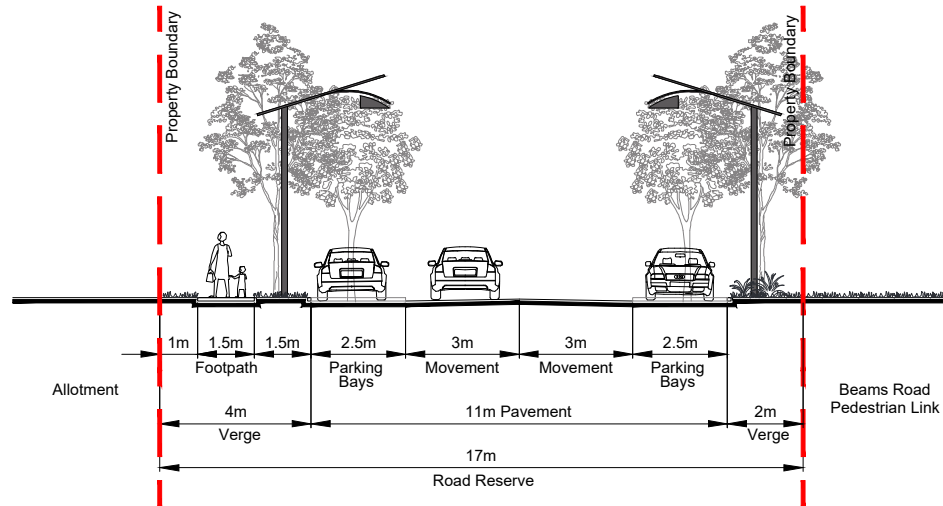
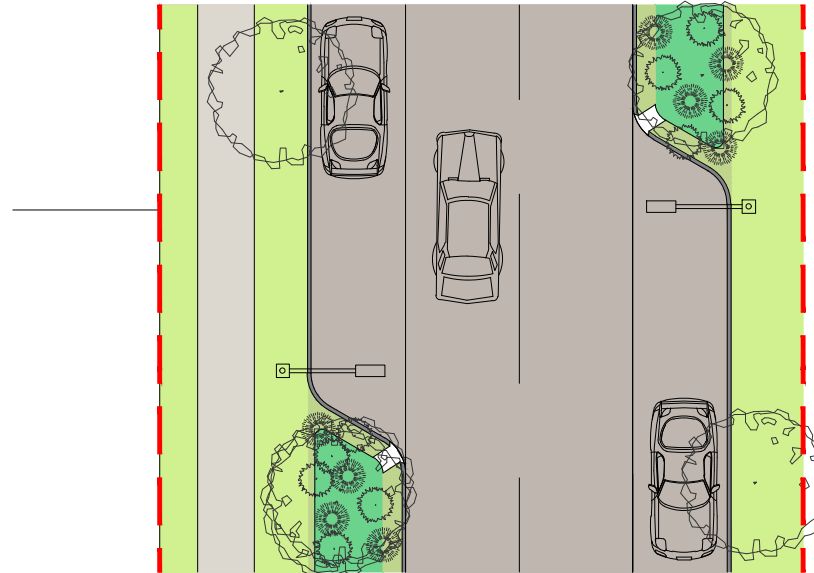
# Access Place - 17m Wide

**Disclaimer:** Cross Sections are indicative only and subject to detail design. Location of pavement subject to change through detailed design of landscape and servicing.

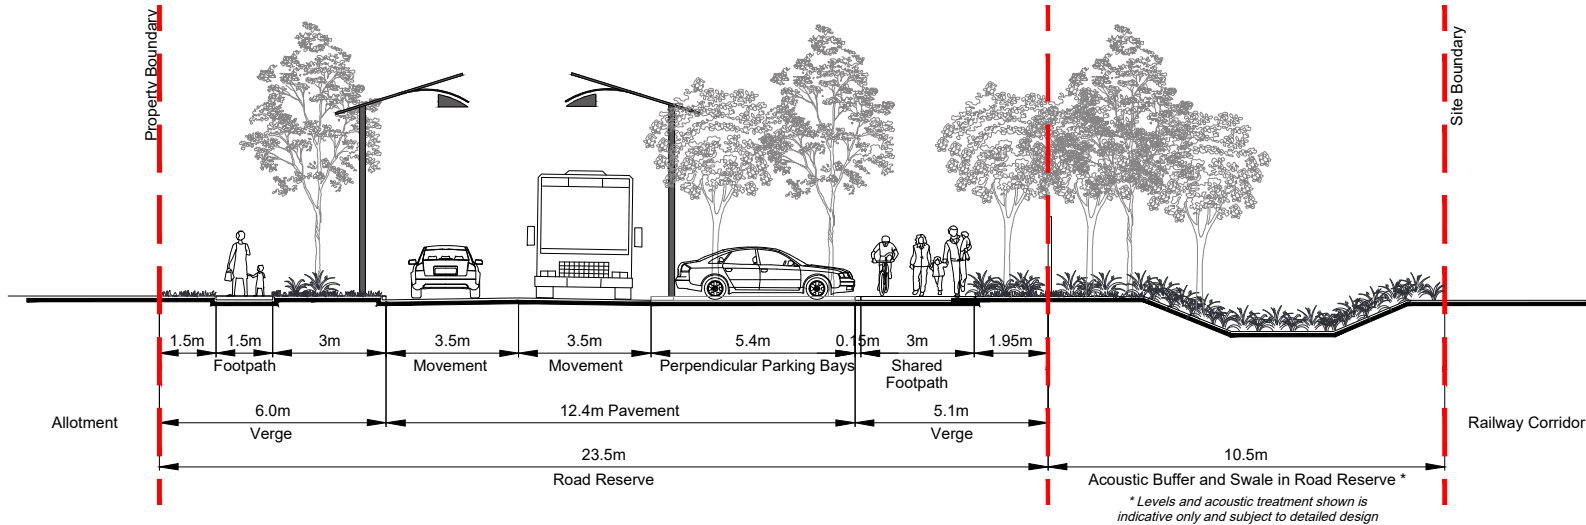
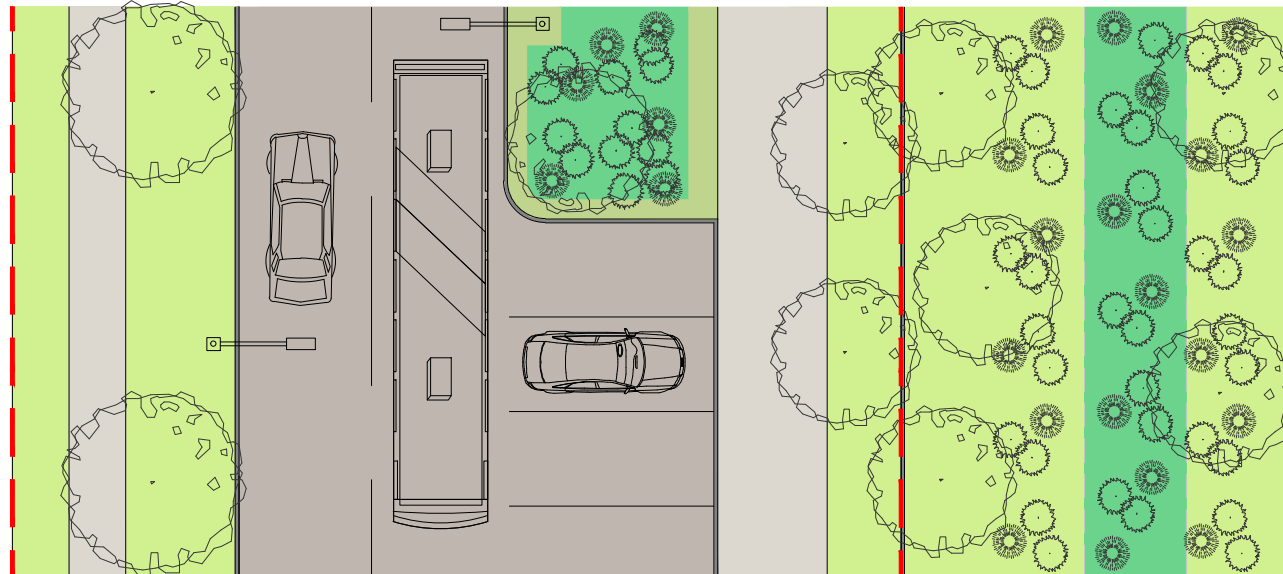
# Railway Esplanade - 23.5m + 10.5m Buffer

**Disclaimer:** Cross Sections are indicative only and subject to detail design. Location of pavement subject to change through detailed design of landscape and servicing.

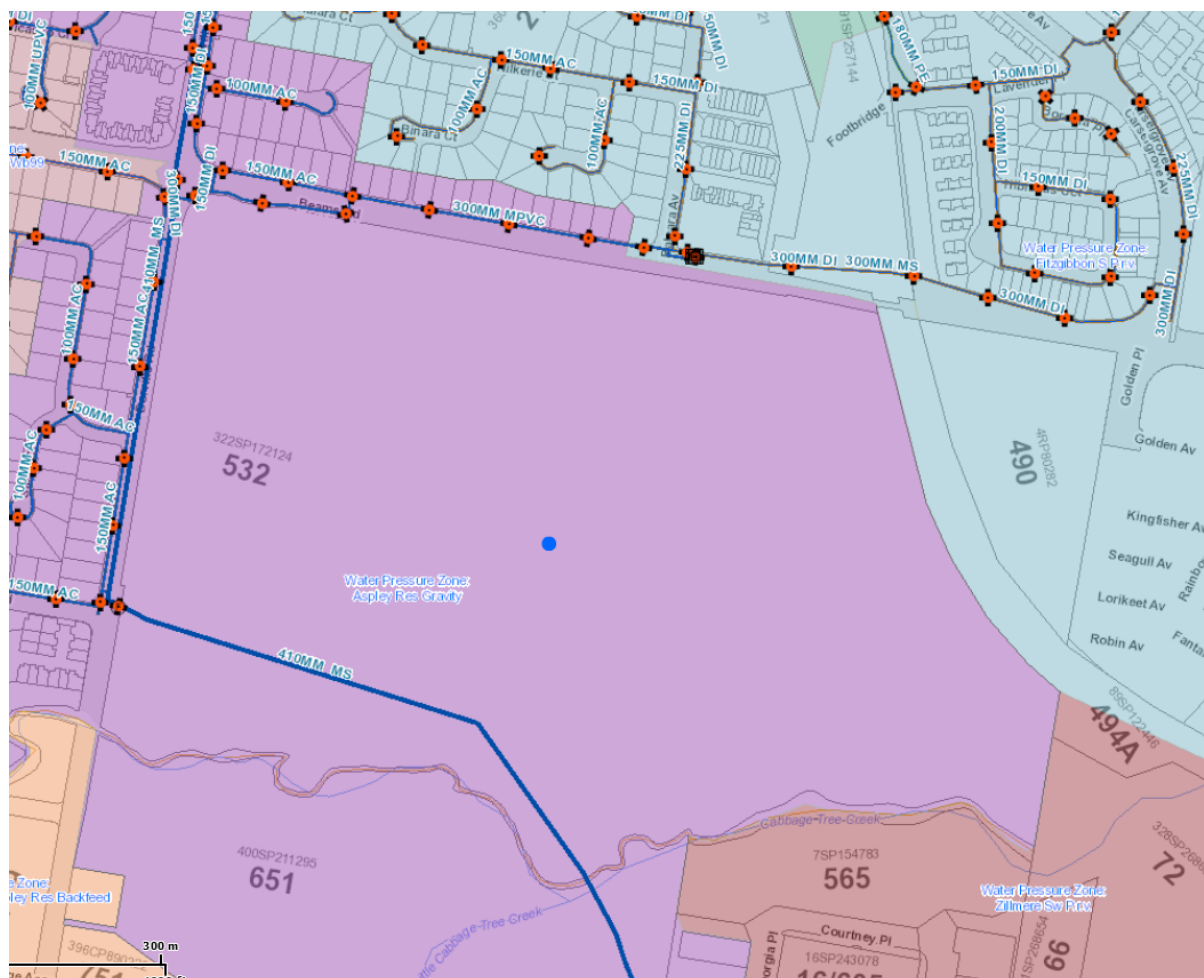
**Figure 1:** Existing Water infrastructure within the vicinity of the subject site

The subject site is located at Aspley Reservoir Gravity water pressure zone.

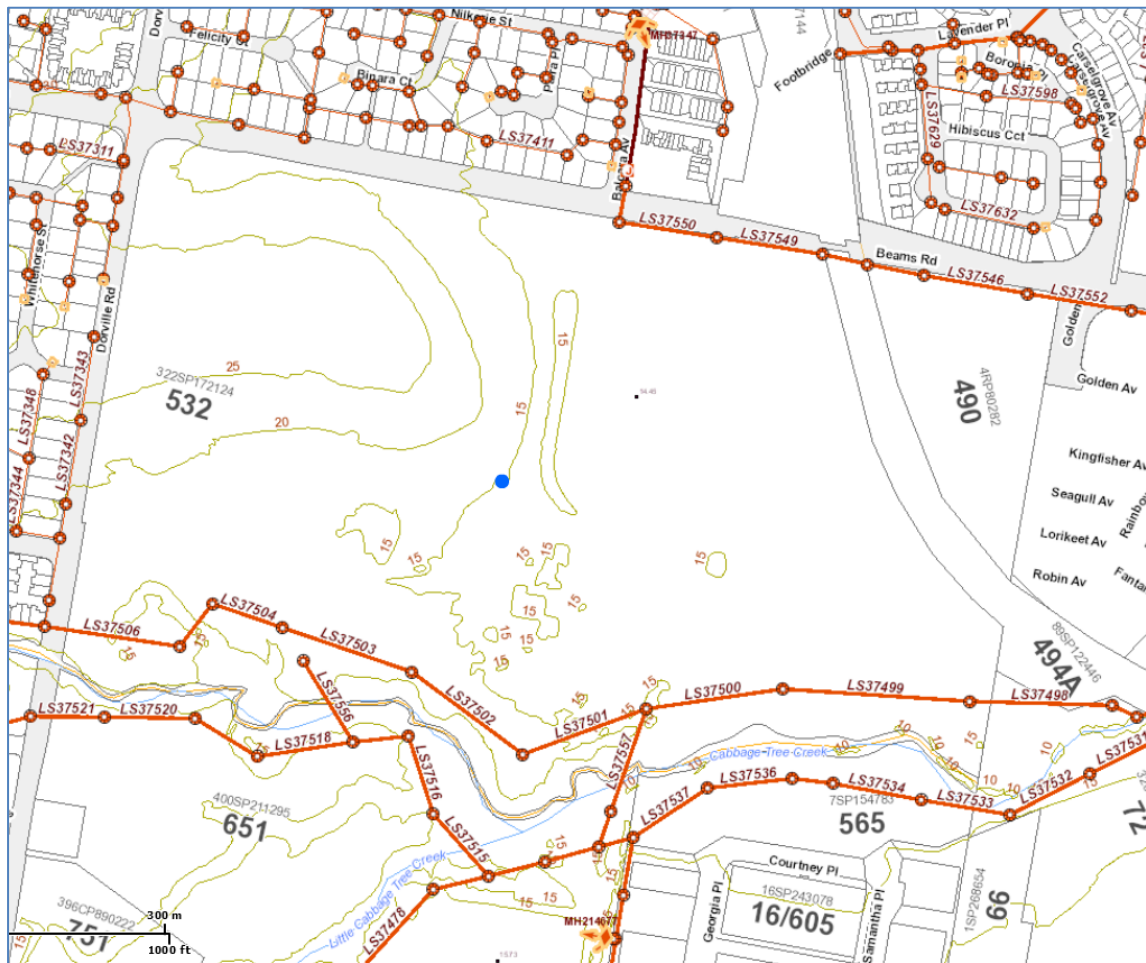
Figure 1: Existing Wastewater infrastructure within the vicinity of the subject site

The subject site is currently serviced by connection to the existing DN300 VC trunk sewer at the near side of Beams Road.

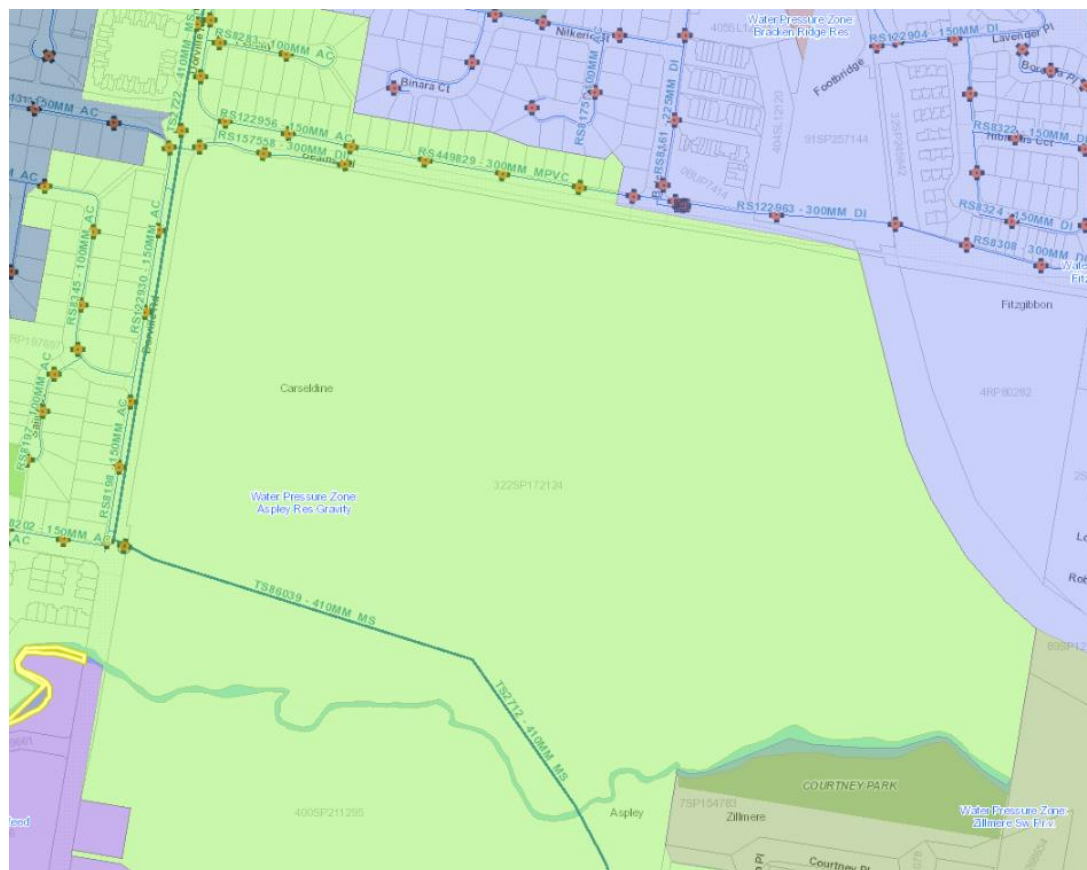
**Figure 1** – Development site and surrounding water supply network

The development site is located at the Aspley Reservoir Gravity Water Pressure Zone. A map of existing infrastructure is provided in Figure 1.

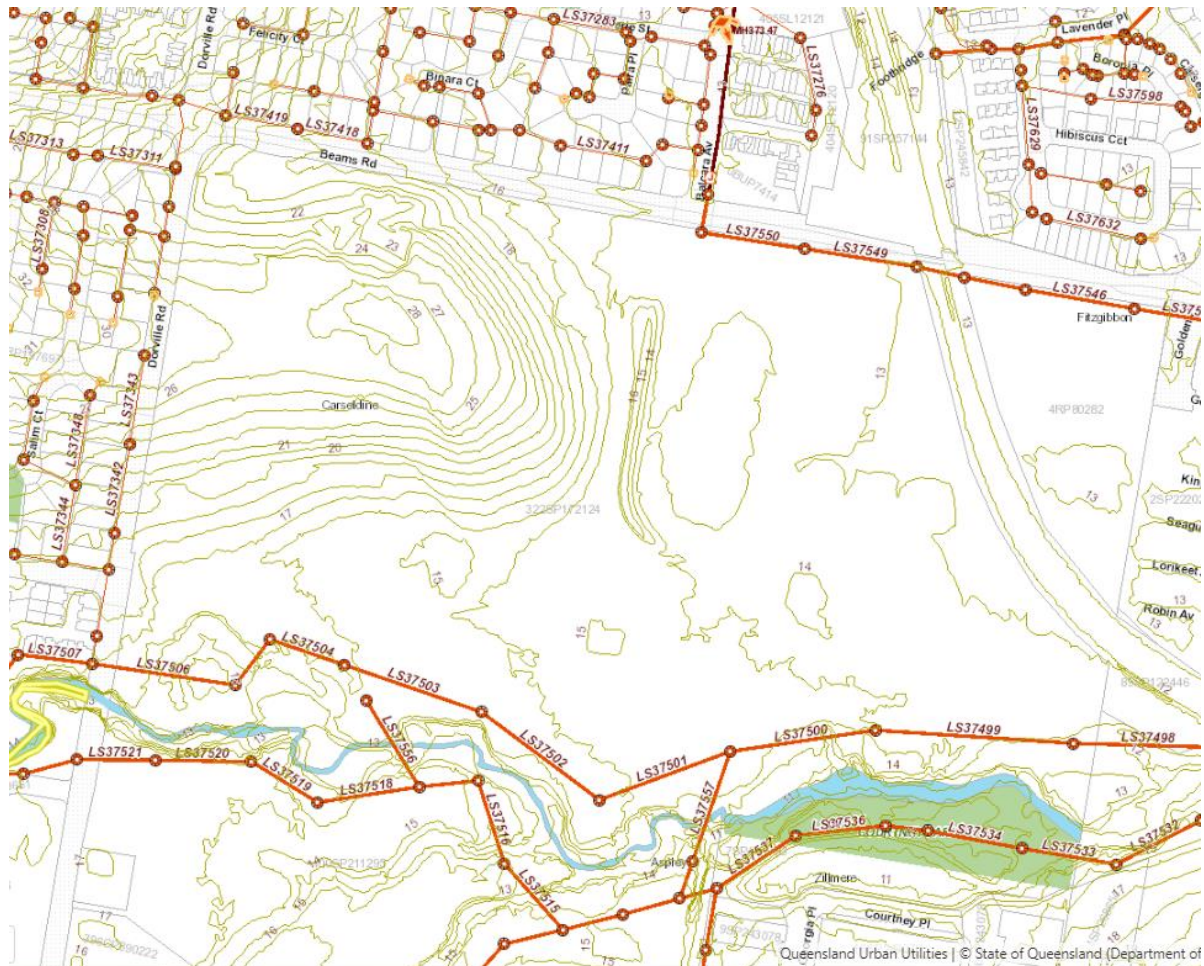
**Figure 2** – Development site and surrounding Sewer network

As per the natural ground topography, the proposed development area drains towards the existing 825mm dia. trunk sewer main (Cabbage Tree Creek Main sewer) in S5 catchment.

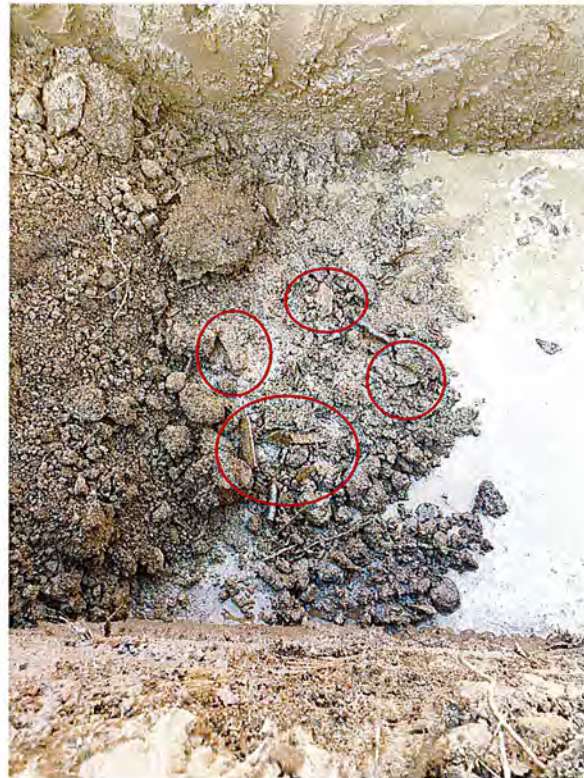
Plate 2: Observed ACM Fragments Post-Excavation

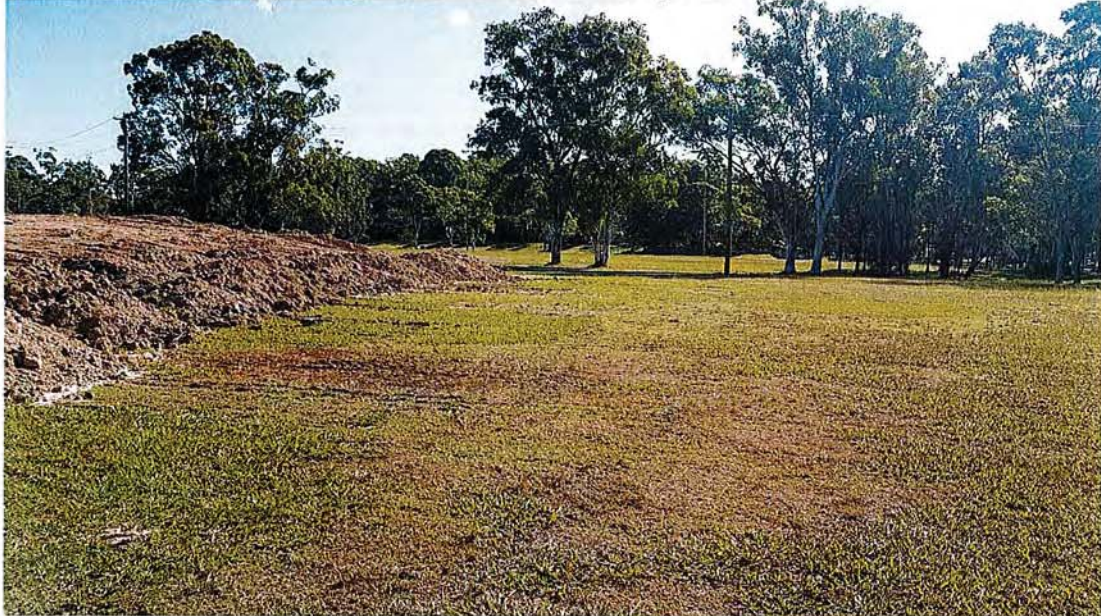
Plate 1: Stable land surface of the general site areas (i.e. intact topsoil cover)

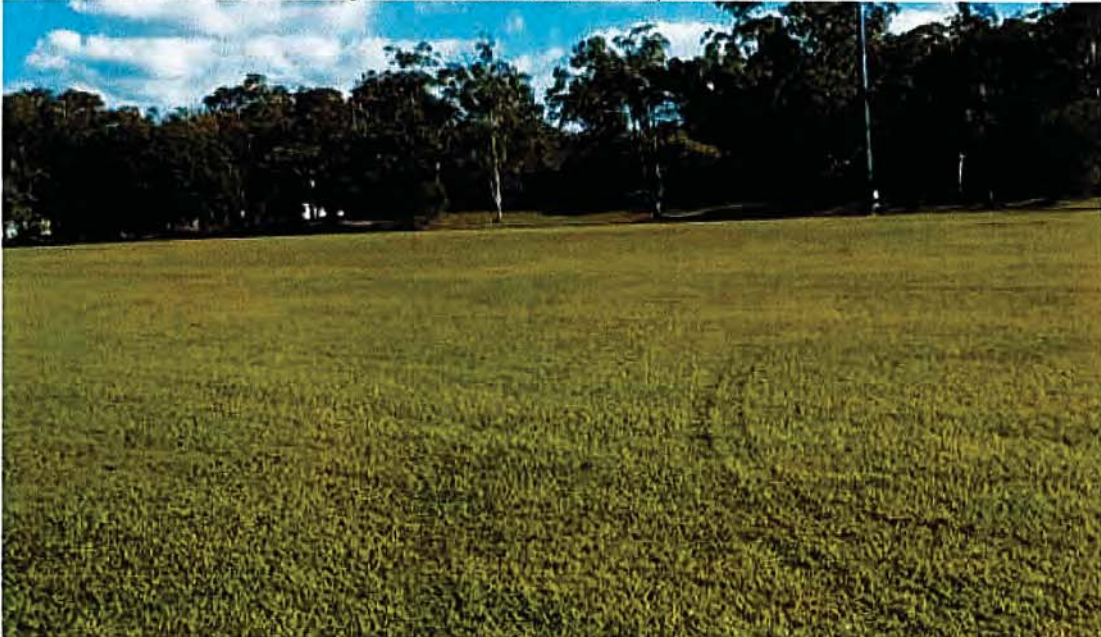
Plate 2: Stable land surface of the general site areas (i.e. intact topsoil cover)

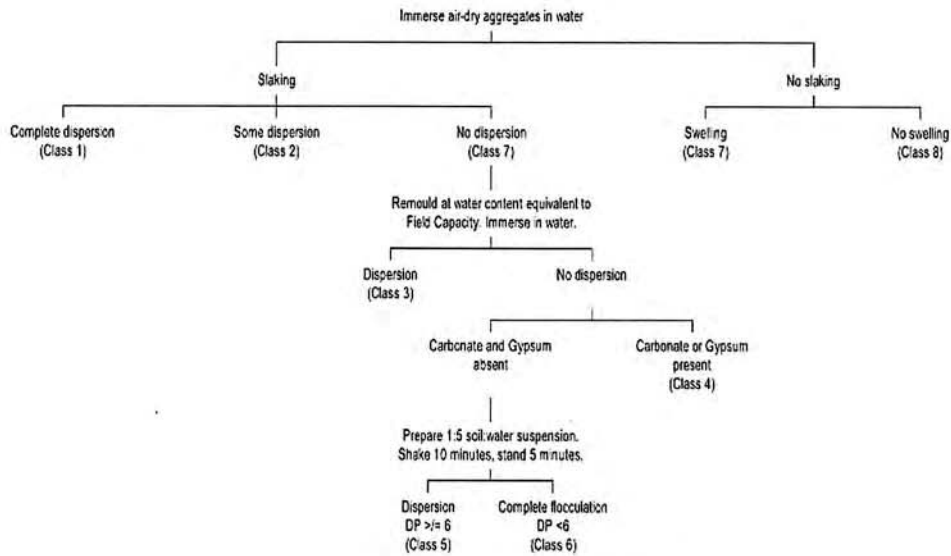
Figure 1. Determining the Emerson Class Number of Aggregates

Sample	Emerson Class
BH1: 0.0m	7
BH2: 0.0m	7
BH3: 0.0m	7
BH4: 0.0m	7
BH5: 0.0m	7
BH1: 0.7m	5
BH2: 0.7m	5
BH3: 0.8m	6
BH4: 0.6m	5
BH5: 0.5m	5
GS1	5
GS2	5
GS3	6
GS4	5

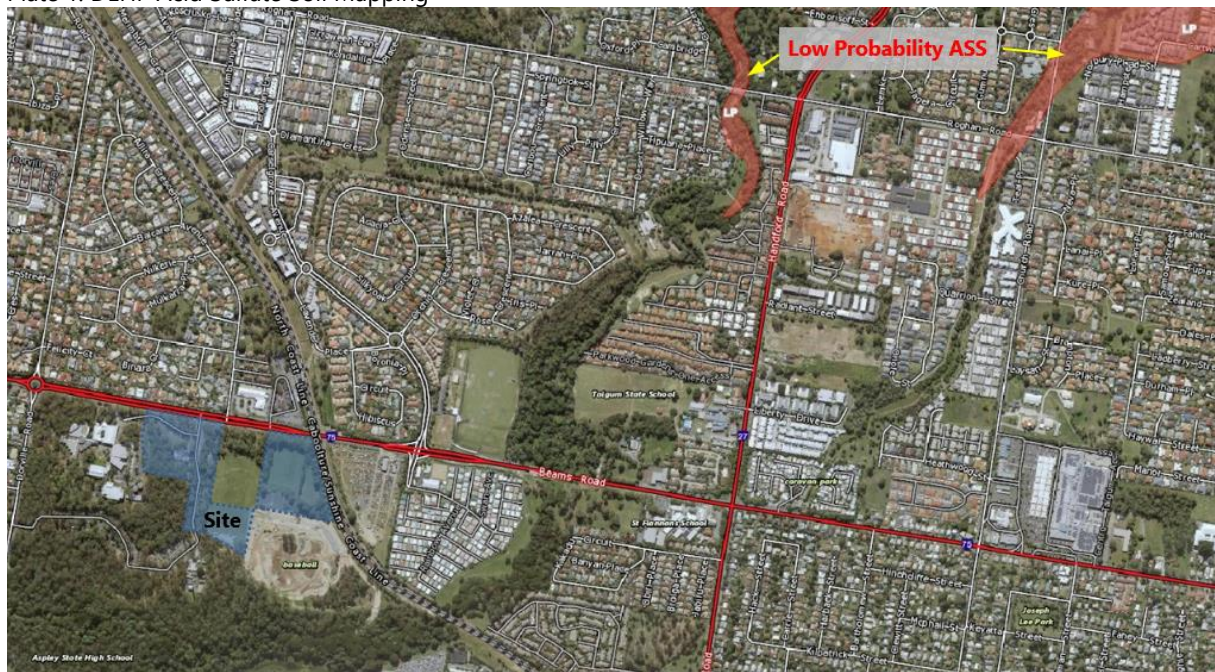
Plate 1: DEHP Acid Sulfate Soil Mapping

According to the Department of Environment & Heritage Protection (DEHP) 'Special Acid Soil Maps', the proposed development area has negligible probability of ASS occurrence. The nearest indication of ASS is associated with two (2) tributaries located to the north-east of the development with 'low probability of ASS occurrence'.

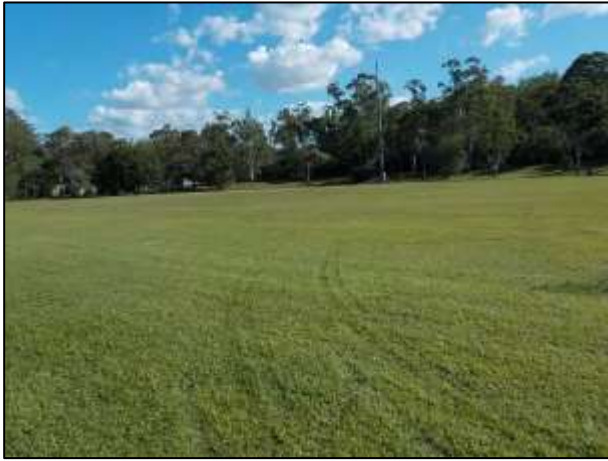
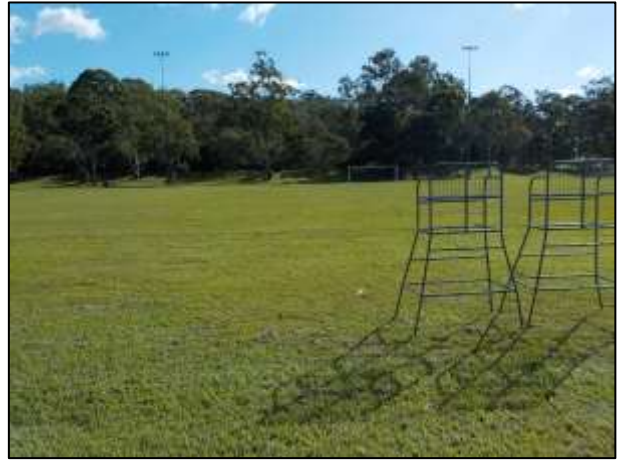
Photos taken facing west over playing fields with uncontrolled fill batter in background

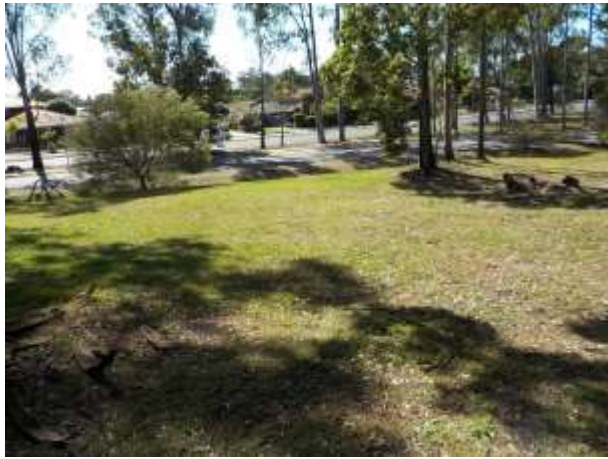
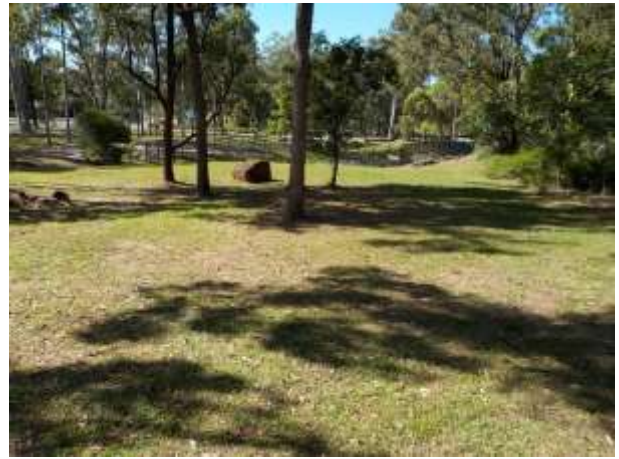
Photos taken facing north-east overlooking existing stormwater basin and Beams Road entrance

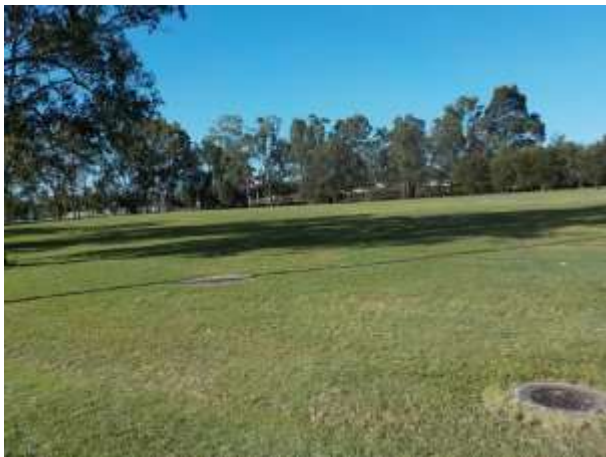
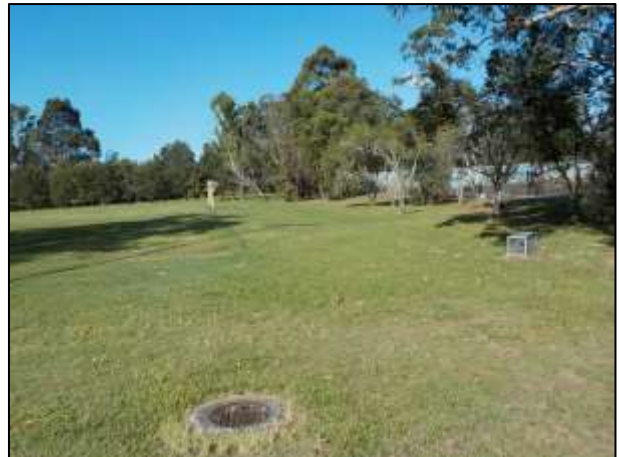
Photos facing north-east overlooking lower playing field and basketball courts
