## Report on Geotechnical Investigation

HMAS Townsville Permanent Docking

Ross Street (Creek), South Townsville QLD

Project 227086.00

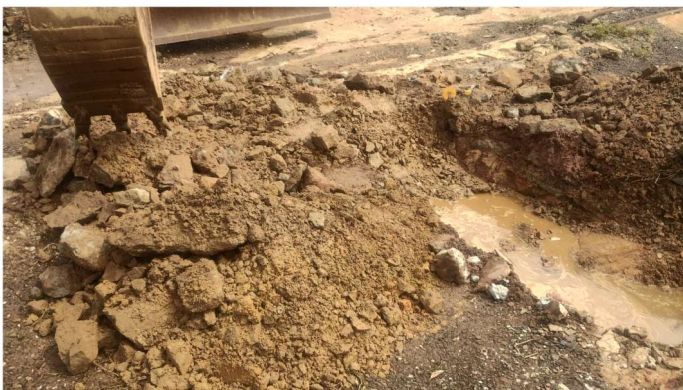
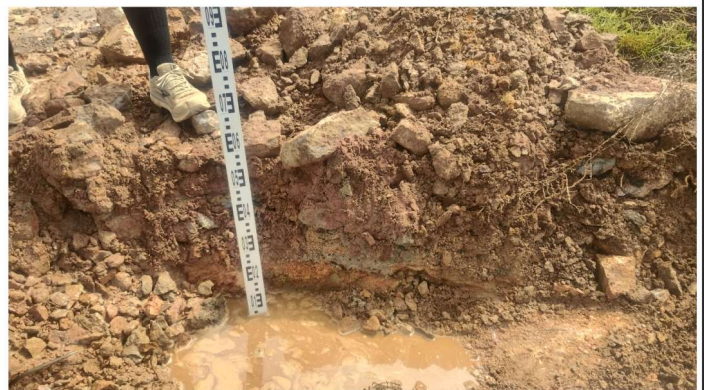
| CONDITIONS ENCOUNTERED | | | | | | | SAMPLE | | | TESTING AND REMARKS | | | |
|---|---|---|---|---|---|---|---|---|---|---|---|---|---|
| | | | Test Pit discontinued at 0.50m depth. Limit of Investigation. | | | | | | | | | | |

Subsurface conditions encountered within the test pits comprised non-reinforced concrete to up to 0.12 m depth, then clayey gravelly sand fill to 0.3 m depth in Pit 2. Below the concrete in Pit 1, and below the fill in Pit 2, residual silty gravelly sand was encountered to 0.3 m and 0.4 m depth, respectively, which was underlain by very low strength or stronger microgranite to virtual excavator refusal at depths of 0.5 m and 0.6 m.
