Geotechnical & Acid Sulfate Soils Investigation Report

Proposed Multi-Storey Residential Development

330 Macarthur Avenue, Hamilton

Report Number: J002466-001-R-Rev0

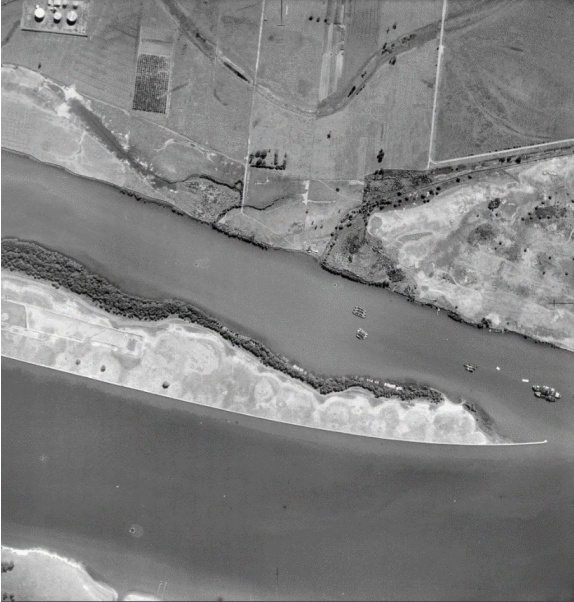
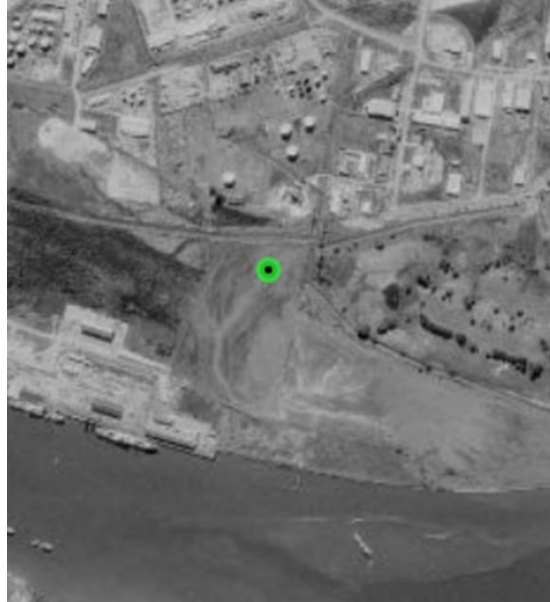
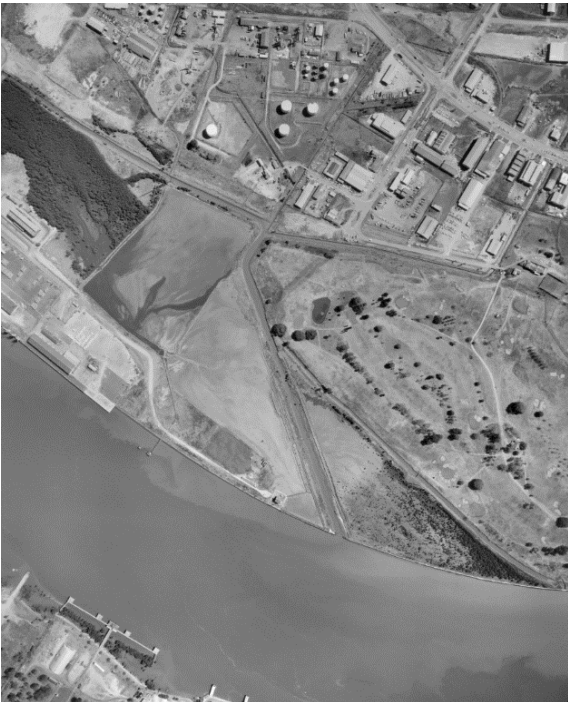
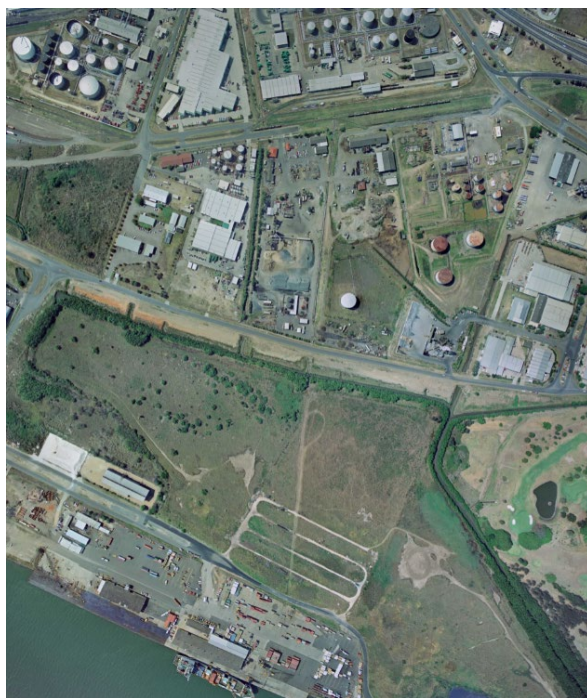
Image 5a: 1936 aerial image (QImagery).

Image 5b: 1967 aerial image (QImagery).

Image 5c: 1972 aerial image (QImagery).

Image 5d: 1991 aerial image (QImagery).

- In 1981 (refer Image 6d) there appears to be land reclamation at the site; after that the site appears grassed until the car storage was constructed sometime between 1994 and 1997.
- The site was used for shipping storage until 2009 at which time MacArthur Avenue was constructed and part of the site adjoining MacArthur Avenue became grassed whilst the remainder continued as vehicle storage.
- The vehicle storage was discontinued by late 2020 and construction of local roads had occurred.

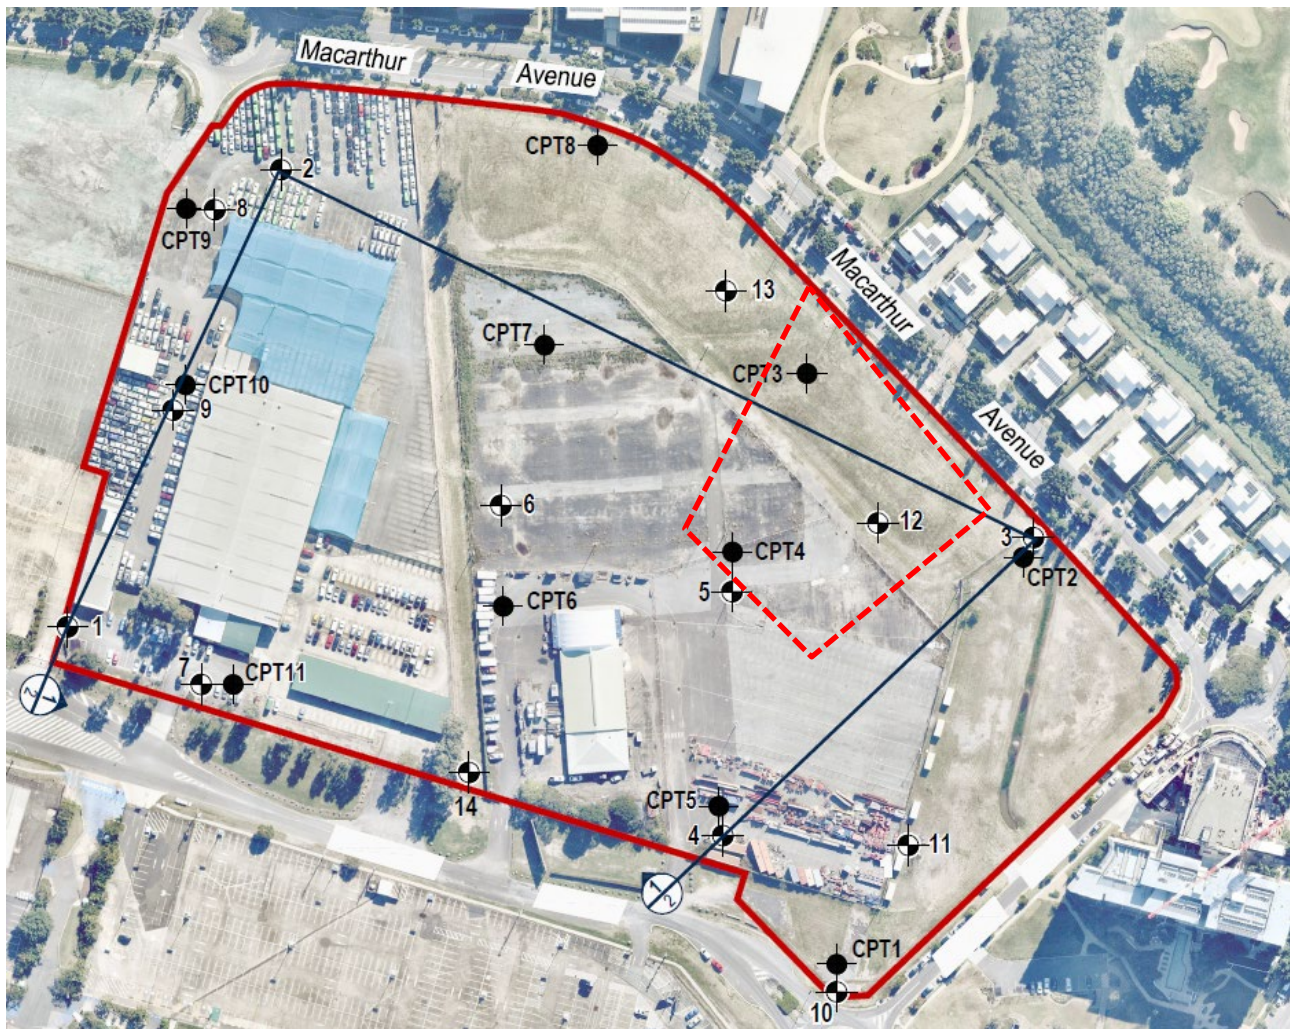
Image 6: Previous investigation locations (extract from Butler Partners report, site location by Core).

- 'Upper alluvium' (possibly including some dredge spoil) comprising very soft to firm clay to about 6.5 to 7.5 m BGL, then very loose to loose clayey sand (with a firm clay band in places) to about 16 m BGL.

- Lower alluvium comprising loose to medium dense clayey sand (with stiff clay bands in places) then medium dense with dense material encountered below about 30 m to 31 m BGL where the CPTs met refusal.

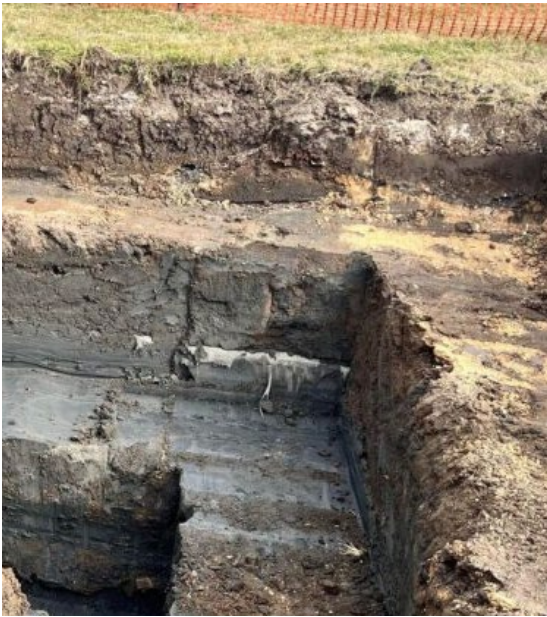
Image 8: Soil strata from surface to 3m BGL.

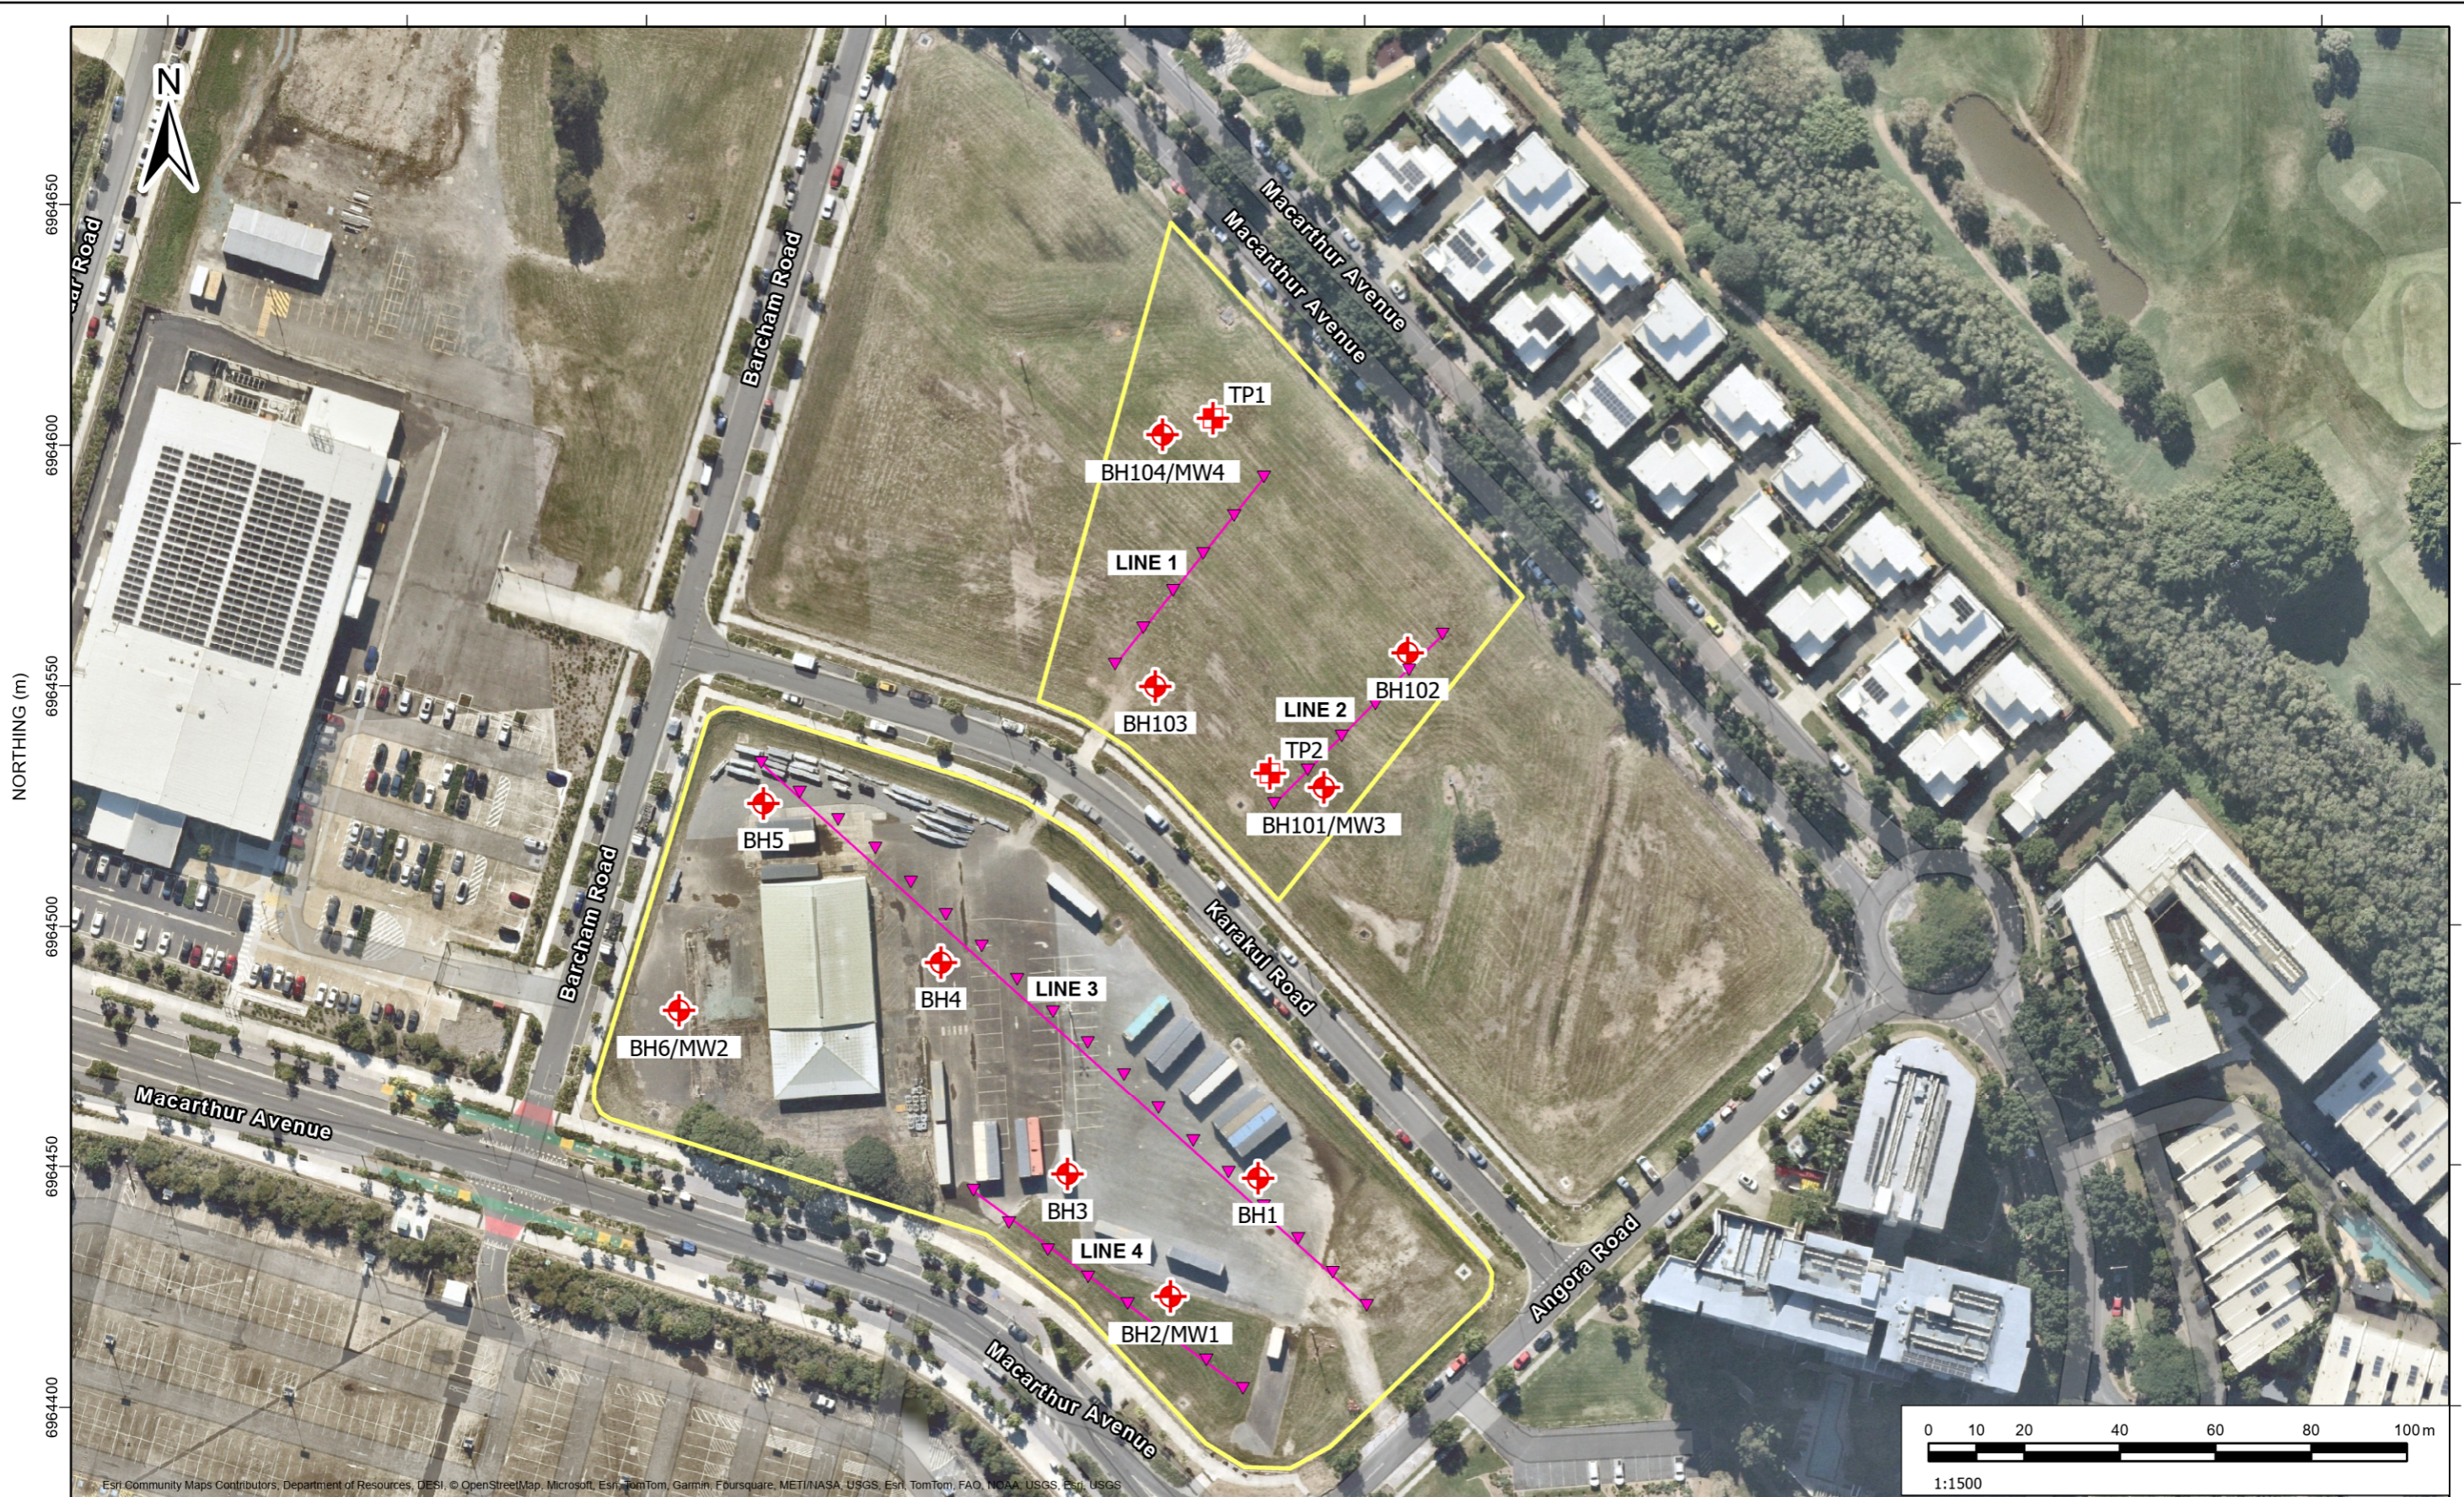
CLIENT SILVERSTON DEVELOPMENTS		PROJECT GEOTECHNICAL AND ACID SULFATE SOILS INVESTIGATION			
DRAWN BY MR	DATE 19/07/2024	DRAWING TITLE SITE BOUNDARY AND BOREHOLE LOCATIONS			
CHECKED BY EA	DATE 24/07/2024				
SCALE 1:1500	SHEET SIZE A3	PROJECT No J002466	DOC No 001	DOC TYPE R	FIGURE No F001
		REVISION 0	SHEET 1 OF 1
